**CCTV REPORT FOR: 41 KNOX GREEN
BINFIELD
BRACKNELL
RG42 4NZ**

Insured: Mrs Alison Sinclair
Reference: DLG-SN-22-004171 Ins Ref: 083212738

Site Visit: 04-Jul-22
Report Date: 09-Aug-22

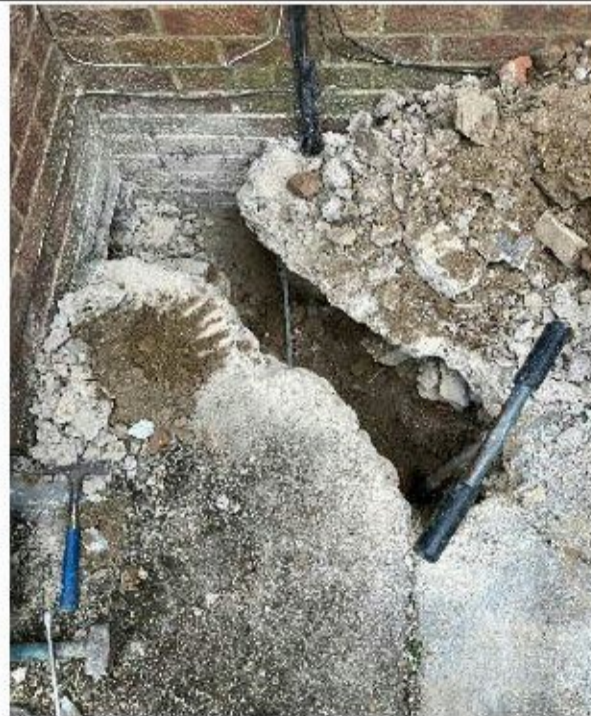
Photograph

General Comments :
 House appears to be built off a concrete raft with a 0.9m spread.

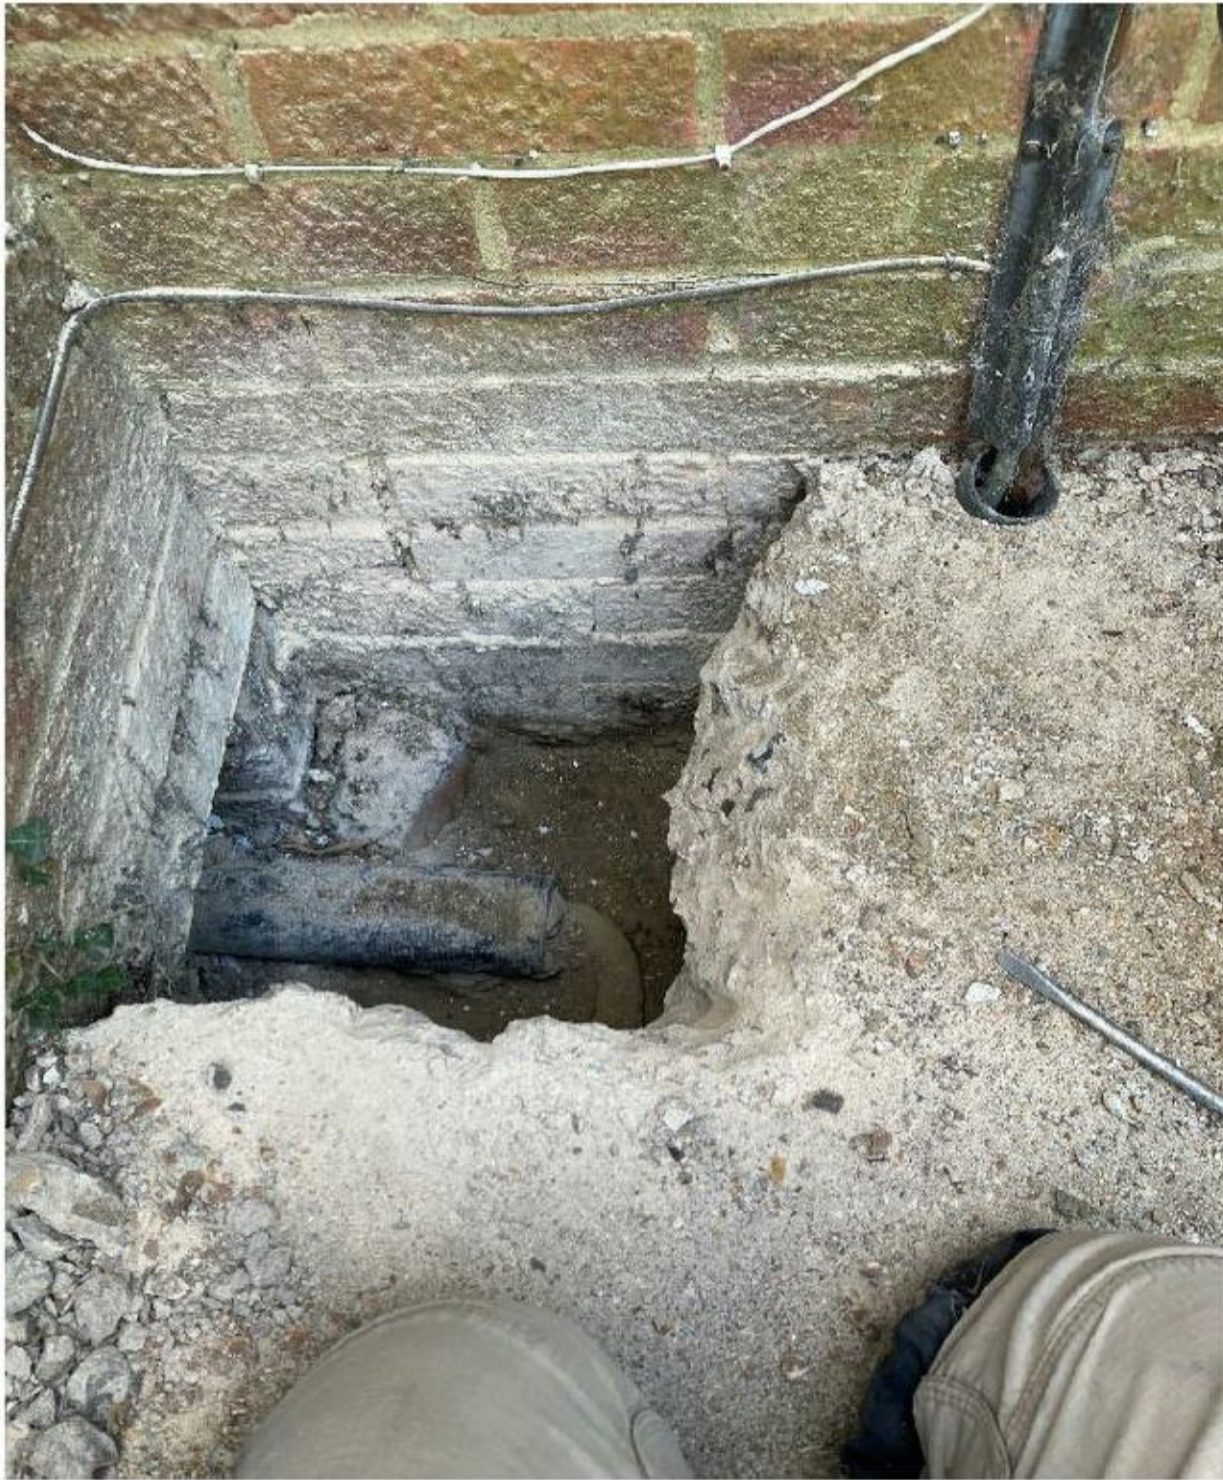
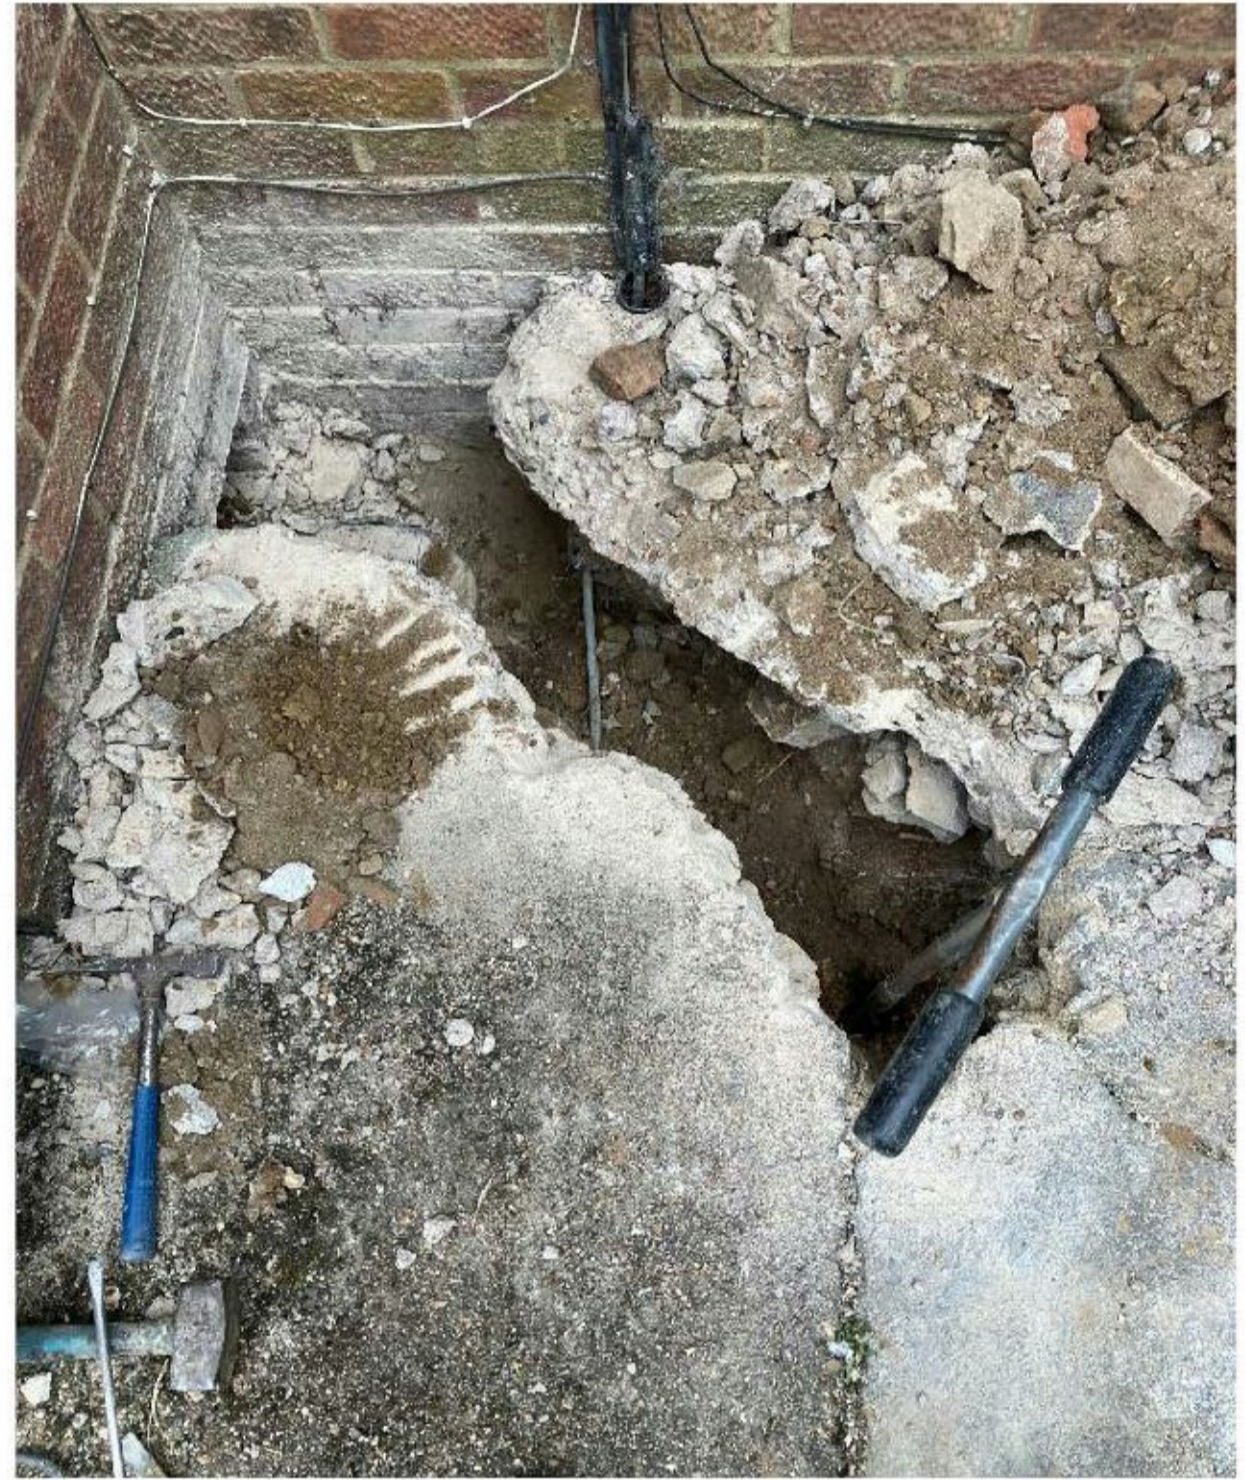
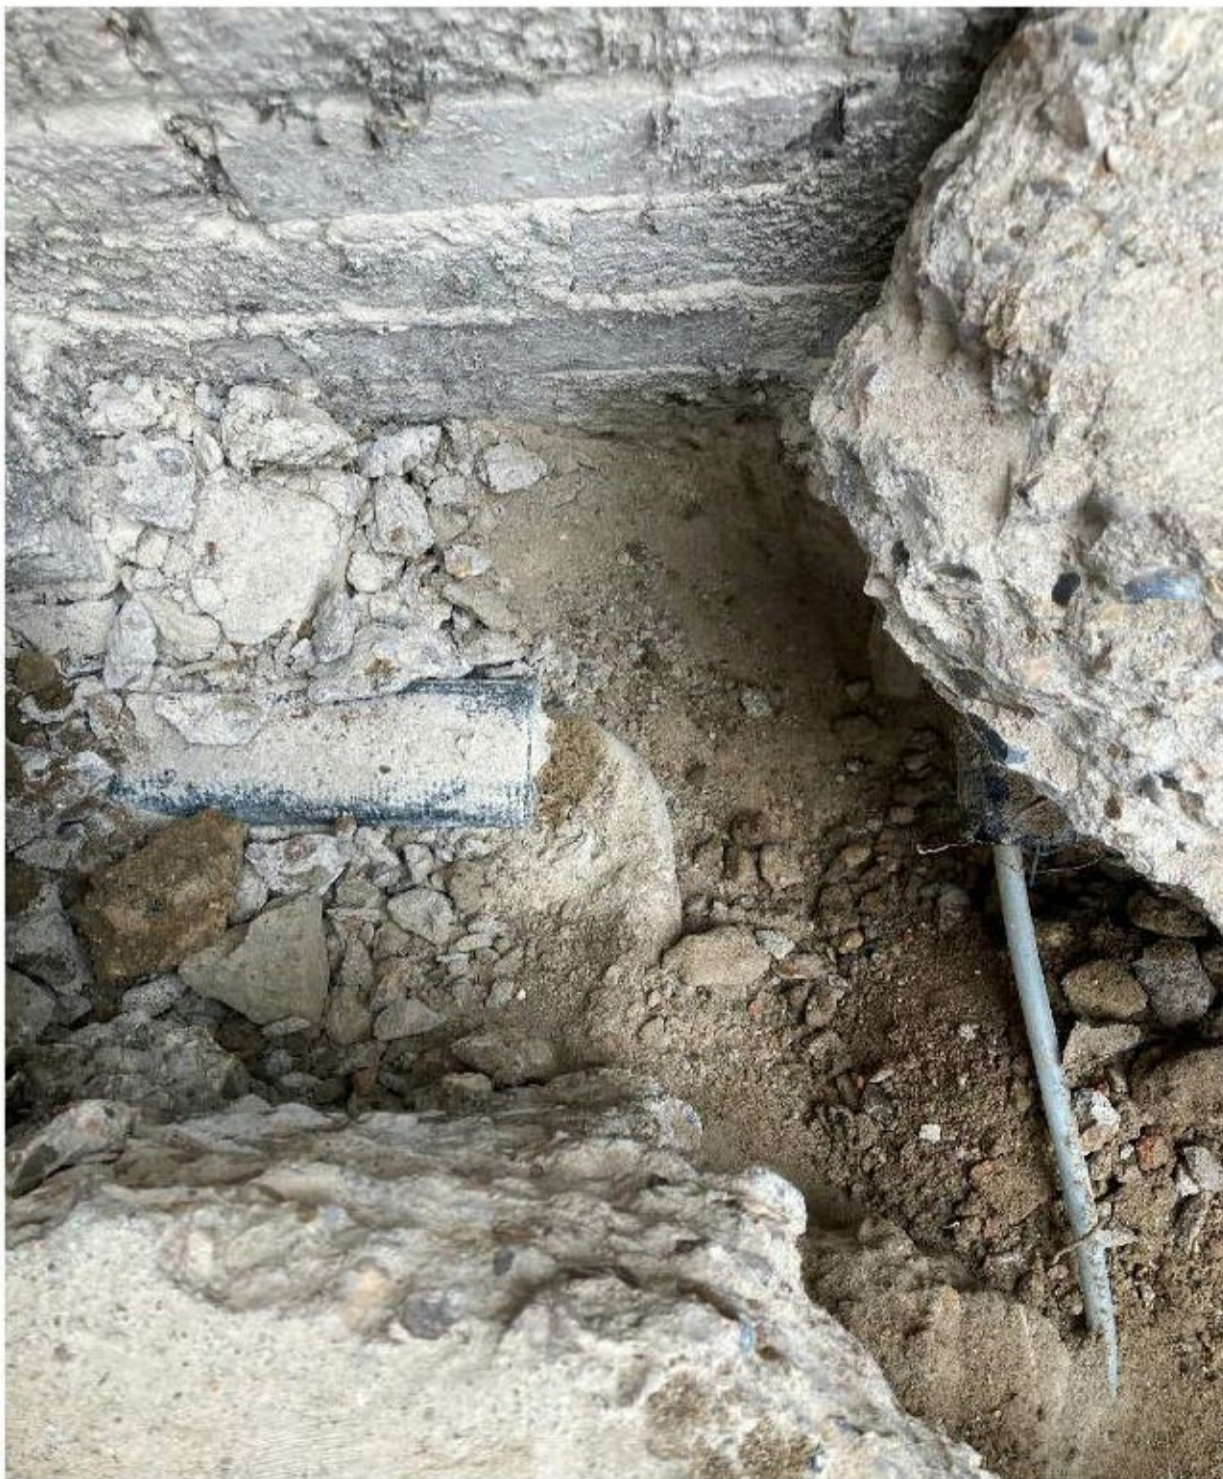
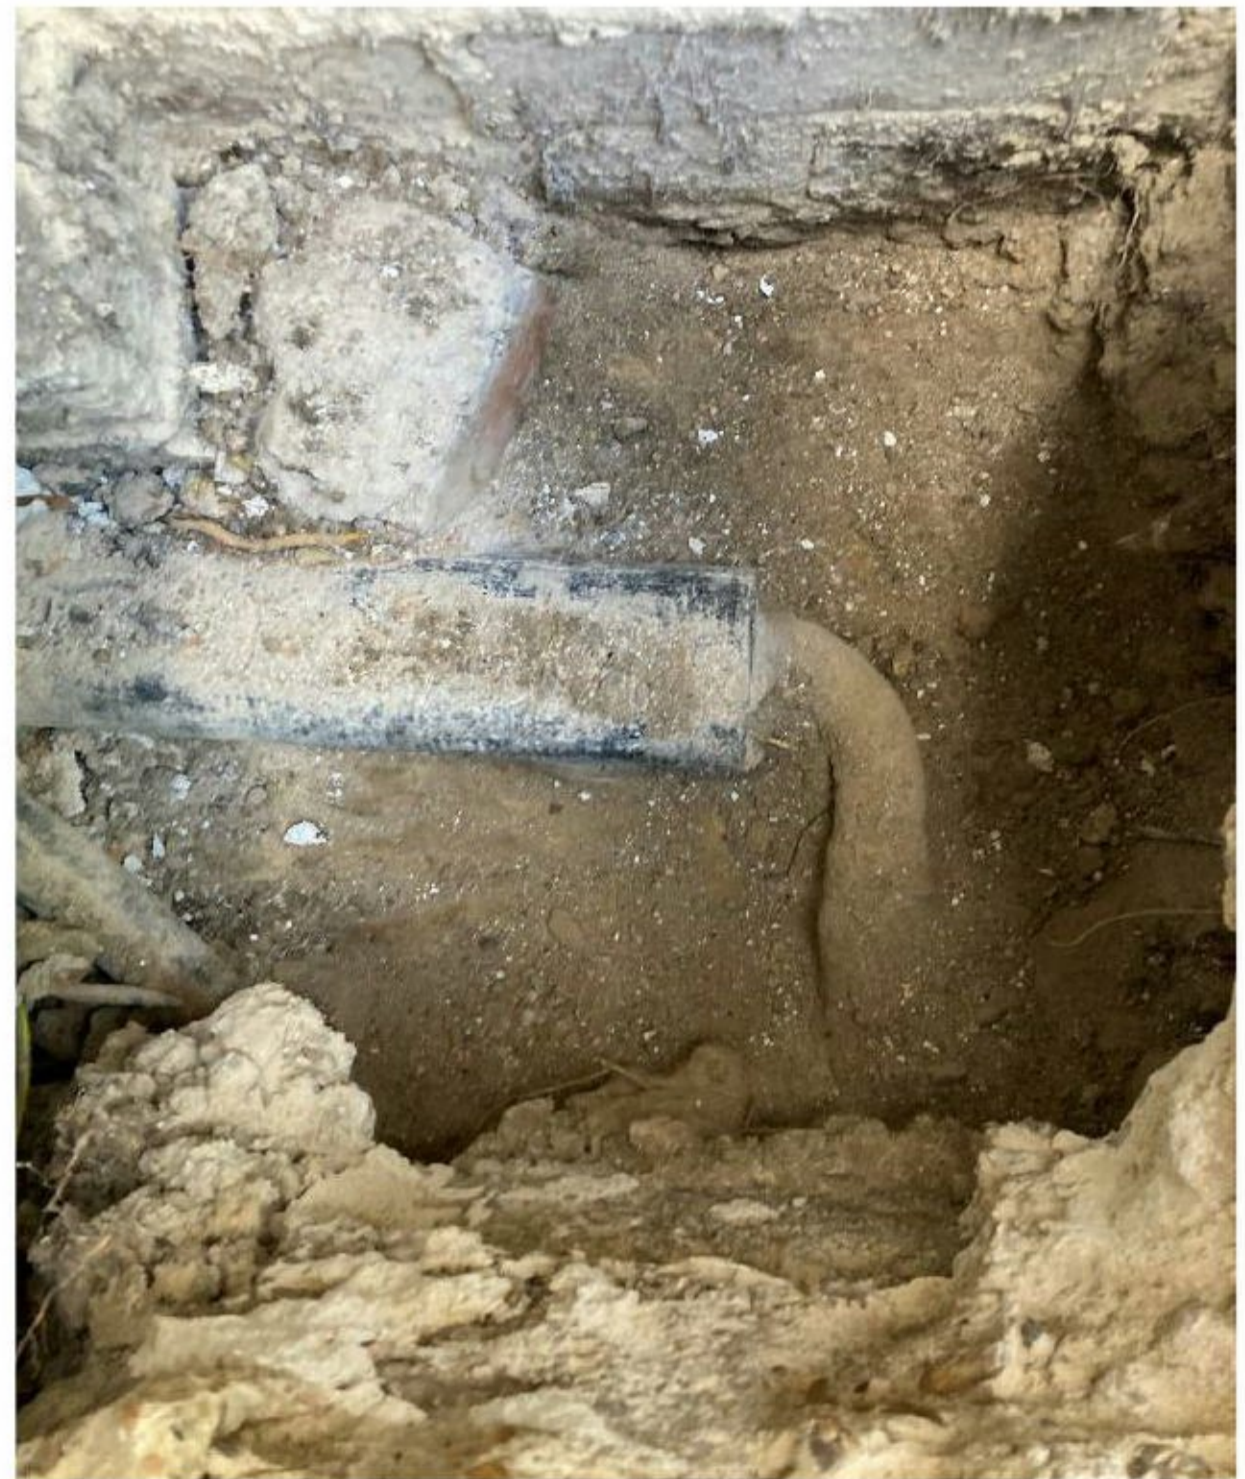
T/H1

Depth (m)	Soil Descriptions <i>(NB: Field crew description only)</i>	Test Type	Depth (m)	
			From	To
G.L.				
0.80	Brown sandy CLAY with rare medium gravel	V(n) 65	0.800	
1.50	Stiff brown/grey slightly sandy CLAY with rare root fibre	V(n) 67	1.500	
2.00	Stiff brown/grey sandy CLAY with rare medium gravel & root fibre	V(n) 65	2.000	
2.50	Firm orange/grey sandy CLAY with rare medium gravel & root fibre	V(n) 51	2.500	
3.00	Firm orange/grey sandy CLAY with rare medium gravel	V(n) 45	3.000	
3.50	Firm orange/grey sandy CLAY with rare root fibre	V(n) 45	3.500	
4.00	End of Borehole	V(n) 47	4.000

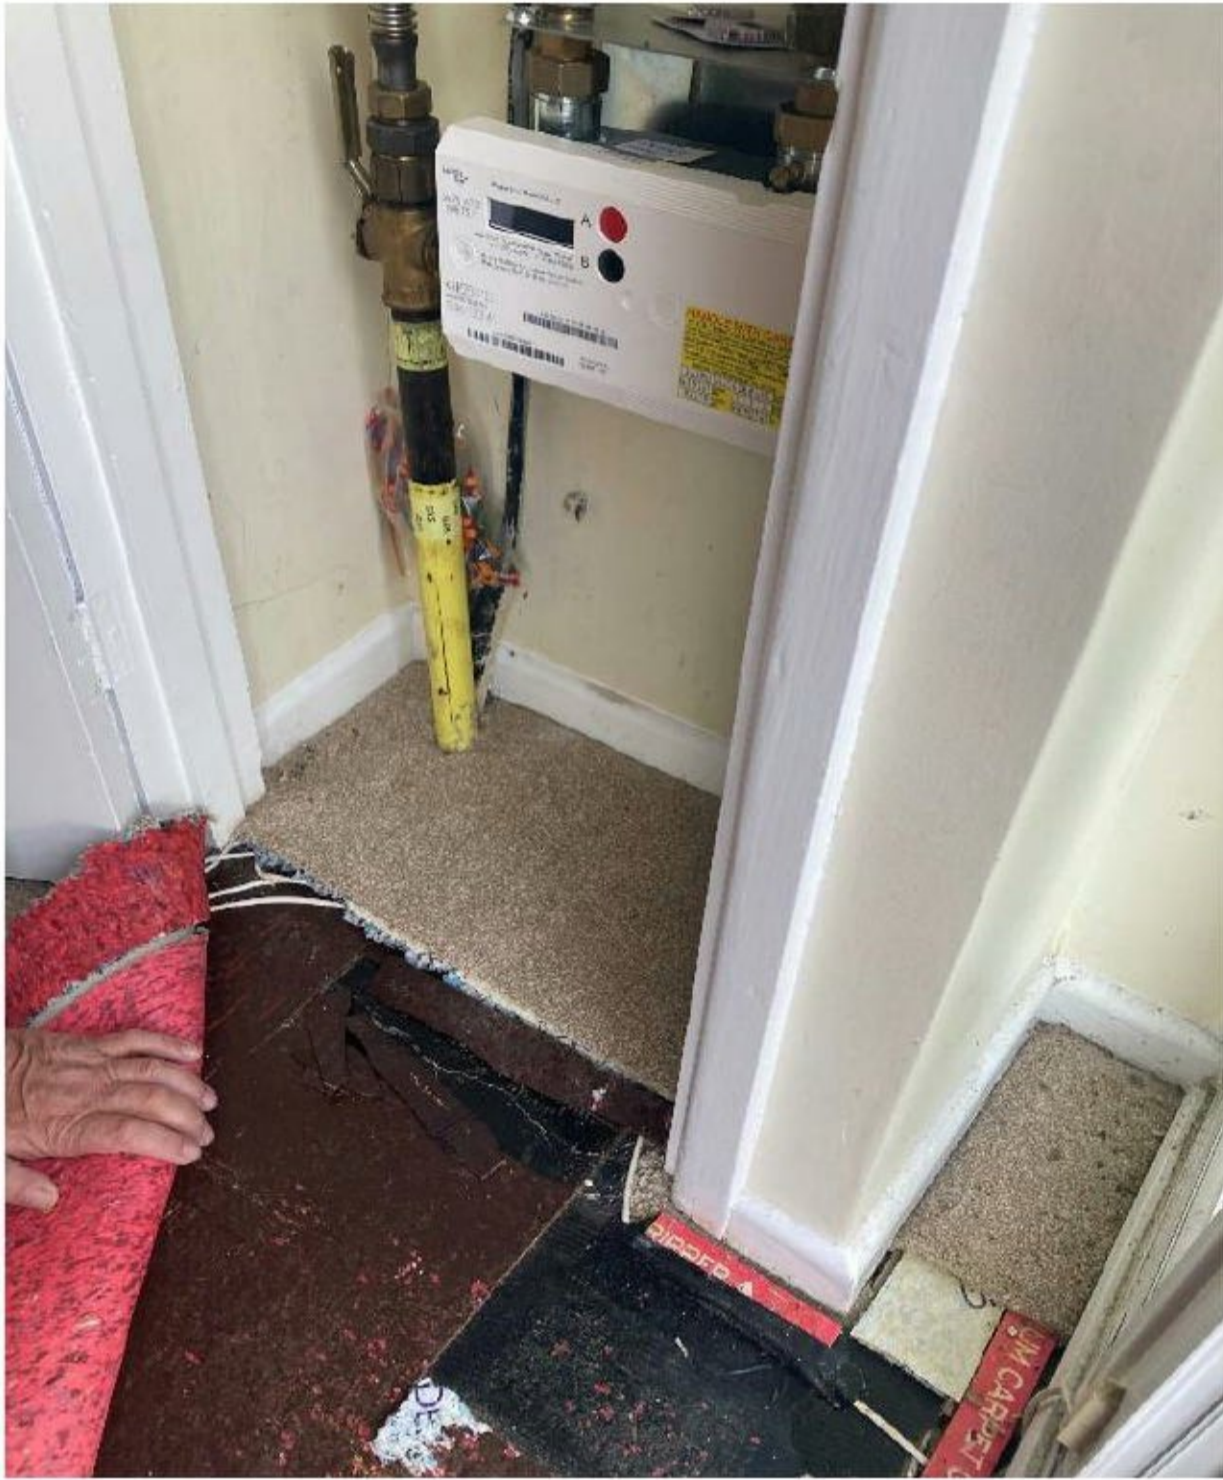
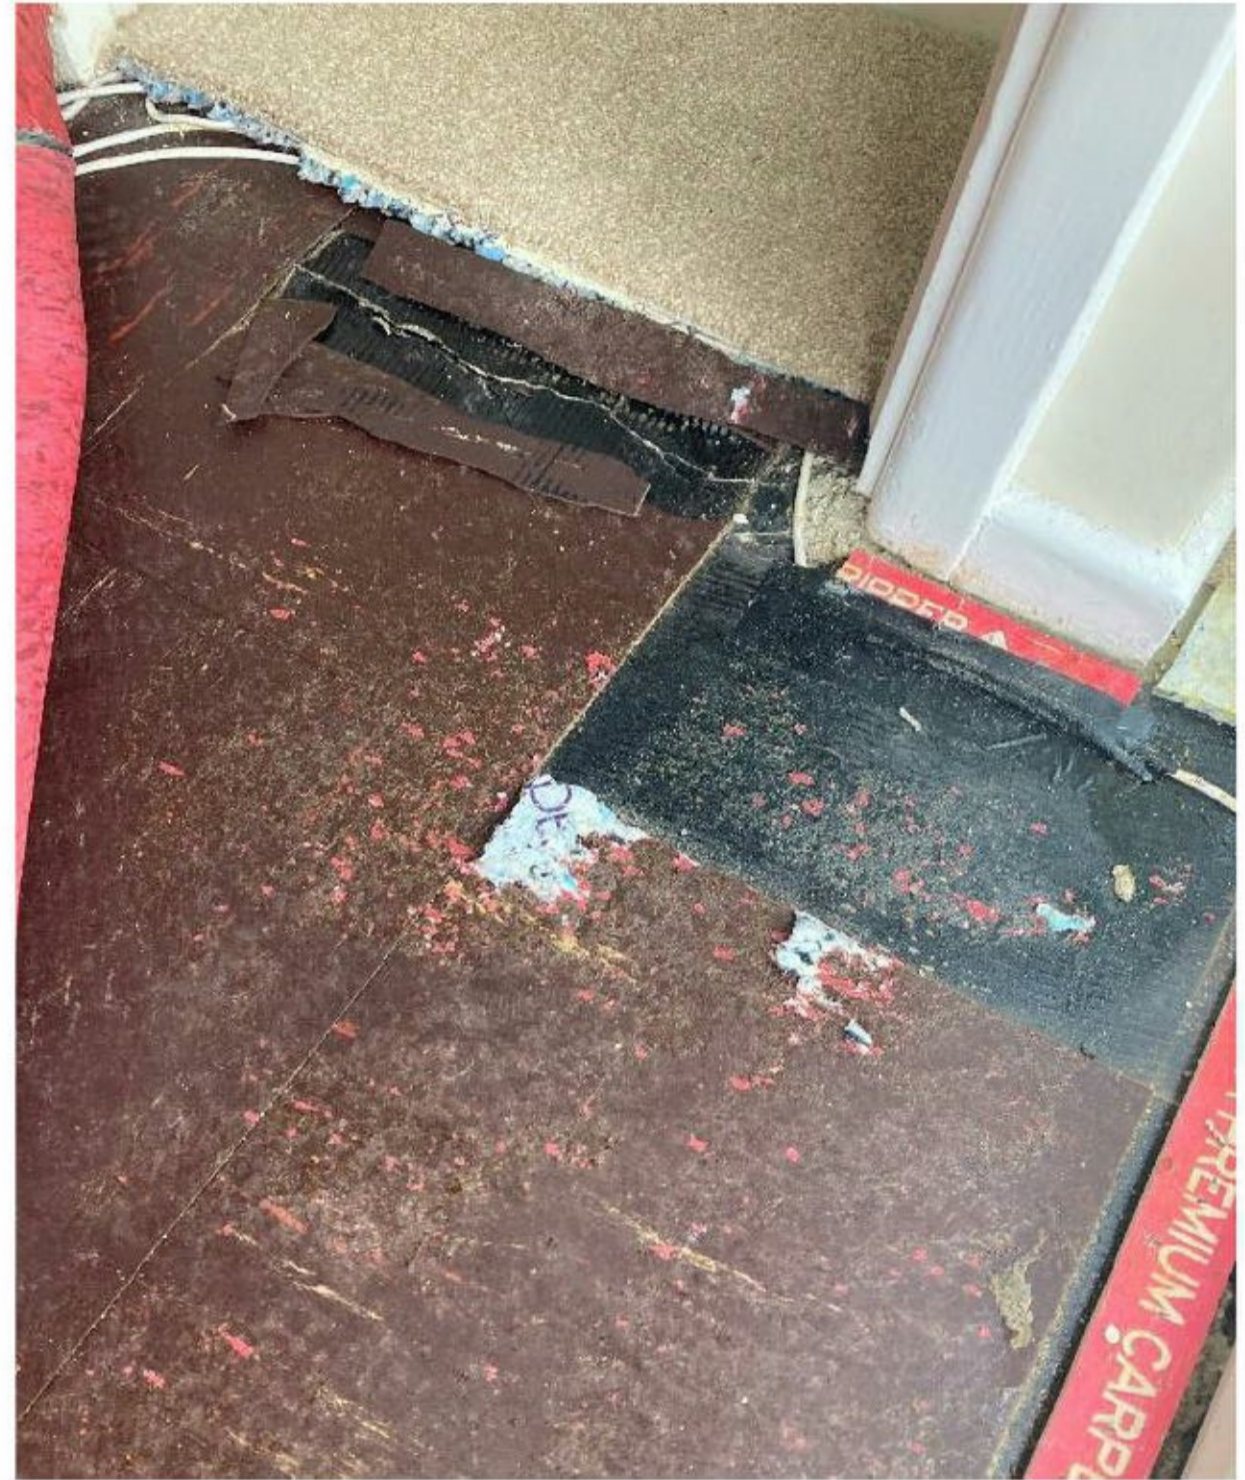
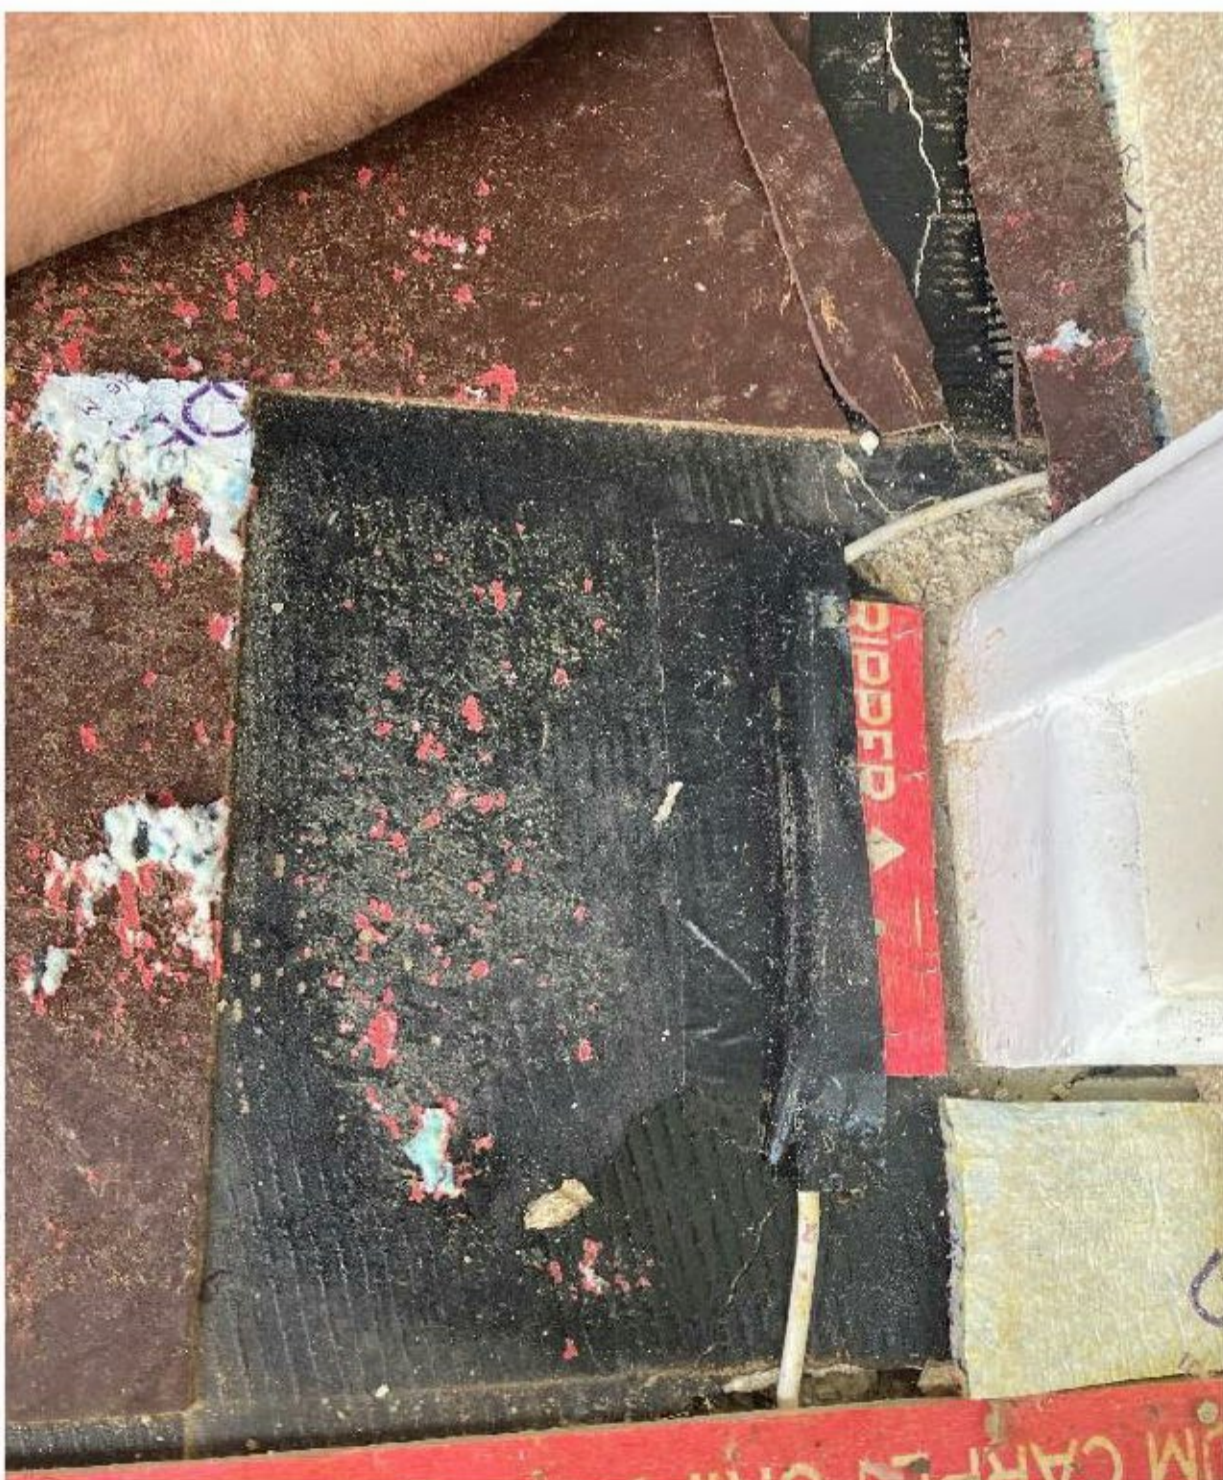
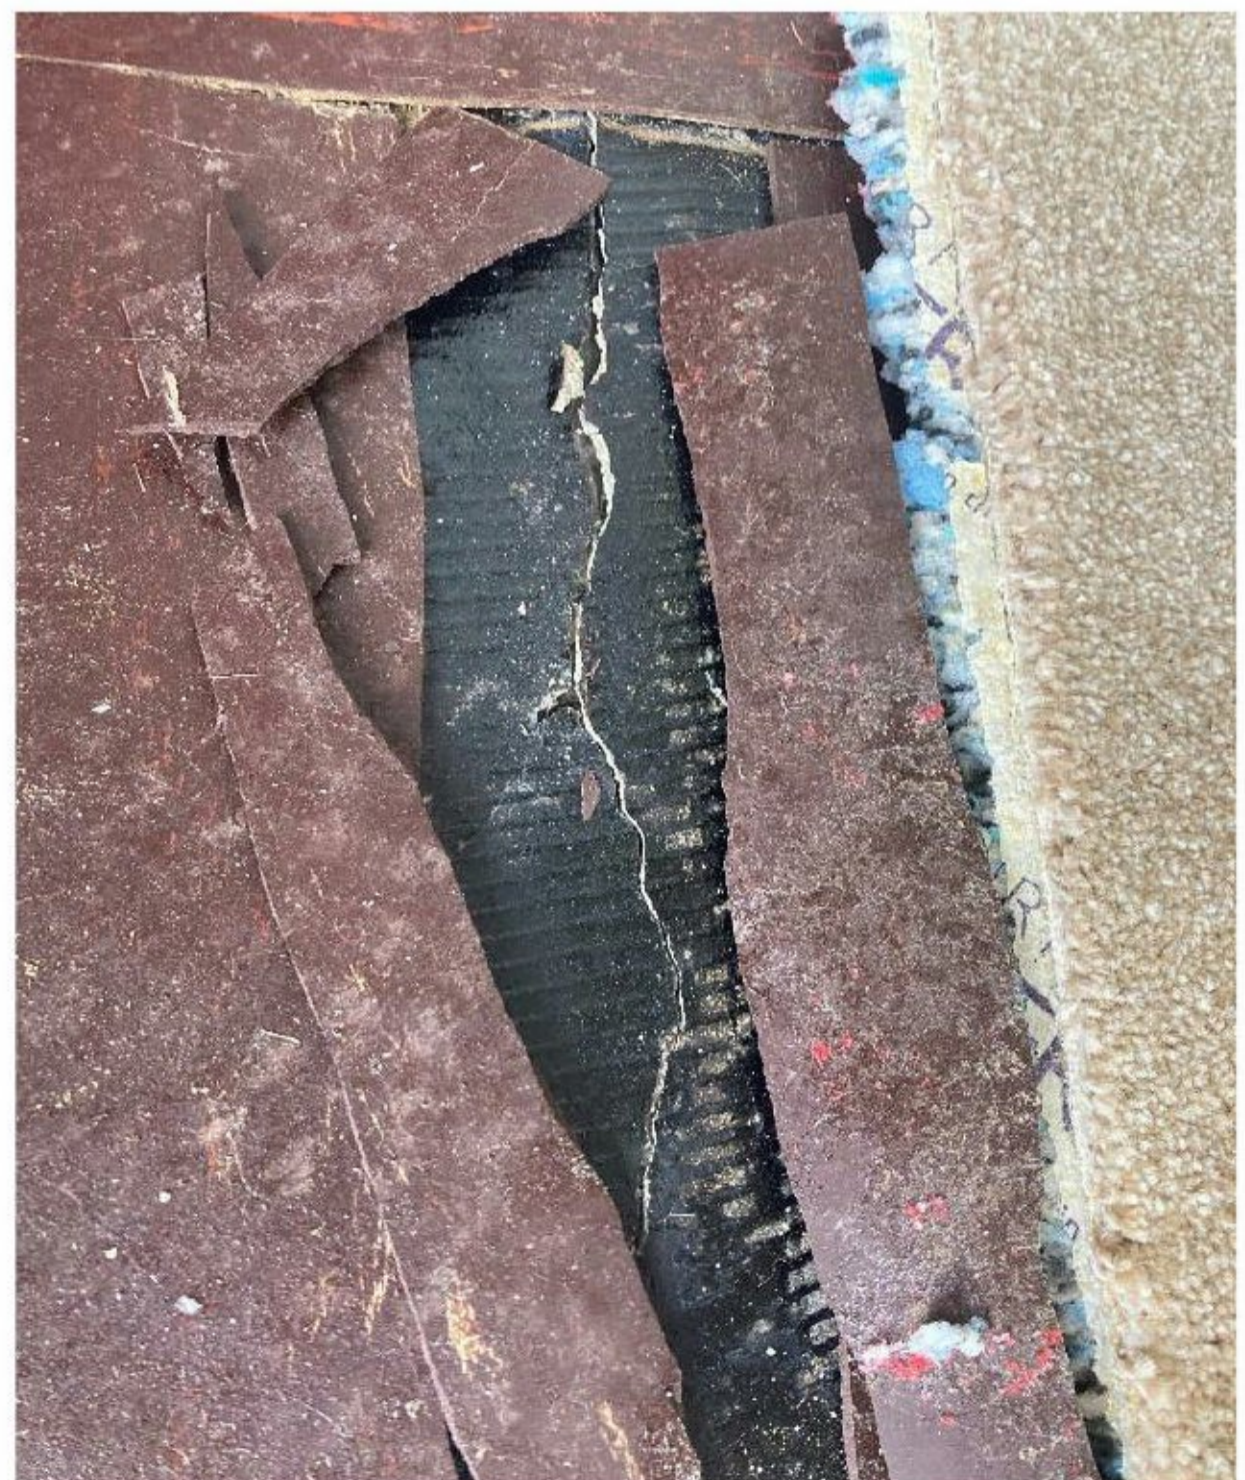
Internal trial hole location

When we took the carpet up we found Marley style tiles and bitumen glue. Consequently we were unable to perform the requested internal trial hole due to the risk of asbestos being present.

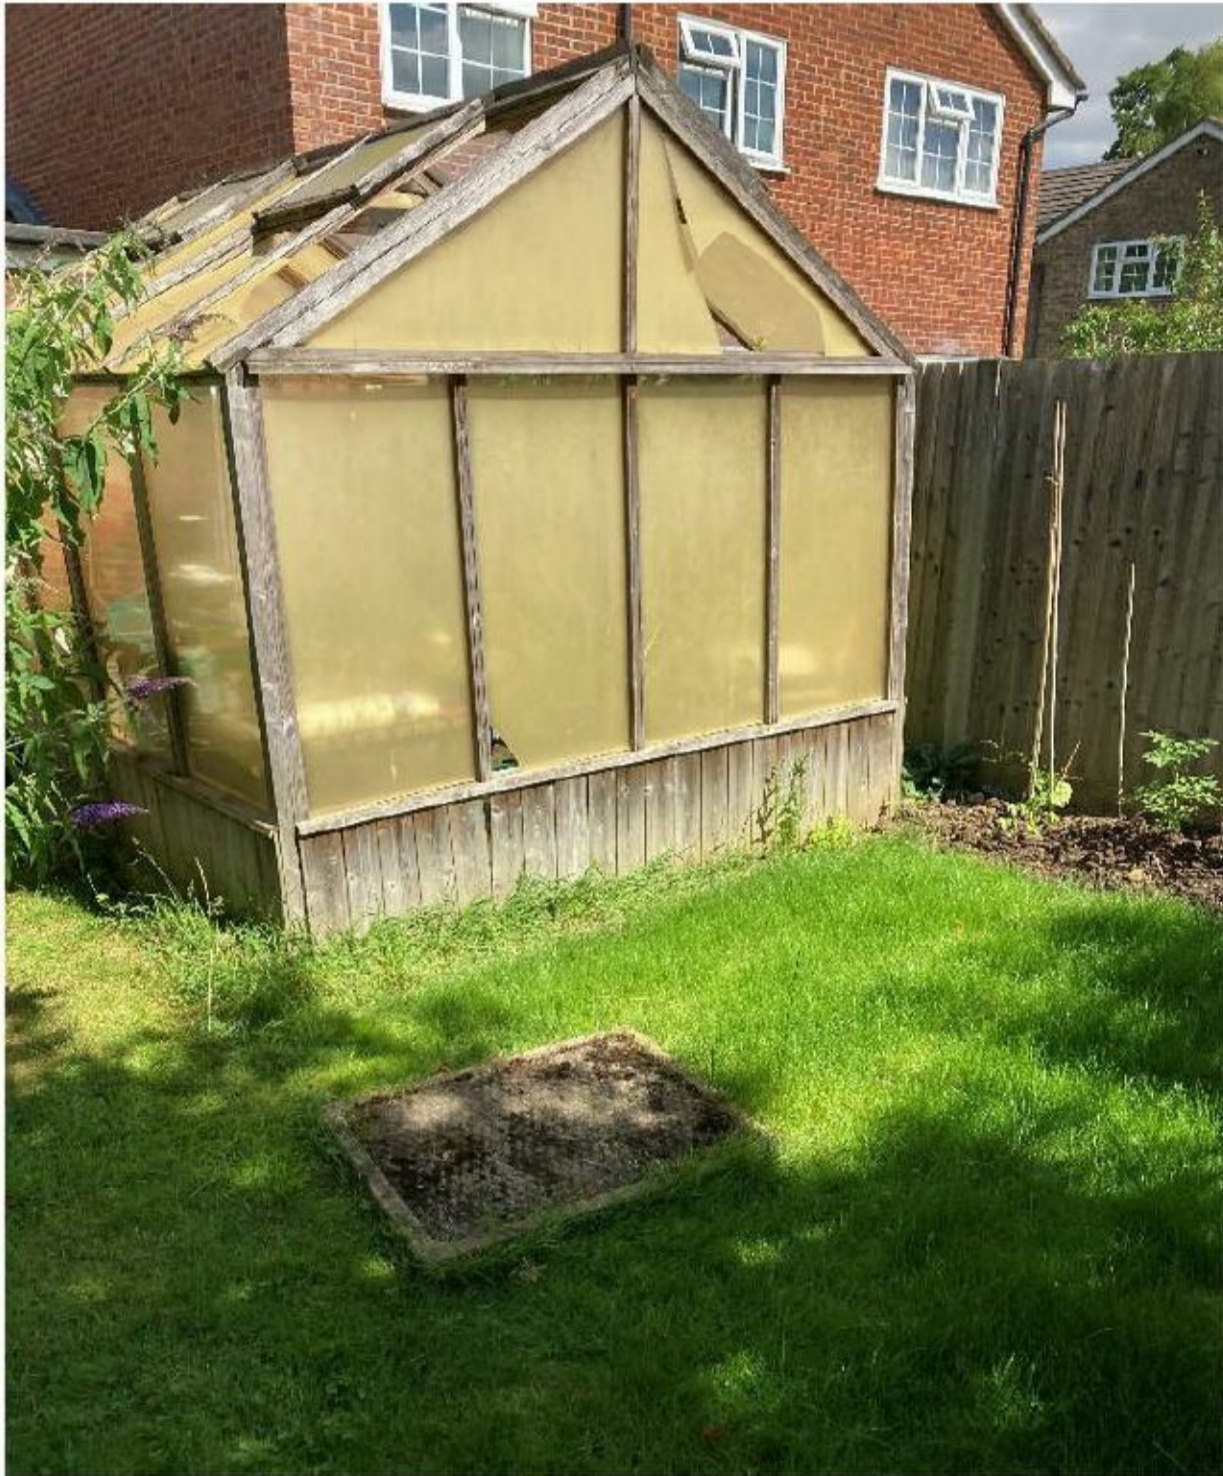
I/C3

The chamber to the at the rear of the green house has very large tap root ingress and looks to have not been used for some time. This is possibly part of an old storm system.
