Engineers Report

Risk Address 41 Knox Green
Binfield
Bracknell
Berkshire
RG424NZ

360 Reference DLG-SN-22-004171
Claim Reference 083212738
Policy Holder Mrs Alison Sinclair

Date Notified 25.04.2022
Date Instructed 25.04.2022
Report Date 08.06.2022

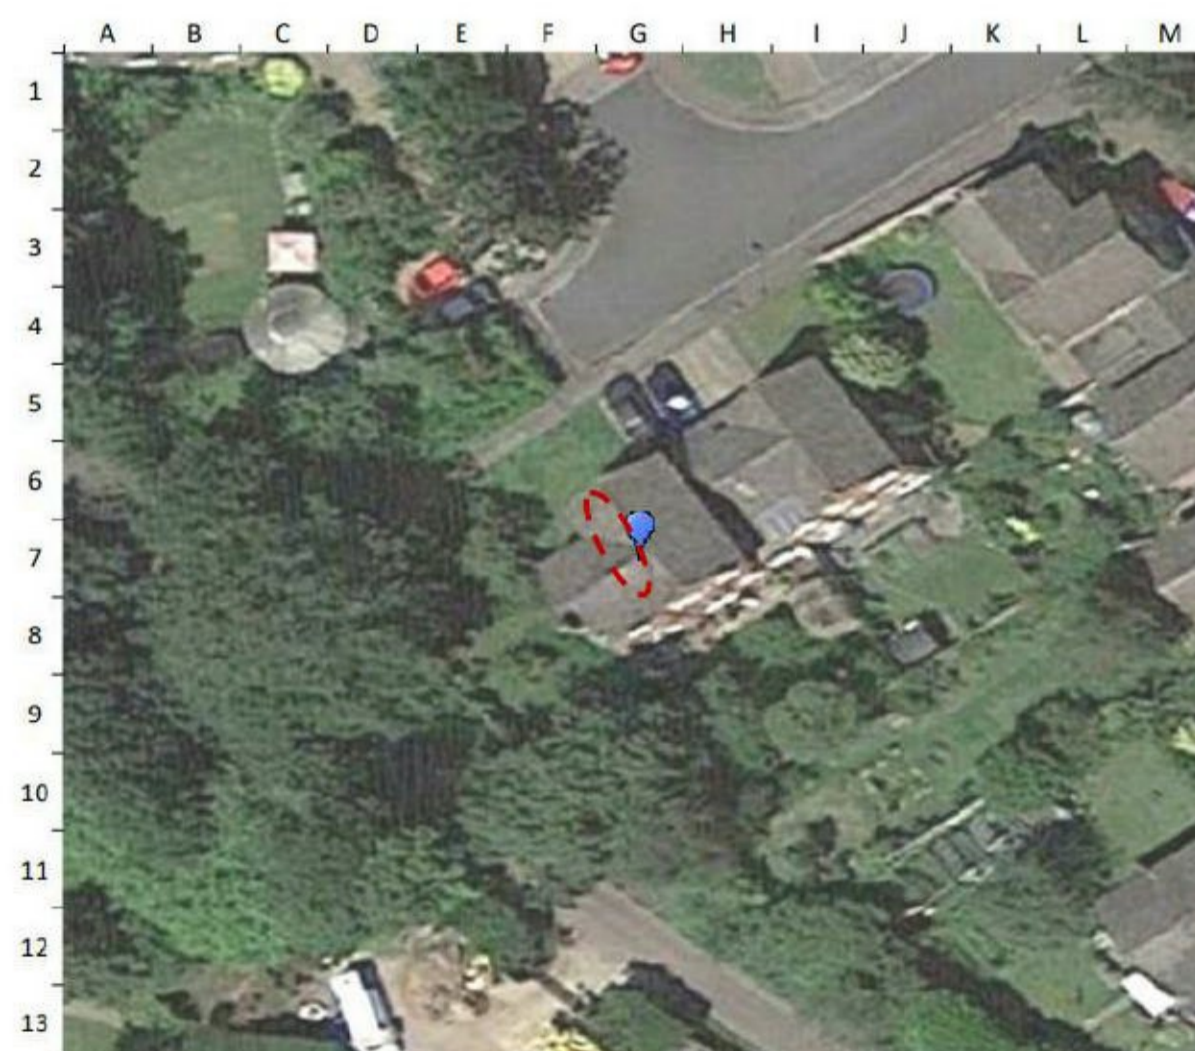
25-04-22

This document addresses damage notified to insurers in relation to movement affecting hallway towards the front of the property and neighbouring room off the front right. The descriptions below relates to the damage;

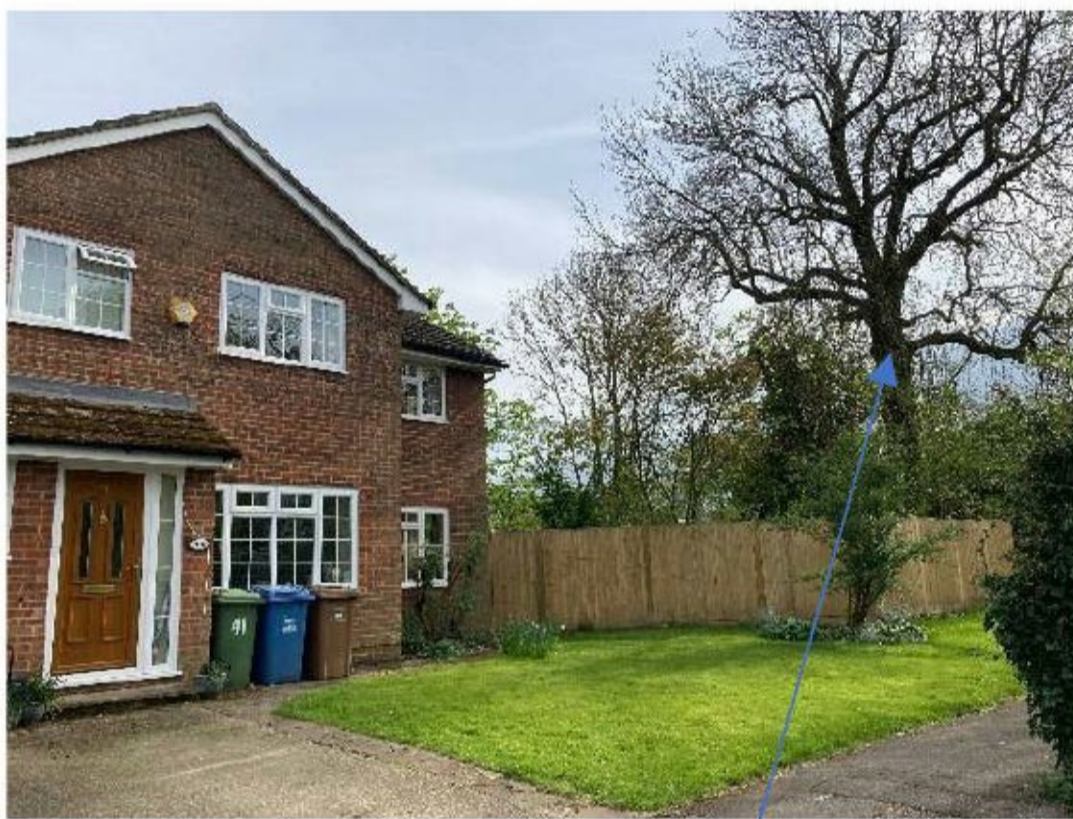
Policyholders has a large Ash tree which is located within their front, right garden. Said tree is confirmed to be protected by means of a tree protection order and therefore falls under the control of the local council - planning department.

Picture 1: Policyholders Ash tree (TPO)
