The University of Sheffield

24a Endcliffe Crescent

Structural Condition Report

Reference: ECR-ARUP-XX-XX-RP-S-000001

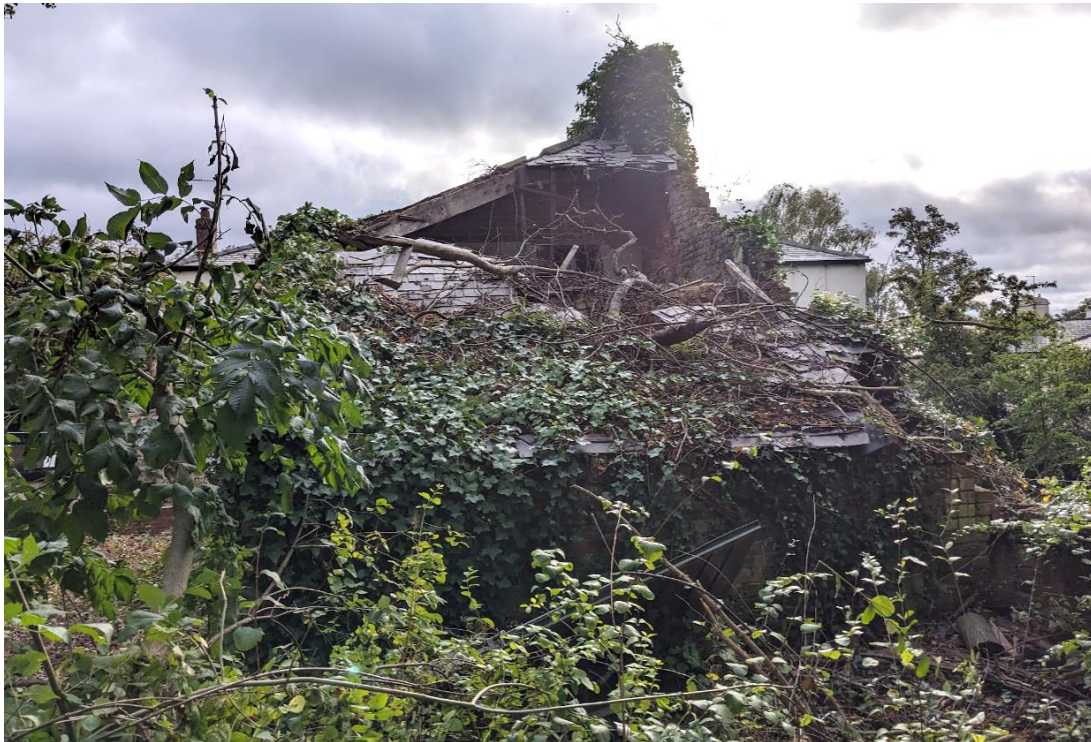
Figure 4 – View from the west of the collapsed section of roof

The western lean-to roof and the western side of the hipped roof have completely collapsed. Damage is likely to have been caused as a result of a tree falling during a storm in early 2023, though it is likely that the roof was in a poor condition before then; the remaining damaged timber members could be seen to be rotten, as shown in Figure 5.

- The main hipped roof and western lean-to roof are beyond repair and will require complete removal and replacement. The majority of the timbers on the western half of the roof have been damaged and need to be replaced. It is estimated that at least 50% of the roof slates have been damaged or lost and require replacement.

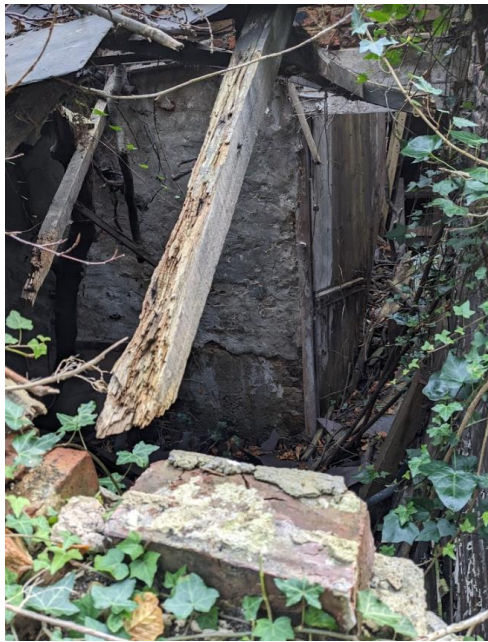
Figure 5 - Example of a rotten timber roof joist

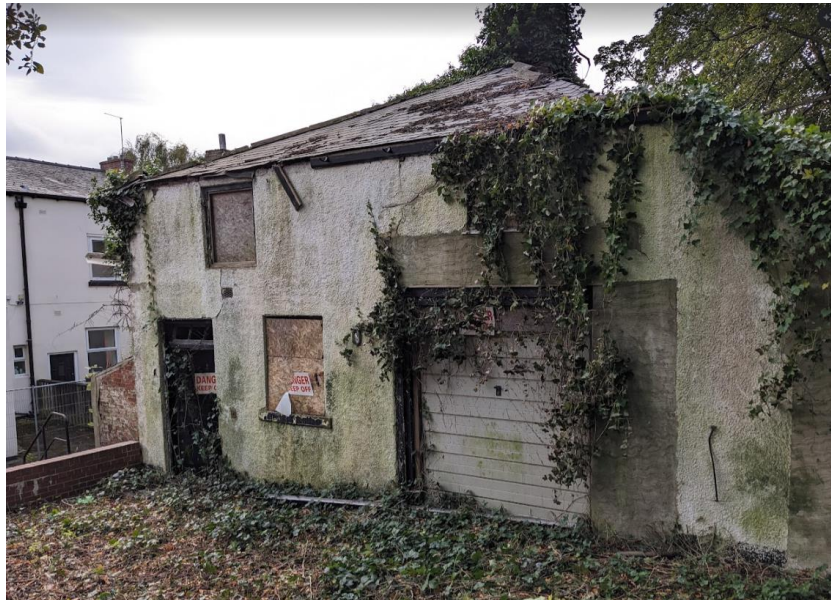
Viewing the remaining portion of the roof from the north it was apparent that several slates and most of the ridge tiles along the hips have been displaced, leaving the roof vulnerable to water ingress. Gutters have fallen from most of the north elevation and were overgrown with vegetation where present. As a result of these defects, it is likely that the supporting timber structure has been subjected to water ingress and so may be suffering from rot.

Figure 6 - View of the roof from the north

- Gutters and rainwater goods should be replaced throughout.

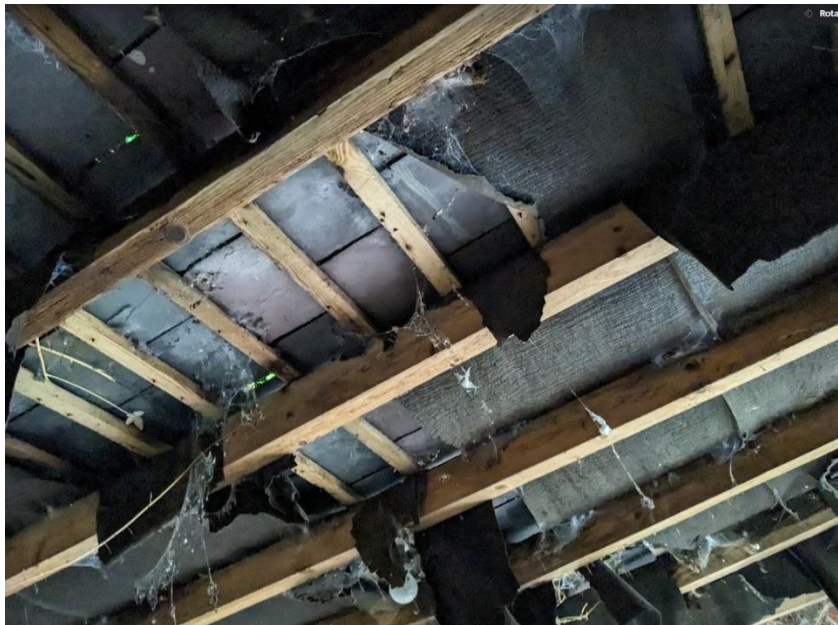
The structure of the lean-to roof to the east was in a better condition, but still exhibited signs of water ingress and vegetation growth. The timber rafters could be inspected from the underside and appeared to be in a reasonable condition. Some rafters appear to have been replaced in the past.

Figure 7 - Underside of east lean-to roof

- The eastern lean-to roof requires vegetation to be removed and slates resetting. The existing slates appear to be suitable for re-use.
- The western wall is beyond repair. It will need to be taken down to foundation level and rebuilt with suitable tying details to the north and south elevation walls.

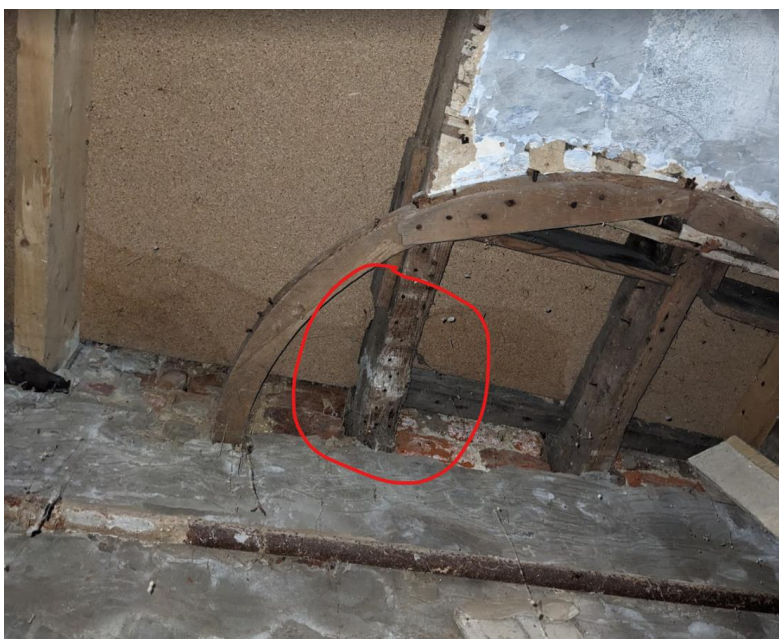
The first floor could not be inspected in detail due to the unsafe access conditions. From below, the first floor structure appeared to be in a relatively poor condition and was suffering from water ingress as a result of the damaged roof. Water staining was evident, and some joists showed signs of rot, as shown in Figure 8.

Movement of the walls resulting from the roof collapse and rot of the timbers is likely to mean that some members no longer have an adequate bearing.

Figure 8 - Apparently rotten first floor joist

- The lintel over the garage is likely to require replacement with a suitable steel or precast alternative.
- The first-floor structure should be completely removed and replaced, with suitable restraint details to the external walls. The masonry walls will need to be propped during floor replacement work.

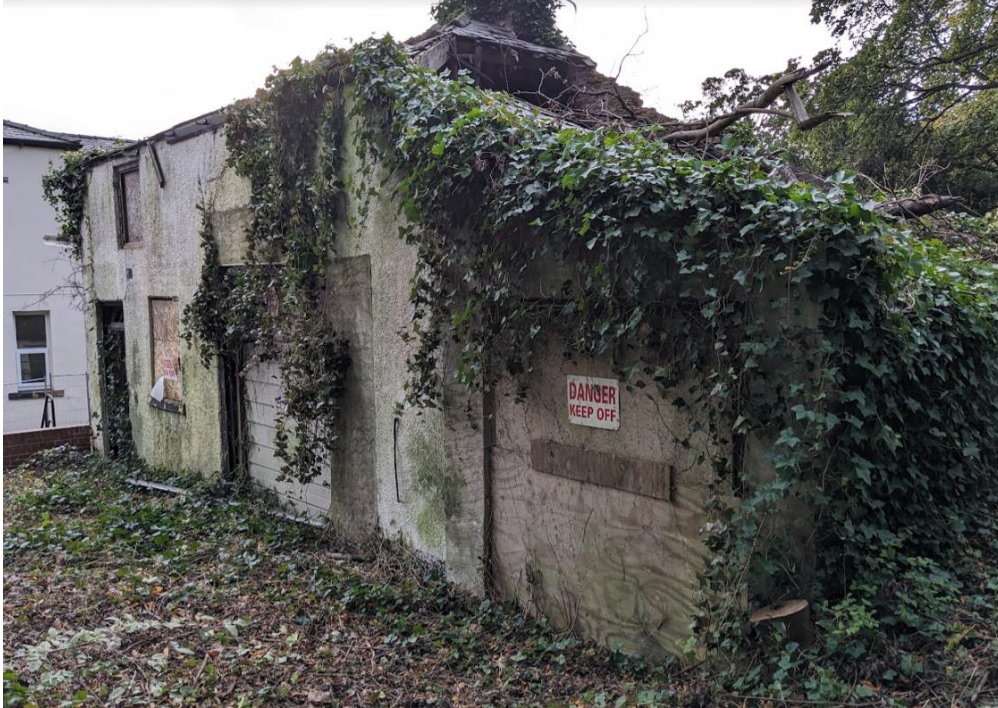
The north elevation is covered in render and so could not be inspected in detail. Cracks were noted in two locations: over the small single door and over the garage door. It could not be determined whether these

The elevation did not appear to show any signs of settlement or other movement.

The section of wall forming the western lean-to had a significant amount of ivy growing over the wall. The roof to this section has collapsed and so there is no restraint to the top of the wall. Whilst it could not be inspected in detail due to the vegetation, it is likely that the top section of this wall has been destabilised by the vegetation growth and roof collapse.

Figure 9 - Overview of north elevation

- The render should be removed from the rest of the southern wall and the northern wall. It is likely that these walls will require repointing. An allowance should be made for remedial ties between these walls and the internal wall.

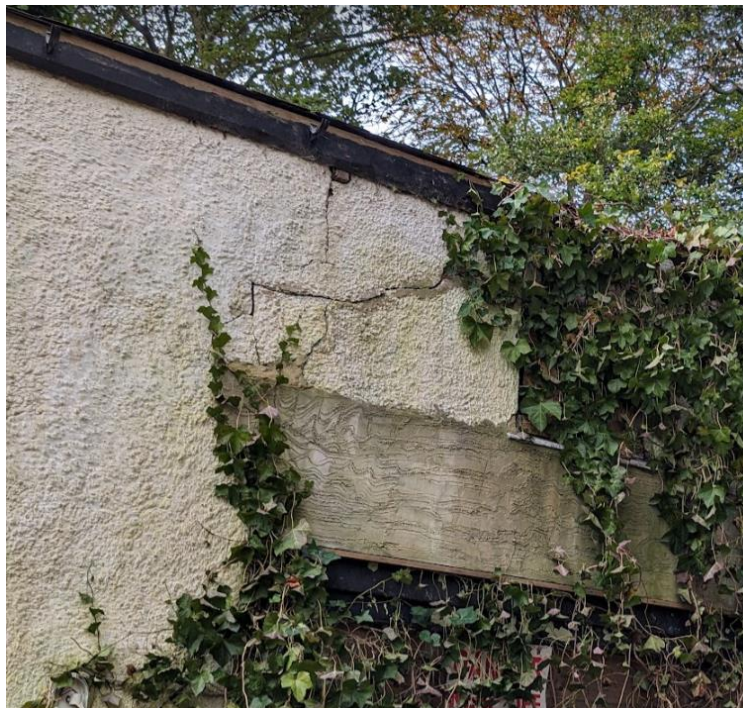
cracks were in the render only or whether they followed through into the masonry walls. The crack over the garage door may be a result of movement of the lintel associated with deterioration such as rot or creep.

Figure 10 - Cracking over doorway on north elevation

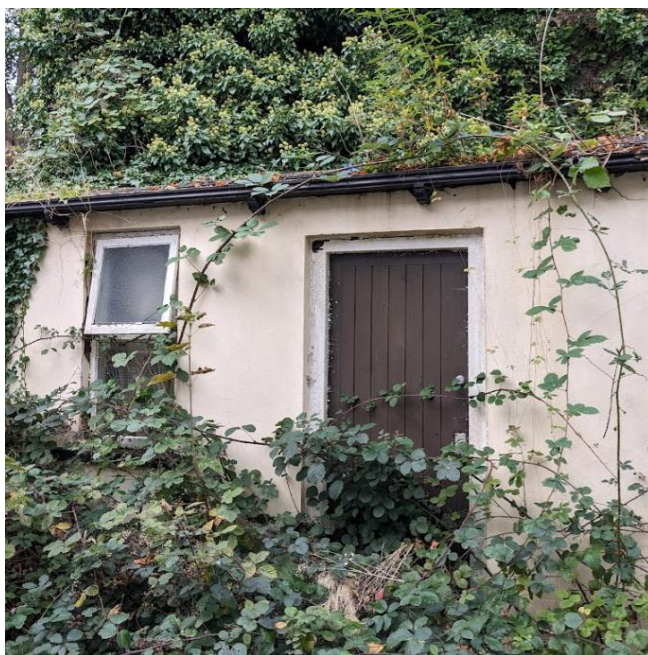
The east elevation forming the end of the lean-to was difficult to inspect due to the vegetation growing in front of it but appeared to be in a reasonable condition.

Figure 11 – East elevation of lean-to

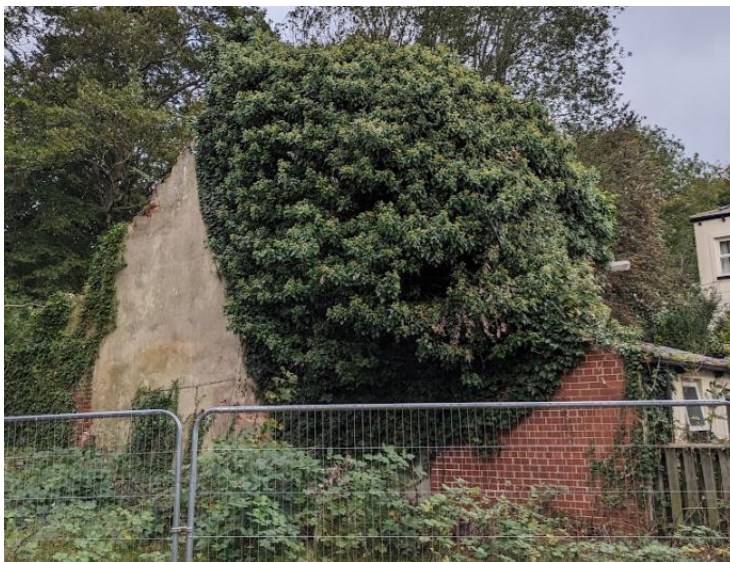
The south elevation is thought to be a spine wall which previously sat between 24a and 26a, before 26a was demolished. The wall has been rendered and has a large growth of ivy covering the eastern half.

The wall appeared to be leaning out to the south, particularly where the eastern portion of the roof has collapsed, likely as a result of loss of restraint. The connectivity between the south elevation and the internal dividing wall could not be inspected due to the unsafe access – if there is any discontinuity between the two walls this may be contributing to the lean of the southern wall.

The chimney at in the centre of the elevation was almost completely obscured by ivy but appears to have sustained some damage from the roof collapse.

Figure 12 – South elevation

- The chimney will need to be taken down and rebuilt if retention is desirable.
- Internal walls are likely to require local repairs and brick replacement, with remedial tying details to adjoining walls.

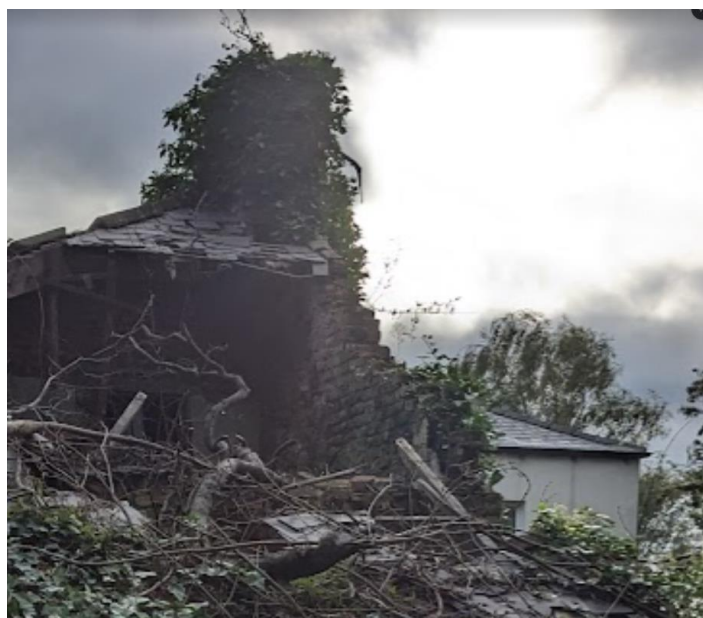
Viewed from the east where the roof has collapsed, the top of the wall was in an exceptionally poor condition; most of the masonry units at the top were loose, likely as a result of the roof collapse.

The eastern portion of the wall is likely to have been damaged by the growth of ivy, particularly at ridge level where it would be easier for growth to penetrate.

Figure 13 - Damaged section of south elevation

- The top section of the southern wall where the roof has collapsed (approximately the top 1.5m from roof level) will need to be carefully taken down and rebuilt.

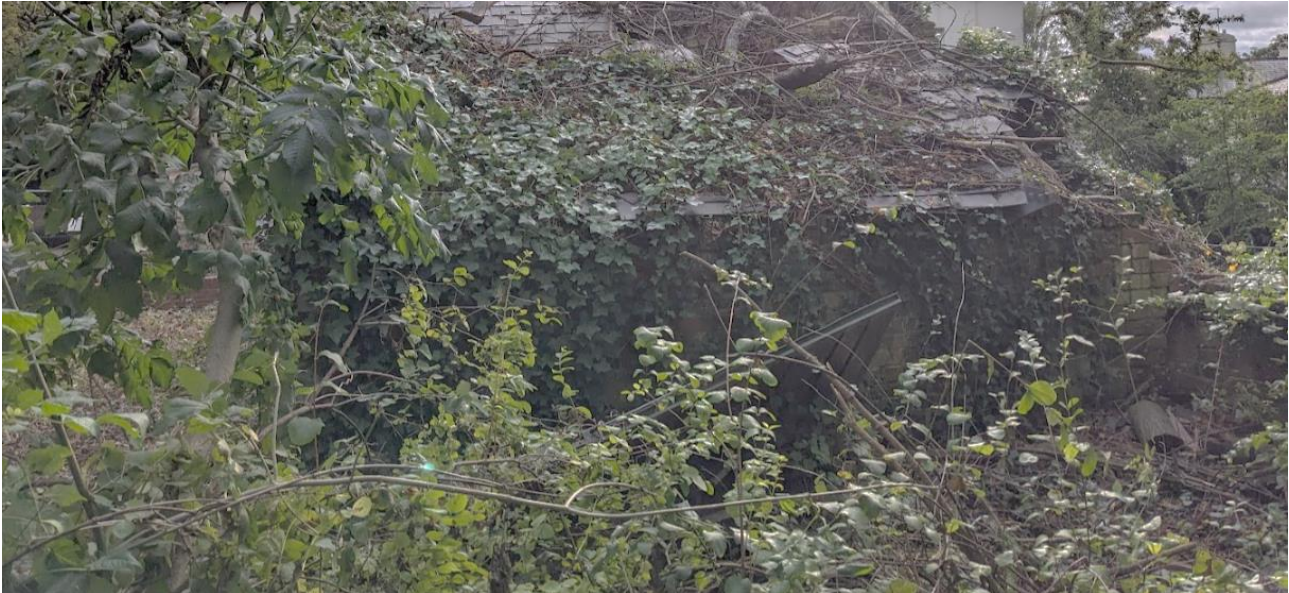
The west elevation is in a very poor condition following the collapse of the lean-to roof. Many masonry units along the top are loose, and there is a significant gap between the west and south wall – see Figure 15.

Figure 14 – West elevation

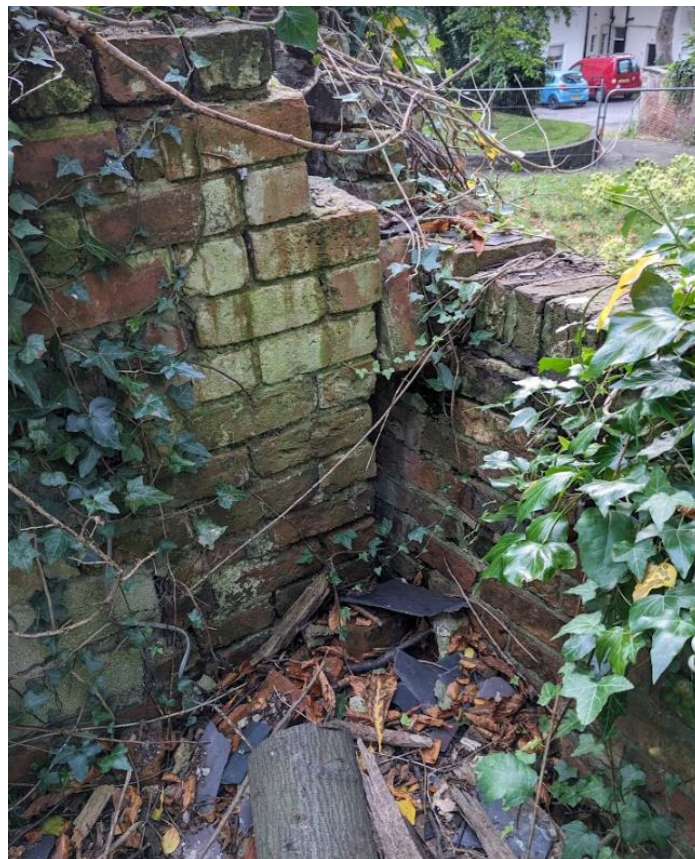
Figure 15 - Junction between west and south elevation walls
