Site Investigation Report

143562.2.BSI

Client	Crawford's
Client ref	SU2204195
Visit date	15/02/2023
Report date	08/03/2023

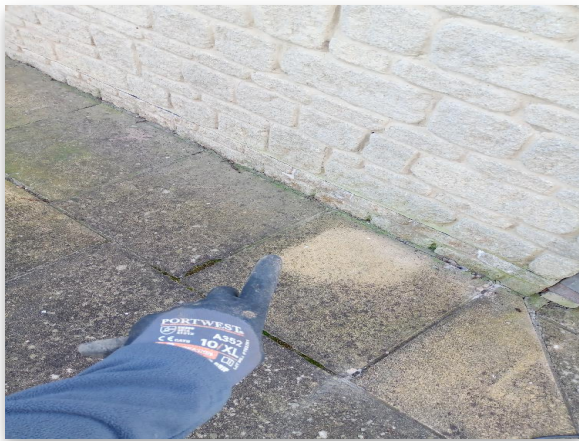
Fig 1.1: Trial Hole 2 Location

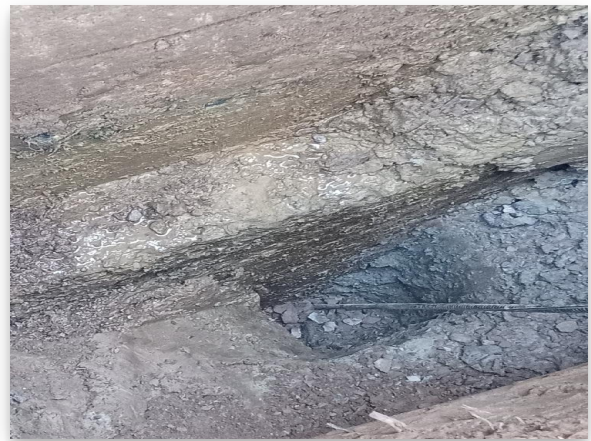
TH2 was completed in the proposed location. The footing was revealed and in situ testing was done down to 3m.

Fig 1.2: Trial Hole 2 Footing

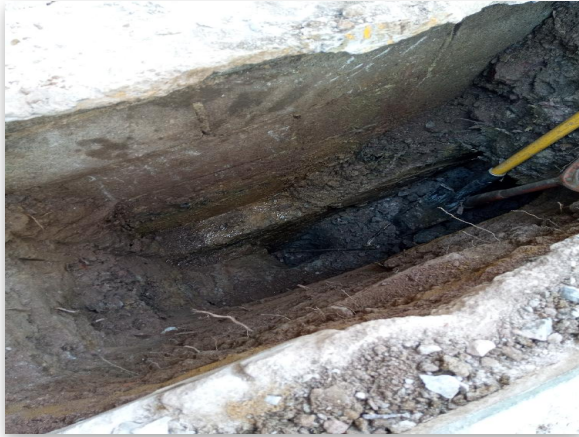
Fig 2.1: Trial Hole Open

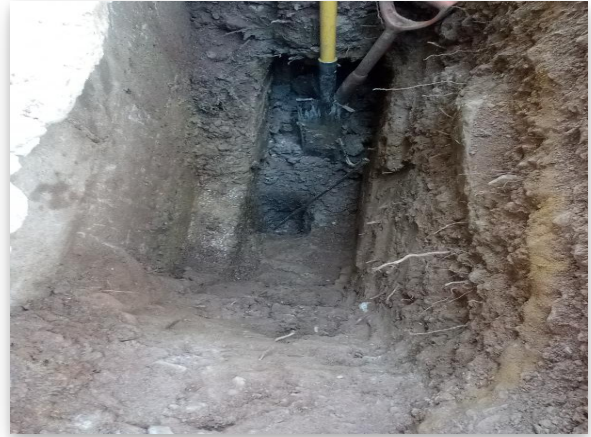
Fig 2.2: Footing

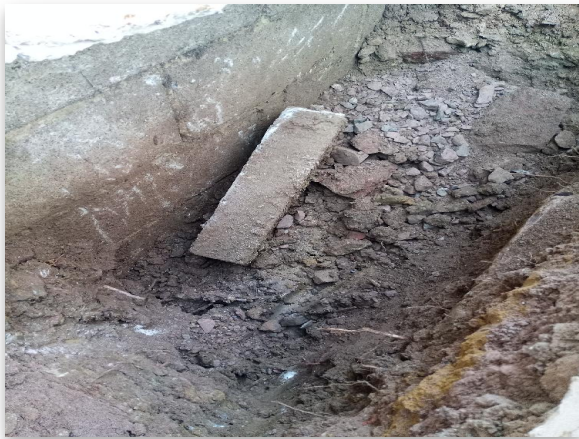
Fig 2.3: Rubble within Hole
