Arboricultural Appraisal Report

Subsidence Damage Investigation at:

Heath Farm, Ram Hill
Coalpit Heath
Bristol
BS36 2TX

CLIENT:	Crawford & Company
CLIENT REF:	SU2204195
MWA REF:	SUB230331-12825
MWA CONSULTANT:	David Williams (N.D.Arb MArborA)
REPORT DATE:	16-05-2023

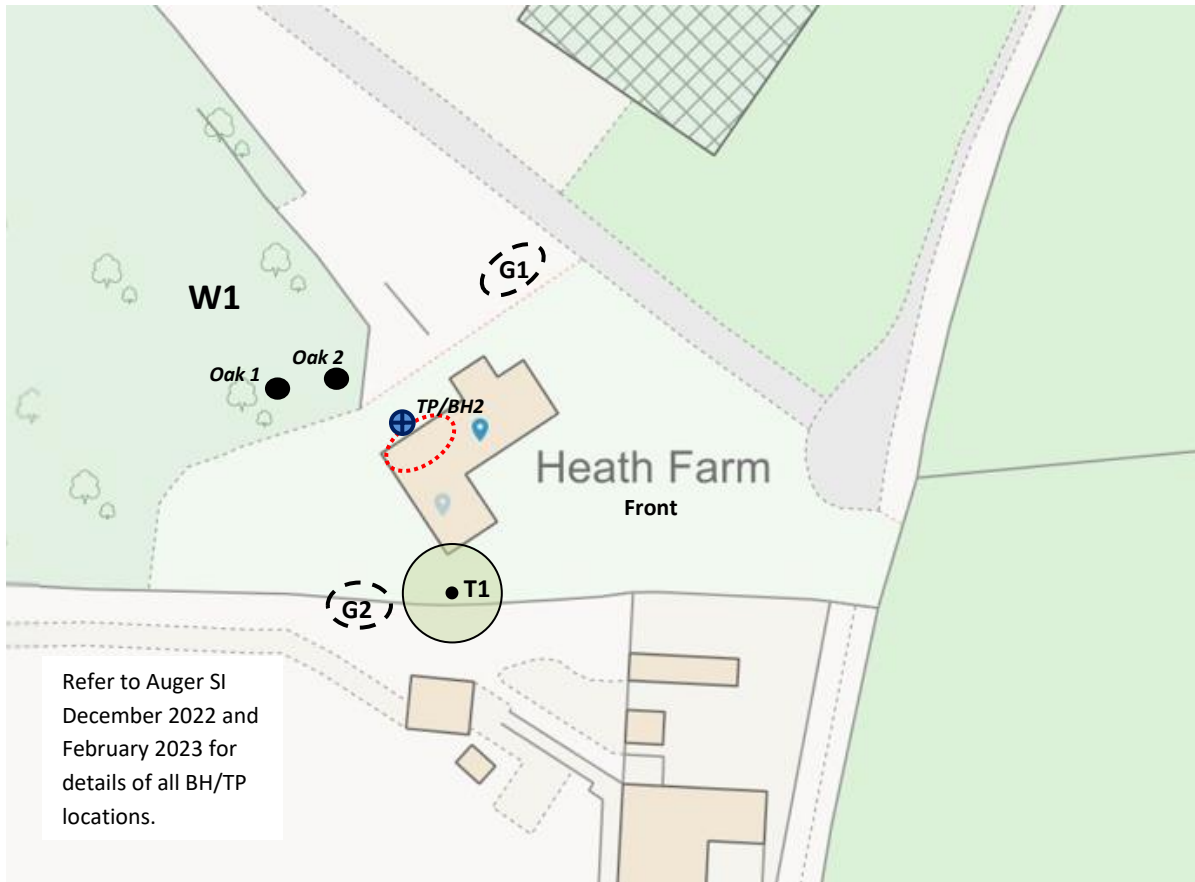
Site Plan

Approximate areas of damage

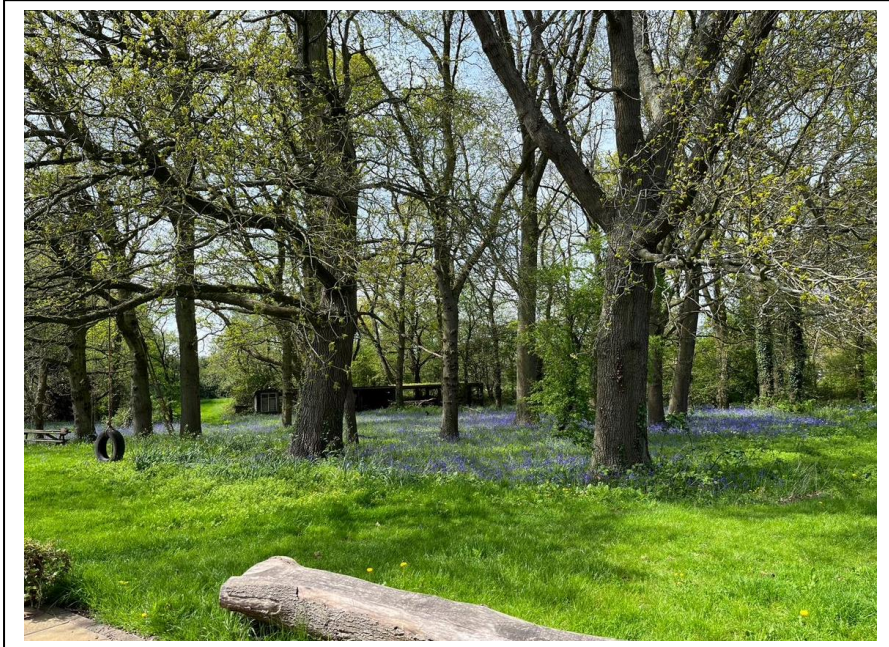
View of W1

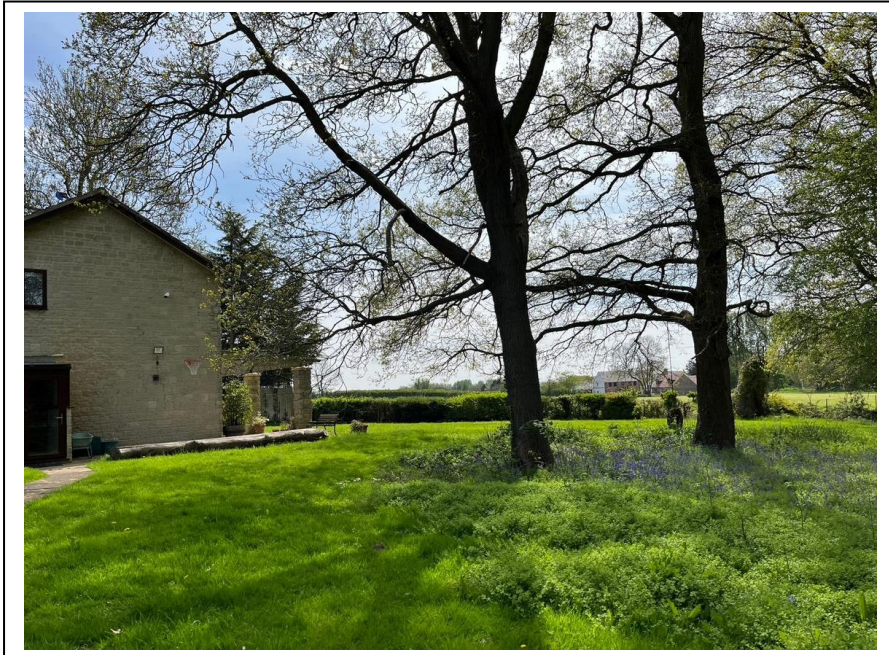
Based on the technical reports currently available, engineering opinion and our own site assessment we conclude the damage is consistent with shrinkage of the clay subsoil related to moisture abstraction by vegetation. Having considered the information currently available, it is our opinion that the drying action of oak 1 and oak 2 in W1 will be the principal cause of the current subsidence damage.

View of oak 1 and oak 2 in W1

If an arboricultural solution is to be implemented to mitigate the influence of the implicated trees/vegetation we recommend that the two oaks be removed. Other vegetation recorded presents a potential future risk to building stability and management is therefore recommended.

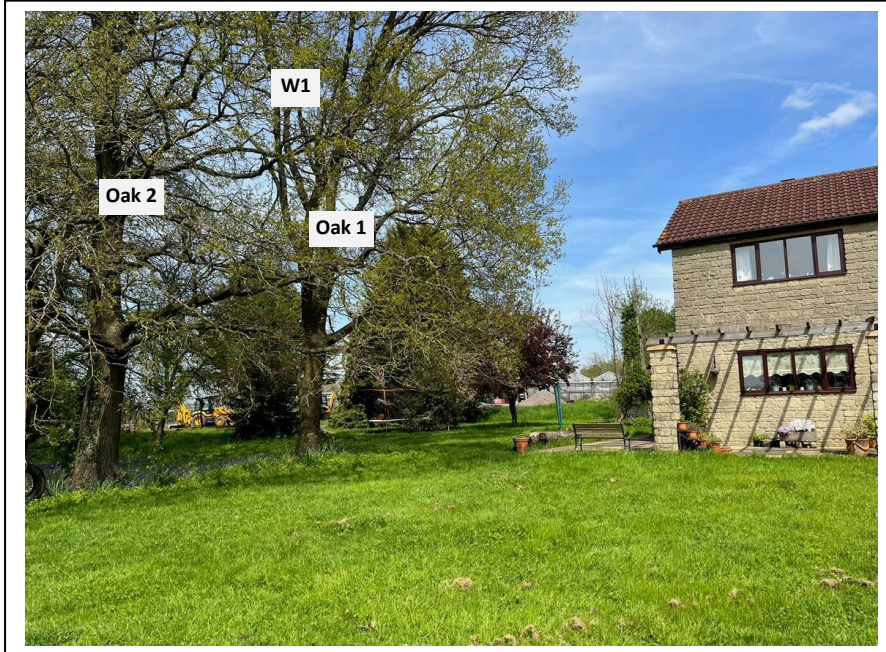
The current damage affects the rear right-hand corner of the main dwelling.

View of rear RH corner and two implicated oaks in W1

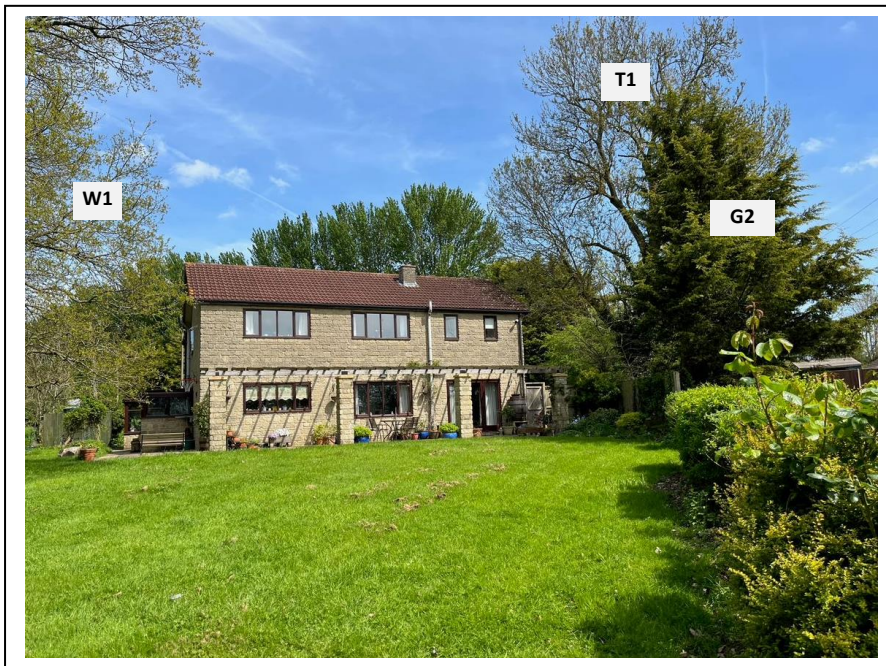
View of rear elevation, W1, T1 and G2

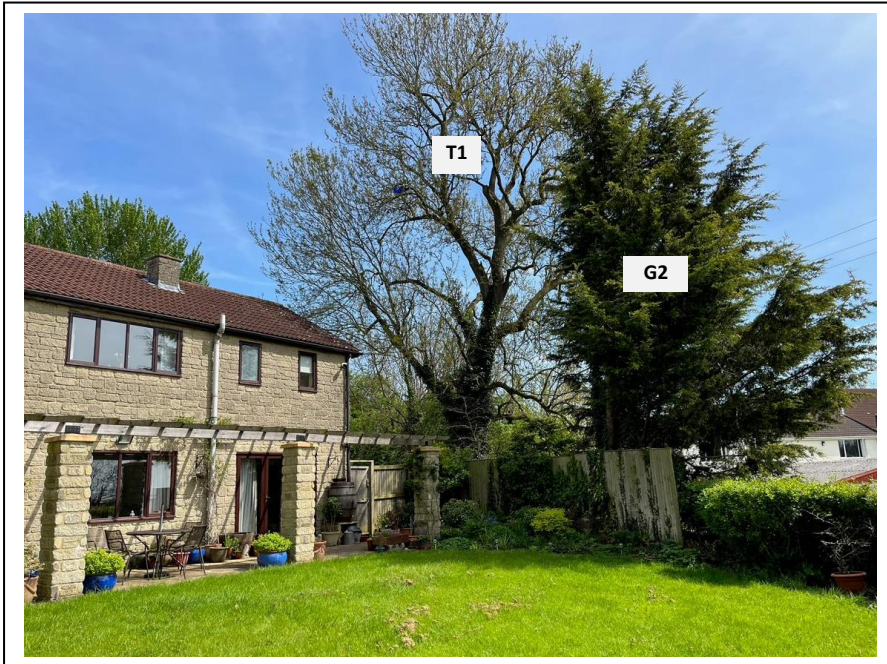
View of T1 and G2

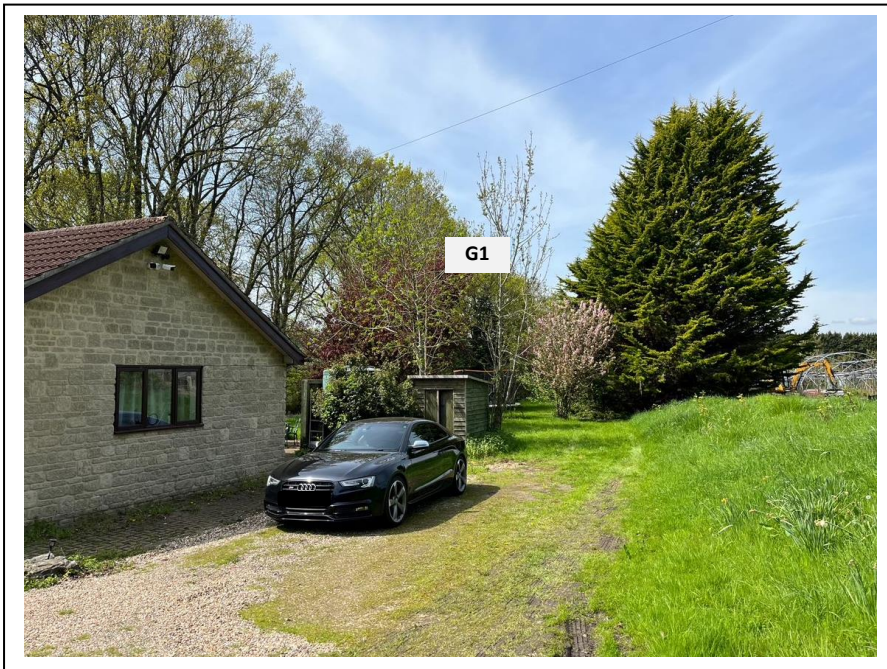
View of G1
