TECHNICAL REPORT ON A SUBSIDENCE CLAIM

Crawford Reference: SU2204195

**Heath Farm
Henfield Road
Coalpit Heath
Bristol
BS36 2UL**

SUBSIDENCE CLAIM

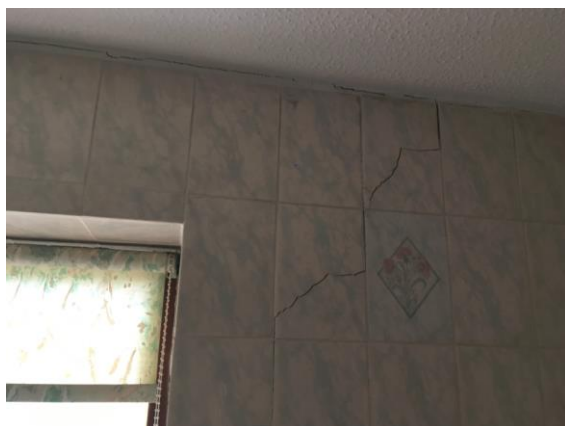
Cracking to bathroom

In the rear bedroom and bathroom at first floor level, 3-4mm diagonal tapering cracking is evident on the rear and side wall.

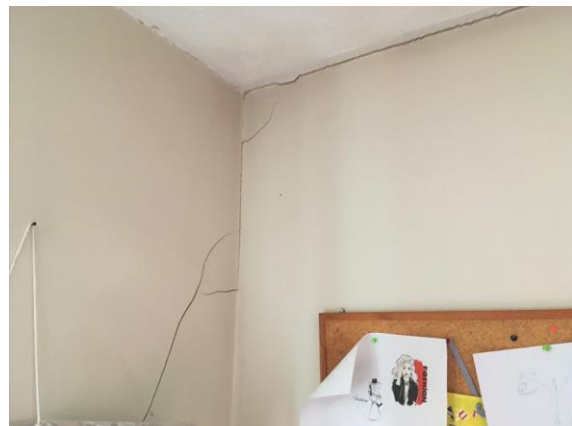
Cracking to bedroom

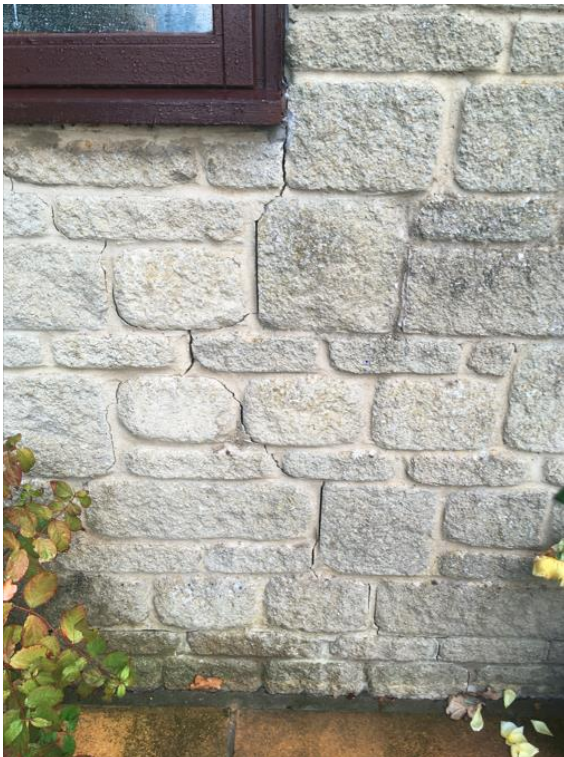
Cracking below kitchen window.

On the rear and left side walls, tapering cracking is evident extending from low level to roof level

The cracking is noted above and below the kitchen window and above the rear door and below the bathroom window.

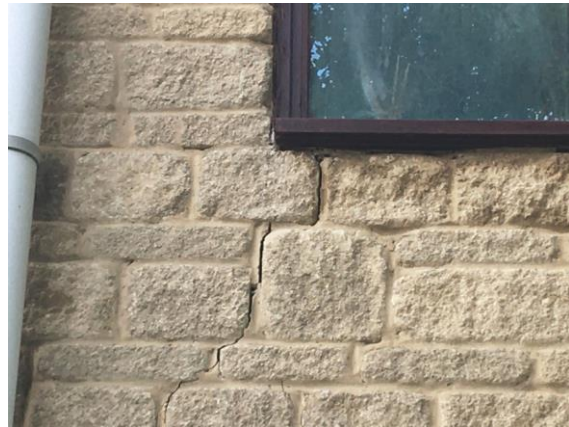
Cracking below bathroom window.

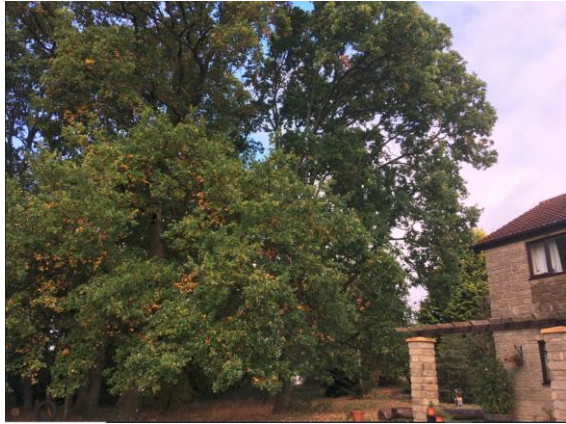
Type	Height	Distance	Ownership
Oak	20 m	11 m	Owners
Oak	20 m	14 m	Owners

The timing of the event, the presence of shrinkable clay beneath the foundations and the proximity of vegetation where there is damage indicates the shrinkage to be root induced. This is a commonly encountered problem and probably accounts for around 70% of subsidence claims notified to insurers.

Large Oak trees to rear of property.

Although the cause of the movement needs to be dealt with, we note the vegetation is subject to a Preservation Order. Unfortunately, current legislation requires certain investigations to be carried out to support an application for the tree works.

Typically, these investigations would involve trial pit(s) to determine the depth and type of footings, boreholes to determine the nature of the subsoil/influence of any roots and monitoring to establish the rate and pattern of movement. The monitoring data provided must be sufficient to show a pattern of movement consistent with the influence of the vegetation and therefore it may be necessary to carry out the monitoring for up to a 12 month period.

It will also be necessary to obtain a specialist Arboricultural Report.

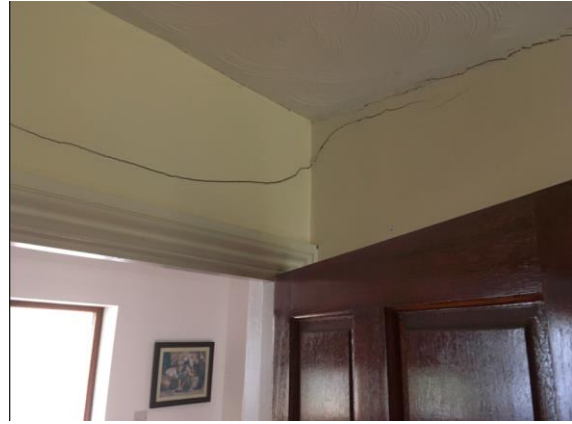
At ground floor level, the kitchen office and utility room all have 2-4mm diagonal cracking on the rear / side wall as well as internal dividing walls.

Cracking above office door head..

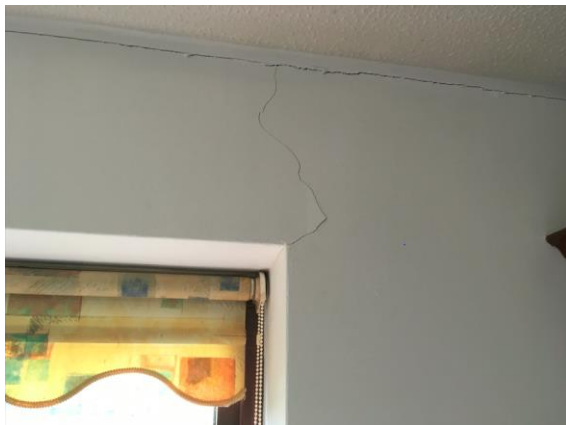
Cracking above kitchen window.
