Arboricultural Consultancy for Lloyds Bank

| Insured | Mr Roger Wood | Address | 9 Strathbrook Road, London, SW16 3AT | | |
| Client | Subsidence Management Services | Contact | Nigel Buxton | Claim No. | IFS-LBG-SUB-22-0102319 |

Scope of Report: To survey the property and determine significant vegetation contributing to subsidence damage, make recommendation for remedial action and assess initial mitigation and recovery prospects. The survey does not make an assessment for decay or hazard evaluation.

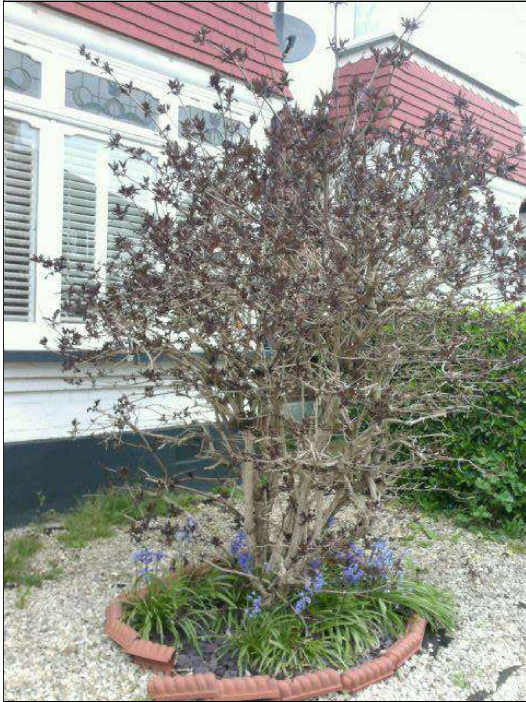
T1 - Elder

With due regards to species profile, size and proximity, the Elder (T1) is considered the dominant feature proximate to the focal area(s) of movement and accordingly, where vegetation is confirmed as being causal, we have identified it as the primary cause of the current subsidence damage.

| Tree No. | Species | Age Cat | Approx. Height (m) | Distance to Building (m) * | Ownership | Action | Requirement |
|---|---|---|---|---|---|---|---|
| T1 | Elder | 1 | 2.5 | 1.6 | C - Insured | Remove | Remove close to ground level and treat stump to inhibit regrowth. |

Consequently, we have advocated the complete removal of T1 in conjunction with management, to include partial removal of a section of H1 (as detailed) as it will offer the most certain arboricultural solution likely to restore long-term stability.

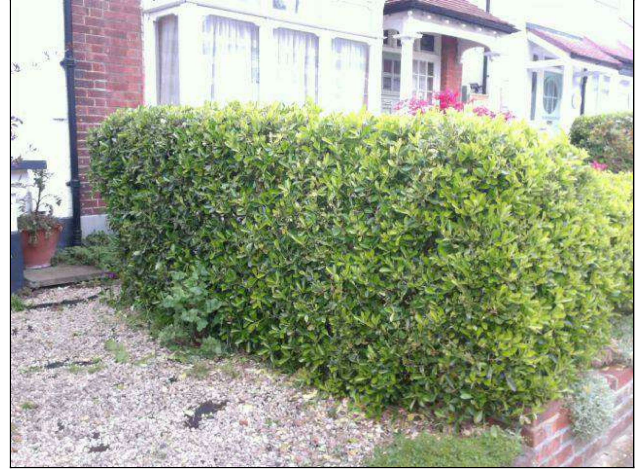
H1 - Euonymus

H1 (Euonymus) is also considered to retain a contributory influence, albeit in a secondary capacity when compared to the above.

| Tree No. | Species | Age Cat | Approx. Height (m) | Distance to Building (m) * | Ownership | Action | Requirement |
|---|---|---|---|---|---|---|---|
| H1 | Euonymus | 1 | 1.6 | 1.4 | A - Third Party | Maintain as detailed | Remove section of hedge to achieve a minimum clearance of 2.5m to the insured property; do not chemically treat stumps due to translocation risk. Where such a risk exists, we advise that any emergent regrowth is removed annually. Maintain retained section thereafter at broadly current dimensions by way of regular pruning. |

| Sub Sample | Species Identified | Root Diameter | Starch |
|---|---|---|---|
| 0.5-1.5m | <i>Euonymus</i> spp. | 1 | 1 mm Moderate |

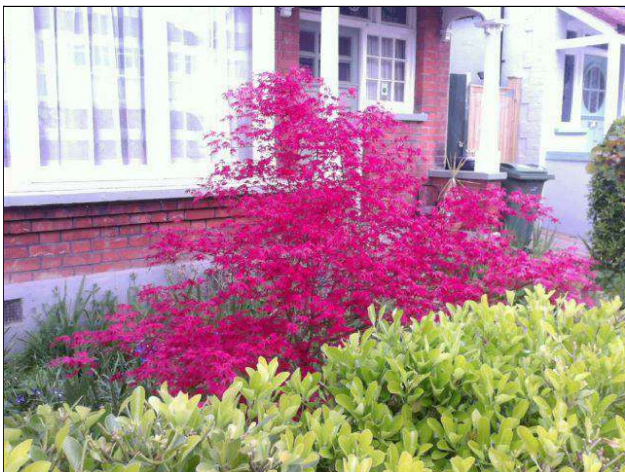
T2 - Maple (Japanese)

| Tree No. | Species | Age Cat | Approx. Height (m) | Distance to Building (m) * | Ownership | Action | Requirement |
|---|---|---|---|---|---|---|---|
| T2 | Maple (Japanese) | 1 | 1.5 | 3.5 | A - Third Party | Action to avoid future risk | Maintain at broadly current dimensions by way of regular pruning. |

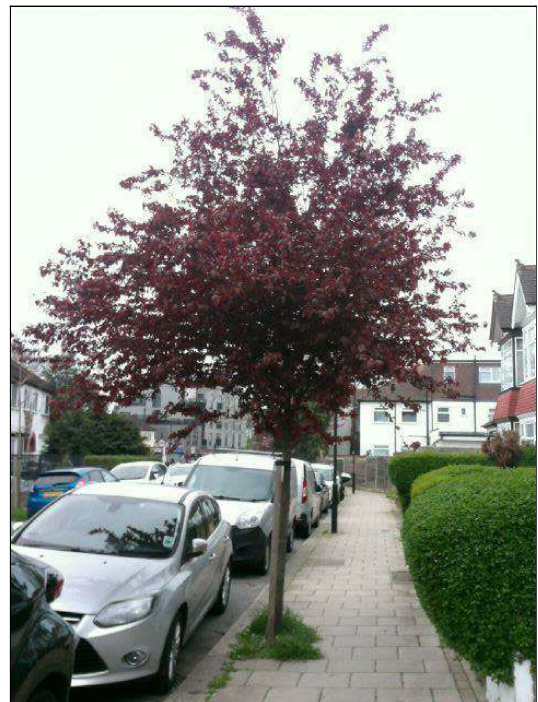
T3 - Plum (Purple leaved)

| Tree No. | Species | Age Cat | Approx. Height (m) | Distance to Building (m) * | Ownership | Action | Requirement |
|---|---|---|---|---|---|---|---|
| T3 | Plum (Purple leafed) | 1 | 5 | 6.5 | B - Local Authority | Action to avoid future risk | Maintain at, or below current dimensions by way of regular pruning. |

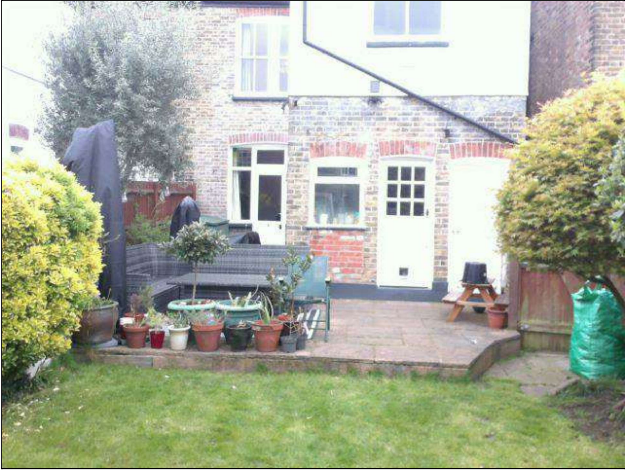
TG1 - Mixed species group

| Tree No. | Species | Age Cat | Approx. Height (m) | Distance to Building (m) * | Ownership | Action | Requirement |
|---|---|---|---|---|---|---|---|
| TG1 | Mixed species group | 1 | 4 | 2.5 | C - Insured | Action to avoid future risk | Mixed species including Olive & Maple. Maintain at broadly current dimensions by way of regular pruning. |

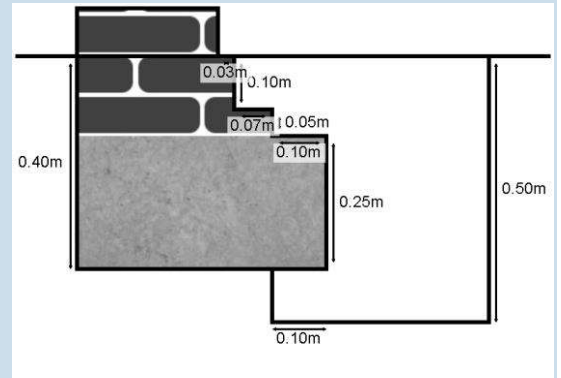
TP/BH1 Foundation Detail and Borehole Log

Bay foundation comprised of stepped brick to 150mm bgl with a total projection of 100mm from the elevation, bearing on concrete to 400mm bgl with a total projection of 200mm from the elevation. Underside of foundation (USF) was exposed to 100mm back from the face of the foundation and probed 500mm back from the face of the foundation.

Bay foundation was exposed and the underside of foundation (USF) recorded to be 0.4m bgl (TP/BH 1).

Roots encountered to 1.5m bgl (TP/BH 1).
