Heritage Impact Assessment – Repairs/alterations to
2no. Chimney Stacks at Hanch Hall, Lysways Lane,
Lichfield, Staffordshire, WS13 8HH

23rd June 2023 - 139365

We are acting on instructions to prepare documents as required, and apply for Listed Building Consent for the repairs/alterations to 2no. chimney stacks at Hanch Hall.

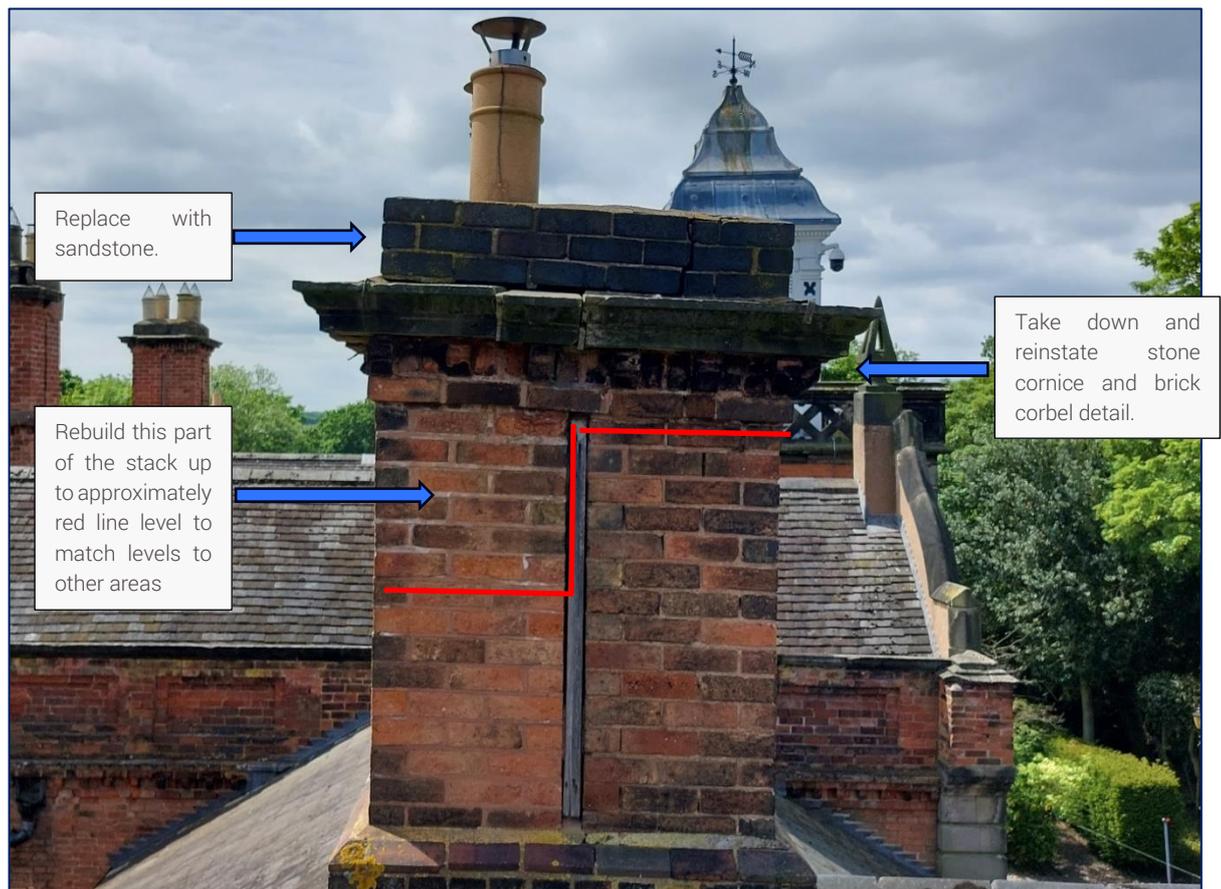
Fig.2 –Stack 2

Stack 2 is shown in Fig.2 below.

This shows the upper part of the stack being considerably out of level. The cause of this appears to relate to a poor-quality reconstruction of the left-hand side stack as shown in Fig.2 below or possibly relating to sulphate expansion of the mortar. Bed joints to upper 6no. courses are considerable larger than other courses. Further inspection of the flue liner and stack will be undertaken once scaffold access is provided.

As indicated in Fig.2 below, the apex stone details as present on other chimneys at Hanch Hall (see Fig.7 in appendix), have been replaced with blue engineering brick as part of a poor-quality past repair. There is also a wide vertical crack within this detail. Metal straps are visible over the stone cornice detail, again, as a poor-quality past repair.

The proposals in the application are to rebuild the upper part of the chimney stack to rectify past poor quality repairs that have caused defects, as well as restoring the stone capping, and ensuring sufficient ties are present to the stone detailing. These will comprise stainless steel cramps and dowels in 2-part epoxy resin as described for Stack 1 above.

New sandstone to match existing sandstone to Stack 1 will be sourced as required, or from existing estate suppliers, depending on the available size and quality of the existing stone.

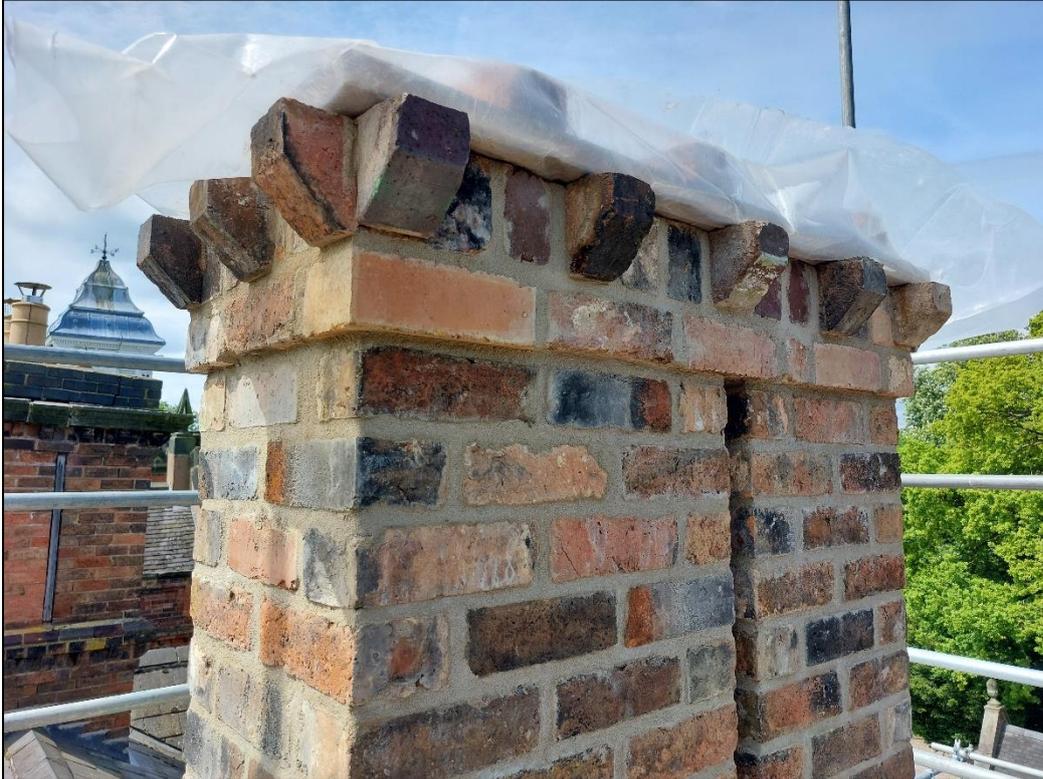
Prior to our inspection on 23rd May 2023, Stack 1 had been taken down to ridge level and rebuilt up to stone cornice level to address a structural defect. At this point, works were placed on hold while the application for Listed Building Consent has been developed.

Stack 1 has been rebuilt almost entirely by re-using the salvaged bricks from the existing stack.

Where new bricks have been provided, these have been sourced from a reclamation yard to match existing. The same are a good match.

Fig.1 – Stack 1 reconstructed up to stone cornice level.

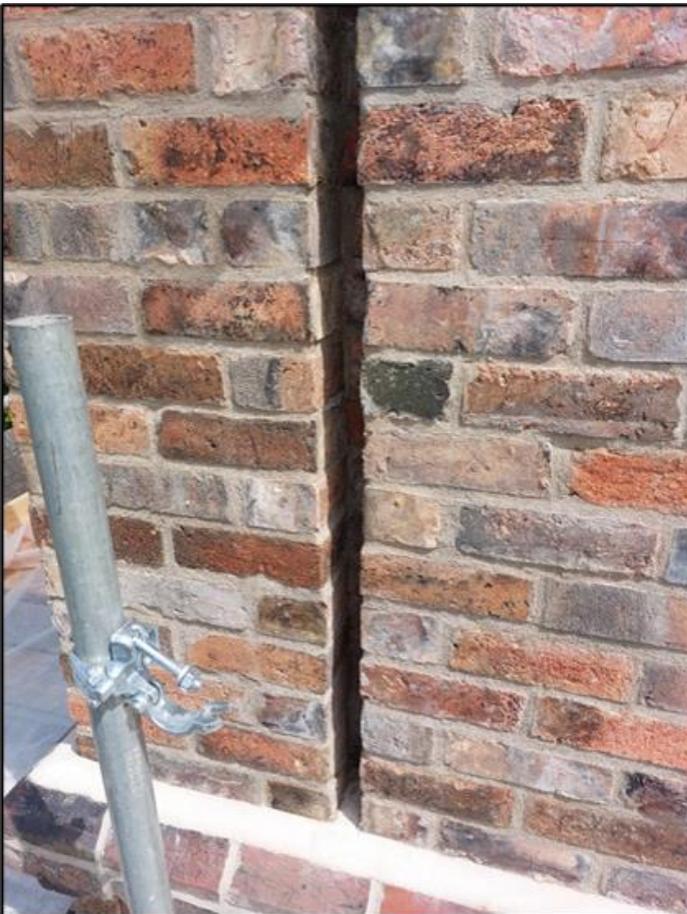
The stack has been reconstructed slightly differently to the 'existing' stack, by tying together the 4no. individual stacks. A deep shadow gap has been maintained (Fig.2). This is a relatively minor alteration but does slightly affect the character of the stack. This has been undertaken to improve the structural integrity of the stack.

The reconstruction of stack 1 to form a single stack, from 4no., smaller stacks has been undertaken to improve the structural integrity of the stack.

The impact is the loss of the historic character and design of this stack. This is partially mitigated by the recessed 'shadow gap' formed.

Fig.2 – Stack 1 – Shadow gap created as part of rebuilding works.

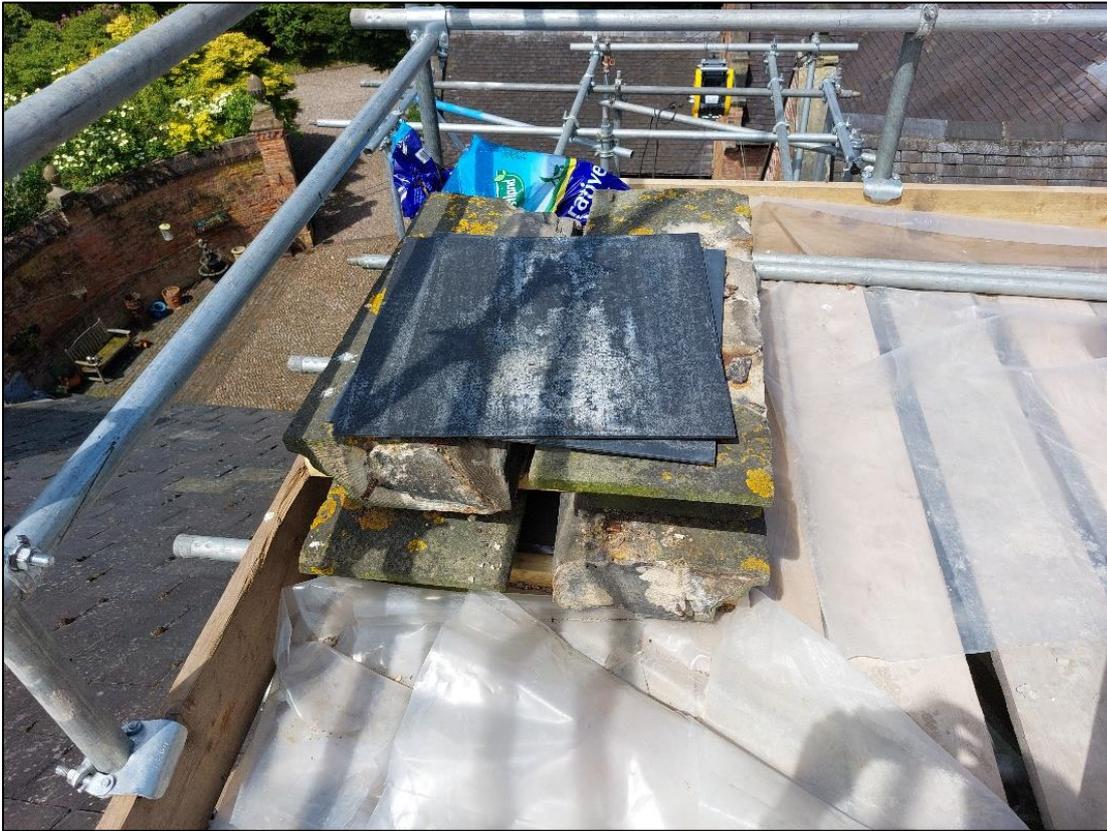
Fig.3 – Stone cornice removed to stack 1 will be reinstated. 1no. new cornice section is required.

To complete the stack re-construction, the salvaged stone cornice band (Fig.3) will be reinstated, using stainless steel cramps and dowels and 2-part epoxy resin to replace the existing corroded iron cramps (and molten lead) used in these locations. These fixings will tie together the stone cornice.

To complete the cornice band, 1no. new cornice stone is required to replace an existing one which is damaged and not capable of being re-used. The stone for this work will be sandstone to match existing, salvaged from existing estate supplies on site, or new sandstone to match existing. Work to be undertaken by competent and experienced stonemason under supervision. Stone to be dressed to match existing profiles before being integrated.

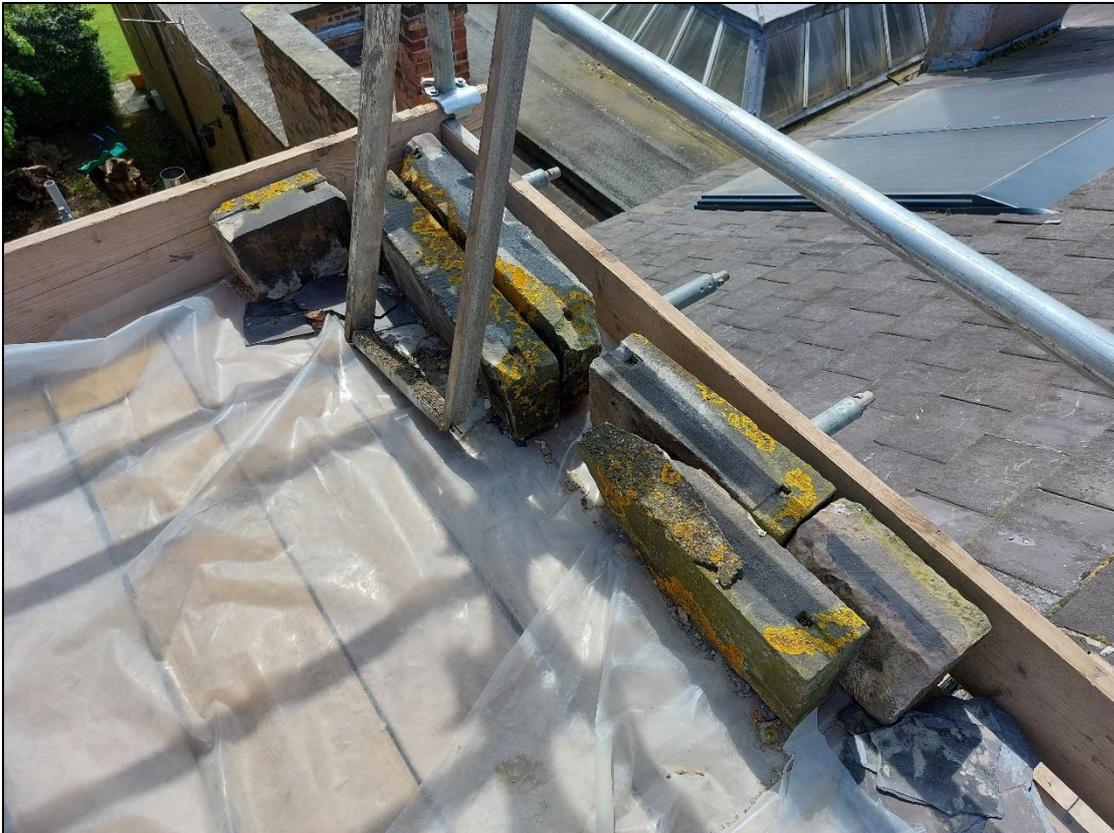
Fig.4 – Stone apex section removed to stack 1 to be reinstated.

The salvaged stone detail above the cornice level will be reinstated to match existing (Fig.4). As described for the corning, this will comprise stainless steel cramps and dowels.

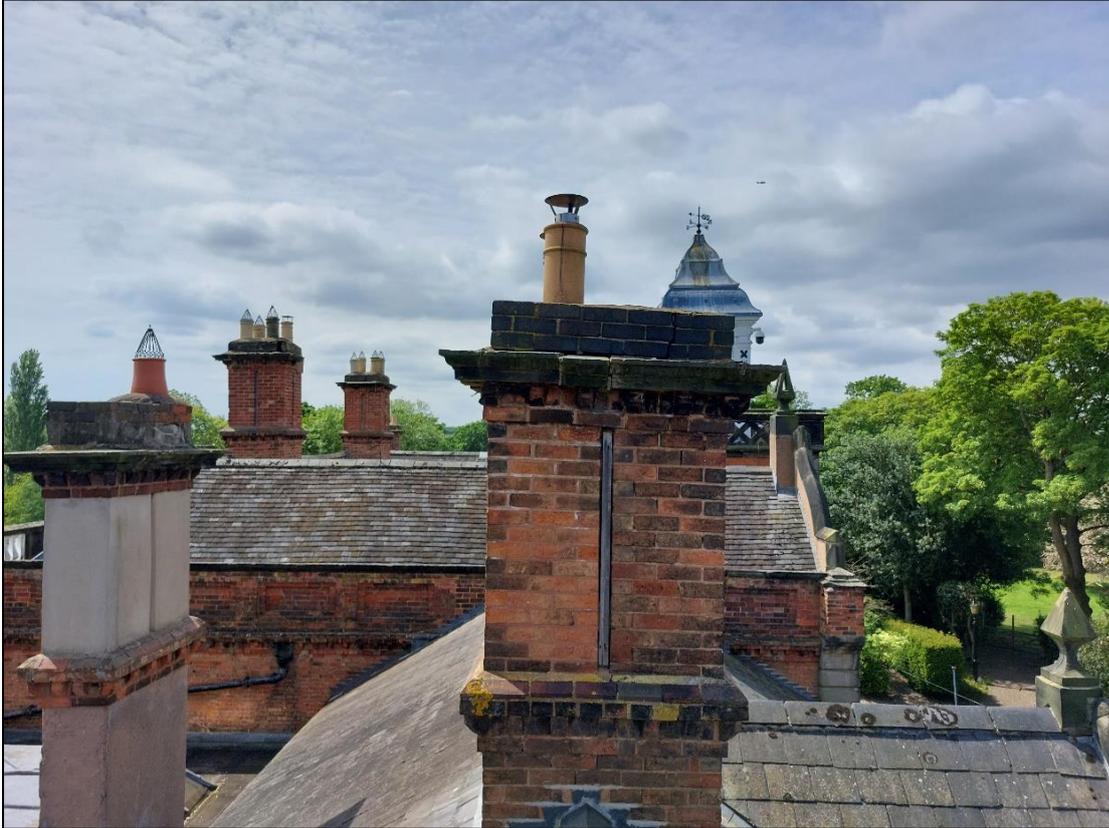
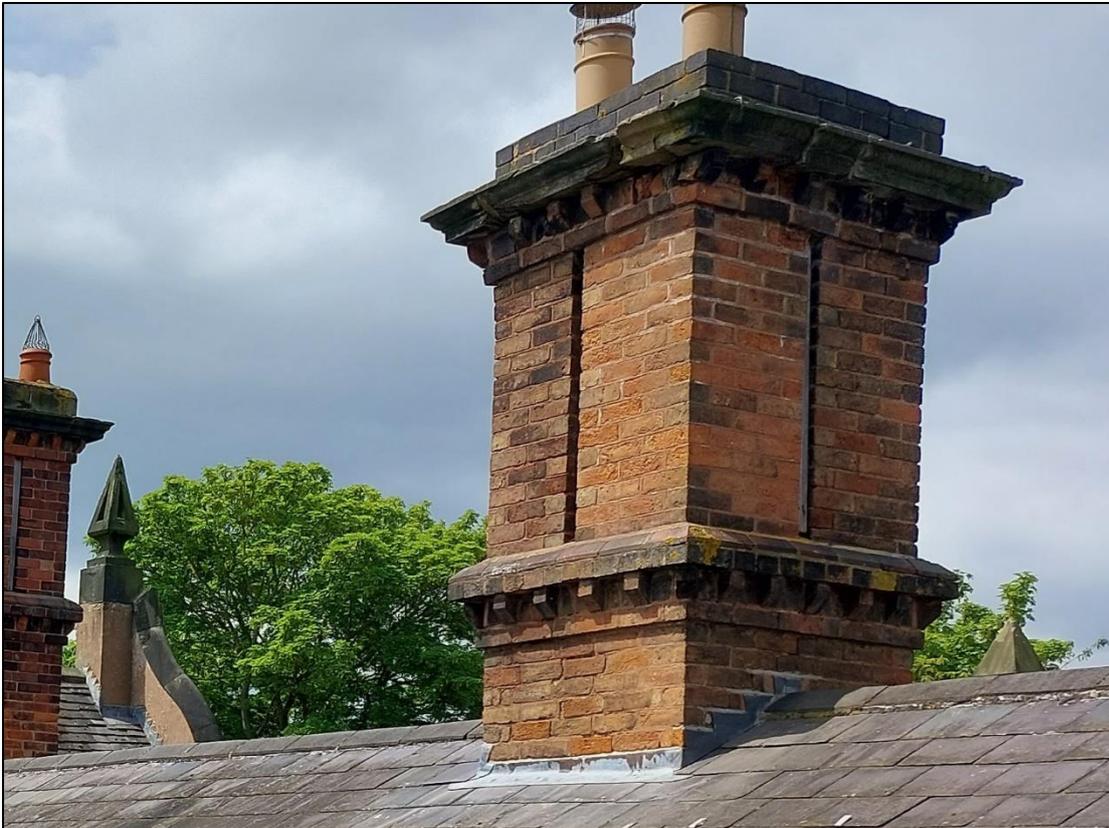
Fig.5 – Stack 2

Fig.6 – Stack 2

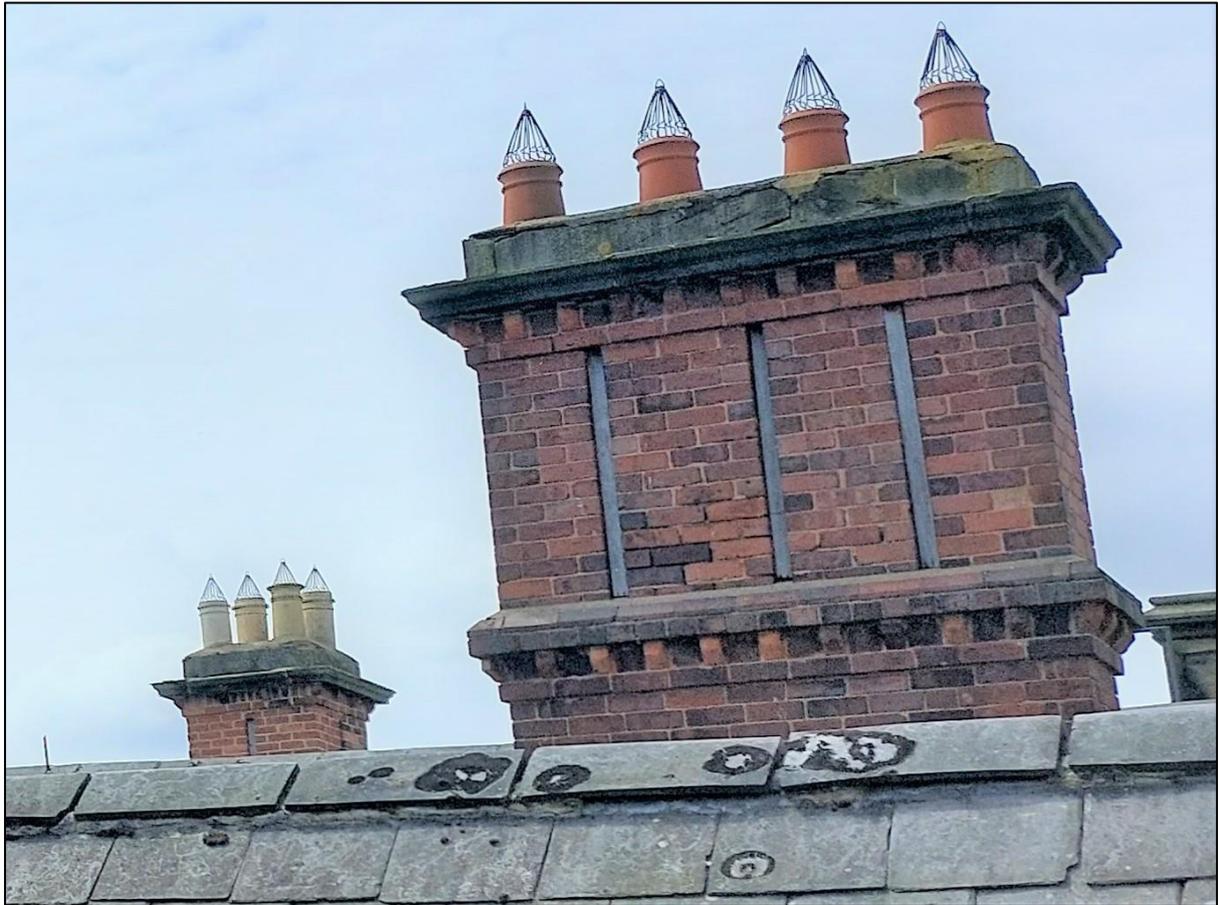
Fig.7 – Typical detail to other Chimney Stacks at Hanch Hall
