Heritage Impact Assessment – Repairs/alterations to
2no. Chimney Stacks at Hanch Hall, Lysways Lane,
Lichfield, Staffordshire, WS13 8HH

23rd June 2023 - 139365

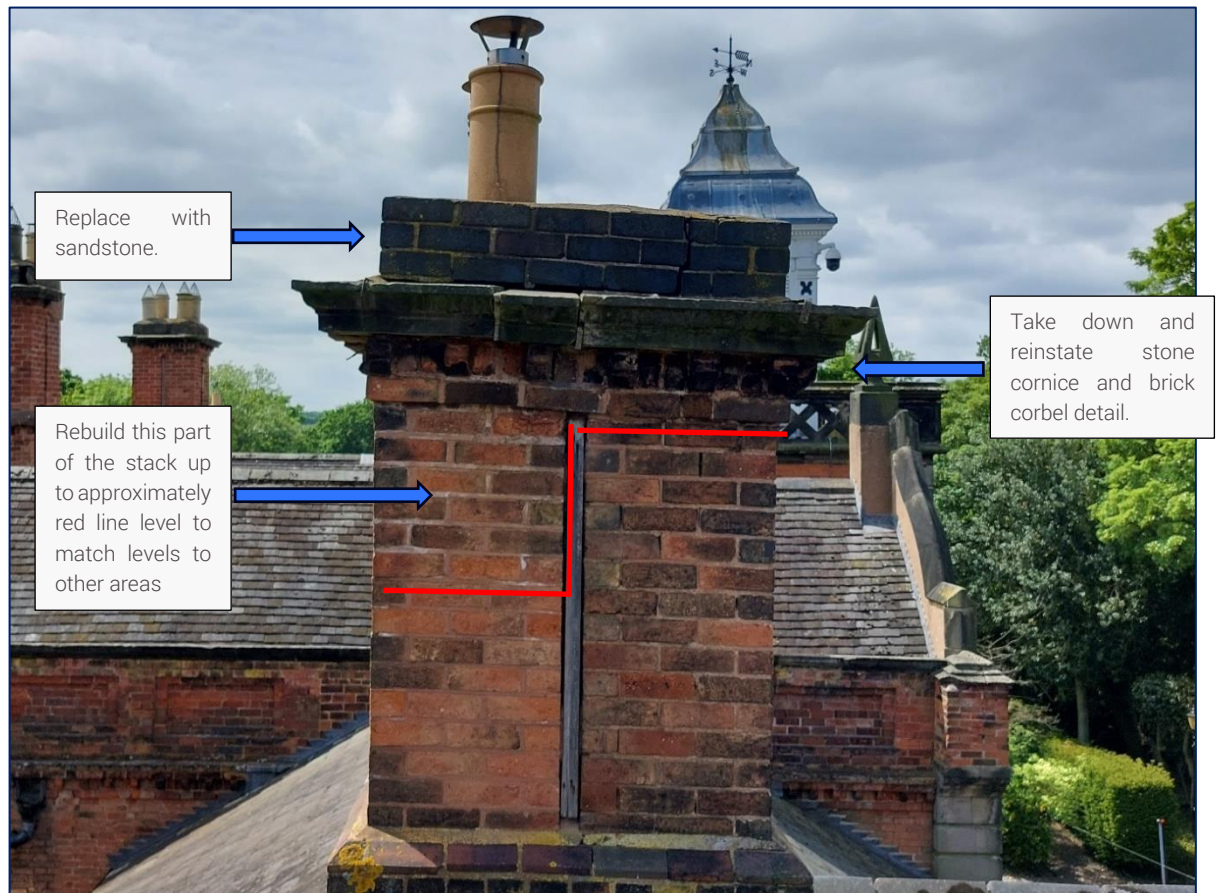
Fig.2 –Stack 2

This shows the upper part of the stack being considerably out of level. The cause of this appears to relate to a poor-quality reconstruction of the left-hand side stack as shown in Fig.2 below or possibly relating to sulphate expansion of the mortar. Bed joints to upper 6no. courses are considerable larger than other courses. Further inspection of the flue liner and stack will be undertaken once scaffold access is provided.

As indicated in Fig.2 below, the apex stone details as present on other chimneys at Hanch Hall (see Fig.7 in appendix), have been replaced with blue engineering brick as part of a poor-quality past repair. There is also a wide vertical crack within this detail. Metal straps are visible over the stone cornice detail, again, as a poor-quality past repair.

The proposals in the application are to rebuild the upper part of the chimney stack to rectify past poor quality repairs that have caused defects, as well as restoring the stone capping, and ensuring sufficient ties are present to the stone detailing. These will comprise stainless steel cramps and dowels in 2-part epoxy resin as described for Stack 1 above.

New sandstone to match existing sandstone to Stack 1 will be sourced as required, or from existing estate suppliers, depending on the available size and quality of the existing stone.

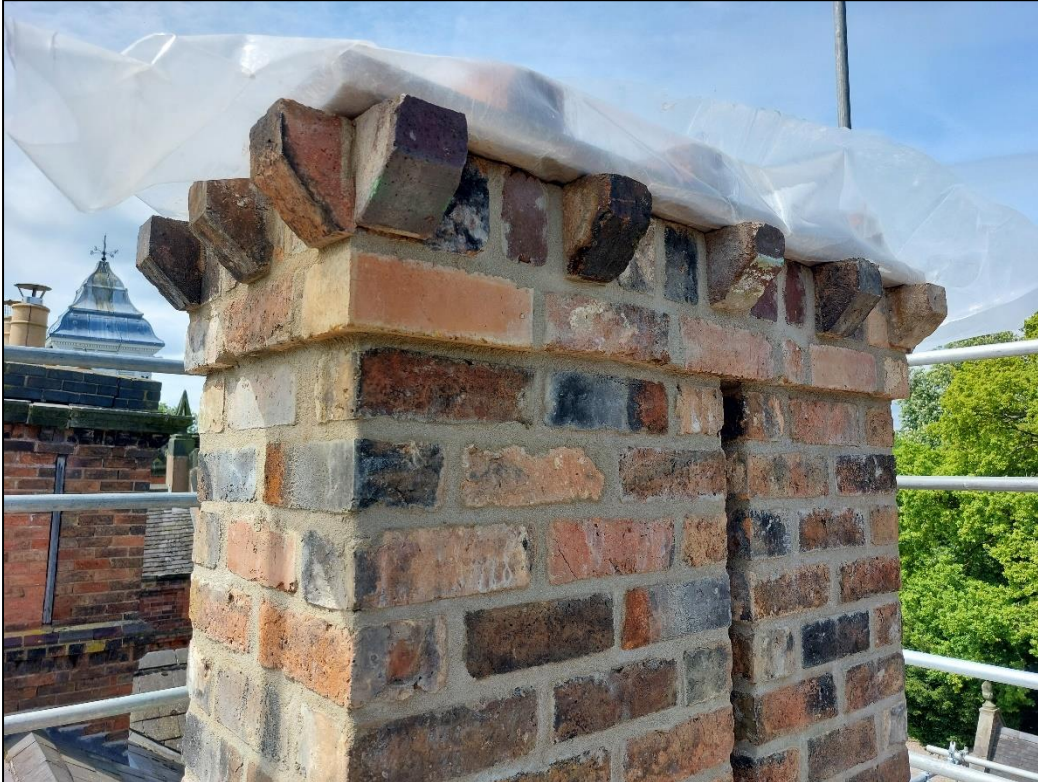
Prior to our inspection on 23rd May 2023, Stack 1 had been taken down to ridge level and rebuilt up to stone cornice level to address a structural defect. At this point, works were placed on hold while the application for Listed Building Consent has been developed.

Stack 1 has been rebuilt almost entirely by re-using the salvaged bricks from the existing stack.

Where new bricks have been provided, these have been sourced from a reclamation yard to match existing. The same are a good match.

Fig.1 – Stack 1 reconstructed up to stone cornice level.

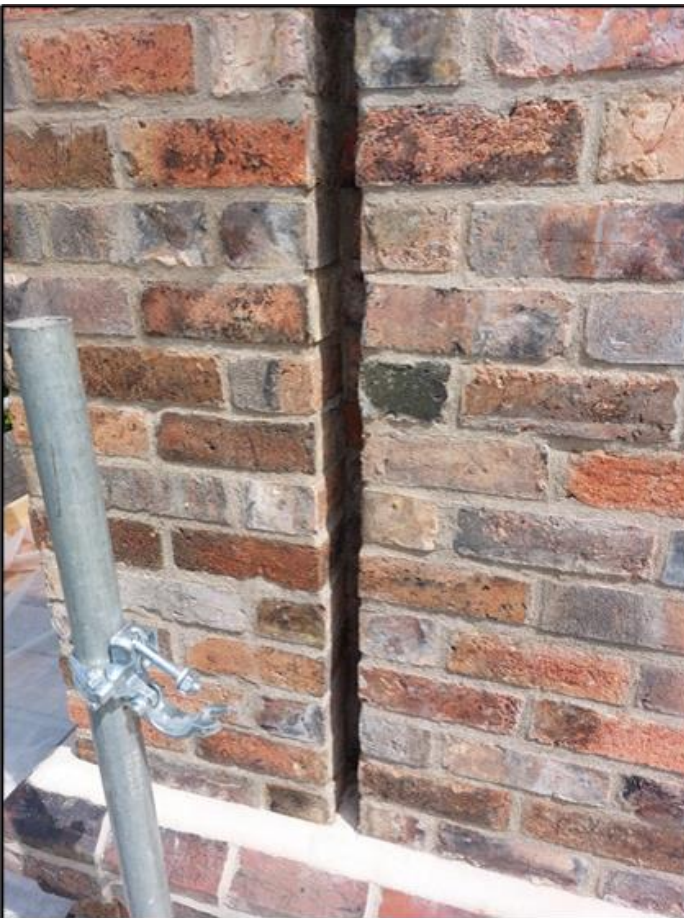
The stack has been reconstructed slightly differently to the 'existing' stack, by tying together the 4no. individual stacks. A deep shadow gap has been maintained (Fig.2). This is a relatively minor alteration but does slightly affect the character of the stack. This has been undertaken to improve the structural integrity of the stack.

The reconstruction of stack 1 to form a single stack, from 4no., smaller stacks has been undertaken to improve the structural integrity of the stack.

The impact is the loss of the historic character and design of this stack. This is partially mitigated by the recessed 'shadow gap' formed.

We have not undertaken close inspections of other chimneys at Hanch Hall, but from a distance, it is evident that timber has been used to infill the gaps between the stacks. This would suggest there is a defect with the chimney designs. Rebuilding the stack in the manner undertaken has removed this assumed defect.

Fig.2 – Stack 1 – Shadow gap created as part of rebuilding works.

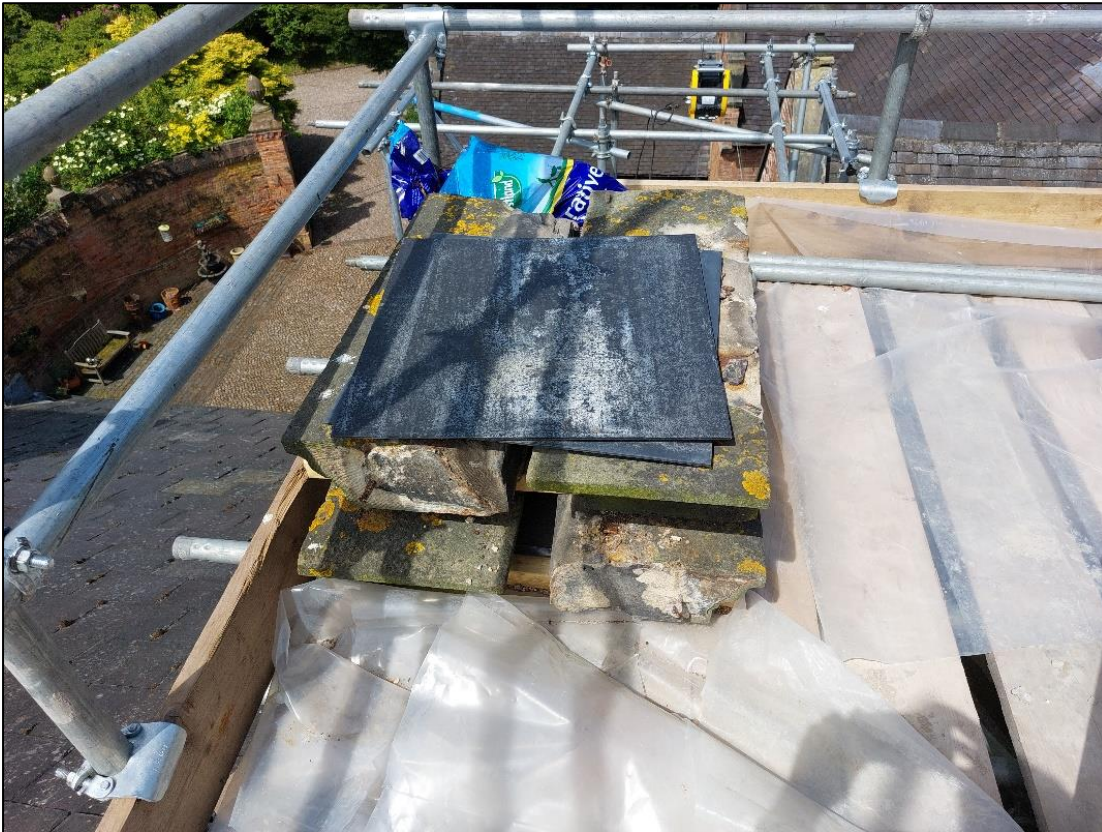
Fig.3 – Stone cornice removed to stack 1 will be reinstated. 1no. new cornice section is required.

To complete the stack re-construction, the salvaged stone cornice band (Fig.3) will be reinstated, using stainless steel cramps and dowels and 2-part epoxy resin to replace the existing corroded iron cramps (and molten lead) used in these locations. These fixings will tie together the stone cornice.

To complete the cornice band, 1no. new cornice stone is required to replace an existing one which is damaged and not capable of being re-used. The stone for this work will be sandstone to match existing, salvaged from existing estate supplies on site, or new sandstone to match existing. Work to be undertaken by competent and experienced stonemason under supervision. Stone to be dressed to match existing profiles before being integrated.

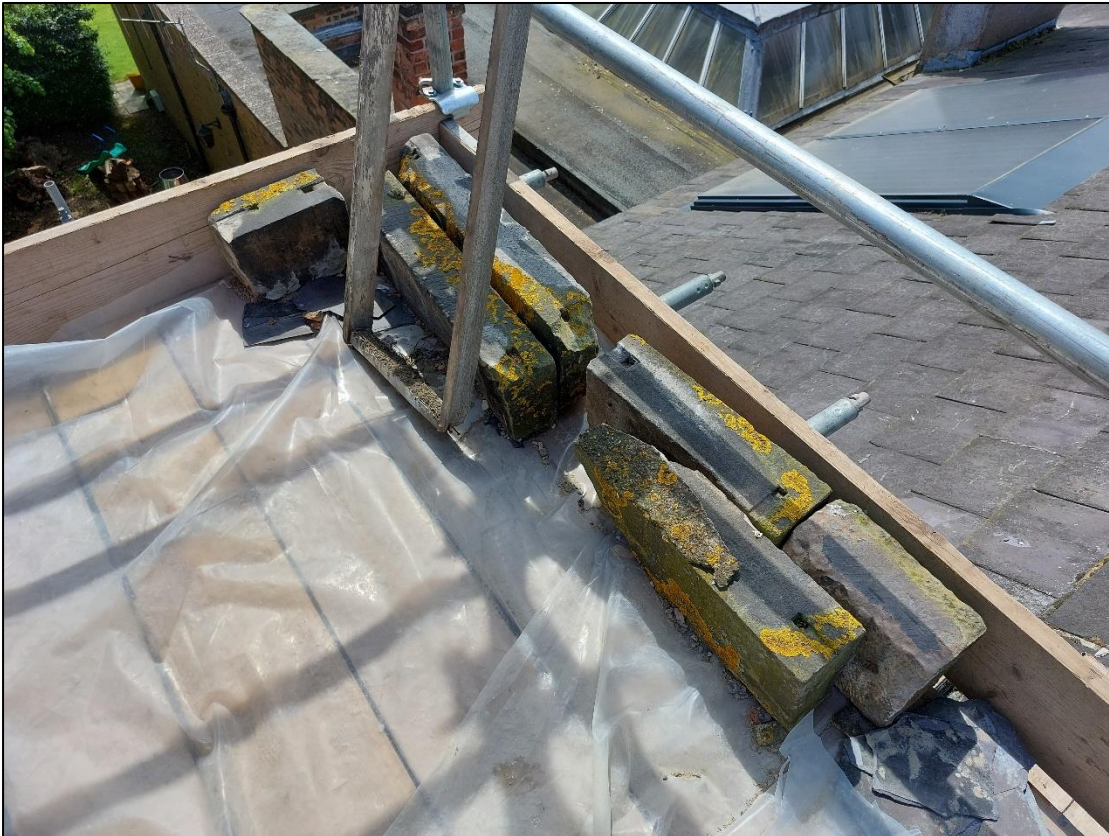
Fig.4 – Stone apex section removed to stack 1 to be reinstated.

The salvaged stone detail above the cornice level will be reinstated to match existing (Fig.4). As described for the corning, this will comprise stainless steel cramps and dowels.

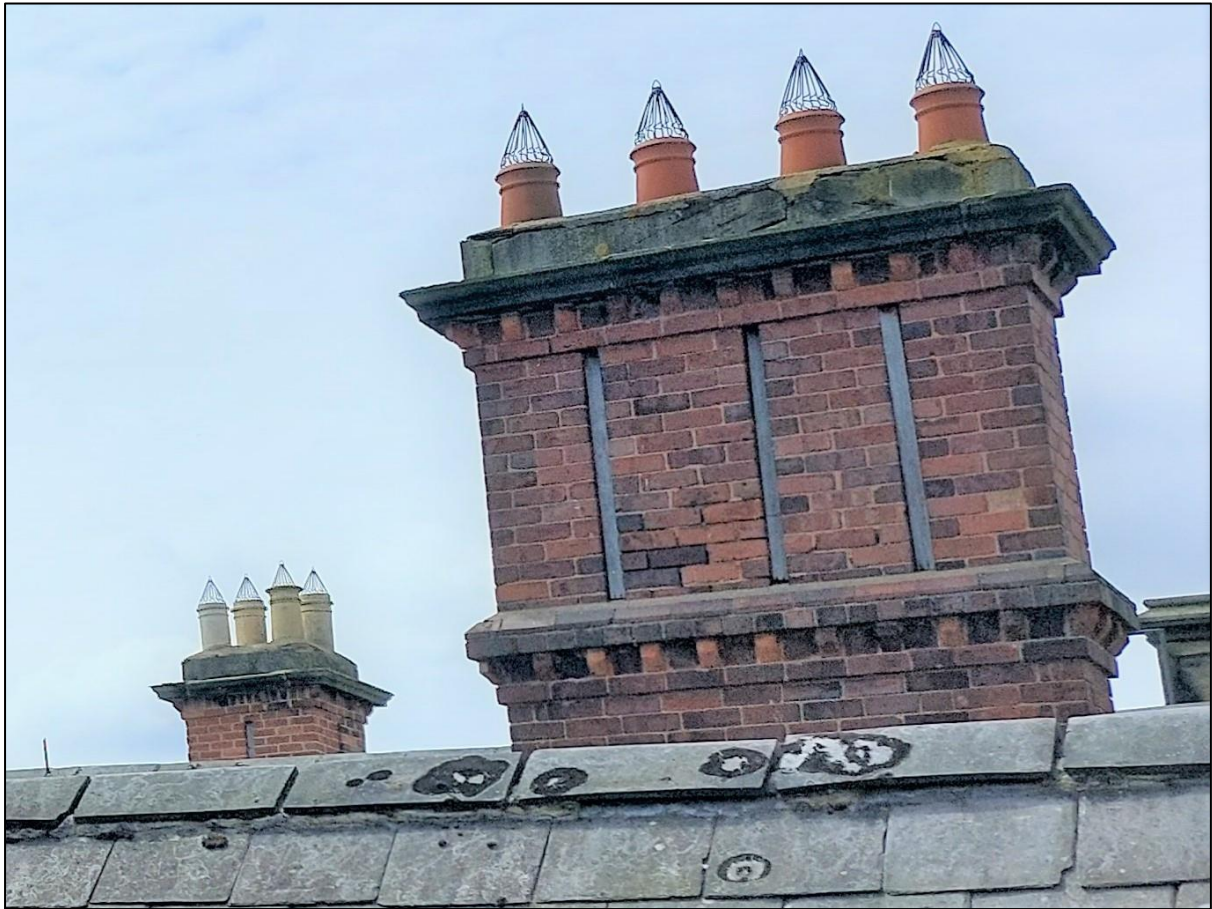
Fig.7 – Typical detail to other Chimney Stacks at Hanch Hall
