COASTAL VULNERABILITY ASSESSMENT REPORT

SITE: TREVERBYN, GWEL AN GARREK, MULLION

Our Ref: TJG / C VA / G 015.Treverbryn.Rev0

[Proposed renovation works at Treverbryn, Gwel an Garrek, Mullion, Cornwall, TR12 7EW](#)

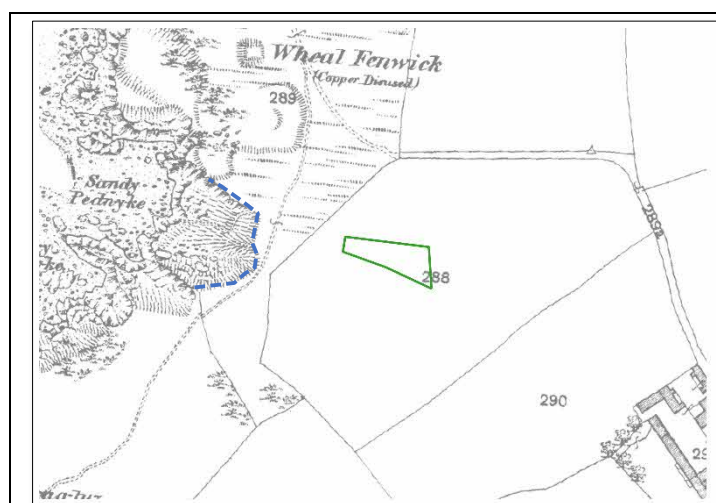
Fig 3a: Historic Ordnance Survey map (1880) – blue hatching indicates ‘collapse lobe’.

The historical OS maps indicate a maximum measurable extent of erosion and regression of the shoreline at this location of < 43 metres since 1880, as indicated by the blue hatching in Figure 3a and 3b. The point of maximum coastal erosion and regression (< 43 m) is located approximately 20 metres to the south of the southwest corner property.

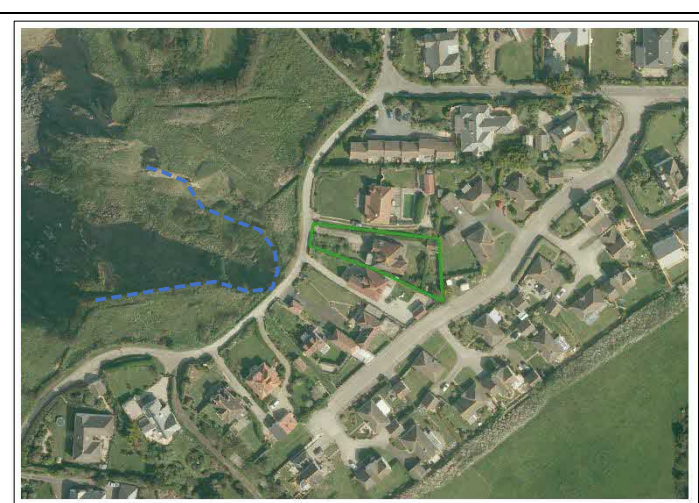
Fig 3b: Modern aerial imagery – blue hatching indicates ‘collapse lobe’.

The shoreline immediately adjacent and to the west to the property has eroded and regressed approximately 39 metres since 1880, and the coastline (sea cliffs) are approximately 16 metres from the western boundary of the property at the closest point.

An assessment of the aerial imagery¹¹ of the site, available from 2001 to 2023, suggests that the rate of erosion and regression over the recent time period (since 2001), and immediately adjacent to the western boundary of the property, has slowed and become negligible.

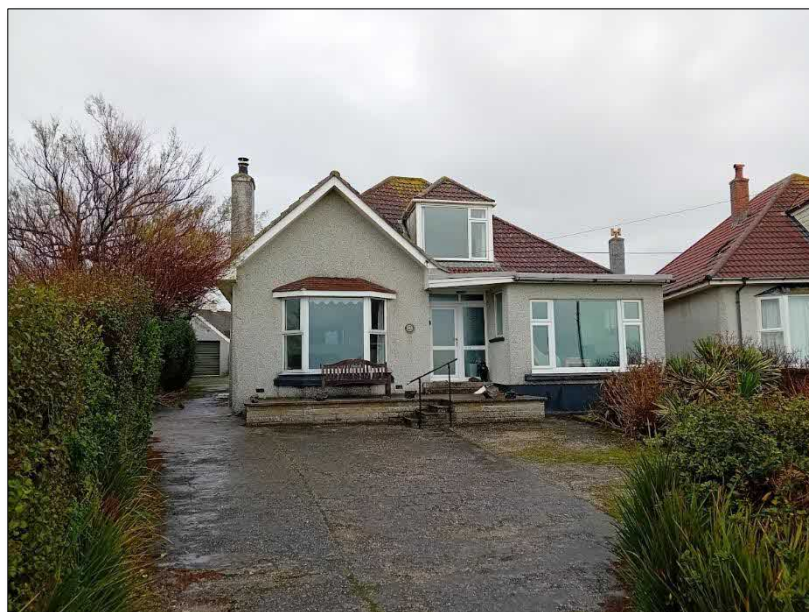
At the time of the inspection, the property, gardens and boundary walls were observed to be in a good state of structural repair and appeared to be well maintained, the building and garden areas were observed to be structurally intact with no evidence of significant damage (cracking) that may be indicative of ground movement or bearing failure.

Figure 04: Treverbyn – image taken from the site entrance / driveway off Cliff Road, looking east.

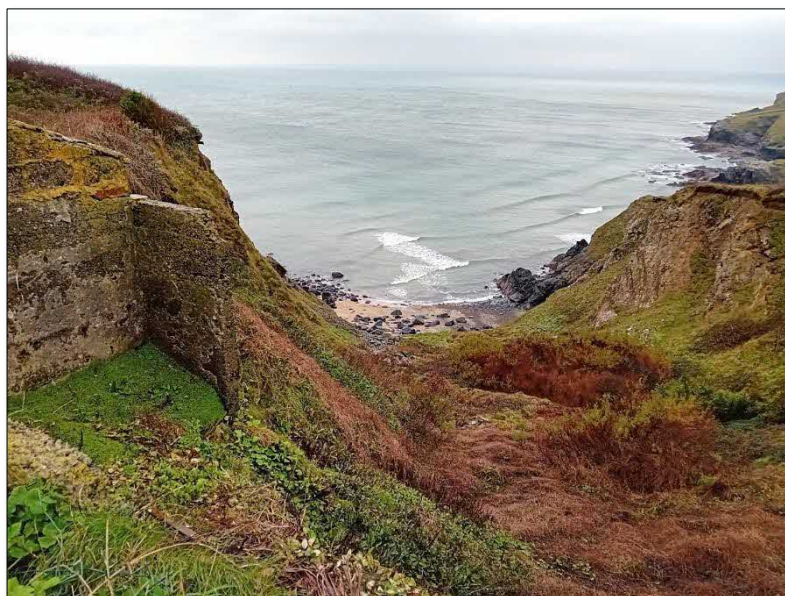
It is apparent from the walkover inspection of the site, that the land to the west of the unnamed access track has fallen away, and there has been significant collapse of material from the sea cliffs, and towards the beach below. This collapse has occurred as an elongate lobe (collapse lobe), extending eastwards from the shoreline and towards the residential properties to the south of Treverbyn. The collapse lobe is between approximately 30 and 40 metres in width and 110 metres in length (as presented in Figure 3b).

The base of the collapse lobe is extensively obscured by vegetation but it forms a relatively consistent slope down to beach level at a gradient of between 25 and 35 degrees (from horizontal). The sides of the collapse lobe are between approximately 60 to 80 degrees (from horizontal, giving the collapse lobe a U-shape in section. There is exposed bedrock within the sides of the collapse lobe, suggesting the collapse has occurred within the bedrock. It was not possible to access the bedrock outcrops, however they were observed from the access track and appeared to be extensively destructured.

Figure 05: Sandy Pedn-y-ke – the ‘collapse lobe’ adjacent to the access track, derelict structure in foreground. Image taken from the unnamed access track, looking west.

The size, shape and orientation of the collapse lobe suggests it has formed as a result of the collapse of an erosional structure (possibly a sea cave) which has formed along an unrecorded linear structural feature (fault), striking from the coastline in an approximately west-northwest to east-southeast orientation. This would account for the elongate shape and orientation of the collapse lobe.

There is a partially collapsed derelict structure immediately adjacent to the unnamed access track, which is constructed of concrete block, and appears to have partially fallen into the collapse lobe. The presence of this structure is consistent with imagery from the 1963 Ordnance Survey dataset which indicates structures on the west side of the access track at this approximate location. This suggests that the collapse has occurred at least in part since 1963.

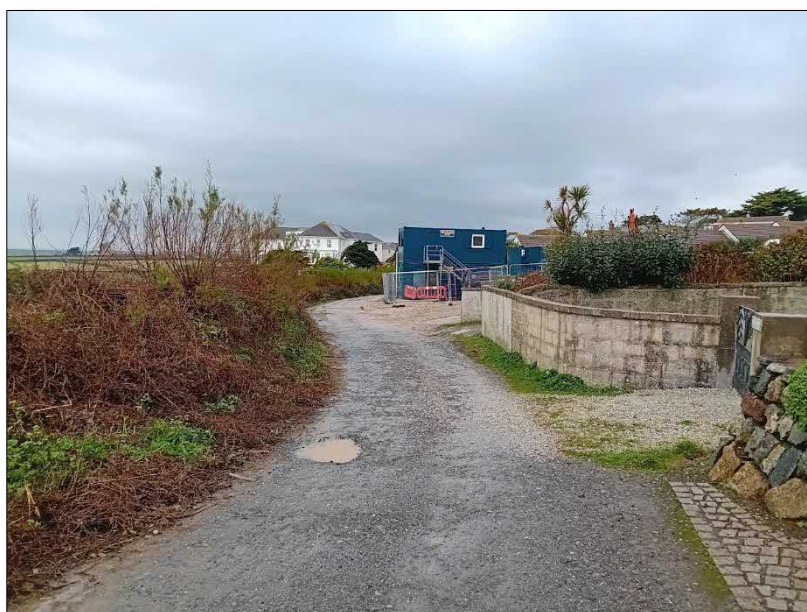
The unnamed access track and the surrounding boundary walls were subject to limited visual inspection. The boundary wall on the western side of the access track comprised of a large Cornish hedge that was obscured by bushes and overgrowth. The access track was unsurfaced and in a moderate to poor state of repair, with numerous shallow potholes and some observation of shallow wheel rutting, however the road surface and the surrounding boundary walls on the eastern side were observed and did not show any indication of subsidence, bulging, or structural damage such as cracking or tension cracking, that might be indicative of ground movement as a result of slope failure or further collapse of the lobe structure.

Figure 06: The unnamed access track on the western boundary of the property. Cornish hedge (o on the western boundary. Concrete wall demarks the western boundary of the property (Treverb taken from the access track, looking north.

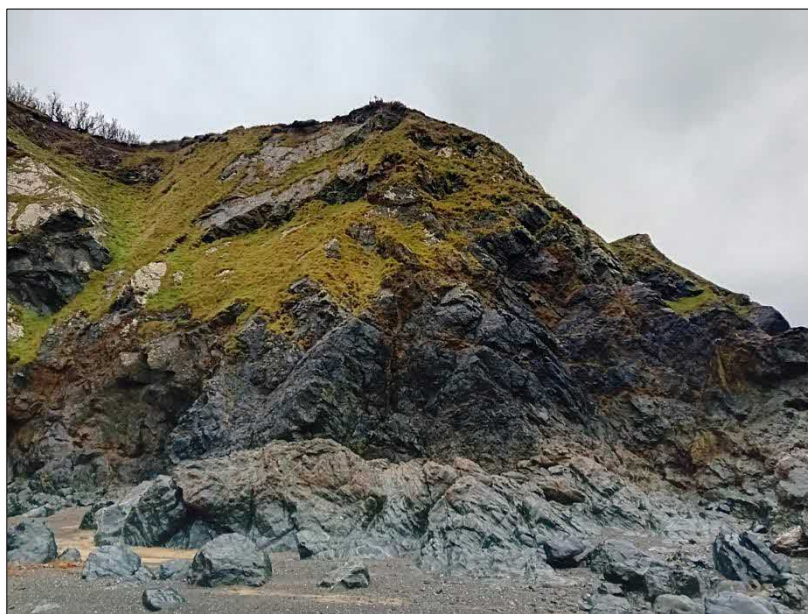
The sea cliffs at this location are < 30 metres in height, with a variable slope face gradient of approximately 40 to 60 degrees from horizontal. The base of the sea cliffs are within the intertidal zone and will therefore be affected by wave and tidal activity, however the base of the sea cliffs are made up of a dark green, finely crystalline hornblende and hornblende schist. The bedrock at the base of the sea cliffs is strong and very strong in situ. There was no observation of erosional features such as platforms or wave cut features at the base of the sea cliffs.

The upper and middle part of the sea cliffs at this location appear to comprise a different lithology, which was observed to be brown and dark brown, destructured, and within an unconformable contact with the underlying hornblende / hornblende schist. On the basis of limited visual inspection, it is considered likely that this represents a weathered basalt, likely to be of the Roseland Breccia Formation, which is not recorded at this location. The basalt bedrock is destructured, though with abundant secondary fracturing. The bedrock appears to be medium strong to strong in-situ but becomes locally weak when weathered.

Figure 07: The sea cliffs at Polurrian Cove (southern end) with green hornblende schist at the base over darker basalt / breccia. Image taken from southern end of the cove looking southeast.
