**Desk Study and Risk Assessment,
Grove Farm
Little Bealings
Suffolk
104442
July 2023**

Client:
Dellwood Homes Ltd
90 Grove Lane
Ipswich
Suffolk
IP4 1NY

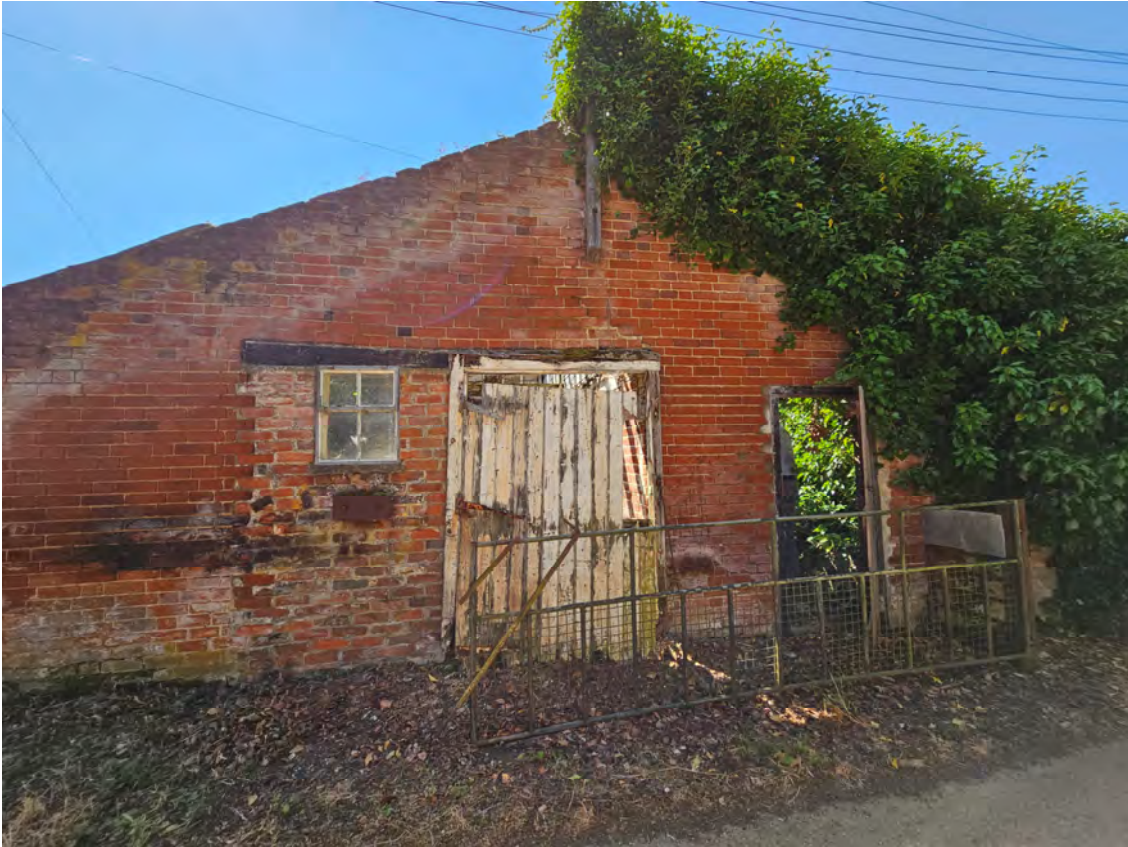
Photograph 2 : Dilapidated brick building on the south side of the track on the east side.

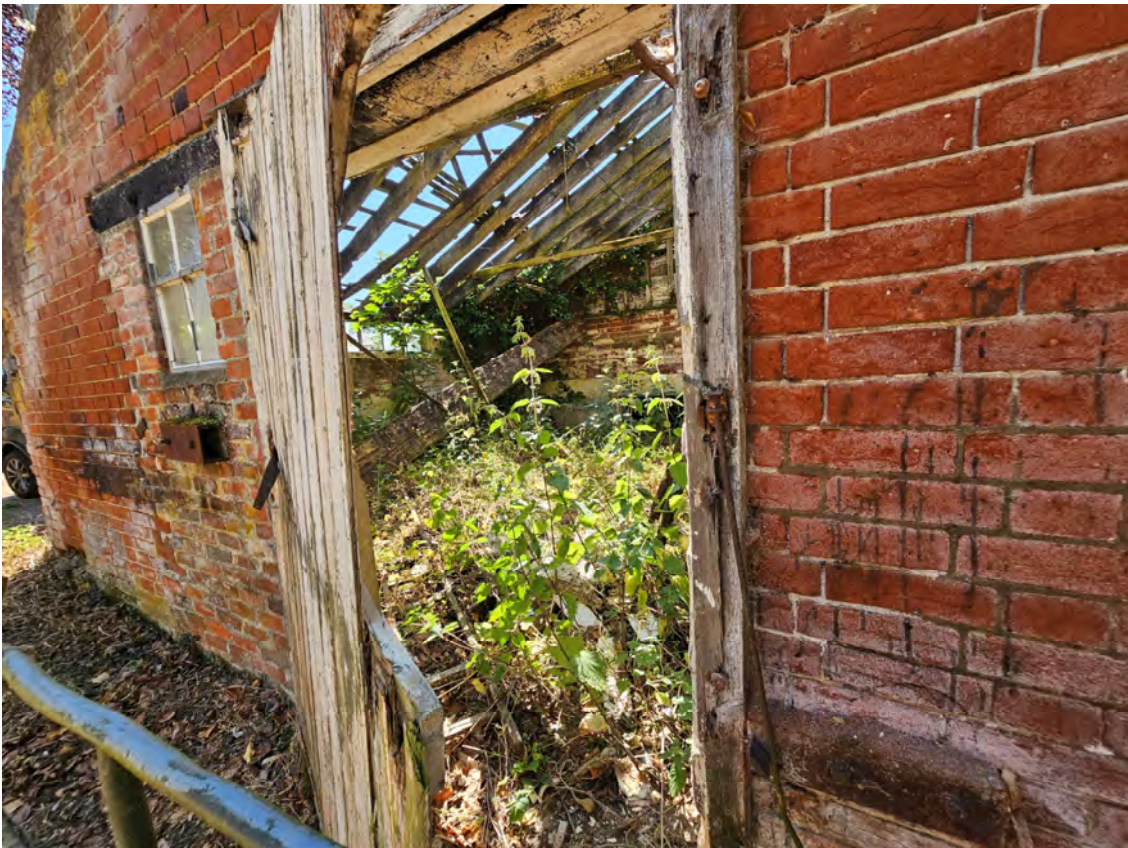
Photograph 3 : Inside the building.

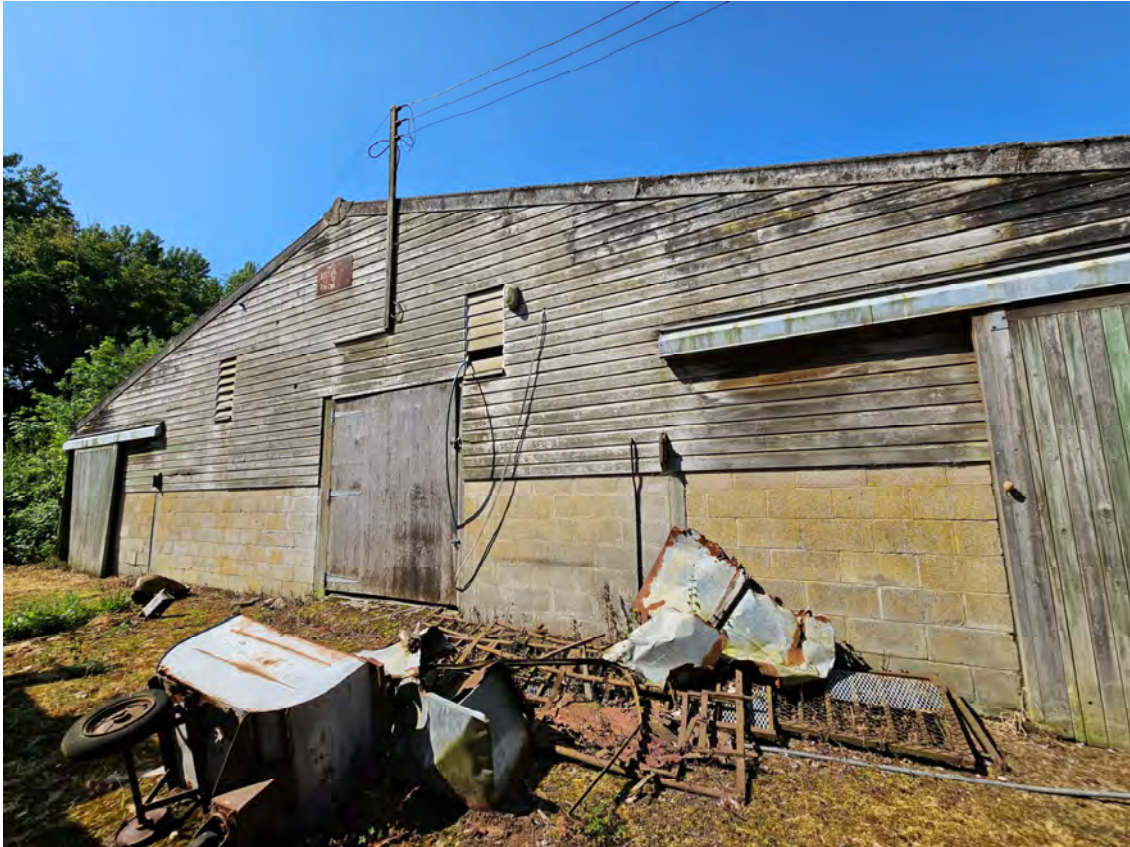
Photograph 10: Eastern end of Barn D south of track.

Cement board sheeting is present as the roofing material and guttering on barns A to D. This material is likely to contain asbestos, therefore a potential Very High Risk (considered that it is to be expected to happen) has been assigned to two of the potential receptors via an airborne linkage. Broken and damaged sheets represent a risk due to the release of fibres. In this instance no broken sheets were seen on the site.

It is recommended that all potential asbestos containing material (ACM) should be removed by a suitably licensed contractor and disposed of to a suitably licensed facility. Consignment notes for any removed asbestos and documentation stating that all Asbestos has been disposed of from the site should be submitted to East Suffolk Council.

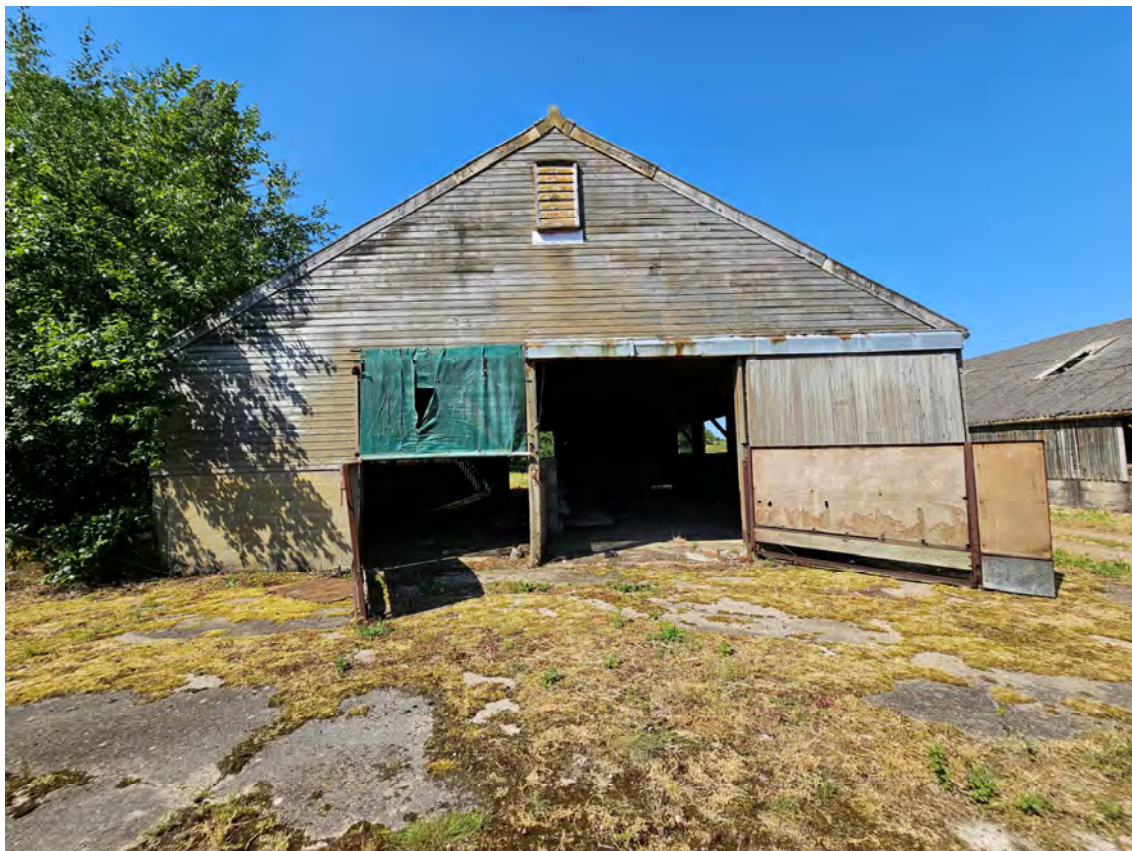
Photograph 13: East elevation of Barn A south of track.

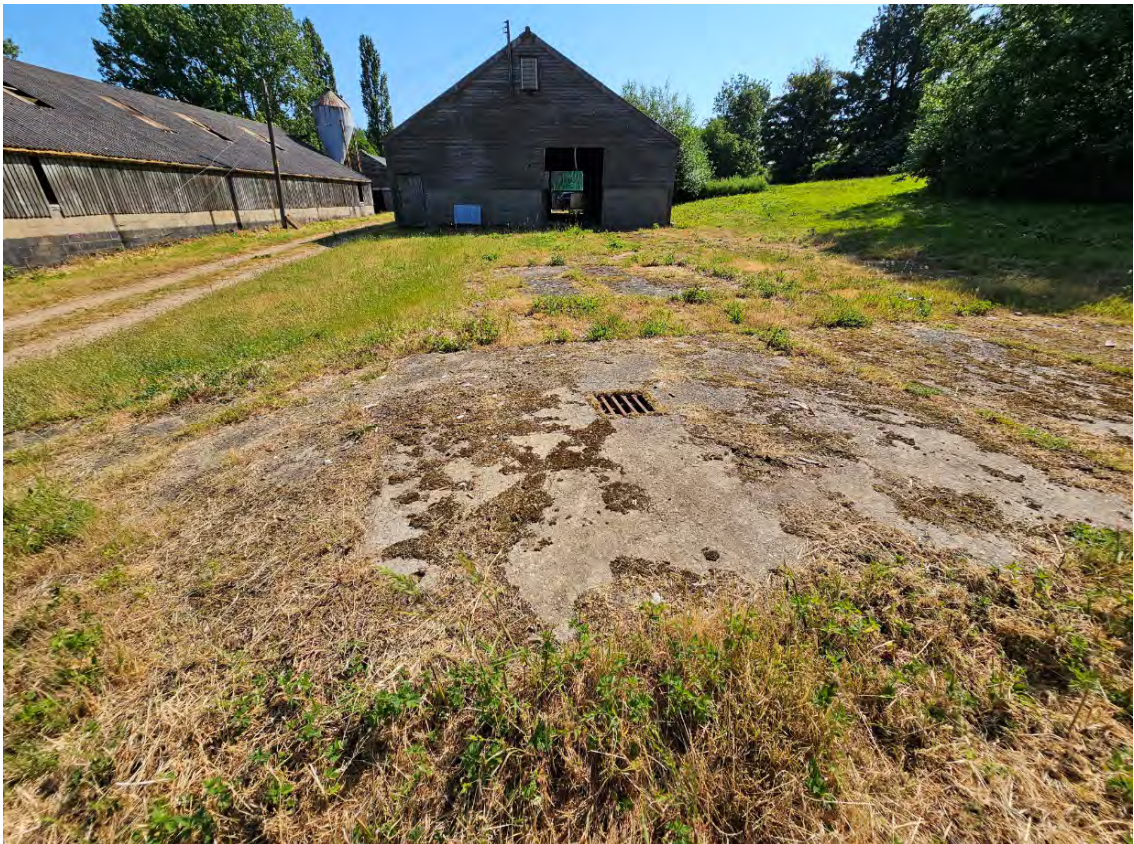
Photograph 15: View looking east at Barn A. Possible below ground slurry tank.

Based upon the information contained herein it is recommended that a site investigation is considered necessary on this site for contamination purposes. This should include investigation of the potential slurry tanks as well as three hand dug trial pits in each garden area to ensure that the soil material on site is suitable for reuse as Topsoil.

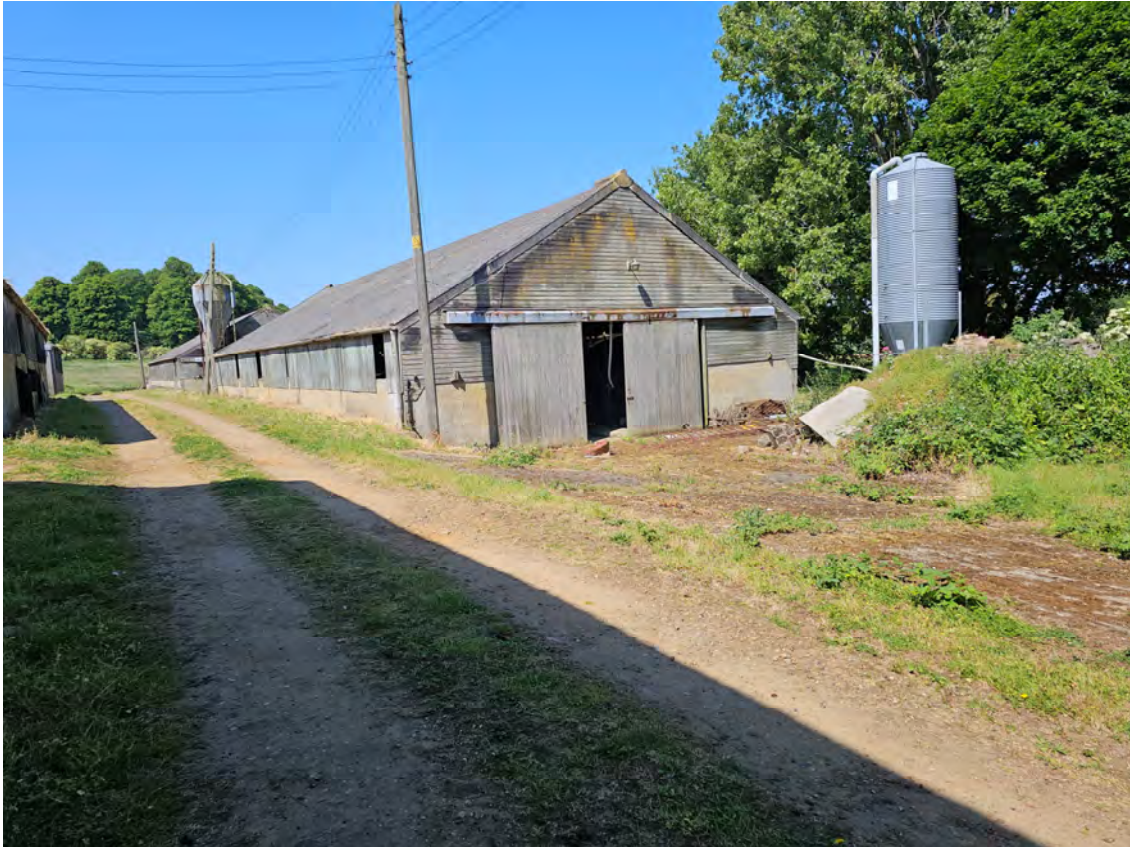
Photograph 16: Barn C located on the north side of the track.

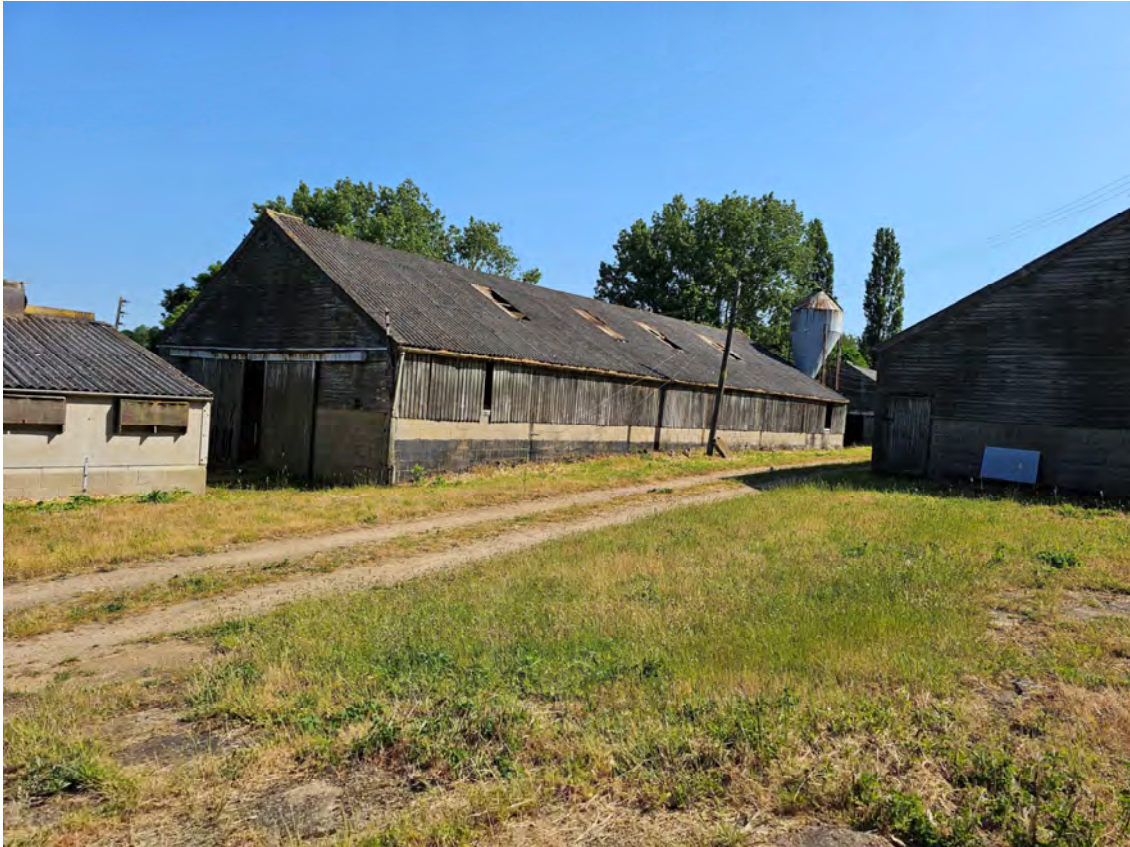
Photograph 18 : Barn B located on the north side of the track.
