Arboricultural method statement to install a root barrier at The Old Church, Ashington

August 7, 2023

POLICYHOLDER ADDRESS: The Old Church, Mereley Park Road, Ashington, Wimborne, BH21 3DF
CLIENT REFERENCE: SU2002228
OUR REFERENCE: OPT-7675
PROJECT MANAGER: Steve Wiseman

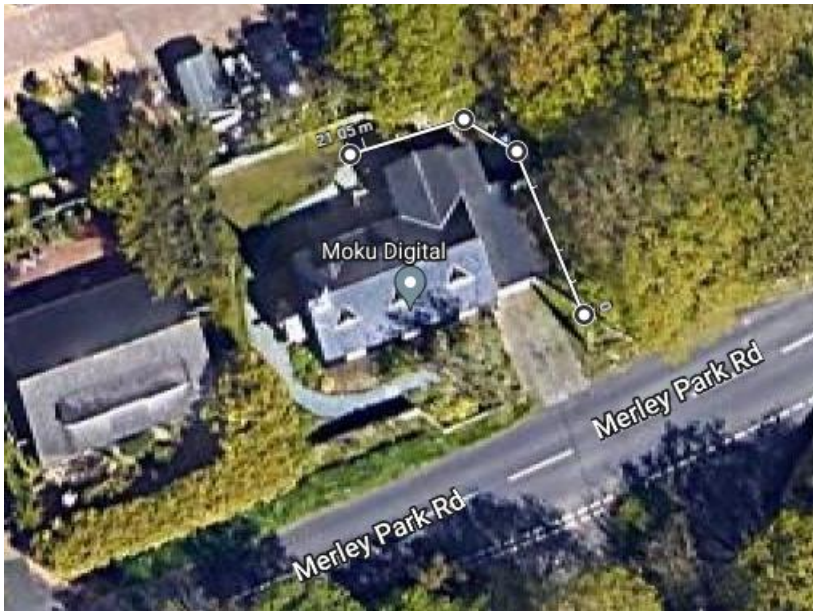
Figure 1 - Aerial plan indicating proposed 21m length and alignment of barrier

The barrier would be approximately 21m in length and achieve a target depth of 2.7m below ground level. The line of the barrier is illustrated at Figure 1 above.

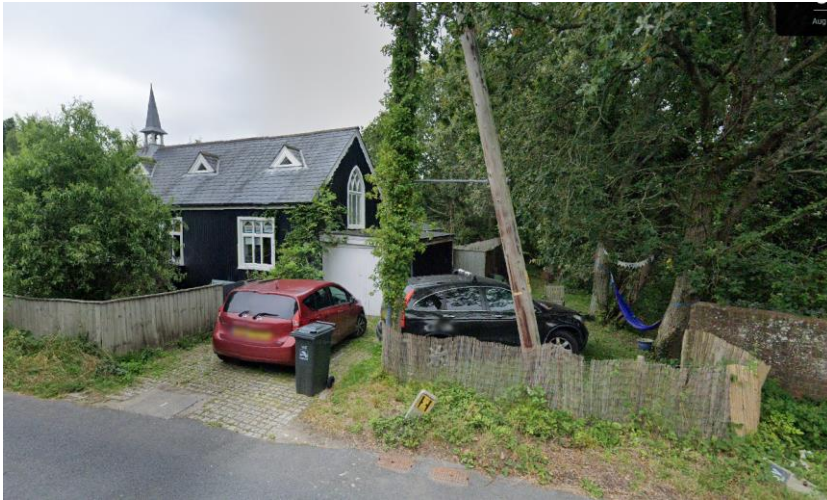
Figure 2 - Front elevation

The property has a projection at the rear-right corner and a lean-to garage at the right-hand side (front). It is understood that some underpinning has previously been installed, but to a relatively shallow depth and that further differential movement has been noted during the extended dry period in the summer of 2022.

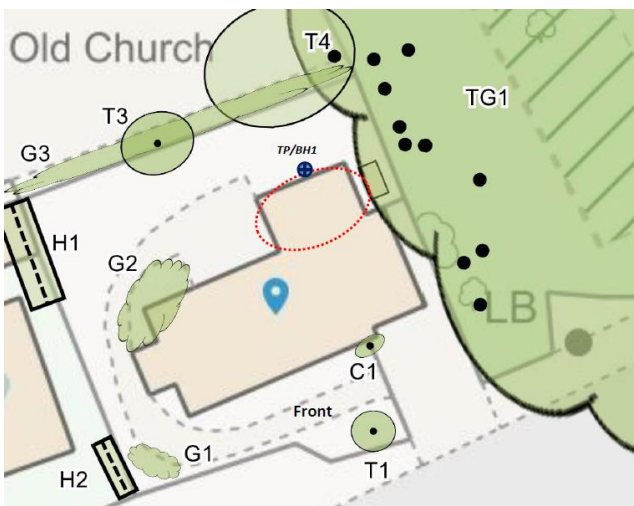
Figure 3 – Tree Plan (extract from MWA report)

The arborist report indicates that T4 and TG1 are protected by Tree Preservation Order (TPO).

We are informed by Crawford & Company that *“T3 Ash has been removed, T4 Oak TPO (consent has been given - council ref: TP/22/00199/X). G3 Pittosporum - Reduce height to 4m. TG1 Oak - Remove within 10m of garage/dwelling (TPO consent TP/22/00758/X 22/11/22)”*.
