**TECHNICAL REPORT ON A SUBSIDENCE CLAIM**

**Crawford Reference: SU2002228**

**The Old Church  
Merley Park Road  
Ashington  
Wimborne  
BH21 3DF**

**SUBSIDENCE CLAIM**

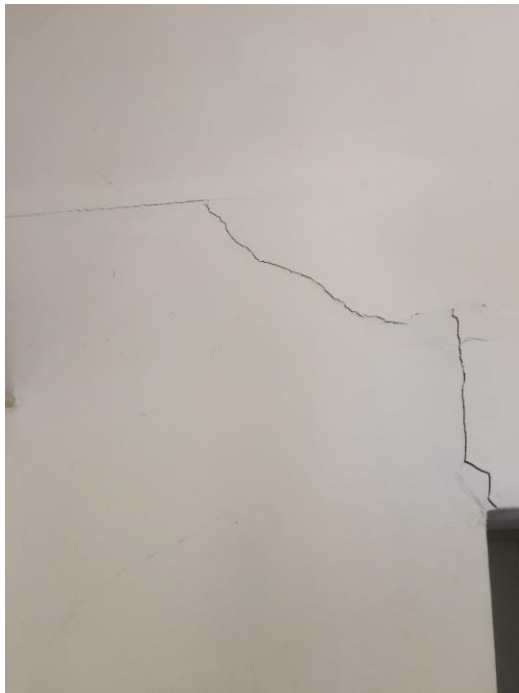
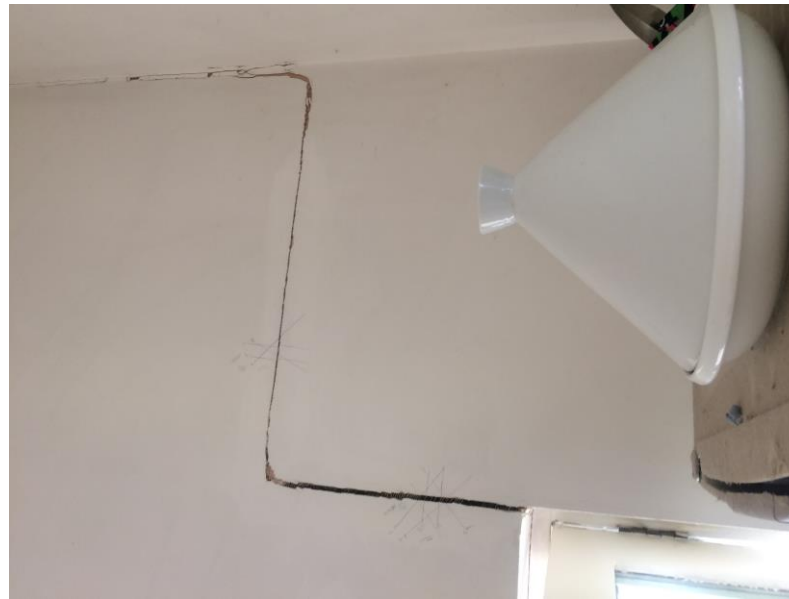
**KITCHEN**

- Stepped crack over entrance door 4.0 mm wide
- Stepped diagonal crack over door to right hand side 2.0 mm wide

In structural terms the crack damage falls into Category 2 of Table 1, Building Research Establishment<sup>4</sup> Digest 251, which describes it as “slight”

The pattern and nature of the cracks is indicative of an episode of subsidence. The cause of movement appears to be clay shrinkage.

The timing of the event, the presence of shrinkable clay beneath the foundations and the proximity of vegetation where there is damage indicates the shrinkage to be root induced. This is a commonly encountered problem and probably accounts for around 70% of subsidence claims notified to insurers. Fortunately, the cause of the problem (dehydration) is reversible. Clay soils will re-hydrate in the winter months, causing the clays to swell and the cracks to close. Provided the cause of movement is dealt with (in this case, vegetation) there should not be a recurrence of movement.

Although the cause of the movement needs to be dealt with, we note the vegetation is subject to a **Tree Preservation Order**. Unfortunately, current legislation requires certain investigations to be carried out to support an application for the tree works.

Typically, these investigations would involve a trial pit to determine the depth and type of footings, boreholes to determine the nature of the subsoil/influence of any roots and monitoring to establish the rate and pattern of movement. The monitoring data provided must be sufficient to show a pattern of movement consistent with the influence of the vegetation and therefore it may be necessary to carry out the monitoring for up to a 12 month period.

It will also be necessary to obtain a specialist Arboriculture Report.
