Arboricultural Appraisal Report

Subsidence Damage Investigation at:

The Old Church, Merley Park Road
 Ashington
 Wimborne
 BH21 3DF

CLIENT:	Crawford & Company
CLIENT REF:	SU2002228
MWA REF:	SUB201116-7876
MWA CONSULTANT:	Mark Bisley (BSc Hons)
REPORT DATE:	02/12/2020

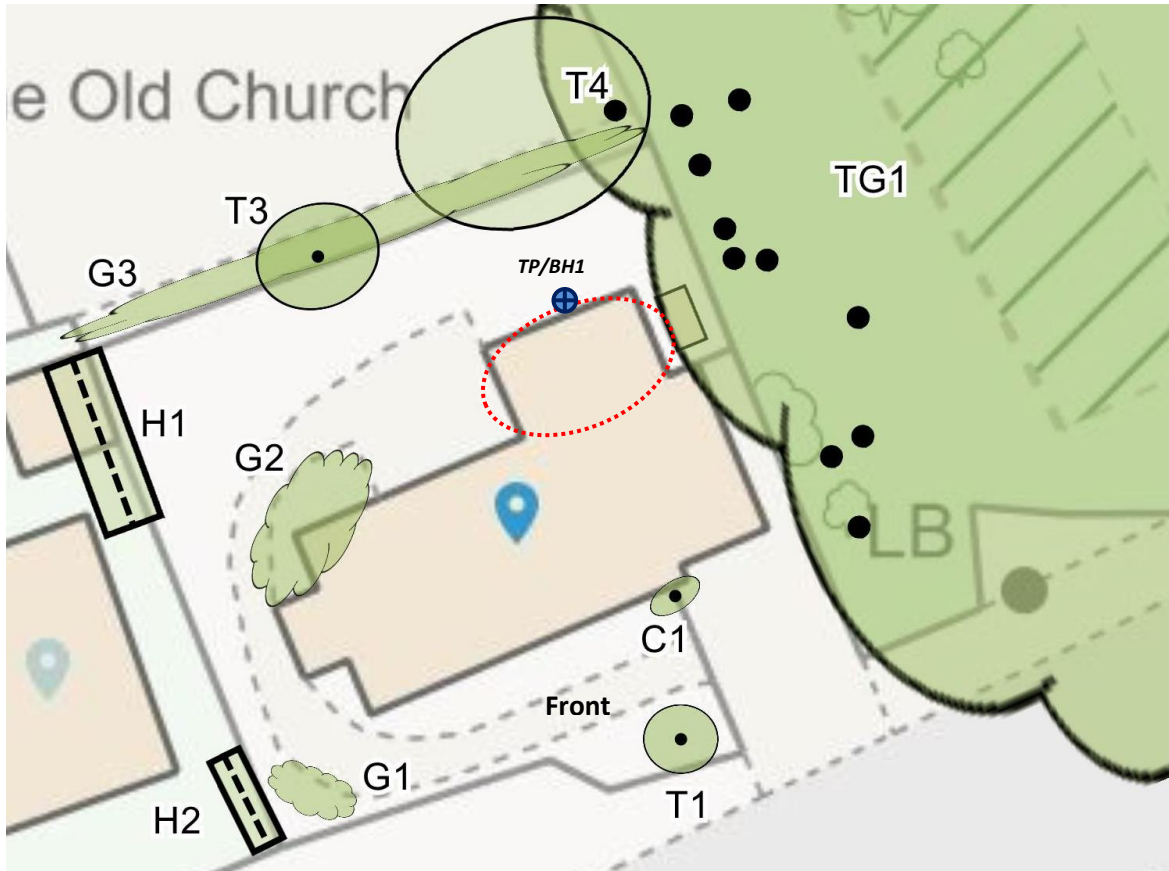
Site Plan

Approximate areas of damage

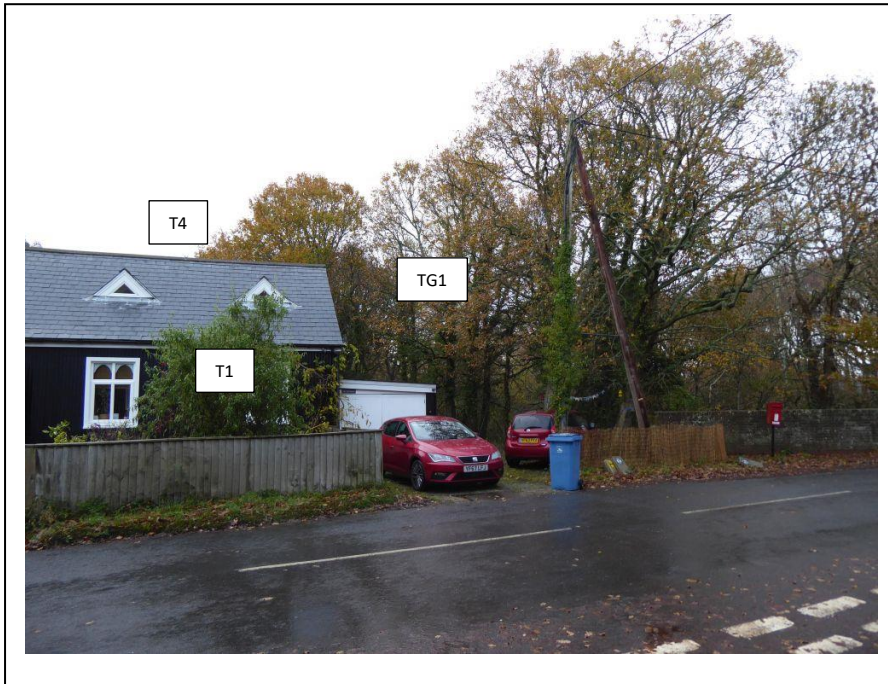
View of front of property

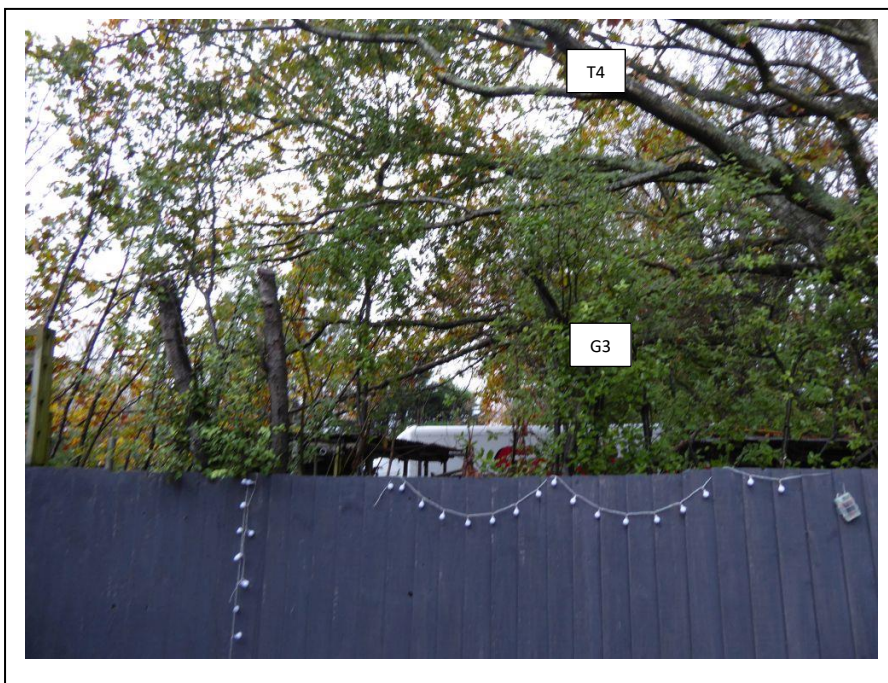
View of trees to rear

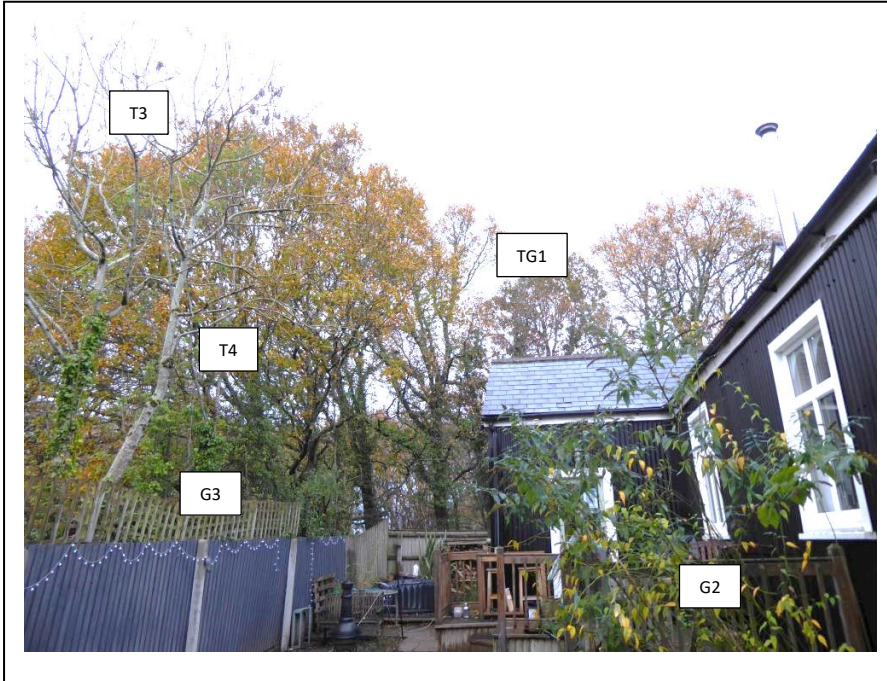
View of trees to rear right

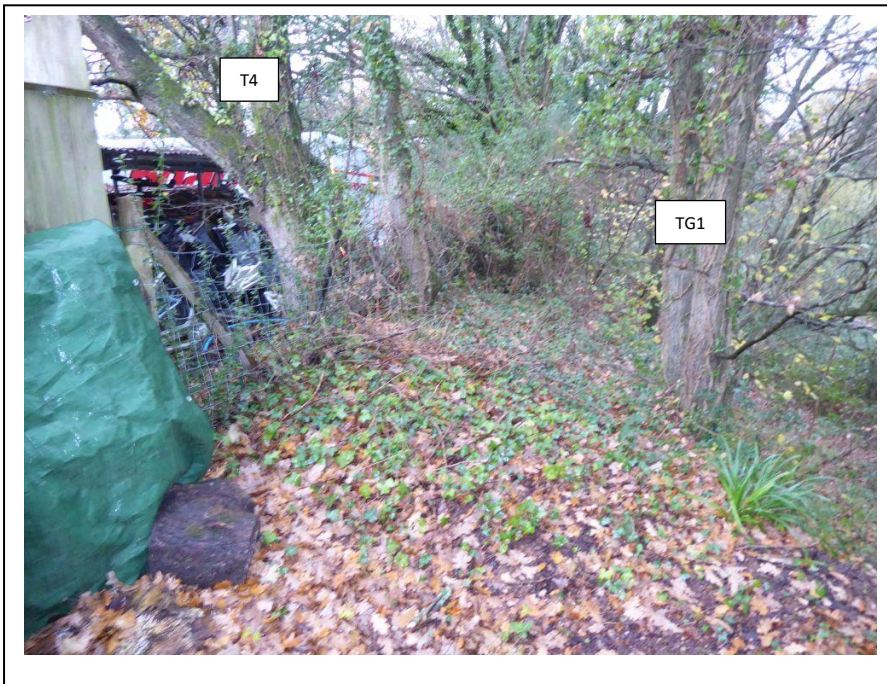
View of trees to rear right
