Report

C1009272

MSCC5_DOMESTIC

64a Acre End Street, Witney, Oxfordshire, OX29 4PD, United Kingdom

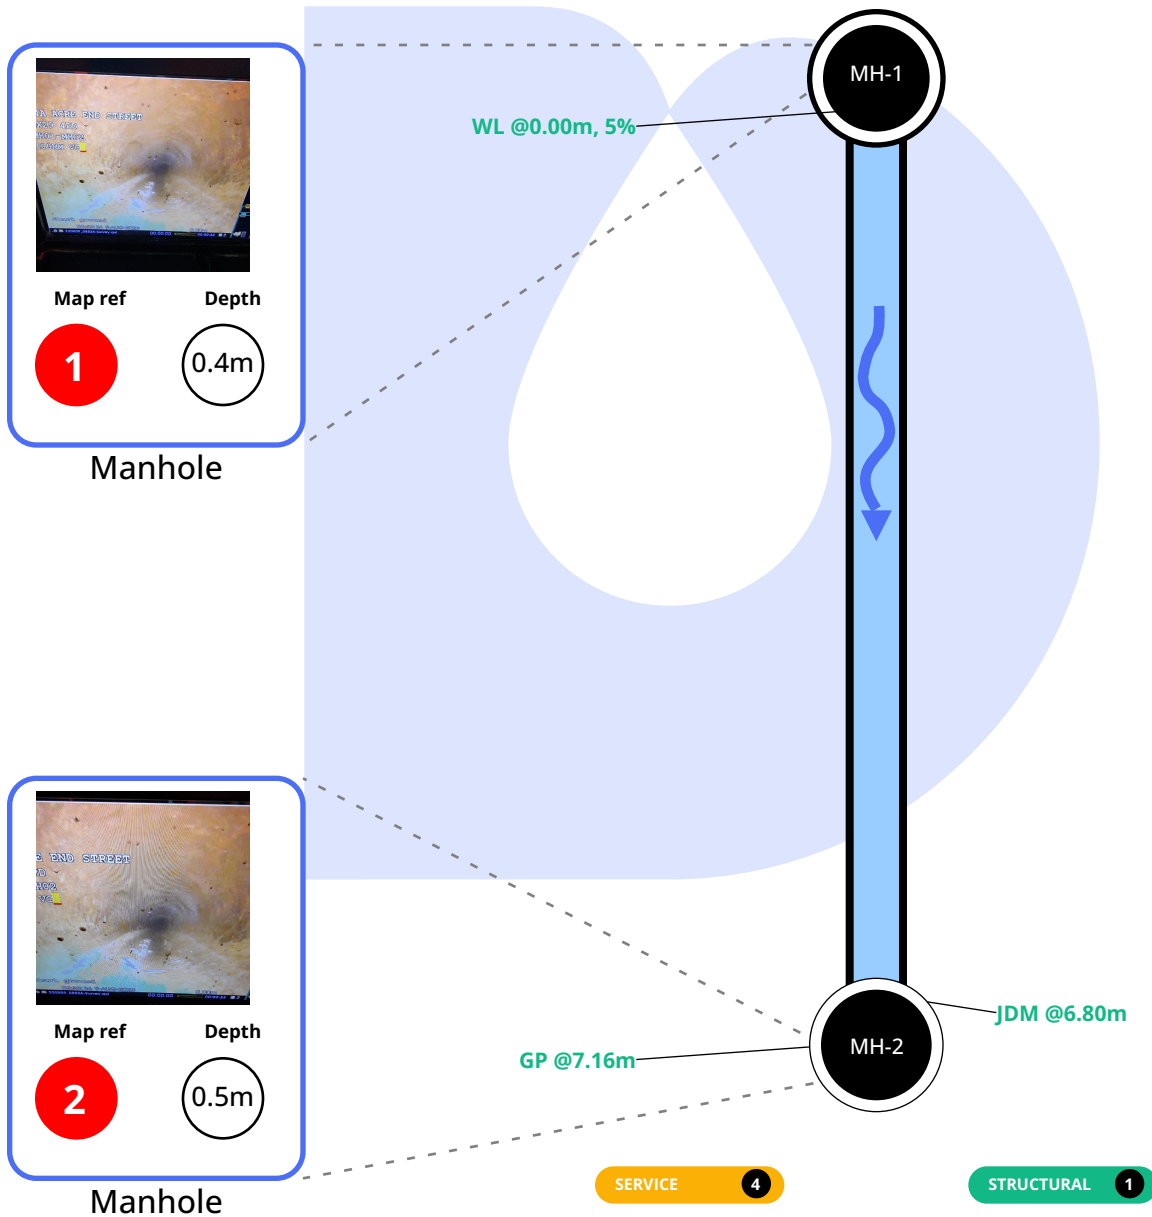
Section 1 - At a glance

JDM (Joint Displaced Medium)

Distance: 6.8m

B

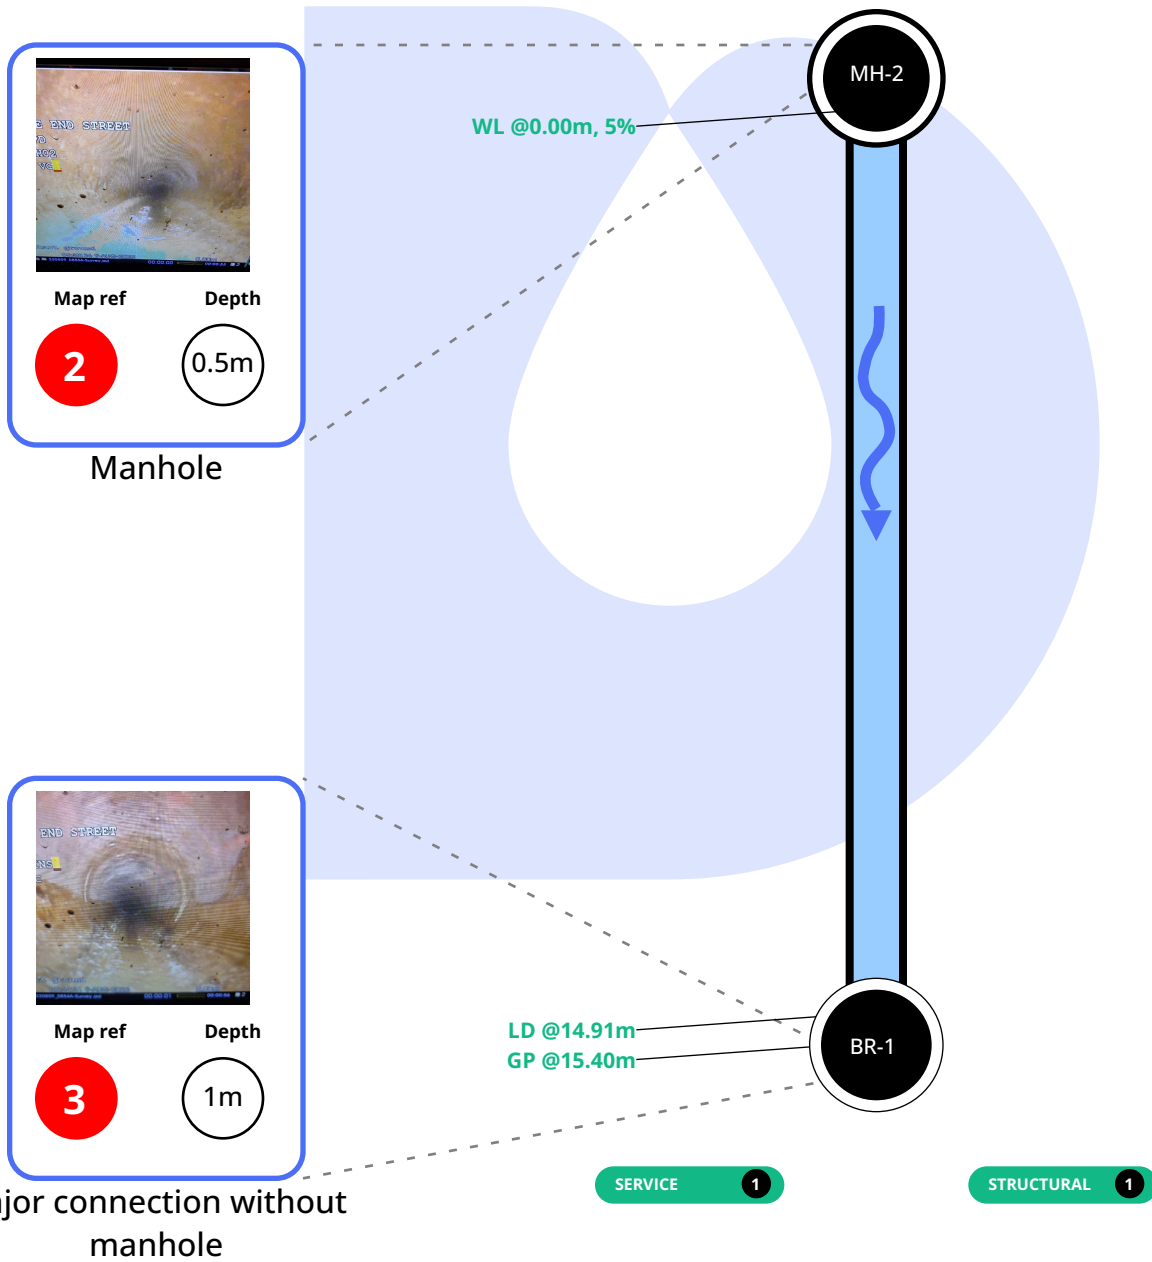
Section 2 - At a glance

LD (Line Deviates Downwards)

Distance: 14.91m

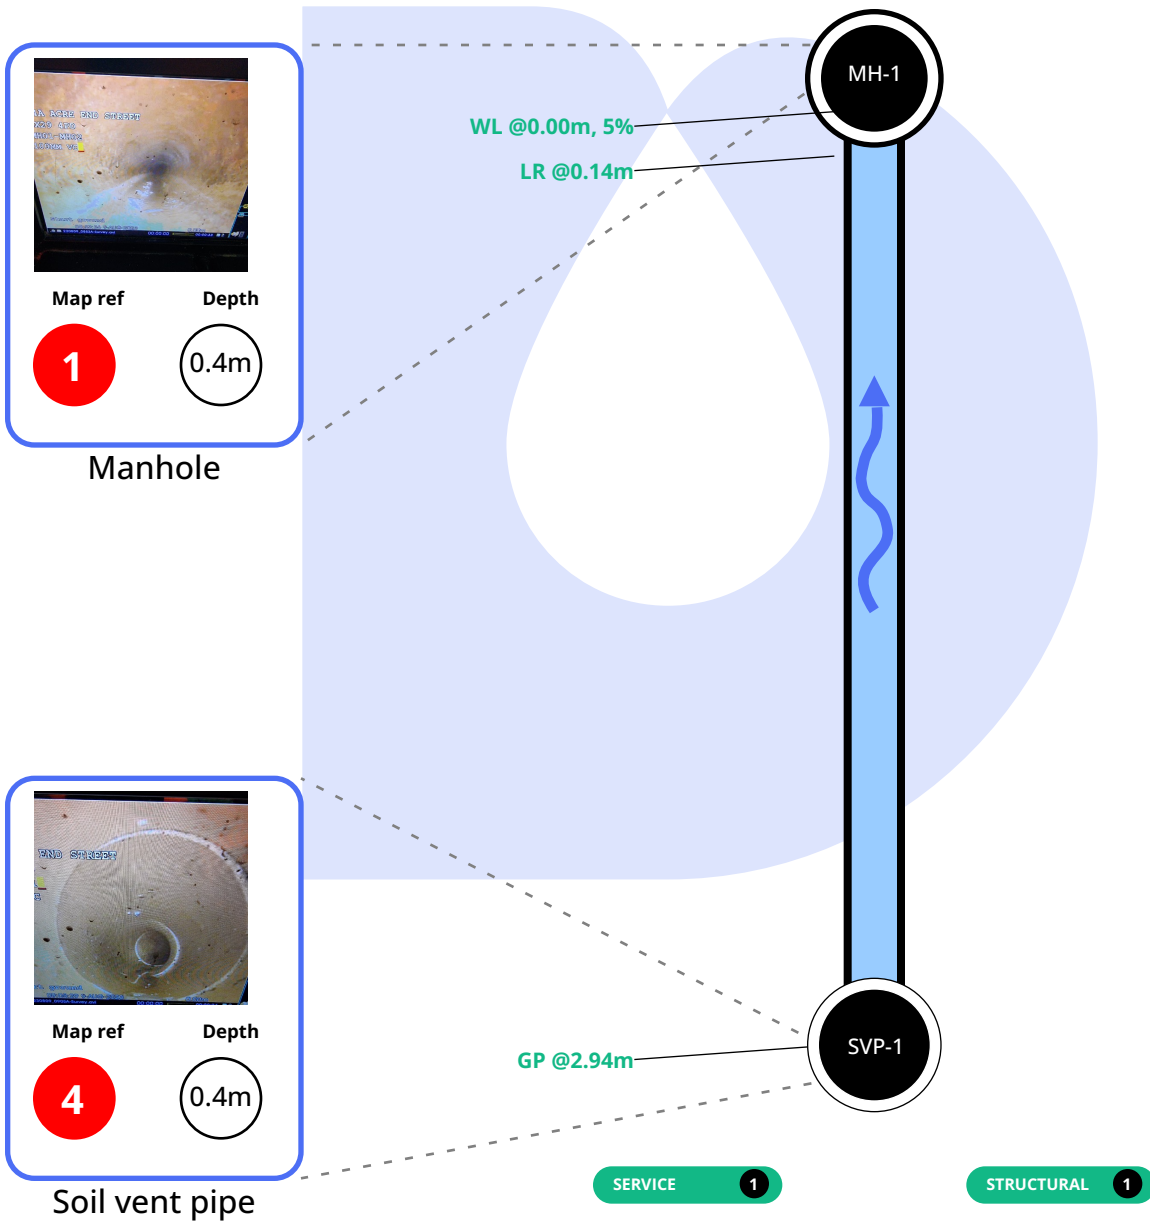
Section 3 - At a glance

LR (Line Deviates Right)

Distance: 0.14m

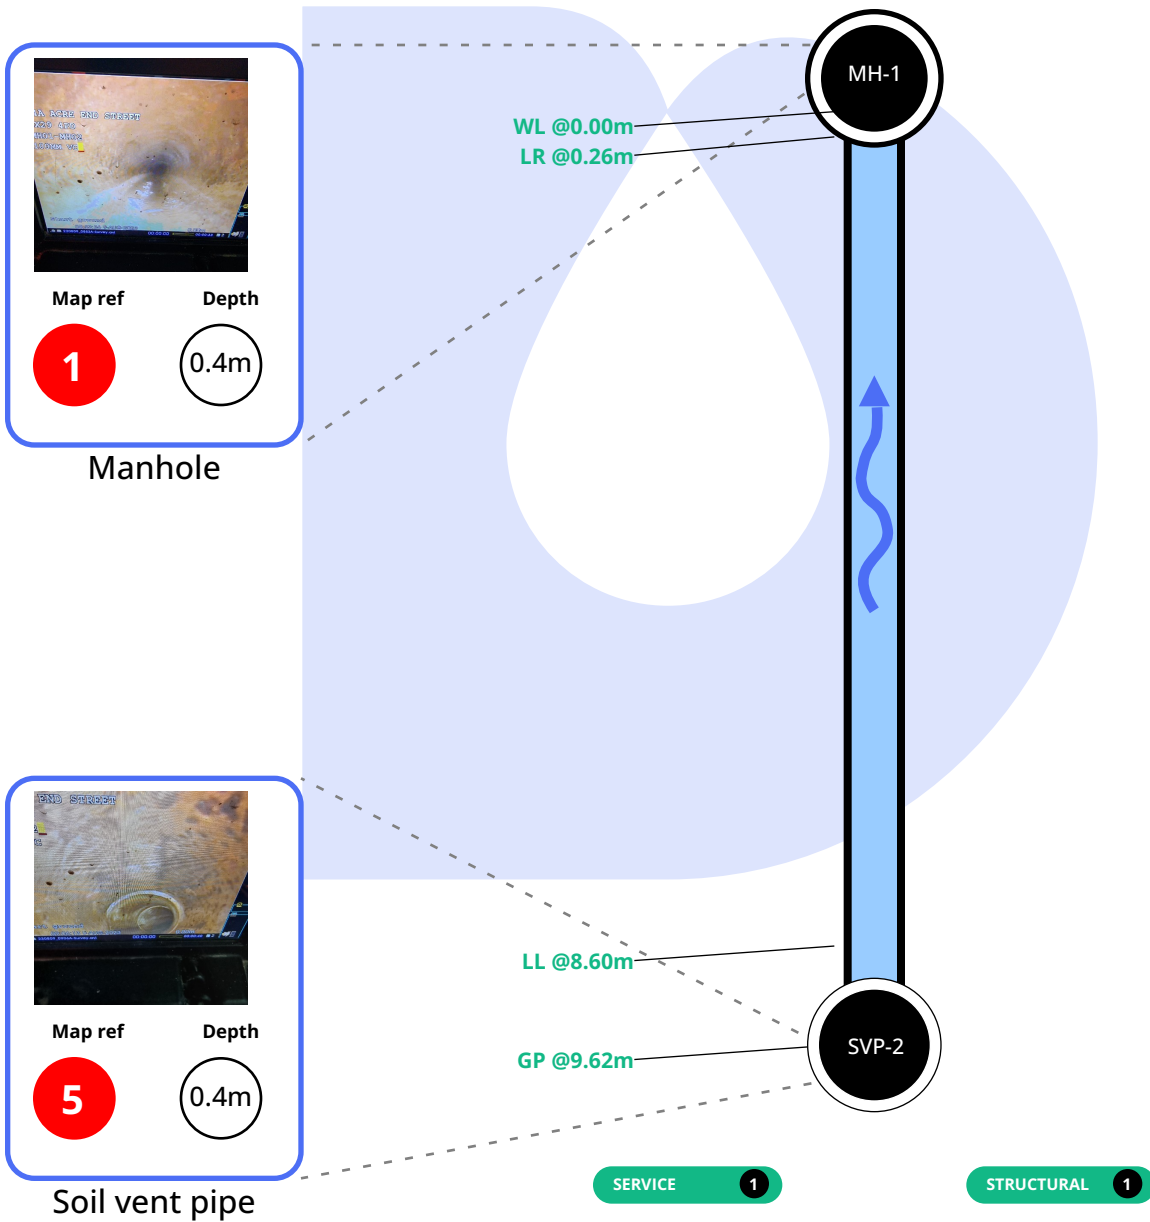
Section 4 - At a glance

LR (Line Deviates Right)

Distance: 0.26m

LL (Line Deviates Left)

Distance: 8.6m

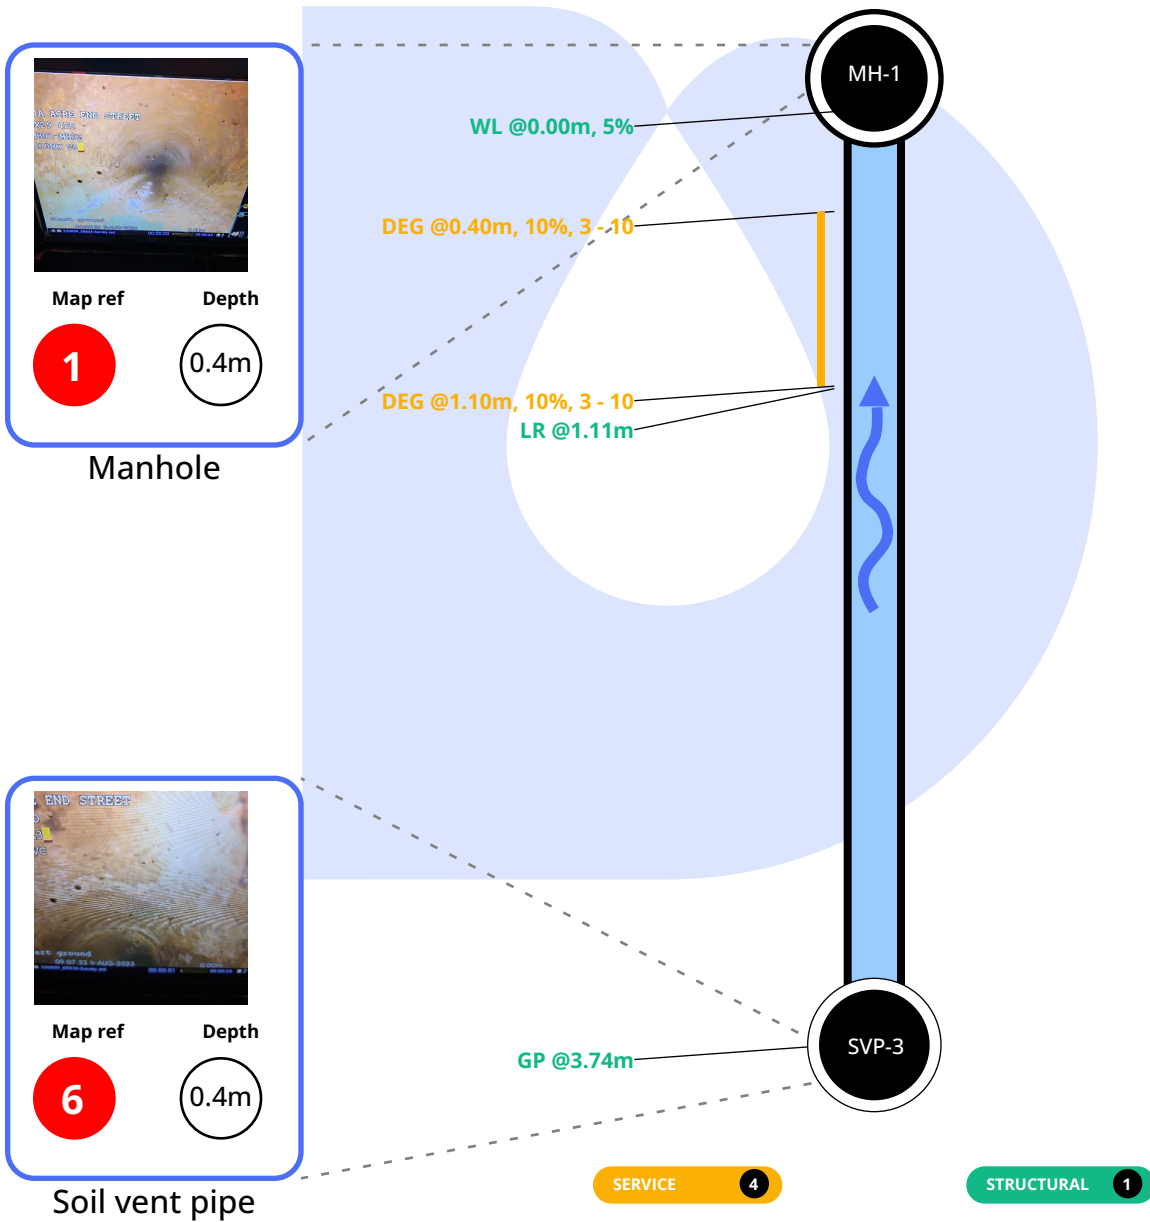
Section 5 - At a glance

DEG (Deposits Grease)

Distance: 0.4m
Start/end clock reference: 3 to 9o'clock
Cross sectional loss: 10%
Continuous: true

B

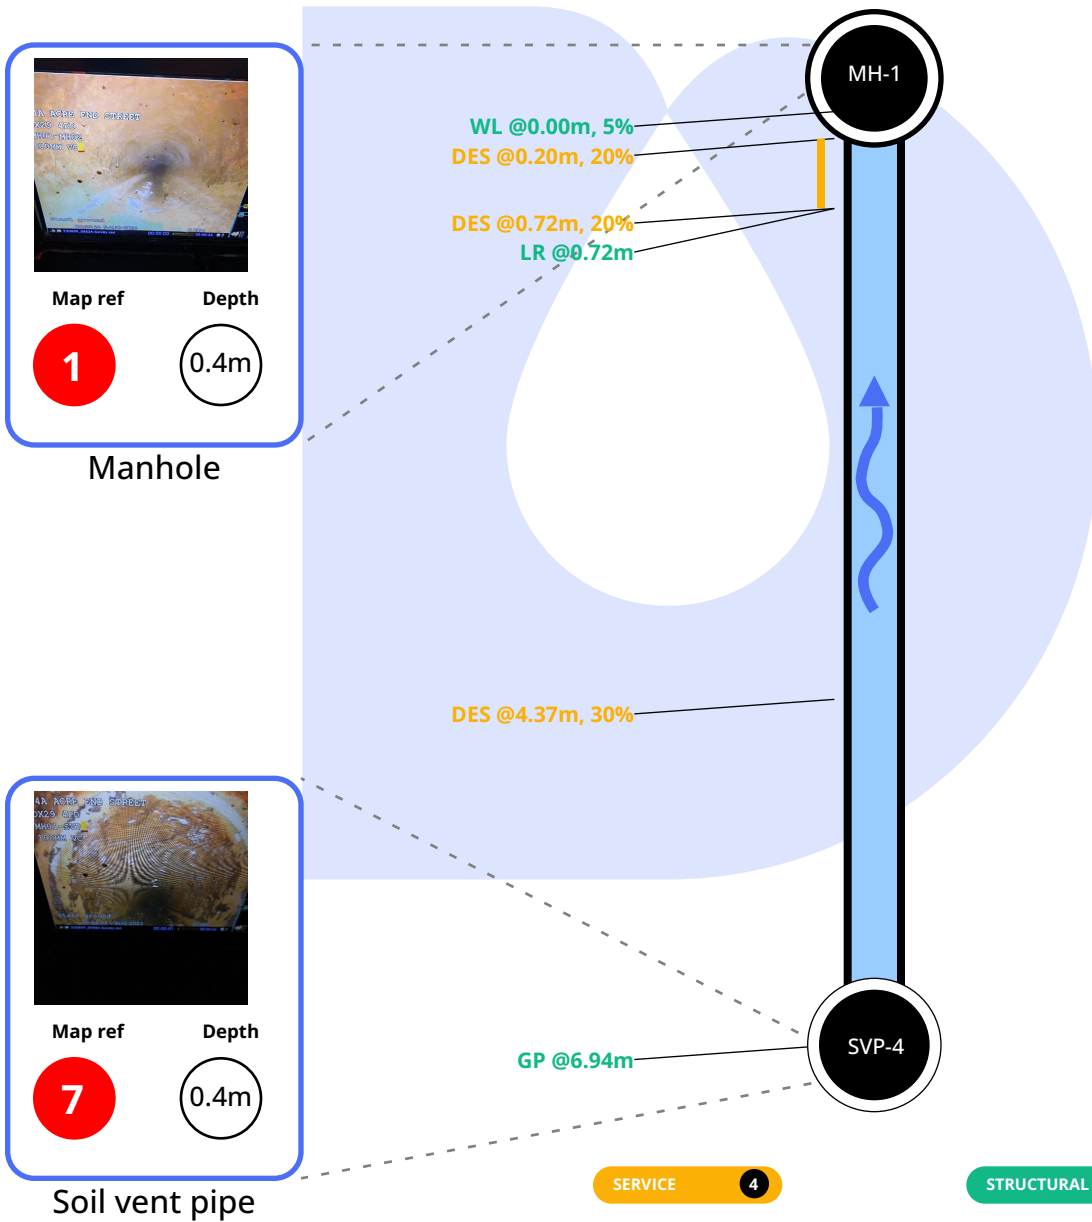
Section 6 - At a glance

DES (Deposits Fine Settled)

Distance: 0.2m
Cross sectional loss: 20%
Continuous: true

Distance: 0.72m
Cross sectional loss: 20%
Continuous: true

Distance: 4.37m
Cross sectional loss: 30%

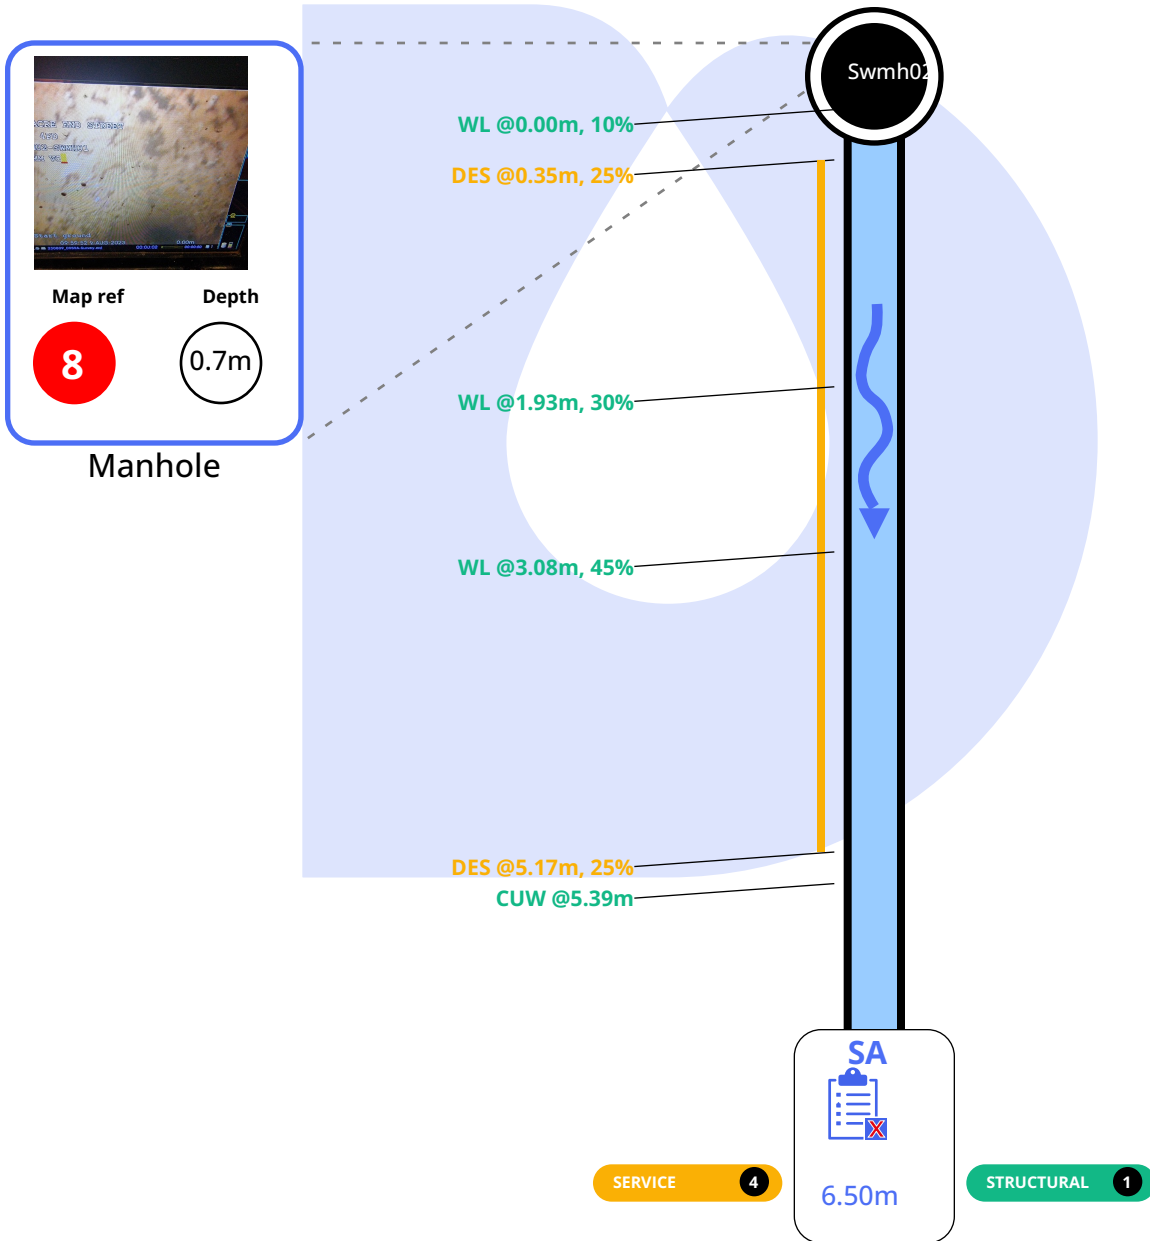
Section 7 - At a glance

DES (Deposits Fine Settled)

Distance: 0.35m
Cross sectional loss: 25%
Continuous: true

Distance: 5.17m
Cross sectional loss: 25%
Continuous: true

SA (Survey Abandoned)

Distance: 6.5m
Remarks: Heavy silt n water levels. Ds mains partially blocked.

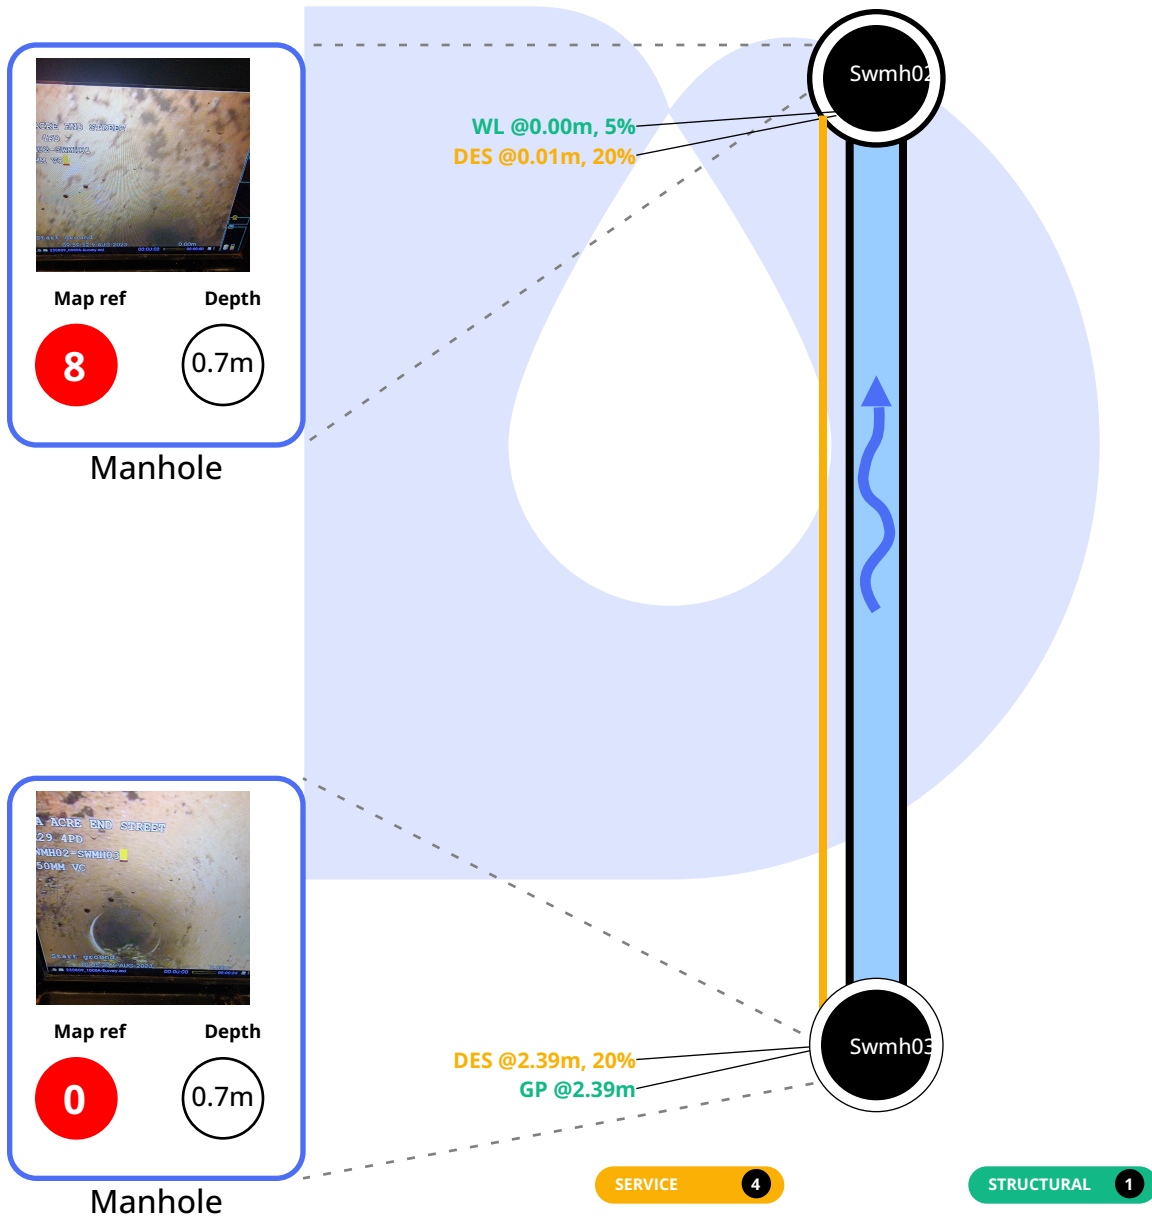
Section 8 - At a glance

DES (Deposits Fine Settled)

Distance: 0.01m
Cross sectional loss: 20%
Continuous: true

Distance: 2.39m
Cross sectional loss: 20%
Continuous: true

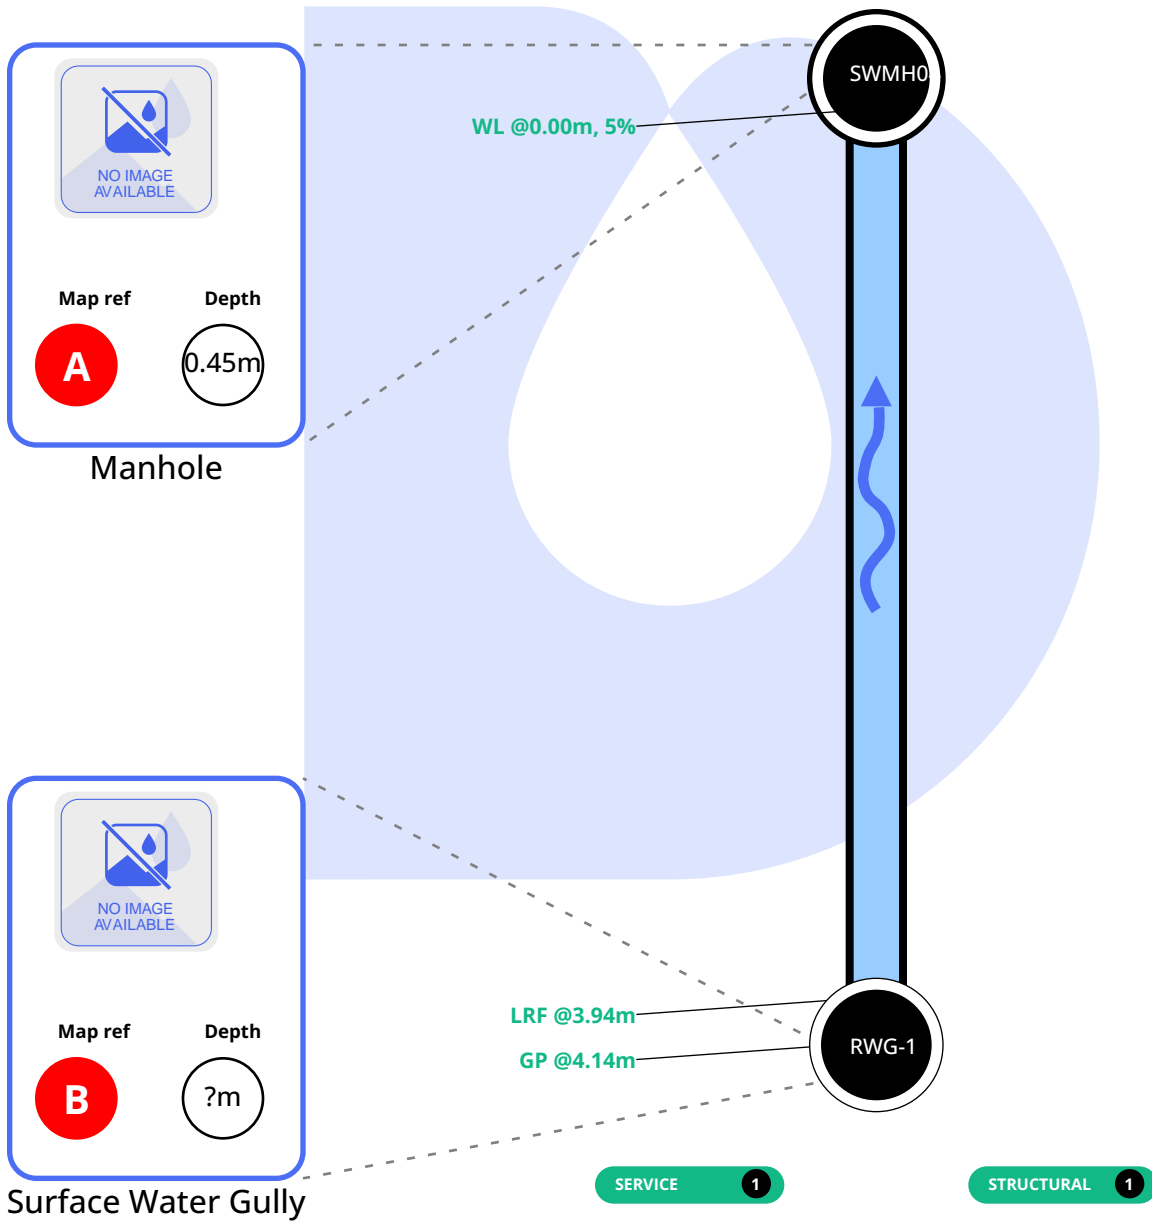
Section 9 - At a glance

LRF (Line Deviates Right Full)

Distance: 3.94m

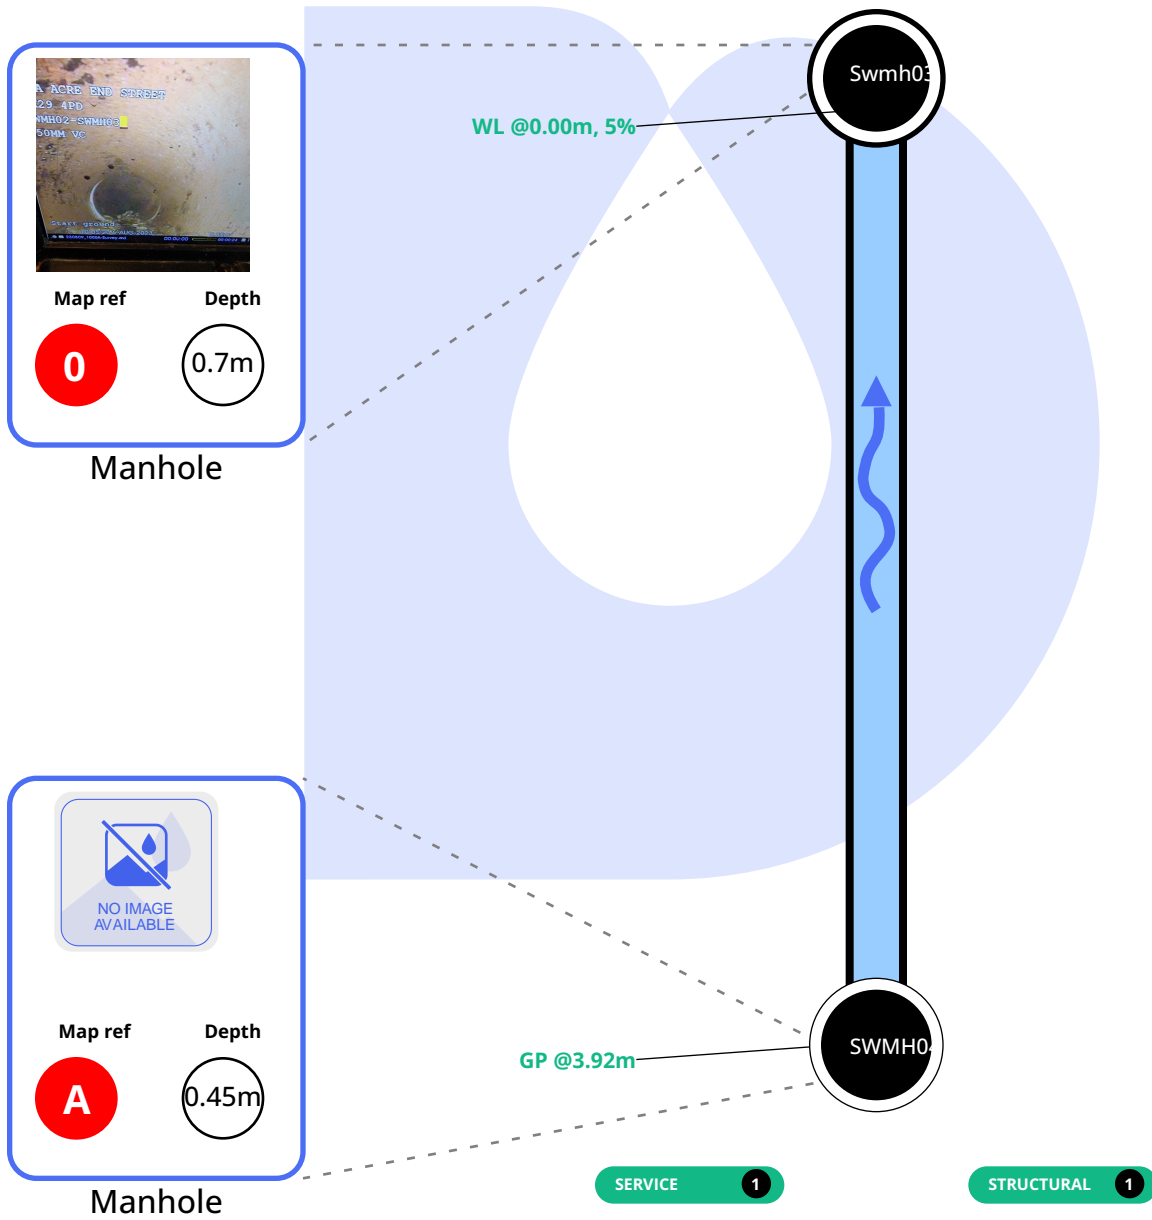
Section 10 - At a glance

WL (Water Level)

Distance: 0m
Amount: 5%
