VETERAN TREE SURVEY REPORT

**IN DISCHARGE OF CONDITION 18 OF OUTLINE APPLICATION
PT14/0565/0**

LAND AT CRIBBS CAUSEWAY, BRISTOL

Date: February 2021

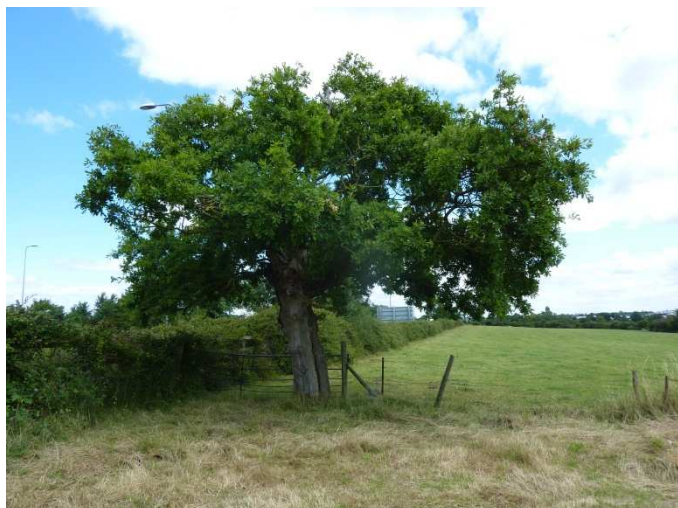
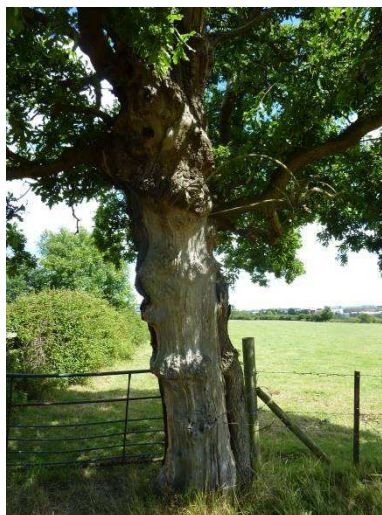
Tree No.	Common Name:	Botanical Name:	Age Class:
1080	Common Oak	Quercus robur	Veteran
No. of Trunks	Trunk Diameter (mm)	Date	30/7/2015
1	700		
Crown Spread (metres)			
North	East	South	West
5	4	2	4
Physiological Condition	Structural Condition		Life Expectancy
Good	Fair		>40 years

Growing in agricultural field conditions. Hedge line tree. Part of linear group. Bark wounds to roots. Compaction at base east side. Bark wound occluding. Major cavities in trunk. Epicormics on trunk. Cracks in trunk. Old pruning wounds on trunk occluding with major decay evident. Minor areas of sapwood exposed on trunk. Partial network of vascular tissue present on trunk. Trunk leans to South. Branch tearout wounds in crown. Crown shape distorted. Crown weighted to North. Large end loaded limb(s) North side. Previously pollarded. Crown reformed. Stags headed. Minor deadwood in crown. Lower crown reforming. 50% of trunk dysfunctional, extensive decay and trunk cavity. Good wildlife habitat potential.

Reduce lateral limbs to leave branches not less than 4 metres long from centre of trunk on north side.

Priority (Months):	12	Next inspection	36
--------------------	----	-----------------	----

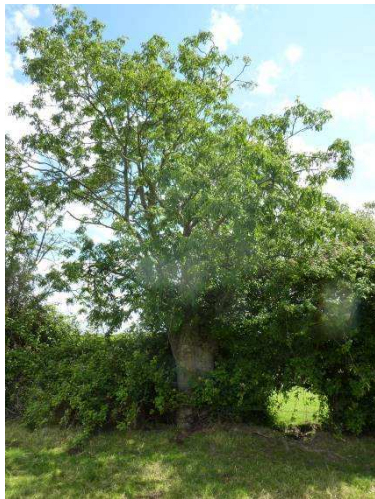
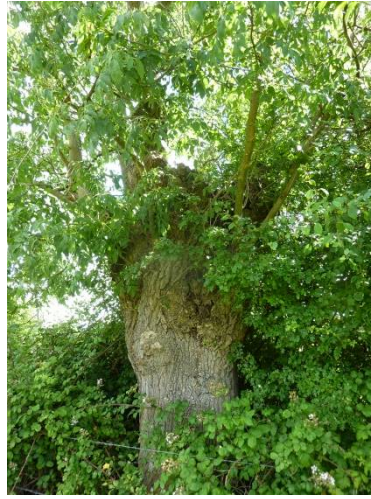
Growing on hedge bank. Growing in agricultural field conditions. Hedge line tree. Unable to verify health and condition due to vegetation at base. Bark wounds to roots. Compaction at base. Exposed surface roots. Mechanical damage to surface roots. Major cavities in trunk. Old pruning wounds on trunk occluding with major decay evident. Fungal fruiting body on trunk (*Inonotus hispidus*). Trunk cavity with major decay evident. Complete network of vascular tissue present on trunk. Previously pollarded. Crown reformed. Crown density reduced. Minor deadwood in crown. *Inonotus hispidus* on trunk with detached fruiting bodies at base of tree.

Reduce entire crown by 2 metres; maintain all lower growth.

Priority (Months):	12	Next inspection	36
--------------------	----	-----------------	----

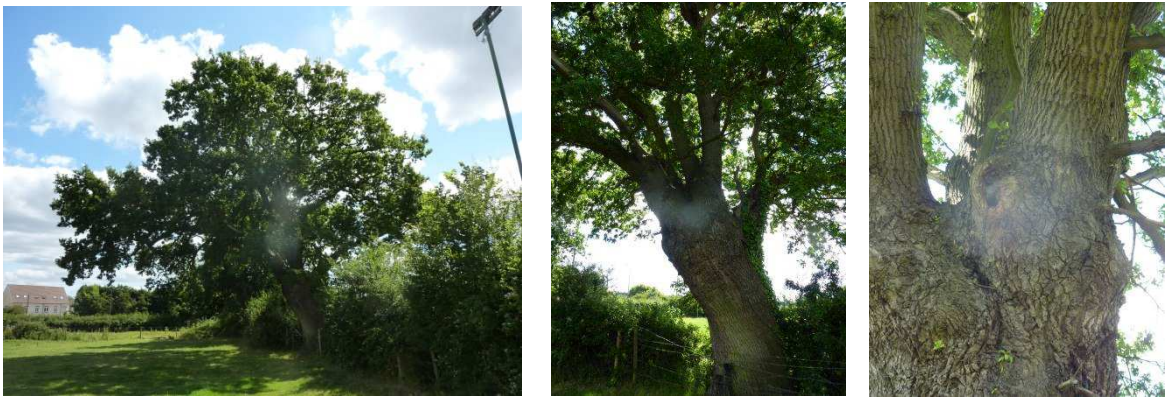
Tree No.	Common Name:	Botanical Name:	Age Class:
1180	Common Oak	Quercus robur	Veteran
No. of Trunks	Trunk Diameter (mm)	Date	30/7/2015
1	1100		
Crown Spread (metres)			
North	East	South	West
10	11	3	5
Physiological Condition	Structural Condition		Life Expectancy
Good	Fair		>40 years
Photographs

Condition Comments:			
<p>Boundary edge tree. Growing in agricultural field conditions. Growing on hedge bank. Hedge line tree. Unable to verify health and condition due to vegetation at base. Large buttress roots. Compaction at base north side. Major cavities in trunk. Cracks in trunk. Old pruning wounds on trunk occluding with major decay evident. Ivy on trunk Trunk leans to East. Complete network of vascular tissue present on trunk. Previously pollarded. Crown reformed. Minor deadwood in crown. Large old pruning wounds on main branches occluding. Epicormics in crown. Large caities in main limbs. Crown weighted to North and East. Large end loaded limb(s) North and South side. Cavities in branch unions North and South side. Asymmetric crown, possibly as result of loss of companion tree West side. Helical crack in trunk. Wire fence attached at base.</p>

Recommendations:			
<p>Further inspection required by climbing to inspect branch structure and unions throughout crown. Reduce end loaded branches by 4-3 metres all round. Reduce crown height by 2-3 metres to encourage formation of denser lower crown.</p>			
Priority (Months):	12	Next inspection	12

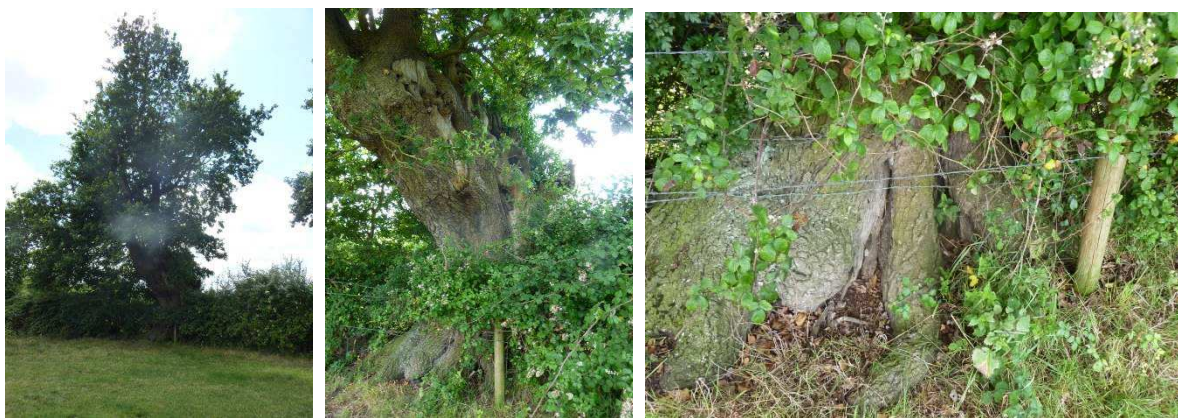
Tree No.	Common Name:	Botanical Name:	Age Class:
1179	Common Oak	Quercus robur	Veteran
No. of Trunks	Trunk Diameter (mm)	Date	
1	1150		30/7/2015
Crown Spread (metres)			
North	East	South	West
5	5	4	4
Physiological Condition	Structural Condition		Life Expectancy
Good	Fair		>40 years

Growing in agricultural field conditions. Growing on hedge bank. Hedge line tree. Buttress roots exposed with observable basal decay. Large buttress roots. Major cavities in trunk. Extensive areas of exposed sapwood on trunk. Ivy on trunk. Epicormics on trunk. Cracks in trunk. Branch tearout wounds. Crown reformed. Old lapsed pollard. Large cavities in main limbs. Deadwood and stubs in crown. Epicormics in crown. Minor deadwood in crown. Lower crown reforming. Storm damaged branches in middle crown. Significant cavities and decay providing important habitat.

Reduce crown height by 3-4 metres, maintain all internal growth and deadwood.

Priority (Months):	12	Next inspection	36
--------------------	----	-----------------	----

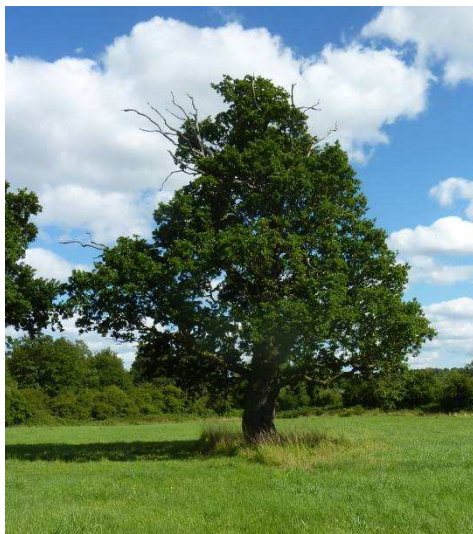
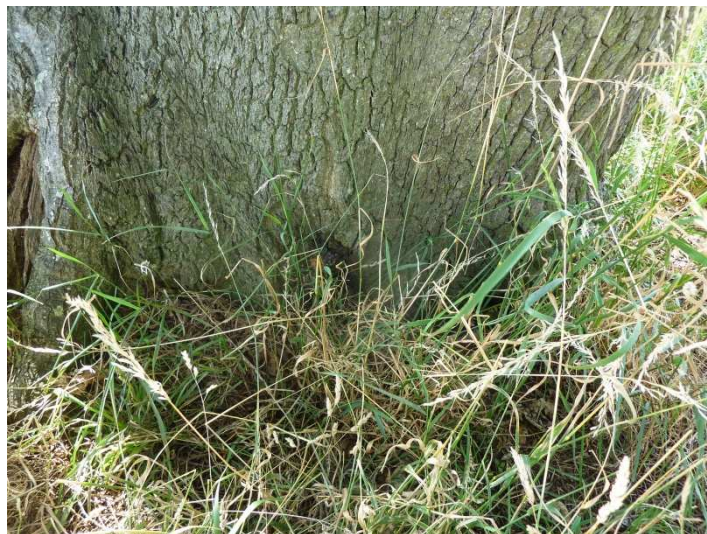
Tree No.	Common Name:	Botanical Name:	Age Class:
1033	Common Oak	Quercus robur	Veteran
No. of Trunks	Trunk Diameter (mm)	Date	30/7/2015
1	980		
Crown Spread (metres)			
North	East	South	West
6	6	6	6
Physiological Condition	Structural Condition		Life Expectancy
Good	Fair		>40 years
Photographs

Growing in agricultural field conditions. Parkland tree. Part of group. Large buttress roots. Bark wounds to roots. Buttress roots exposed with observable basal decay. Old pruning wounds on trunk occluding. Old pruning wounds on trunk occluded with minor decay evident. Major decay in lower trunk. Apical dieback. Small cavities in main limbs. Major deadwood in crown. Crown reformed. Stags headed. Epicormics in crown. Fungal fruiting body east side at ground level (possibly *Inonotus dryadus*). Extensive basal decay (bottle butt formation).

Stabilise major deadwood.

Priority (Months):	12	Next inspection	36
--------------------	----	-----------------	----
