Photographic Schedule

Site: 15 High Street, Chipping Sodbury, South Glos, BS37 6BA

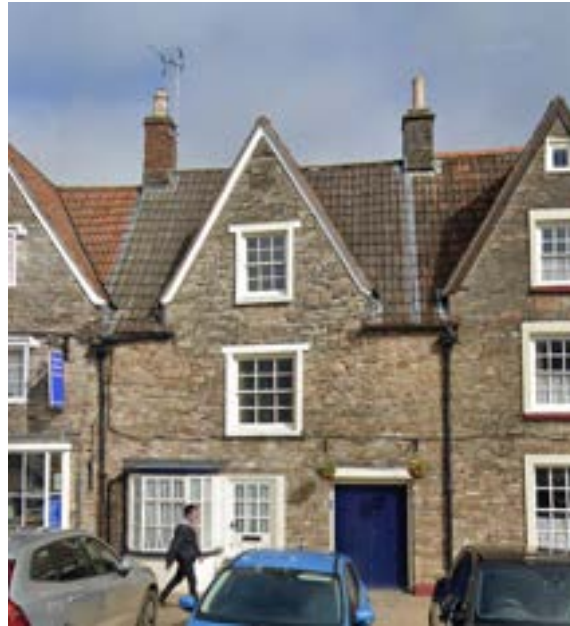
Photograph 01 – View of the principal southern elevation.

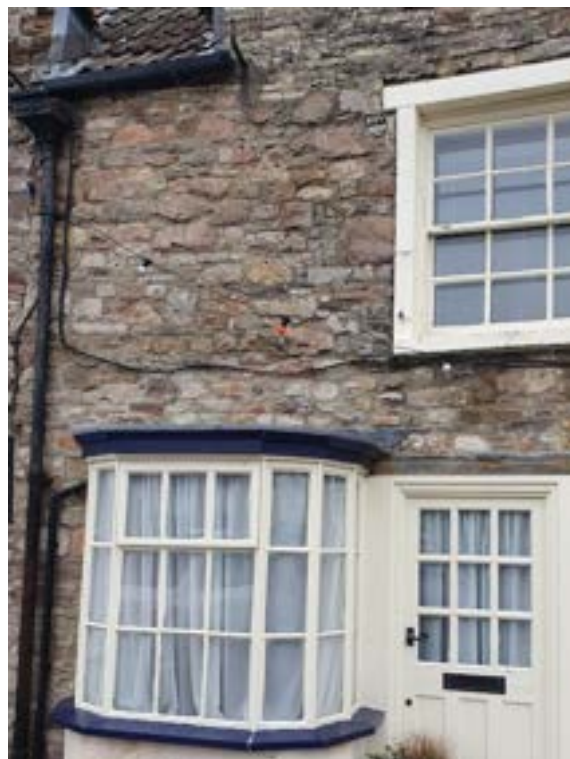
Photograph 02 – View of the bay window, door and sash window to which the application relates.

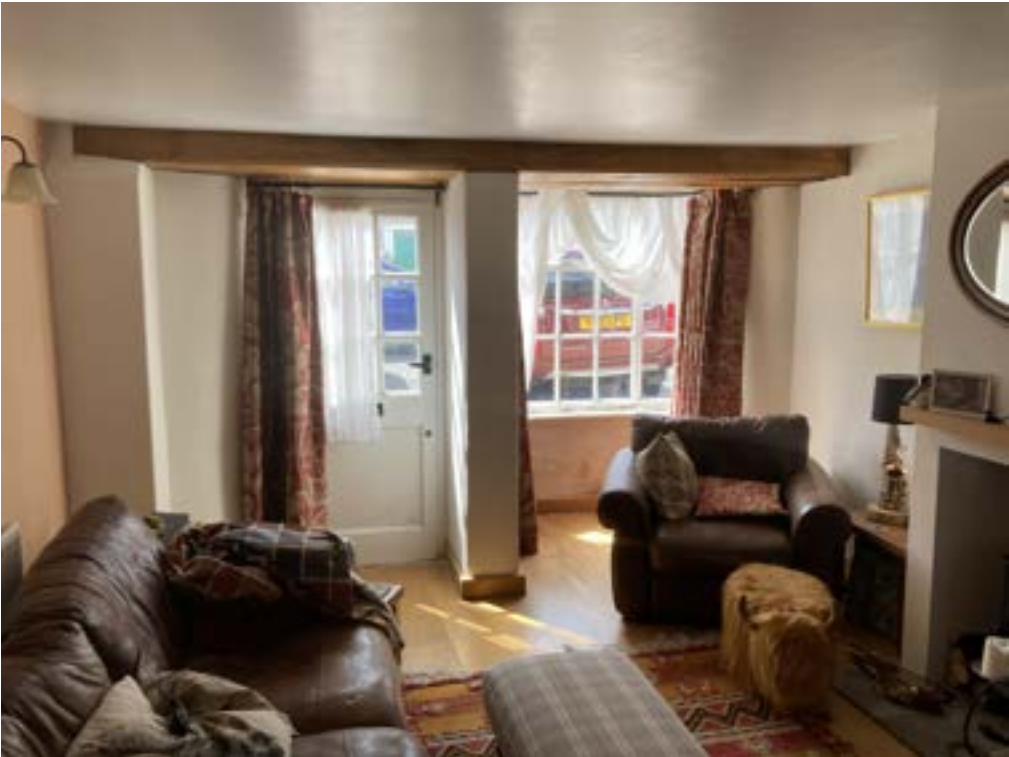
Photograph 03 – Internal view of the bay window and door to which this application relates.

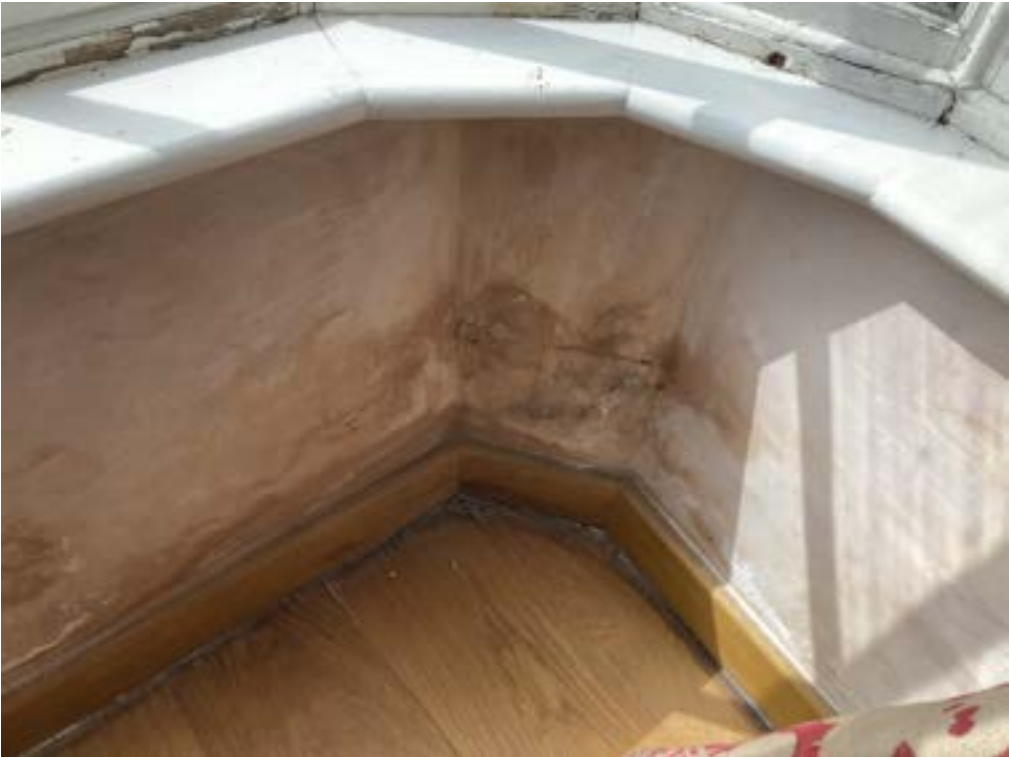
Photograph 04 – Internal view of the bay window plinth wall. Note the damp issues.

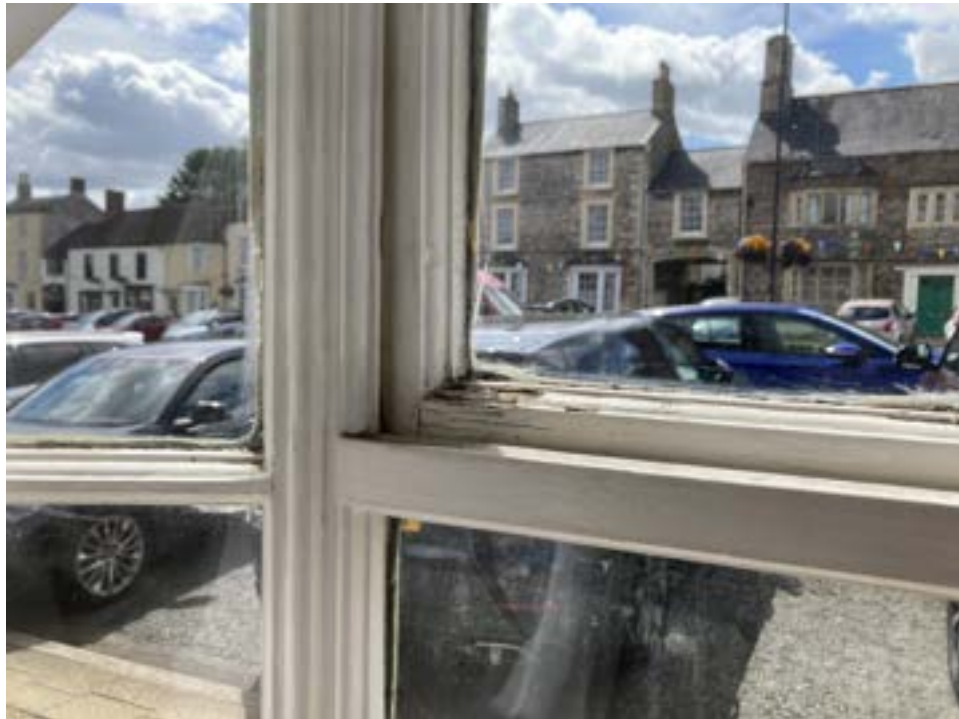
Photograph 05 – Typical example of poor condition of bay window frame.

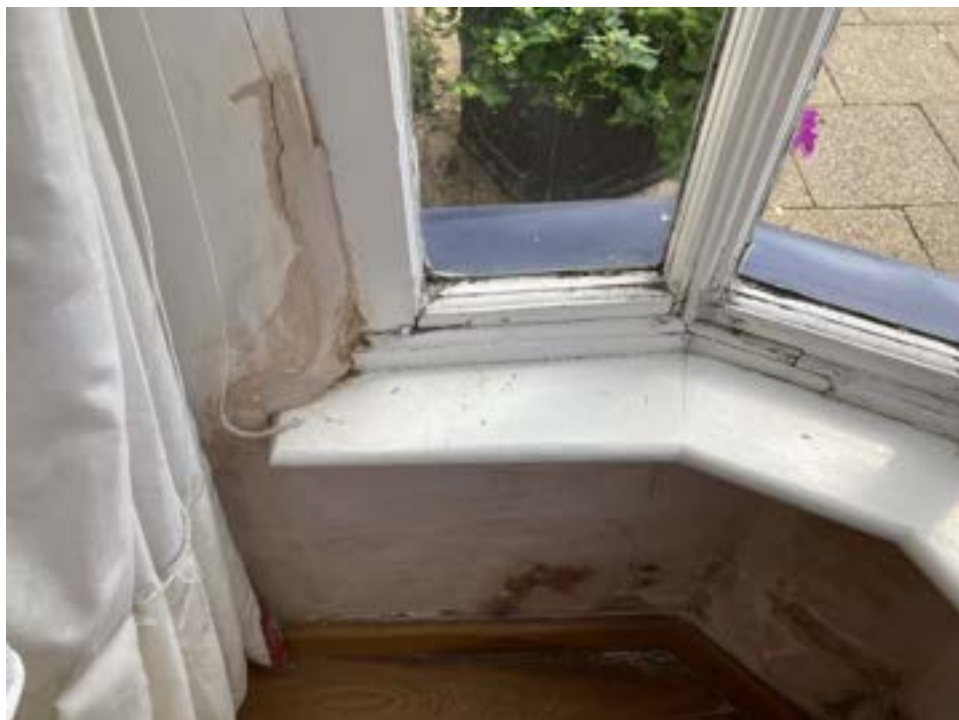
Photograph 06 – Typical internal view of bay window. Again, note the damp issues and poor condition of softwood joinery.

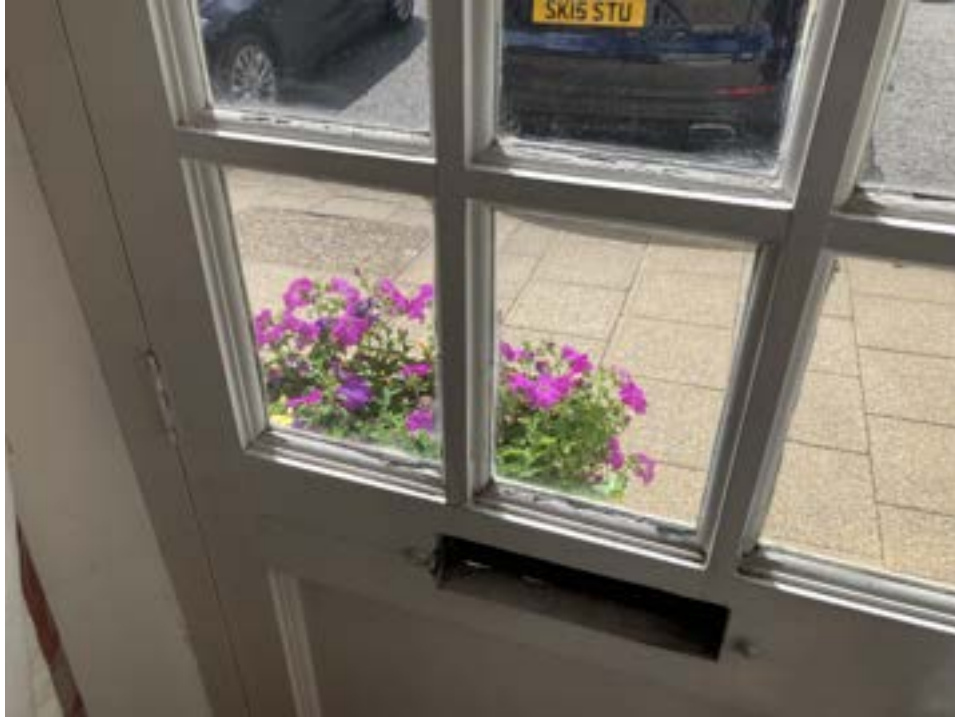
Photograph 07 – Typical internal view of the door to which this application relates. Note the state of disrepair.

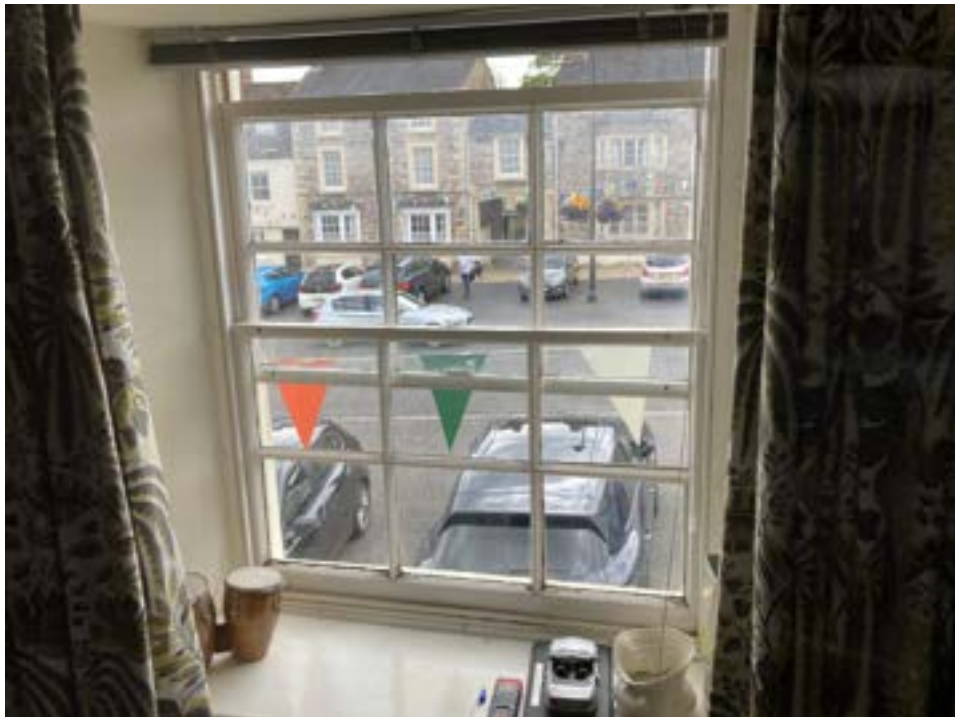
Photograph 08 – Internal view of first floor sash window to which this application relates.

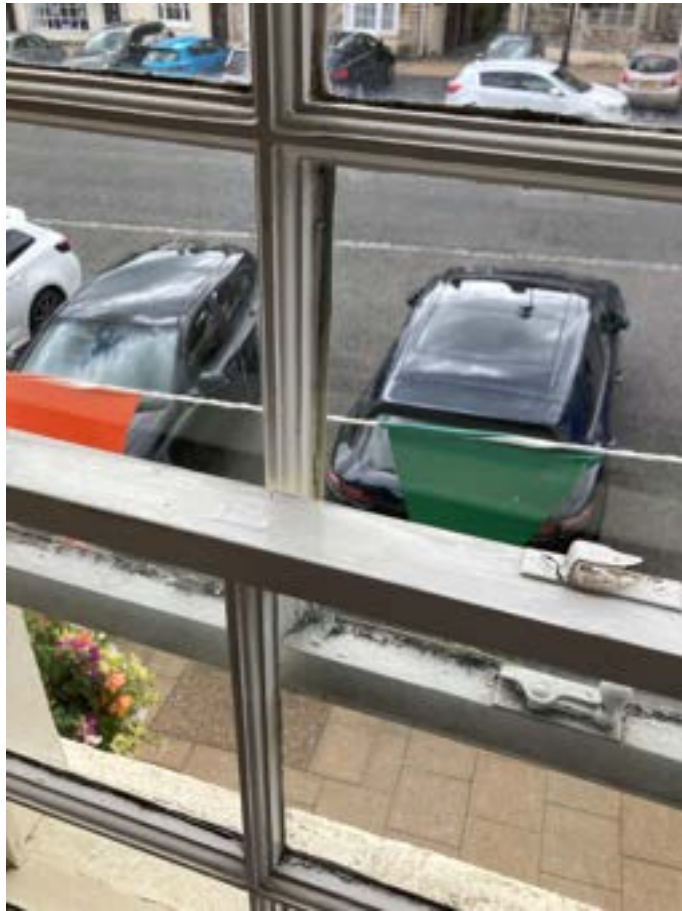
Photograph 09 – Internal view of sash window. Note the poor condition of the frame and glazing bars.

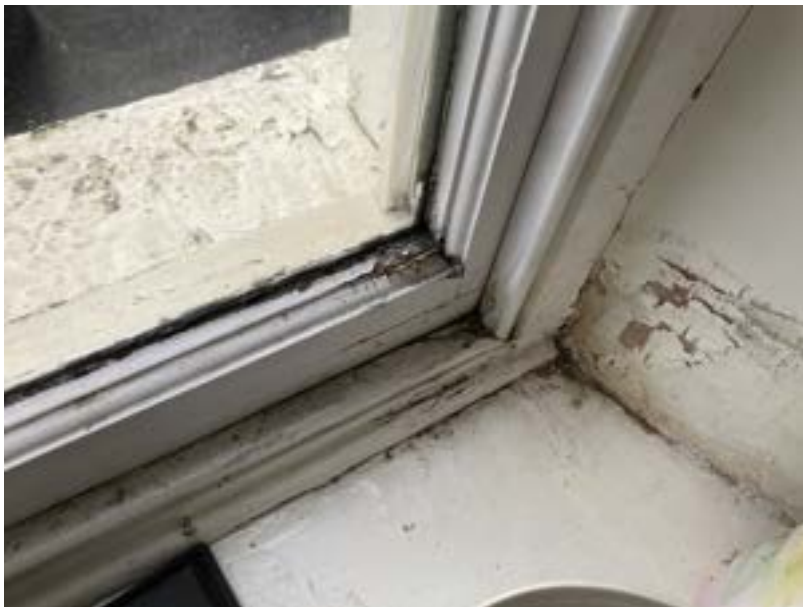
Photograph 10 – Typical internal view of sash window. Note the poor condition of the frame.
