project: **watertower ormskirk**
dwg no: **008**
dwg: **structural survey**
scale: **1:100 @ A1**

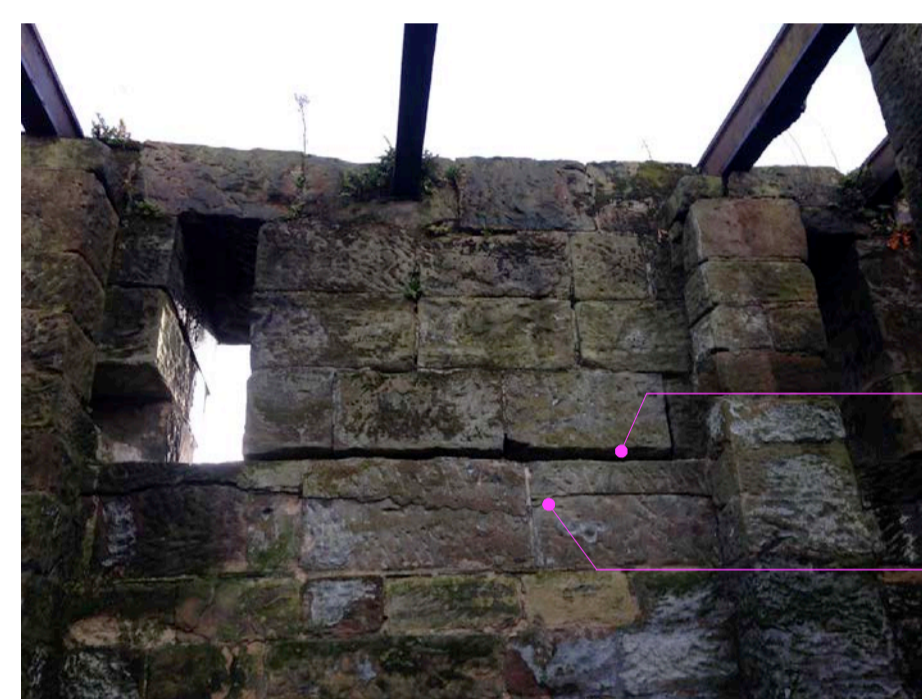
ring beam rusting and forcing corbelled element out; ring beam needs removing stone taking down cleared of iron debris and then reinstating

note: pressure from expanding rust causing lower level of stone to crack and de laminate; condition of stone will only be known once it has been taken down and exposed

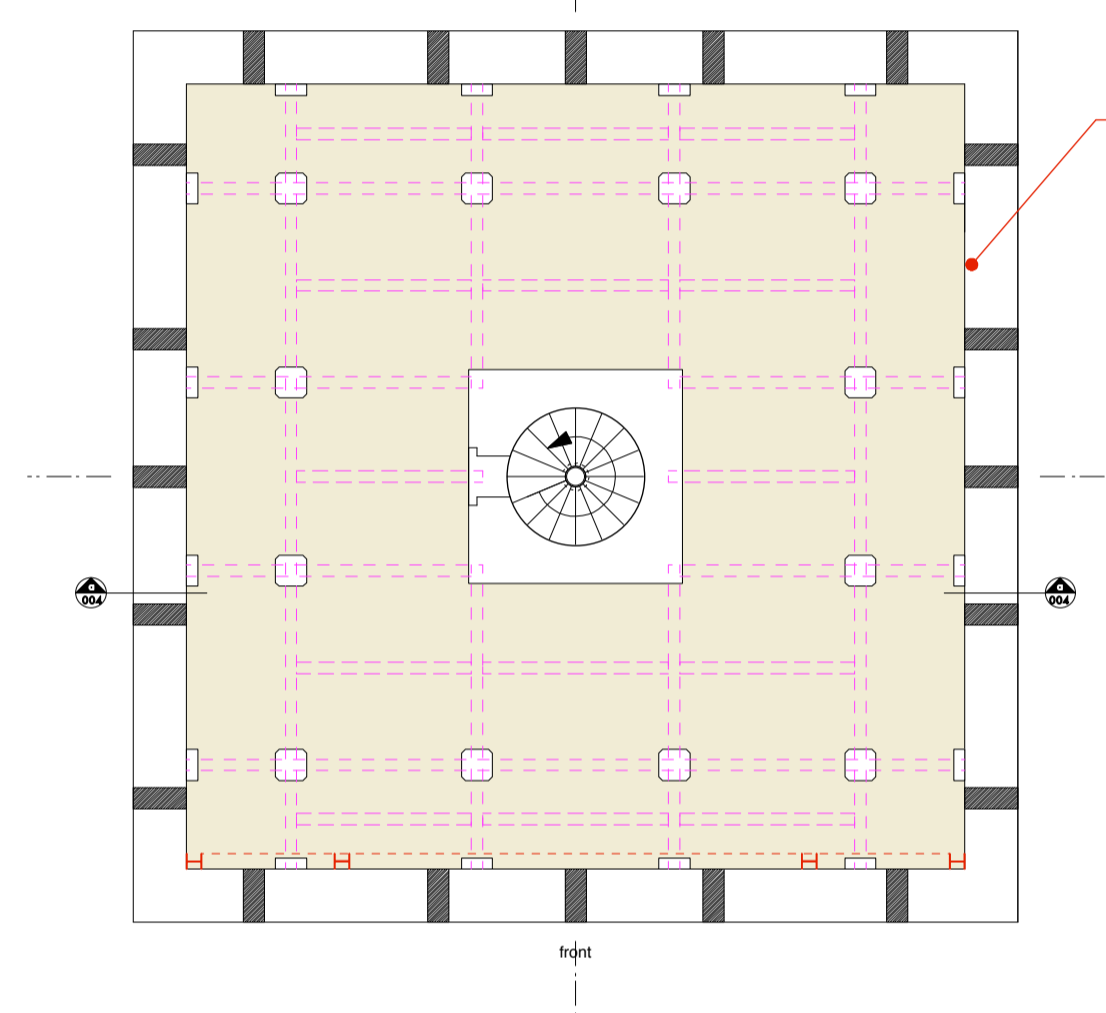
intermediate supports missing

limited movement in front corner

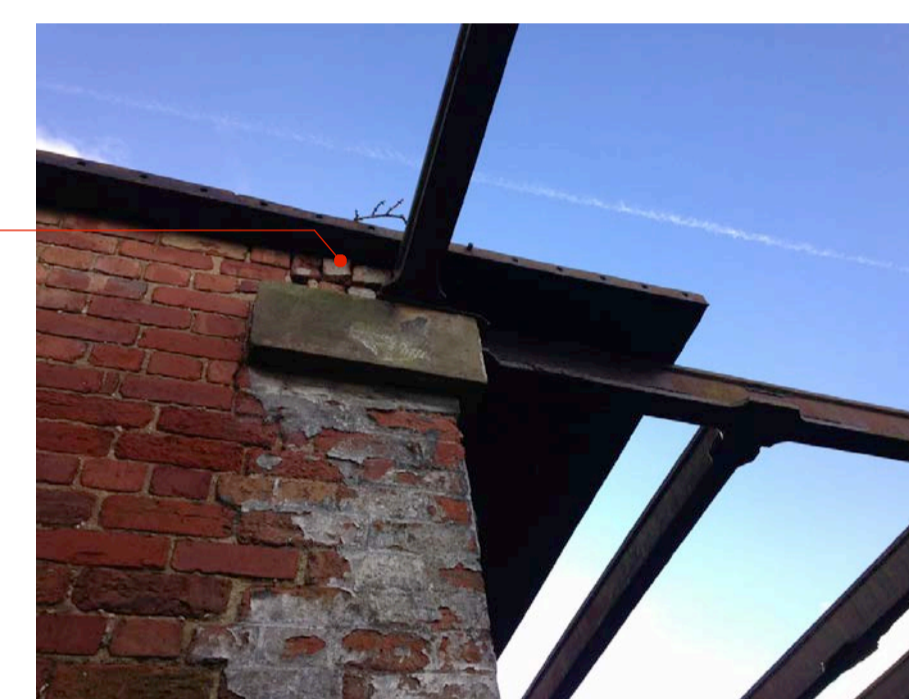
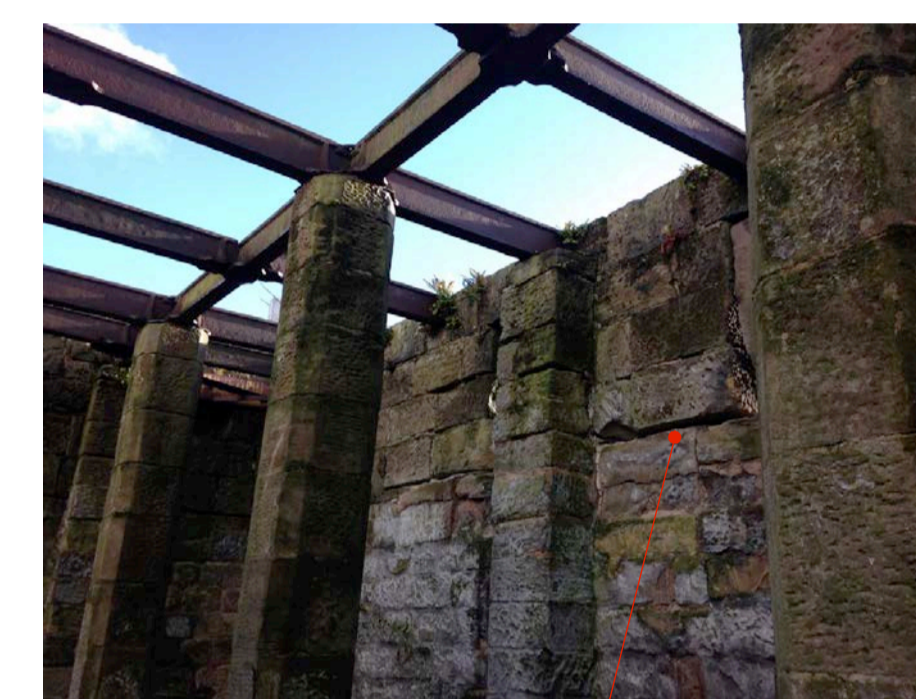
rusting of bottom ring beam forcing wall out [around entire perimeter]

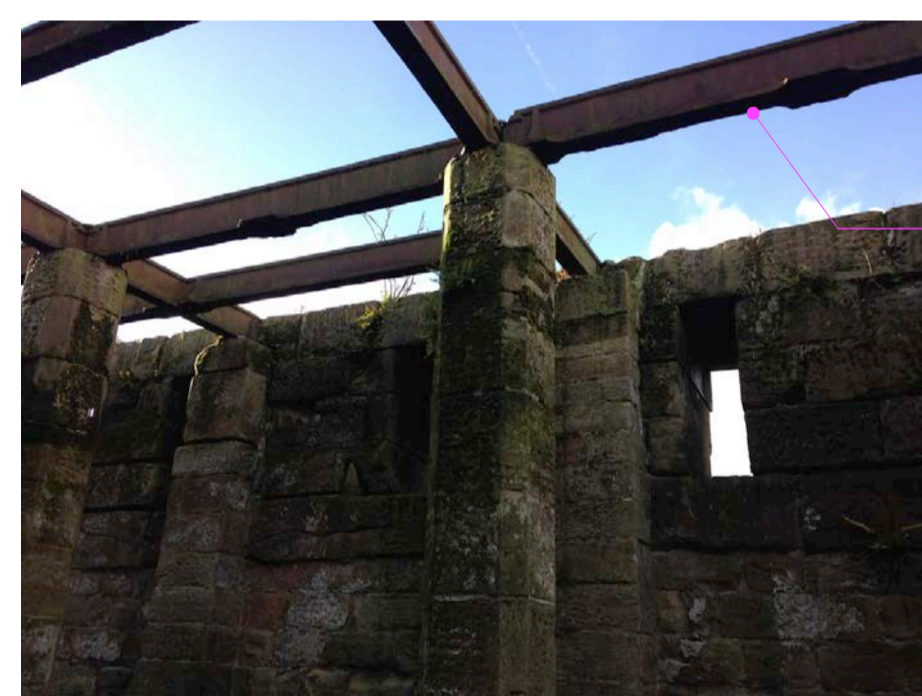
iron beams damaged in places and suffering from stress fractures throughout [through either age or damage occurring when water tank was taken down in the 1980's]

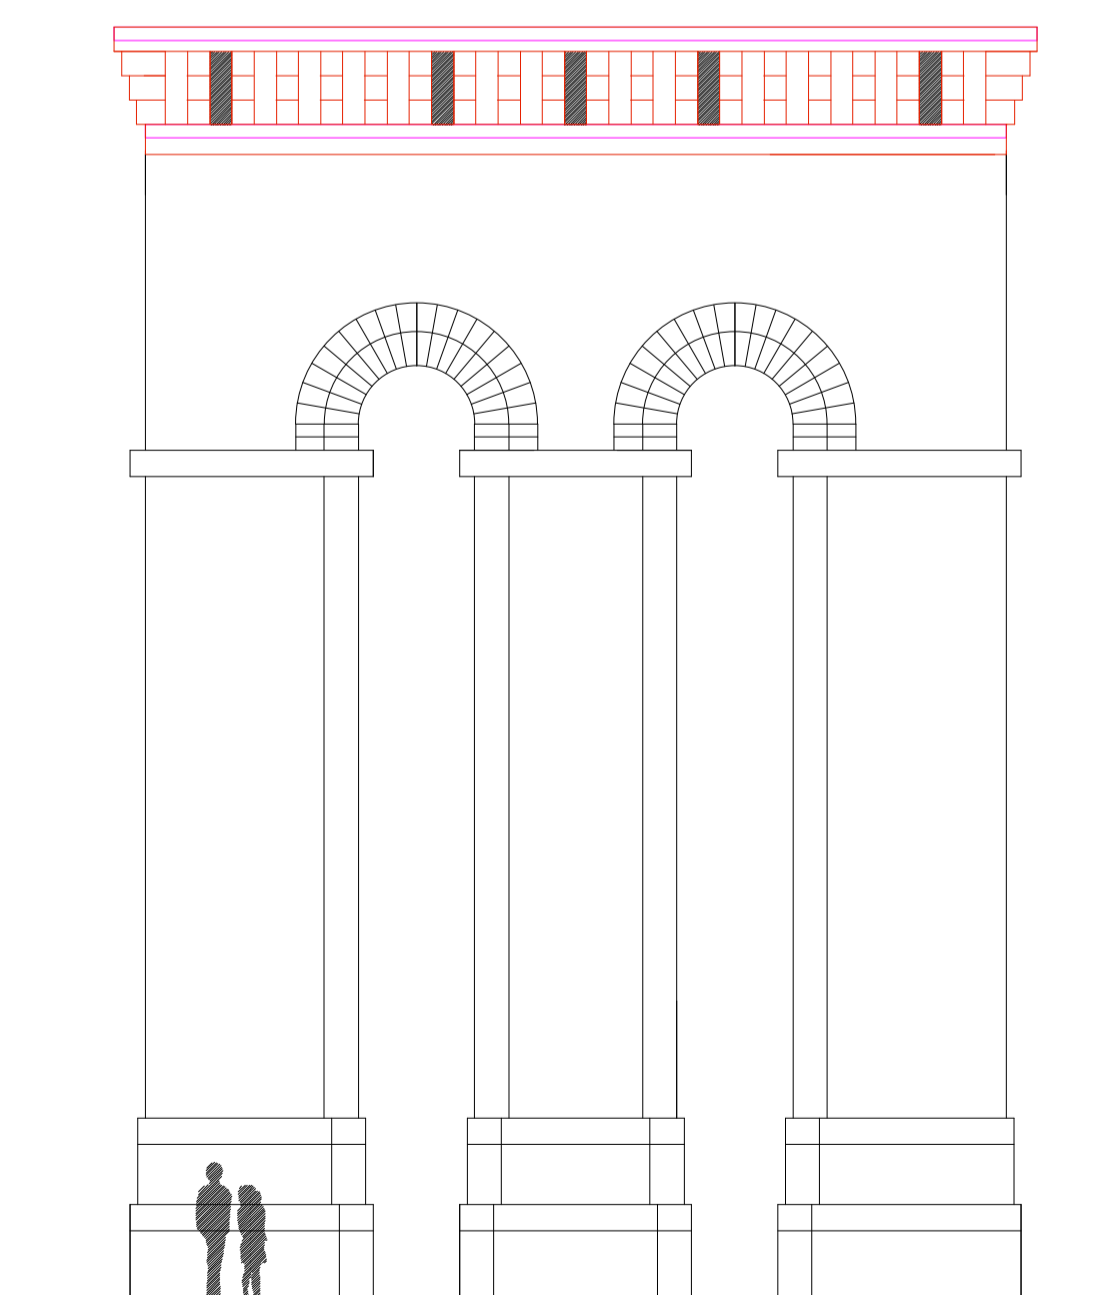
front / west elevation

severe movement in one corner

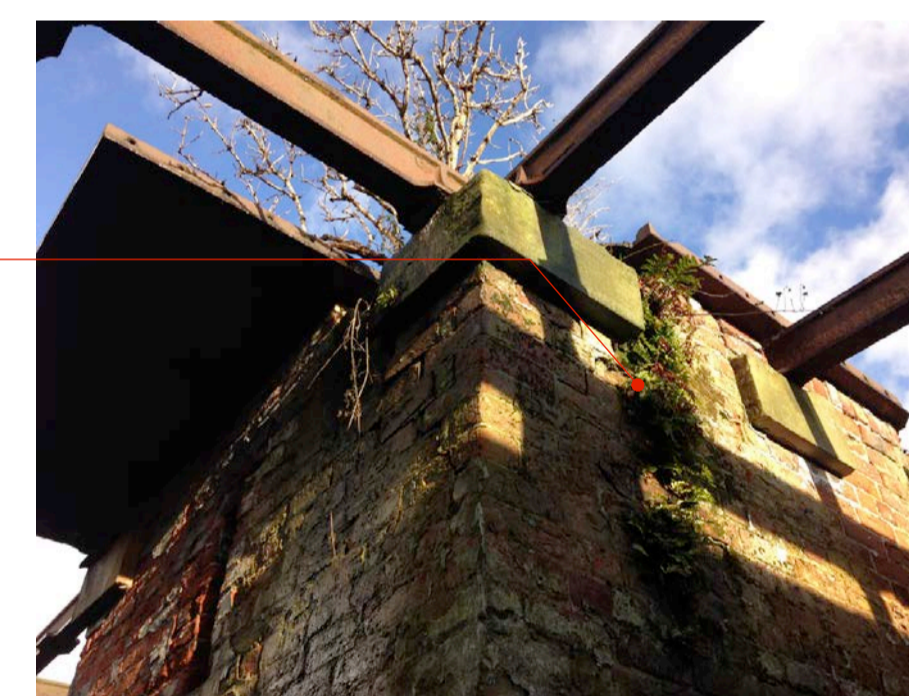
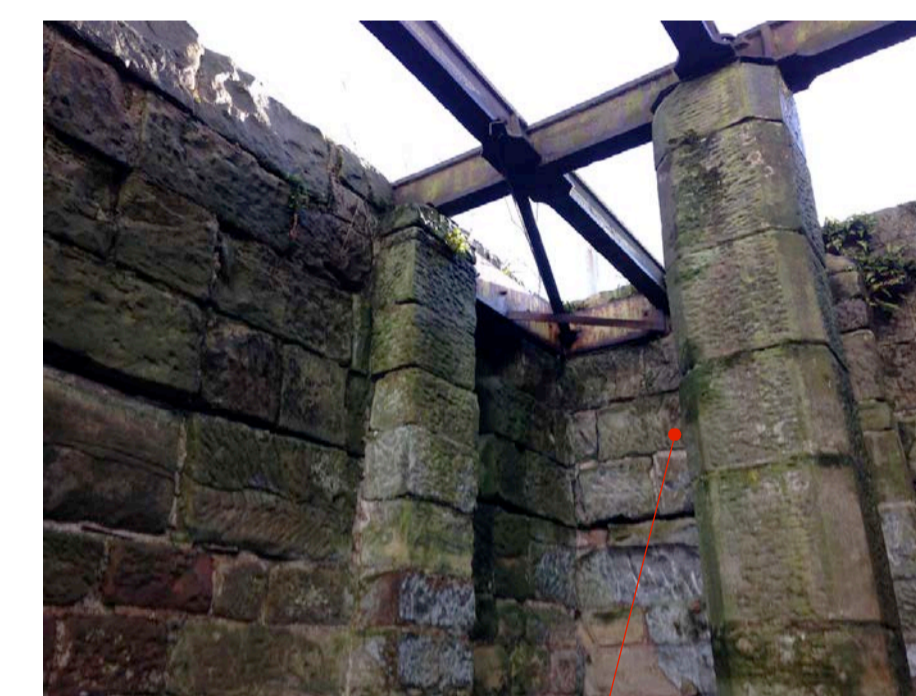
rusting of bottom ring beam forcing wall out [around entire perimeter]

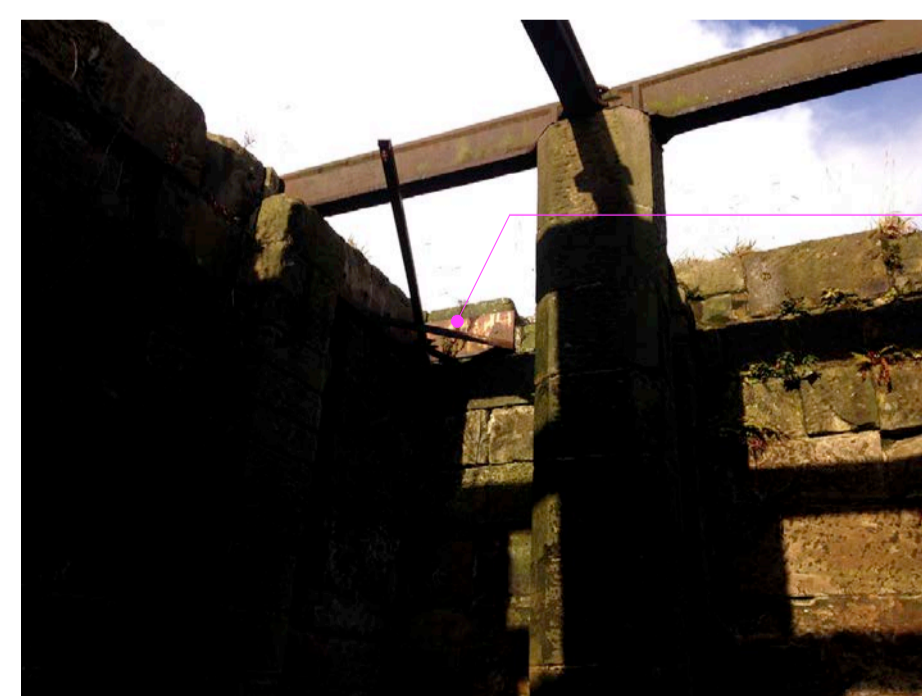
corners strapped somewhat haphazardly - from internet photographs strapping visible from before 2000 [presumably put up when tank was taken down]

movement of outside walls pulling iron frame which in turn is pulling brick staircase

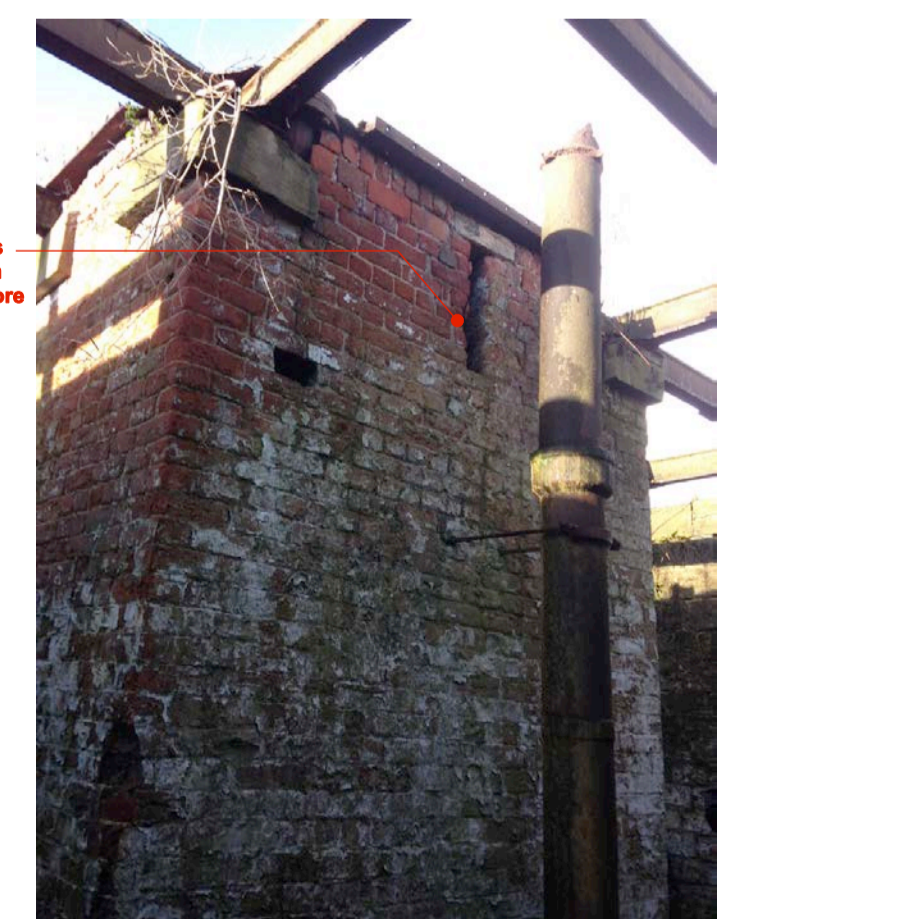
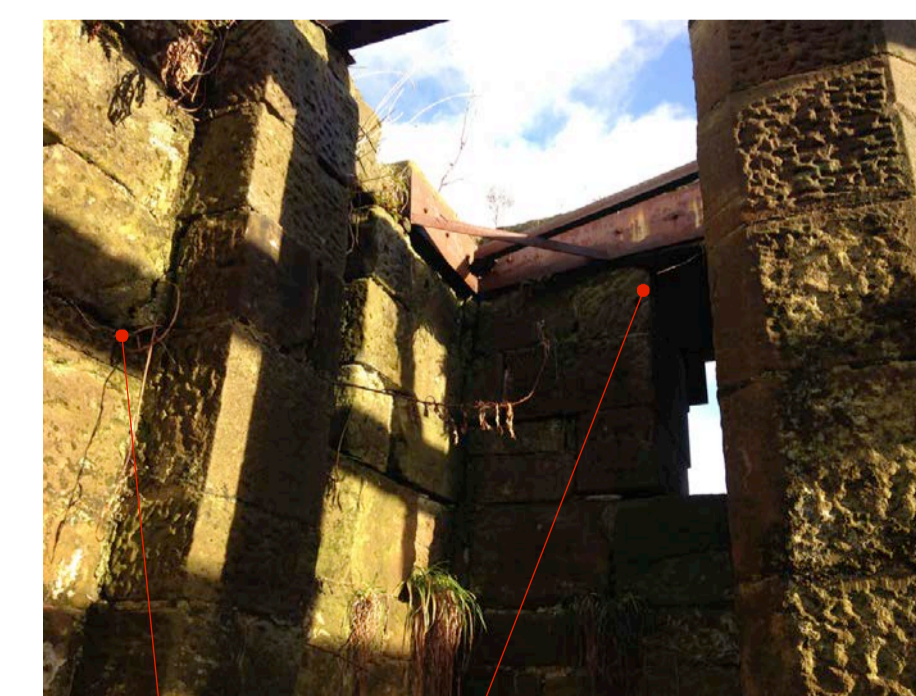
all corners strapped cracking up stone from outward movement of perimeter
