PRELIMINARY ROOST APPRAISAL

42 HODGETTS LANE KENILWORTH CV8 1PJ

Date: 11th December 2023

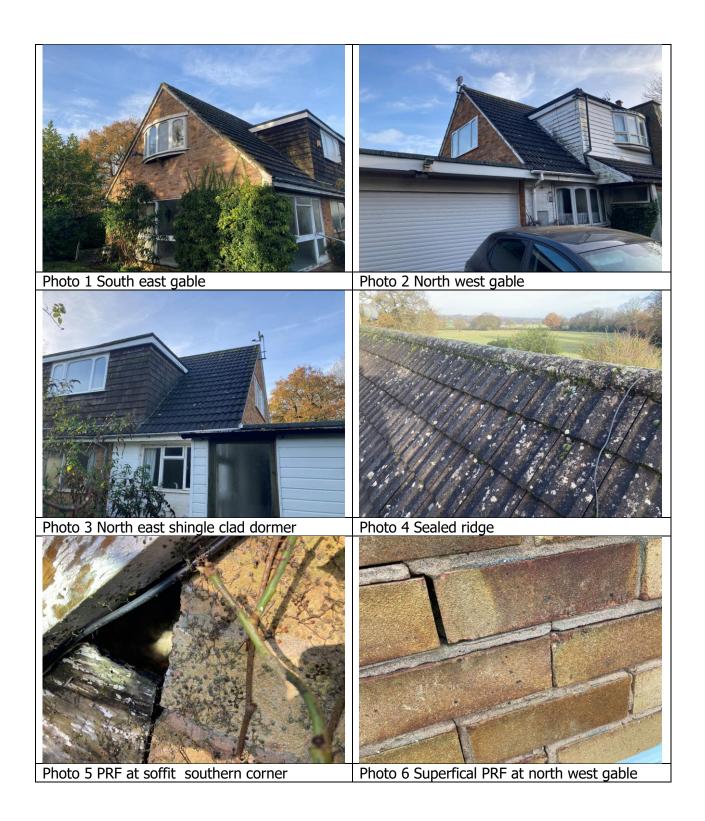
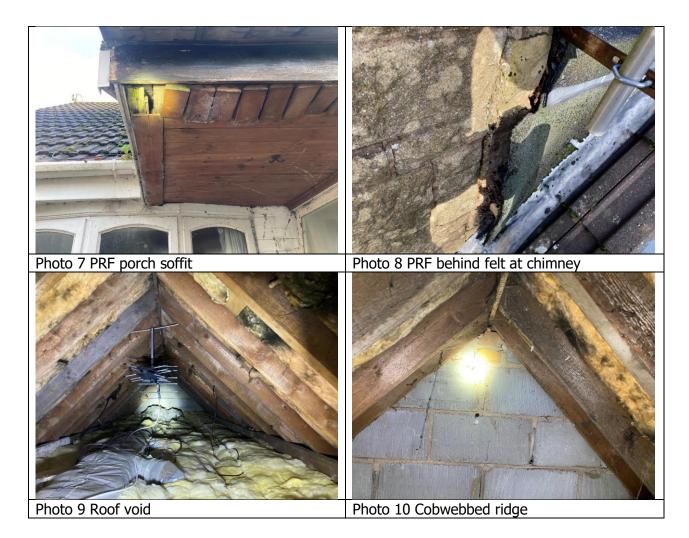
3.1.1 The building was a brick, one and a half storey detached dwelling that appeared to have been built during the mid-twentieth century. The roof was clad with concrete interlocking tiles and included a flat roof dormer at either pitch. The roof was generally in good condition, showing no PRFs; the ridges and verges were intact and sealed and the fascia boards were also well sealed. Elsewhere around the structure, PRFs were discovered and included:

- A feature behind exterior felt attached to the chimney flashing at the south east elevation. This was closely inspected by lifting the felt away and the feature was full of old cobwebs, although no evidence of bats was present.
- At the soffit of the south corner of the house where rot had occurred. This was a large hole and the soffit was found to be wet inside and did not contain any evidence of bats. The feature had been stuffed with a rag to prevent animal ingress and tis had fallen inside.
- At the porch where the soffit had decayed. This left an opening into the soffit, although inside this was found to be full of cobwebs and no evidence of bats was encountered.
- At the north west gable where mortar had fallen from a brick joint. However, this was shallow and suitable only for opportunistic use by bats.

4.2 No evidence of breeding birds was discovered, although the soffit at the south corner showed potential for breeding birds. Prior to works commencing (between now and February 2024) it is recommended that the PRFs shown in photo 5 is blocked off to prevent ingress by birds in future.
