EXISTING BARN STABILITY

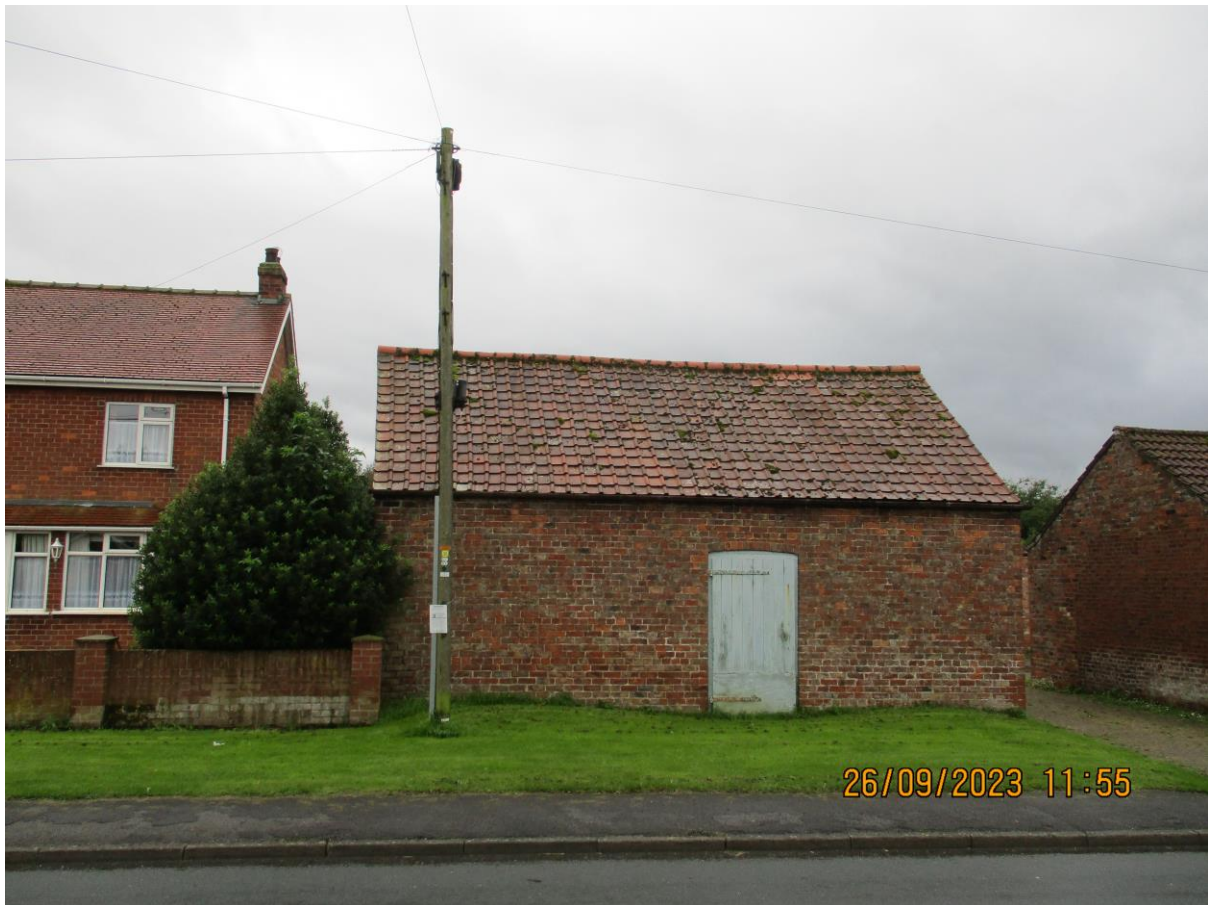
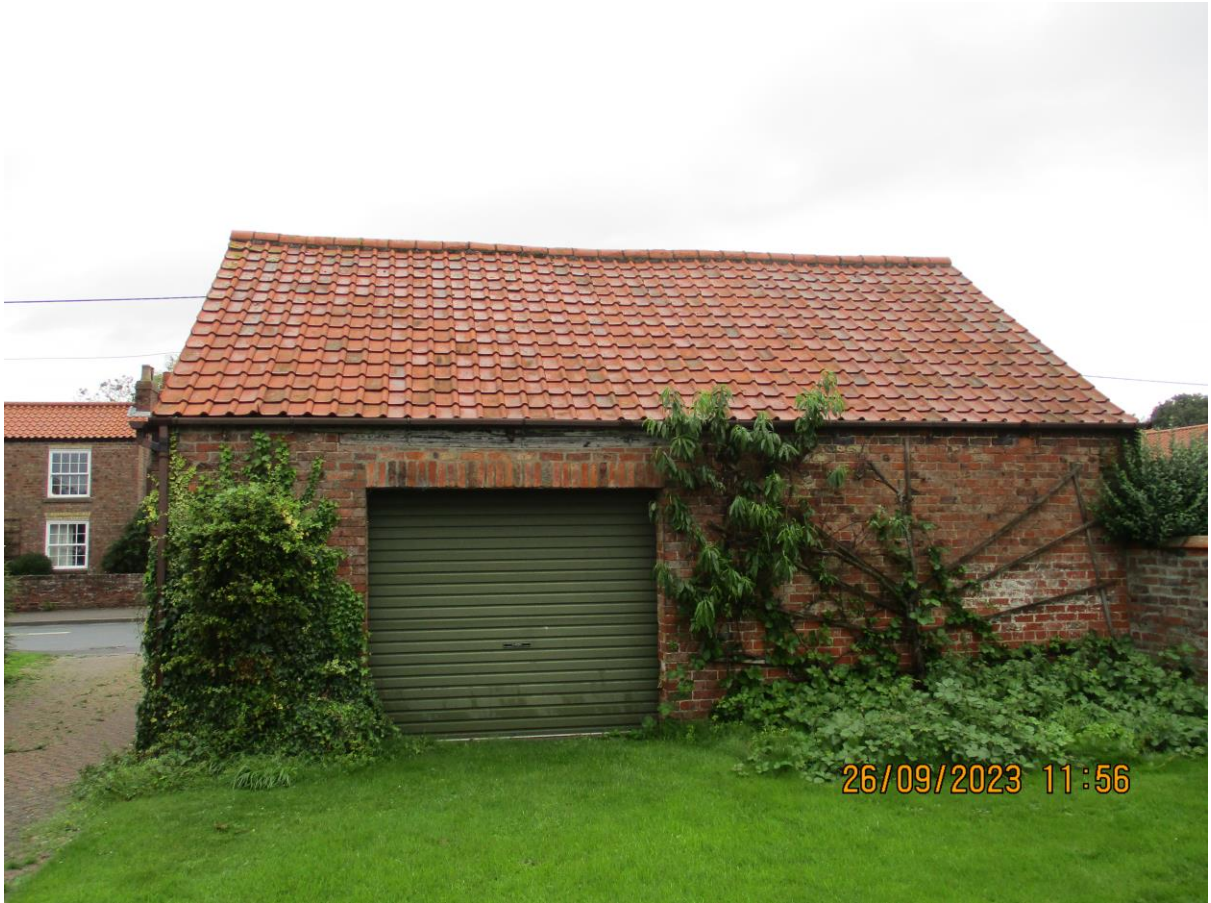
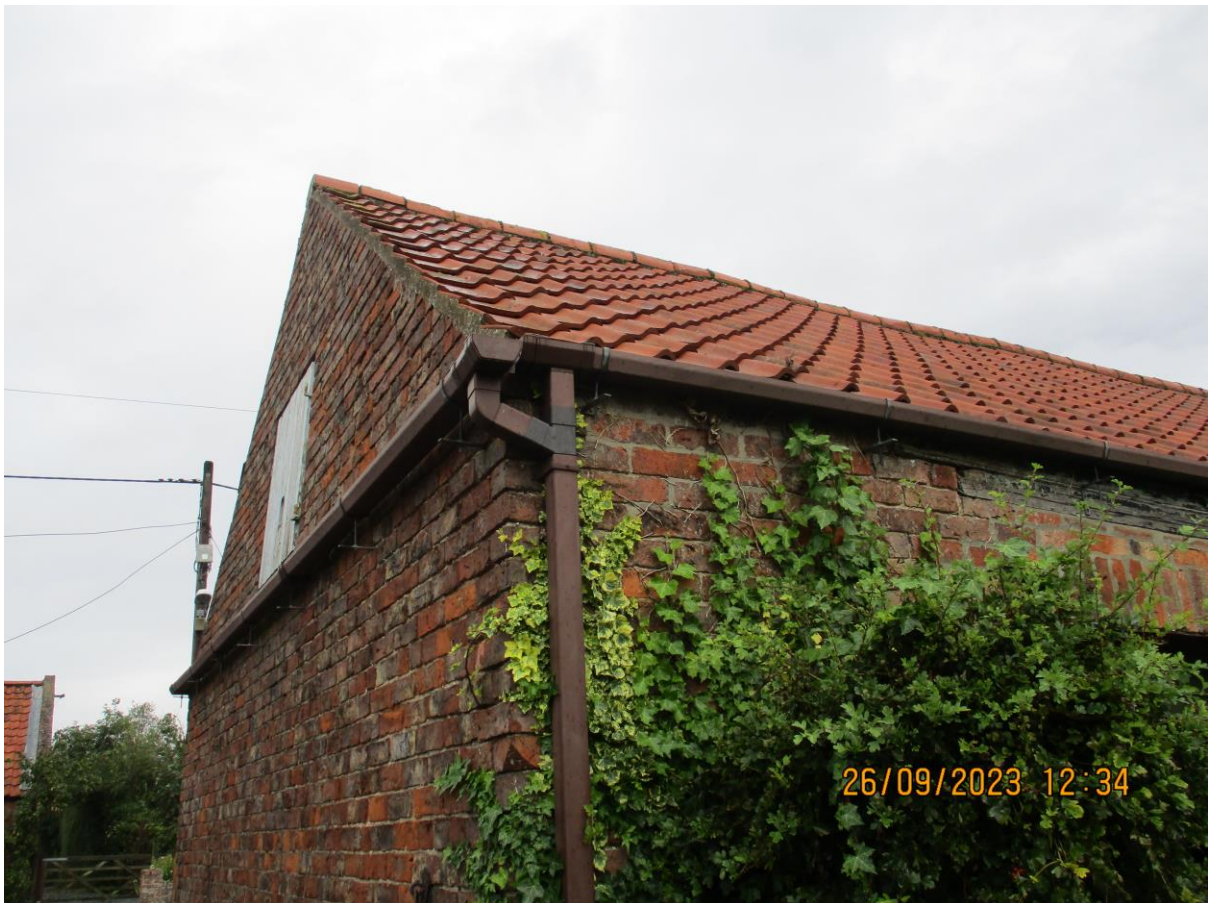
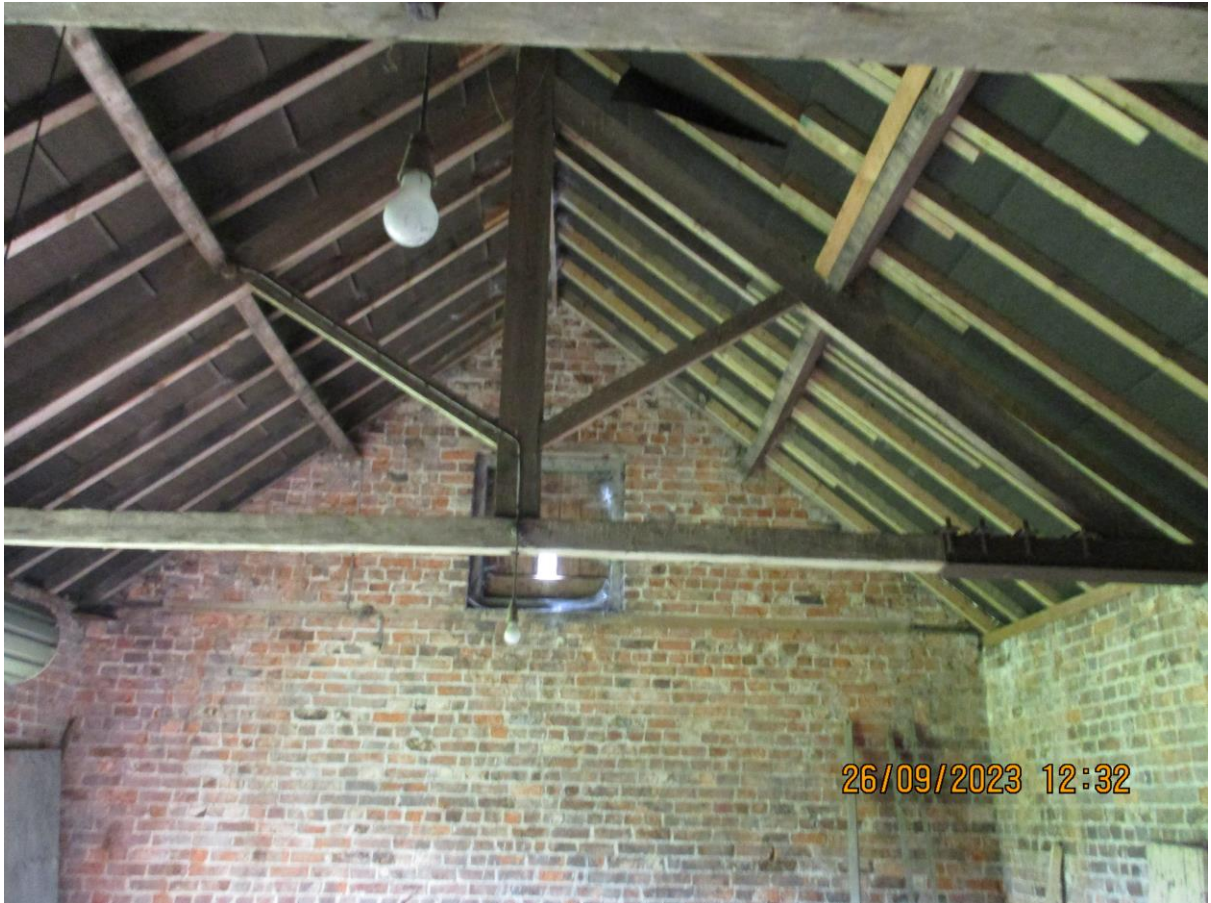
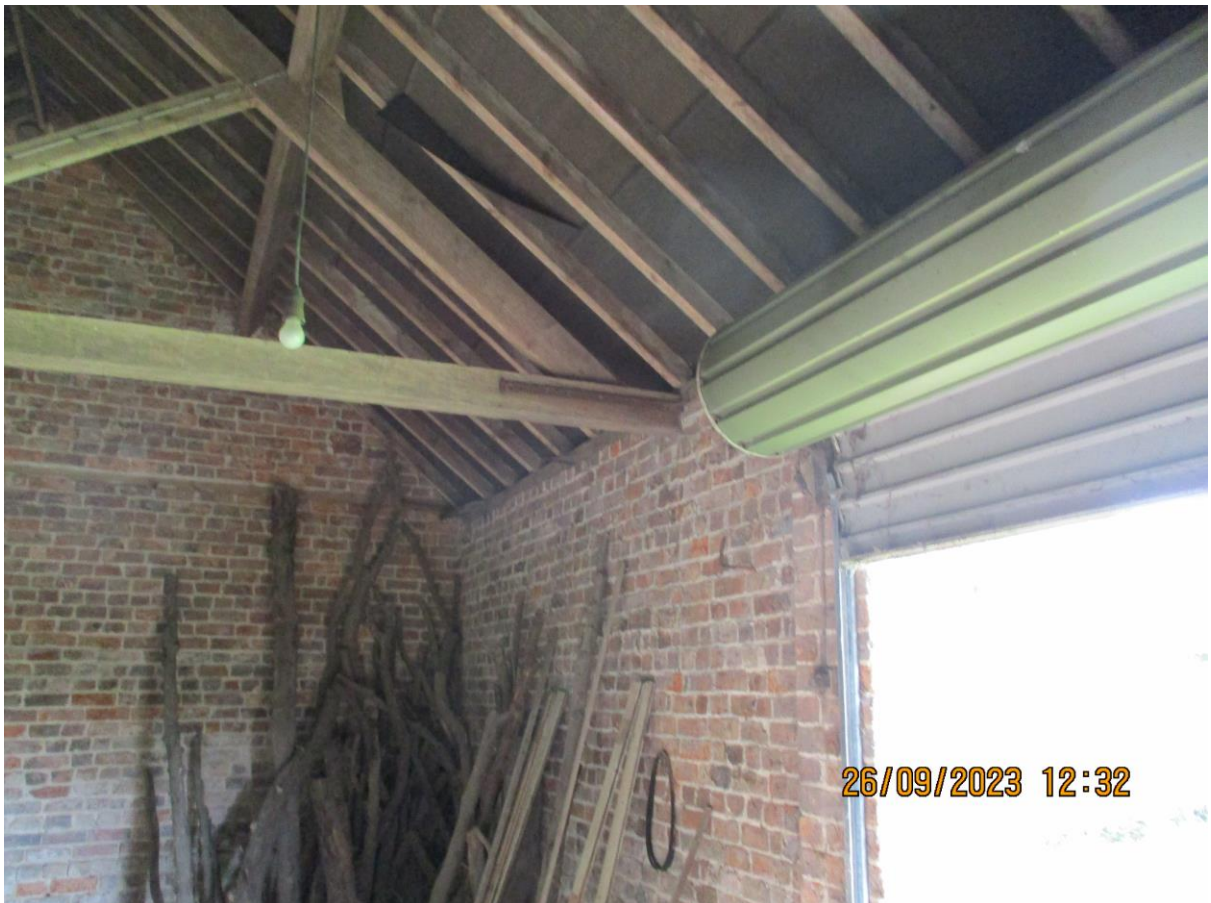
The existing barn which is to be converted is a brick built building with a concrete pantile roof. The photographs below shows the building is in an exceptionally good condition and has no signs of any structural defects. All the brickwork, the roof coverings and the internal roof structure can all be seen to be in a very good structural condition. Although a detailed structural report and design will be required prior to the conversion of the barn it is not felt a structural report is required to prove the currently stability of the building as this can be clearly seen.
