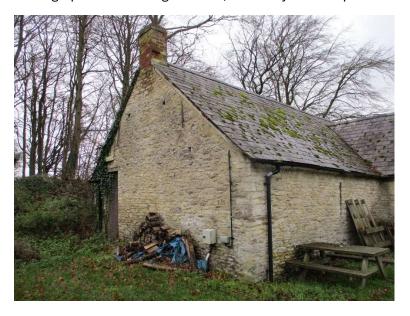
Photograph 1 – eastern gable end, note fully cement pointed verges and closed eaves.

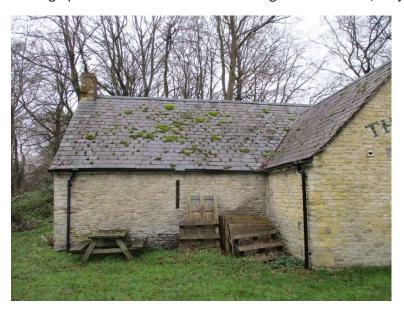
Photograph 2 – eastern end of north facing front elevation, fully tiled and hips close bedded

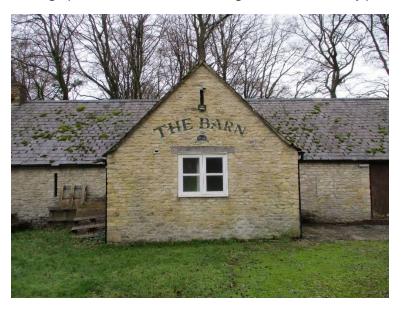
Photograph 3 – centre of north facing elevation with fully pointed verge and sealed openings

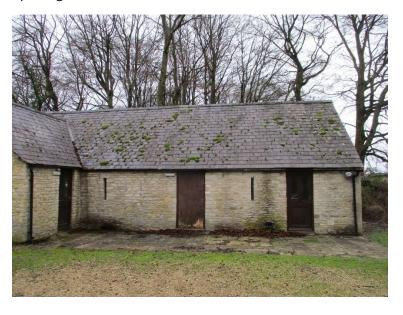
Photograph 4 – western end of north facing elevation with closed eaves, ridge and sealed openings

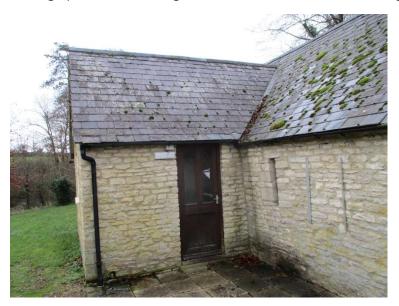
Photograph 5 – West facing return elevation, closed eaves, ridge and valley details

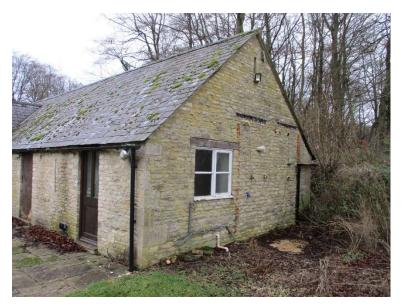
Photograph 6 – western gable end with eaves details all closed.

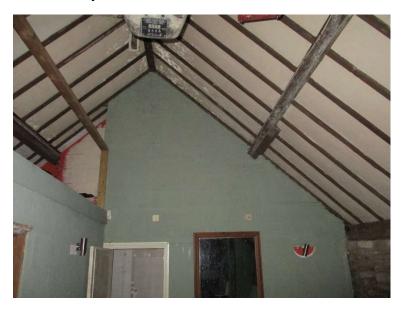
Photograph 8 - inside looking west, note ceilings closed, no roof void and no indication of bird or bat activity.

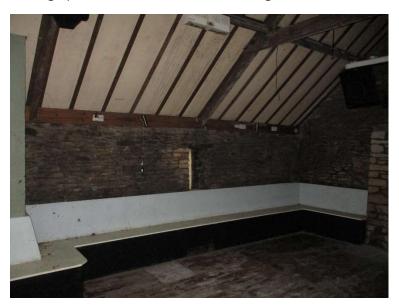
Photograph 9 – inside eastern end looking north, eaves and slits all closed, no access points.

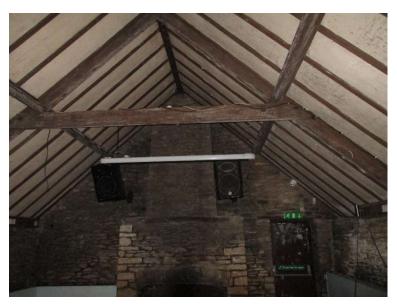
Photograph 10 – looking east, ceiling, eaves etc all closed, no voids.
