**Project Name:** Sandbarn 1 and 2, Tarporley 29-07-2022

**Inspection Standard:** MSCC4 Sewers & Drainage GB (SRM4 Scoring)

**Company:** Envirocare Northwest  
**Town or City:** Wardle  
**Phone:** 01270759755

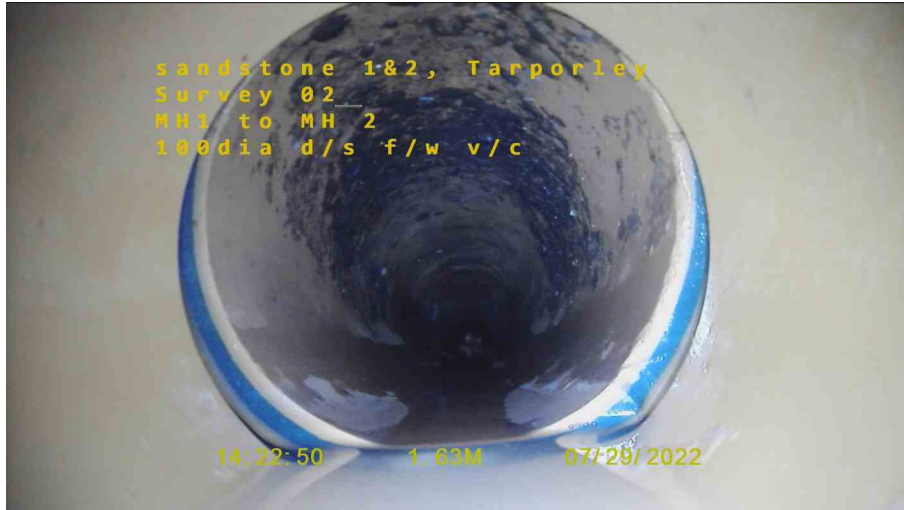
MH 1X\_1e856d60-60ba-4474-a598-72f01a6bfee4\_20220729\_160936\_853.jpg, 00:00:30, 1.63  
m  
Joint displaced, medium

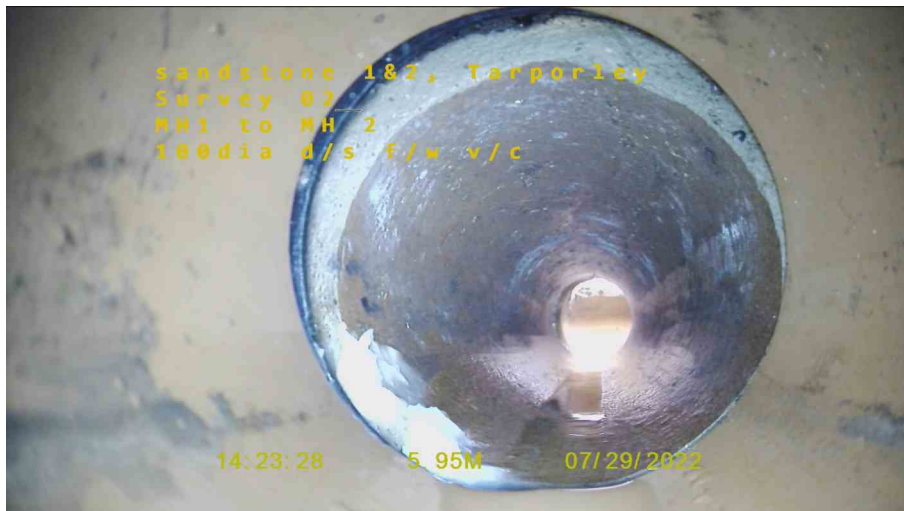
MH 1X\_0023ac56-a4f5-4e78-a38b-39d076f0cd99\_20220729\_161027\_832.jpg, 00:01:08, 5.95  
m  
Joint displaced, medium

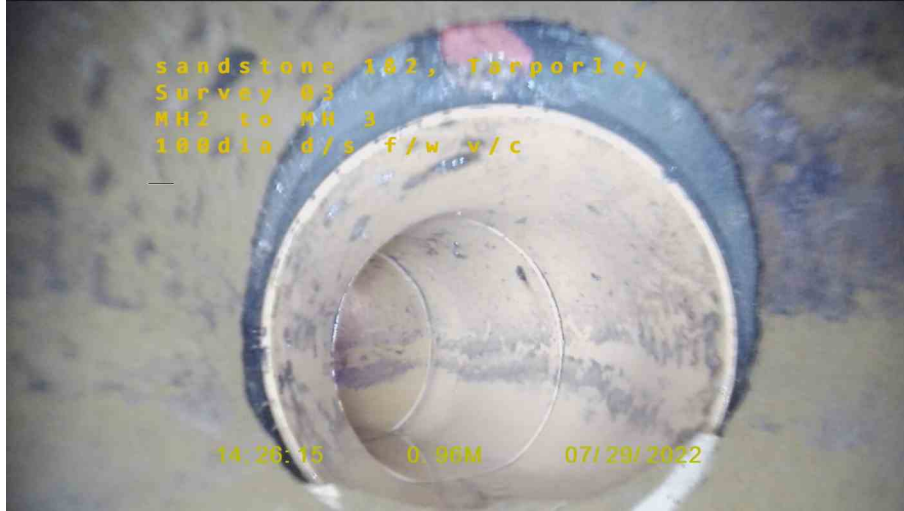
MH 2X\_ee084e23-5be9-4afd-8df4-13e92c44d8c0\_20220729\_161306\_891.jpg, 00:00:17, 0.96  
m  
Joint displaced, medium

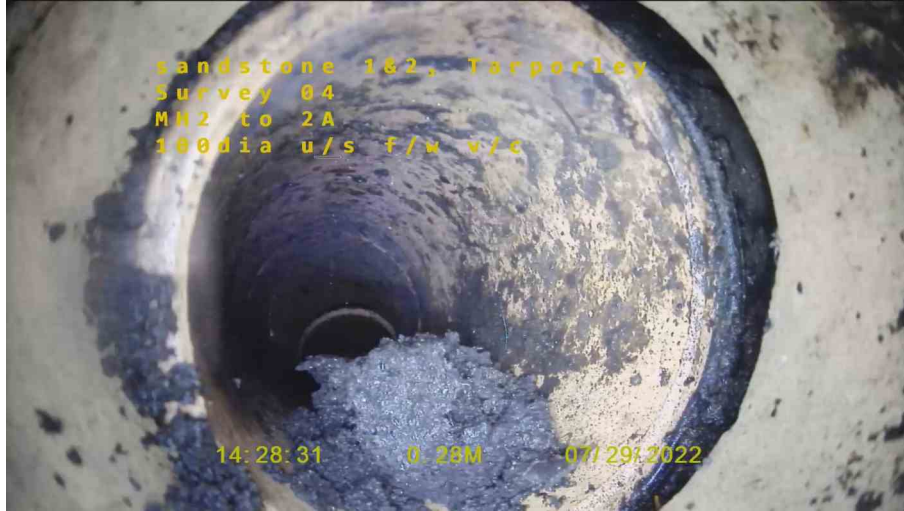
2AX\_b9eef41d-b704-432d-9a8f-ce02de6b06b7\_20220729\_161632\_476.jpg, 00:00:12, 0.28 m  
Joint displaced, medium

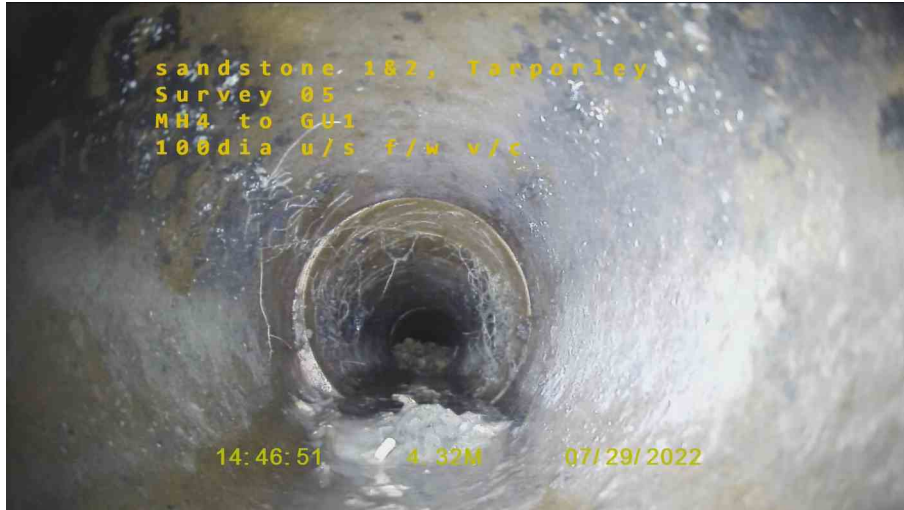
GU1X\_159935f1-e943-4bbf-917c-08b571e269dc\_20220729\_162028\_195.jpg, 00:00:37, 4.32  
m  
Settled deposits, fine, 15% cross-sectional area loss

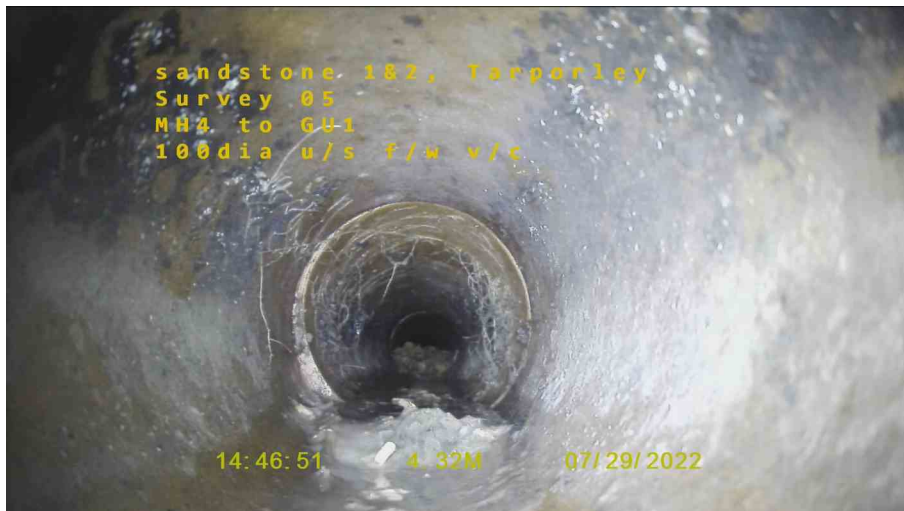
GU1X\_337aec0a-ce45-4485-b1ab-c49e8cc39dd0\_20220729\_162038\_416.jpg, 00:00:37, 4.32  
m  
Joint displaced, medium

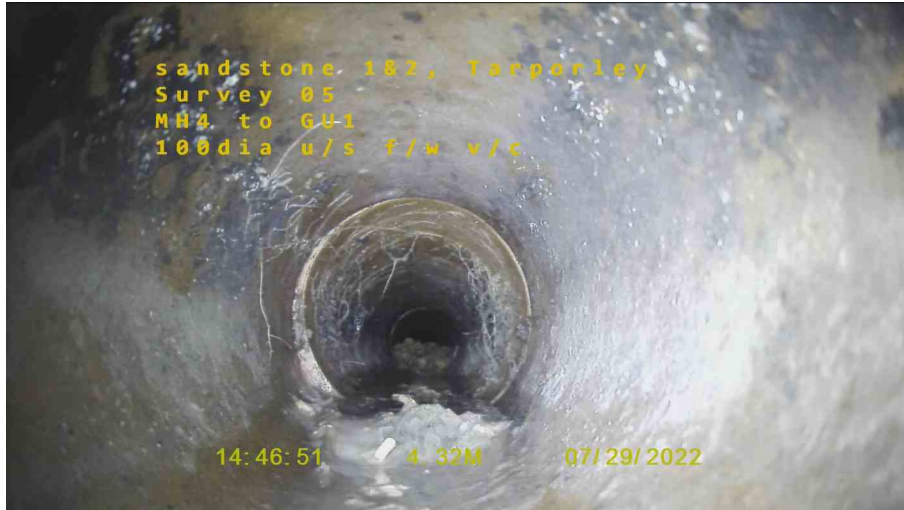
GU1X\_78412ee0-7ada-4252-87ba-8e5fa5d03b40\_20220729\_162056\_784.jpg, 00:00:37, 4.32  
m  
Roots, fine at joint

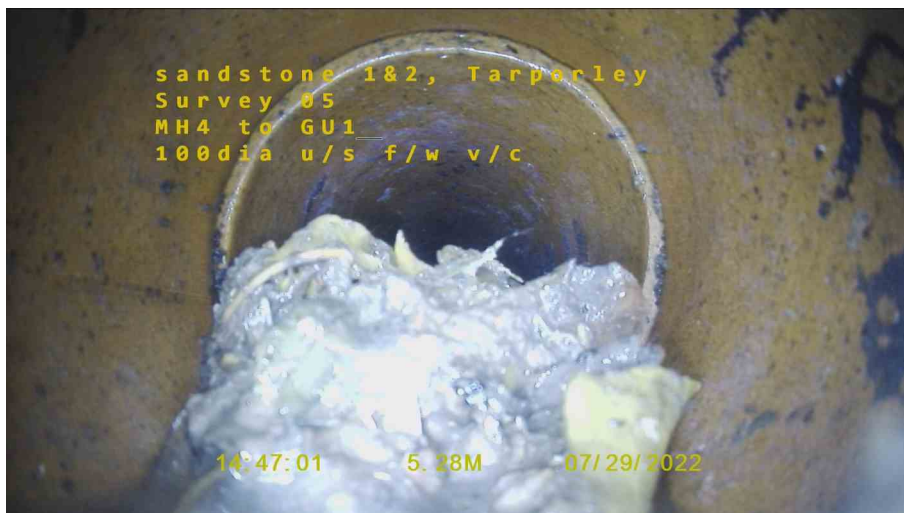
Section	PLR	Grade	Description
5	GU1X	4	Settled deposits, coarse, 35% cross-sectional area loss

GU1X\_2e384199-7d52-425a-81c6-0adef25e5c91\_20220729\_162546\_858.jpg, 00:00:45, 5.08  
m  
Settled deposits, coarse, 35% cross-sectional area loss

Grade 4: Best practice suggests consideration should be given to maintenance activity to avoid potential blockages.

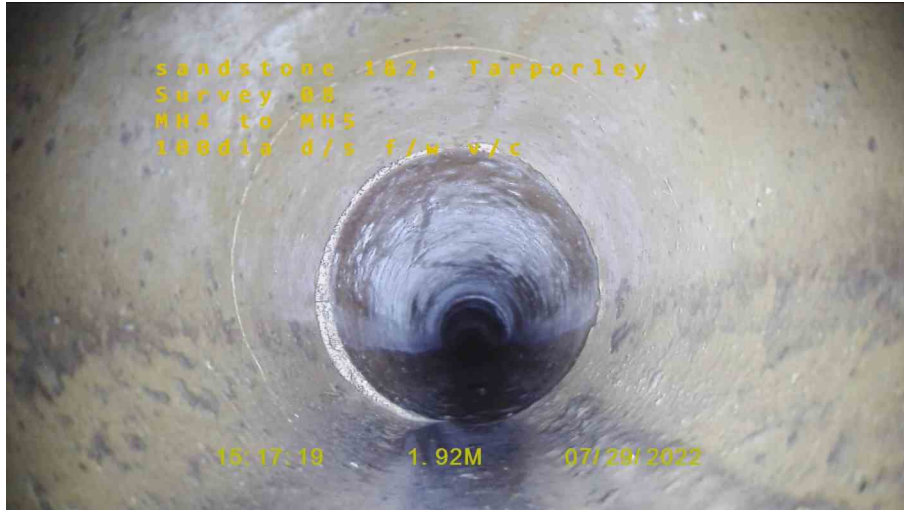
MH 4X\_c45fb9b0-7eb8-4a4e-912a-c2cd59281794\_20220729\_163609\_708.jpg, 00:00:13, 1.92  
m  
Joint displaced, medium

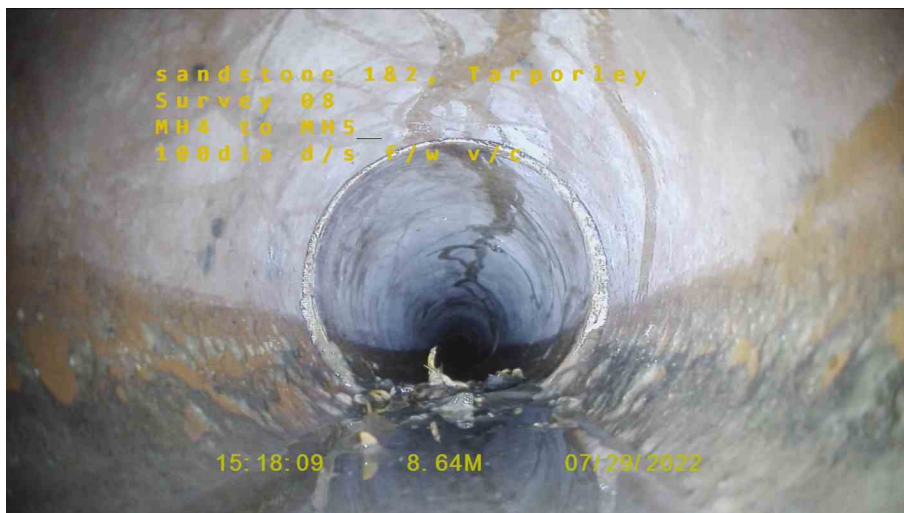
MH 4X\_f9567e28-1b8f-4a3b-948b-f87abbf7b12a\_20220729\_163710\_765.jpg, 00:01:00, 8.64  
m  
Joint displaced, medium

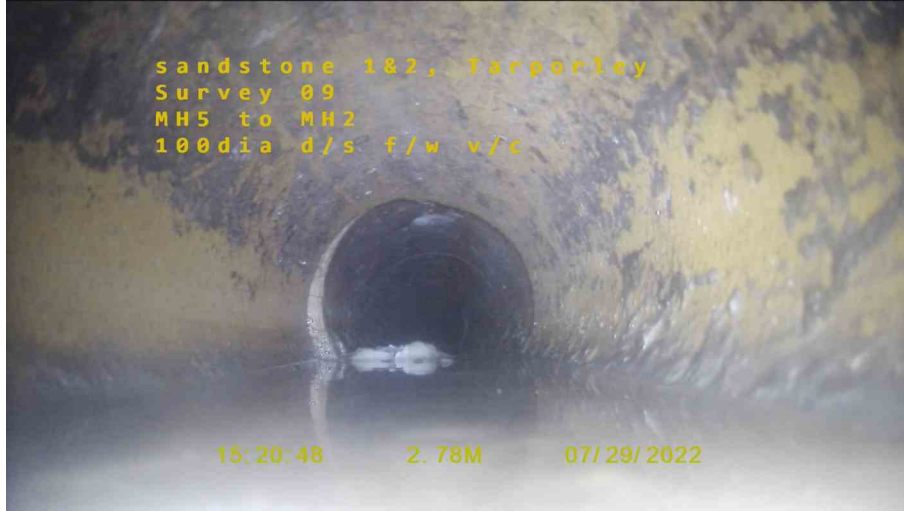
MH 5X\_ab7737c4-07ad-46a8-9165-6def9d88c074\_20220729\_165107\_540.jpg, 00:01:07, 2.78  
m  
Joint displaced, medium

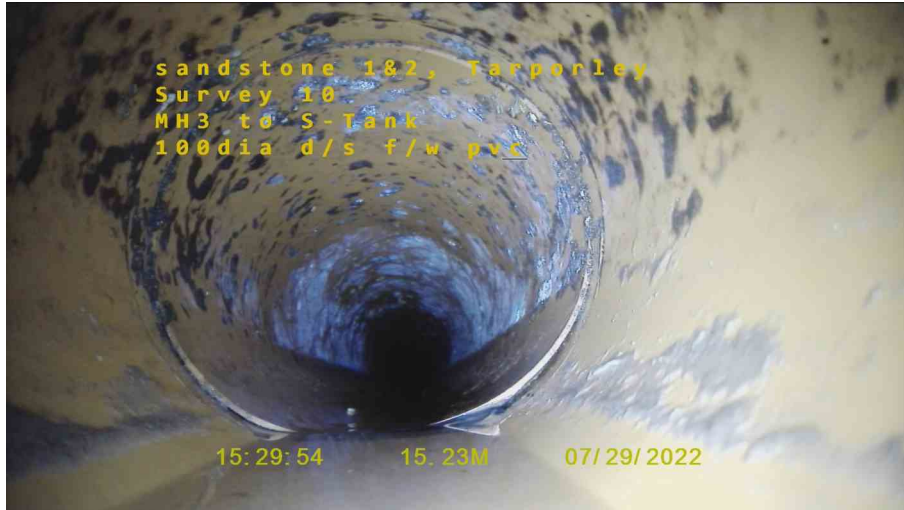
MH 3X\_2cc578d8-d750-4956-a6d5-318fa0867966\_20220729\_170813\_886.jpg, 00:01:38,  
15.23 m  
Joint displaced, medium
