Elmswell Tavern

Preliminary Roost Assessment and Survey Report

Project: The Railway Tavern Public House

Document Title: Elmswell Tavern Preliminary Roost Assessment and Survey Report
Revision: 1.1
Document Status: <Final Draft for Issue>
Date: November 2023
Client Name: Peter Dow
Project Manager: David Magnani
Author: Lee Rudd

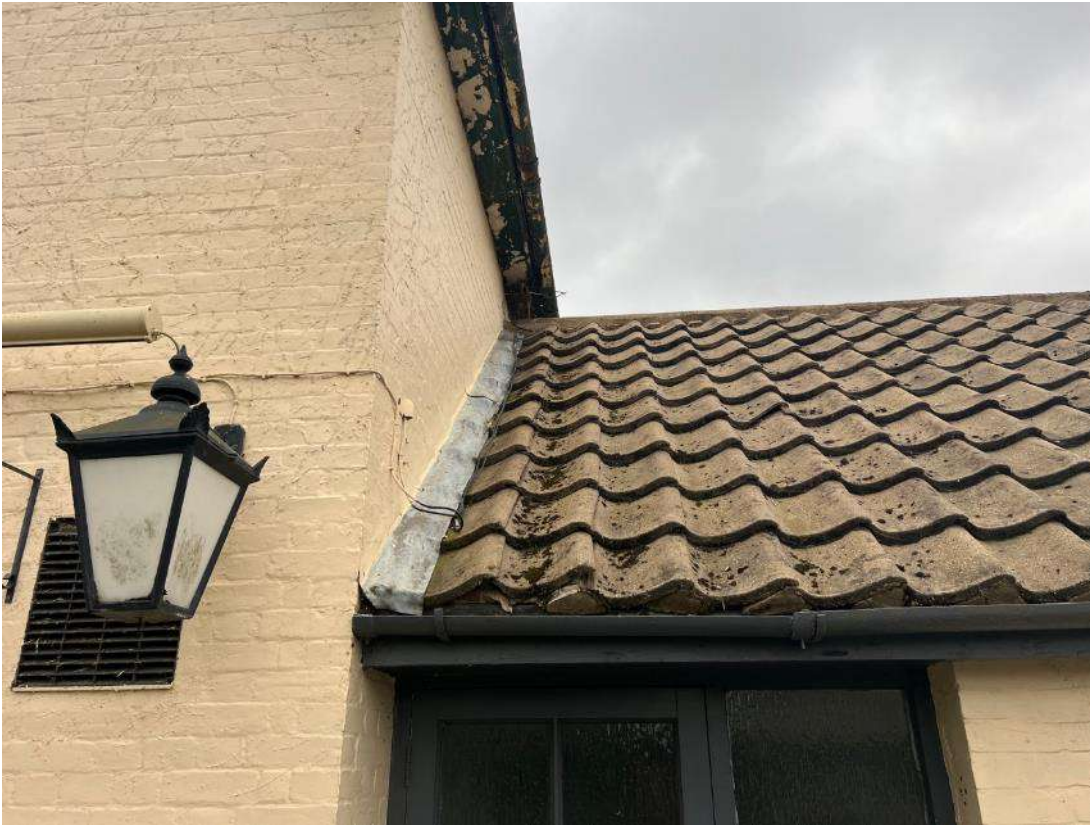
Photo 3. Interface between building section 1 and building section 2. Gap under lead flashing. Shows most of gaps under pantiles as being infilled with mortar. All gaps here, were cobwebbed.

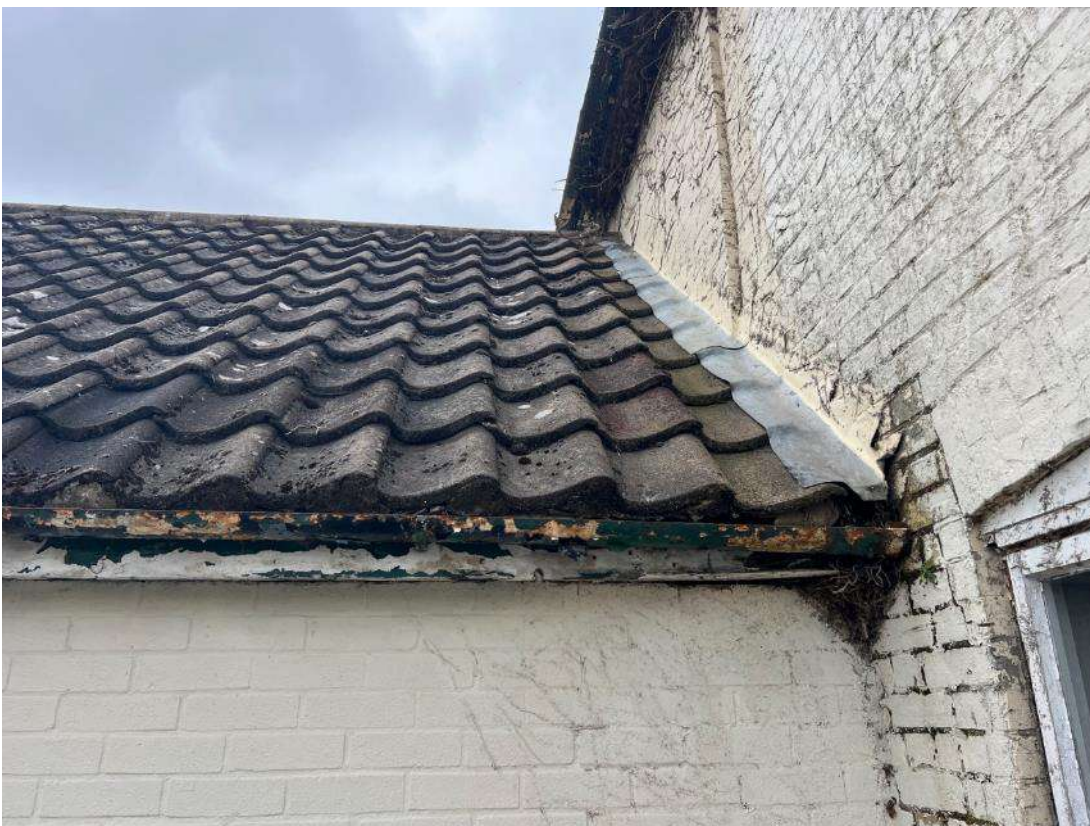
Photo 4. Interface between building section 1 and building section 2. Gap under lead flashing and damaged soffit/fascia. Evidence that this section of the building was recently covered in a climbing plant.

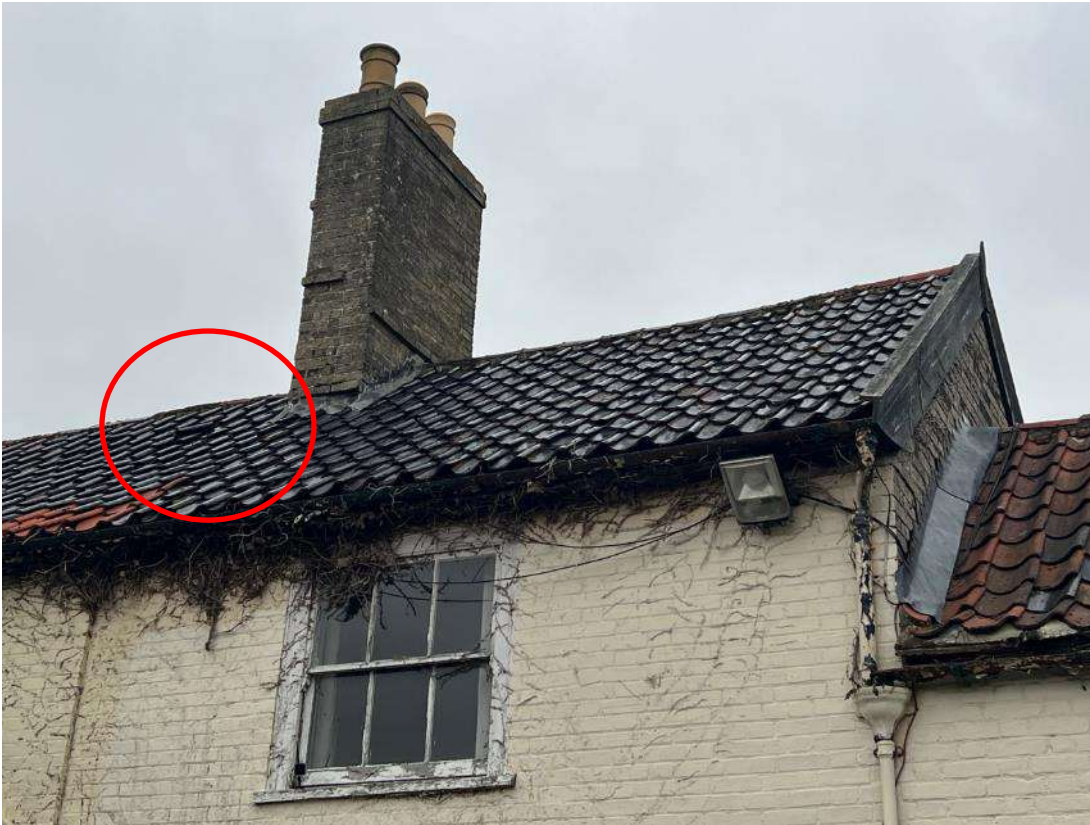
Photo 7. Building section 2 (ref B2A). Shows some slipped pan tiles as outlined in red. Evidence that this part of the building was covered with a climbing plant. This has caused damage to the fascia, soffit and under felt.

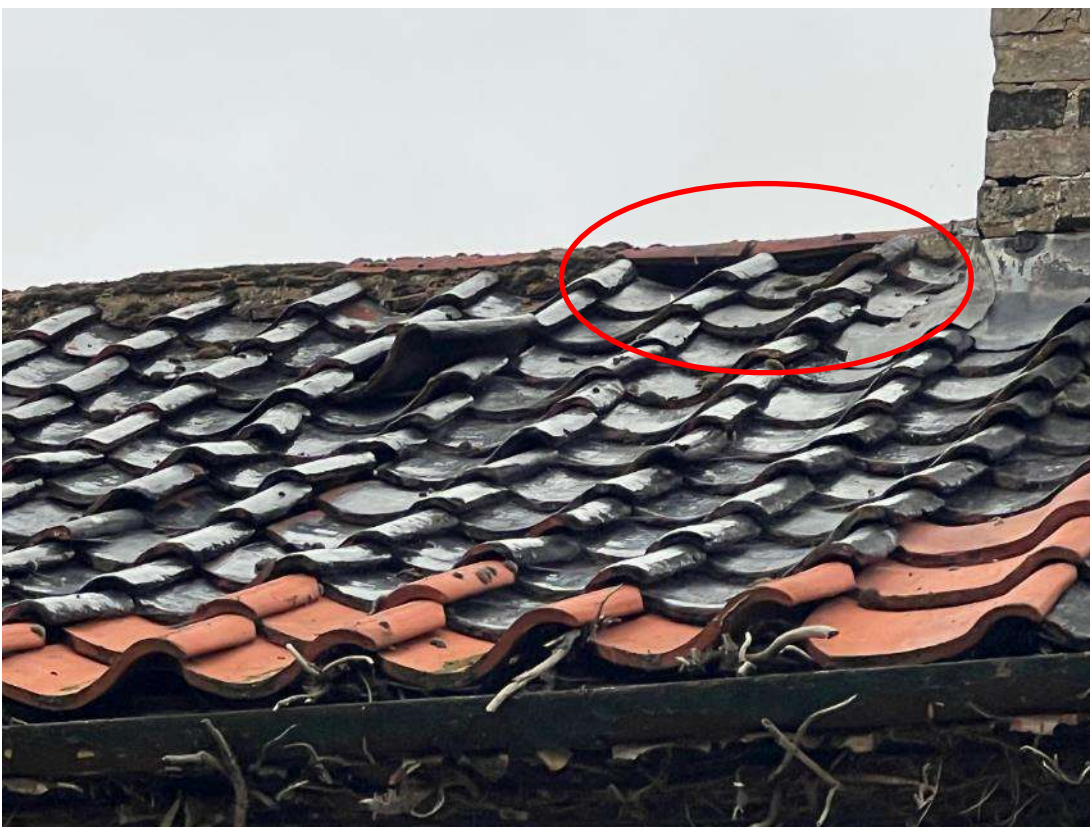
Photo 8. Building section 2 (ref B2A). Close up of roof as shown in photo 7. Shows missing mortar under ridge tiles as shown in red.

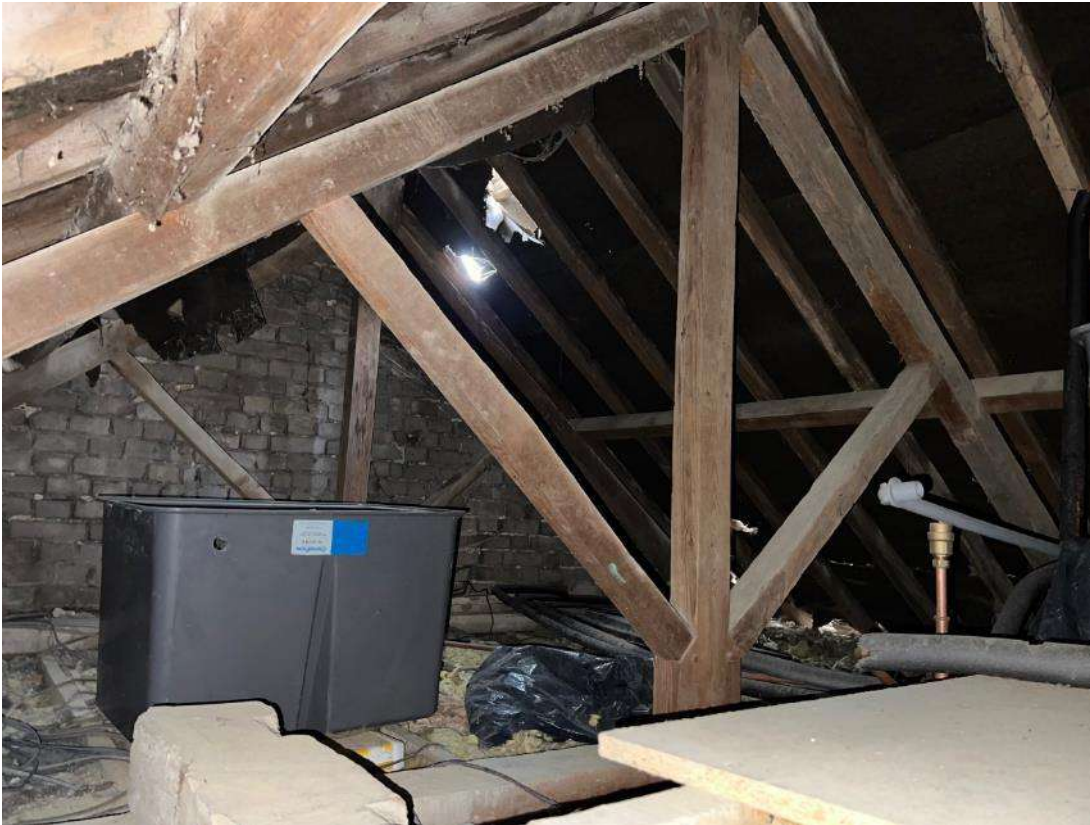
Photo 11. Building section 2 (ref B2A). Interval view of roof space. Shows damaged under felt and fire wall between section B2A and B3A. Taken from loft hatch.

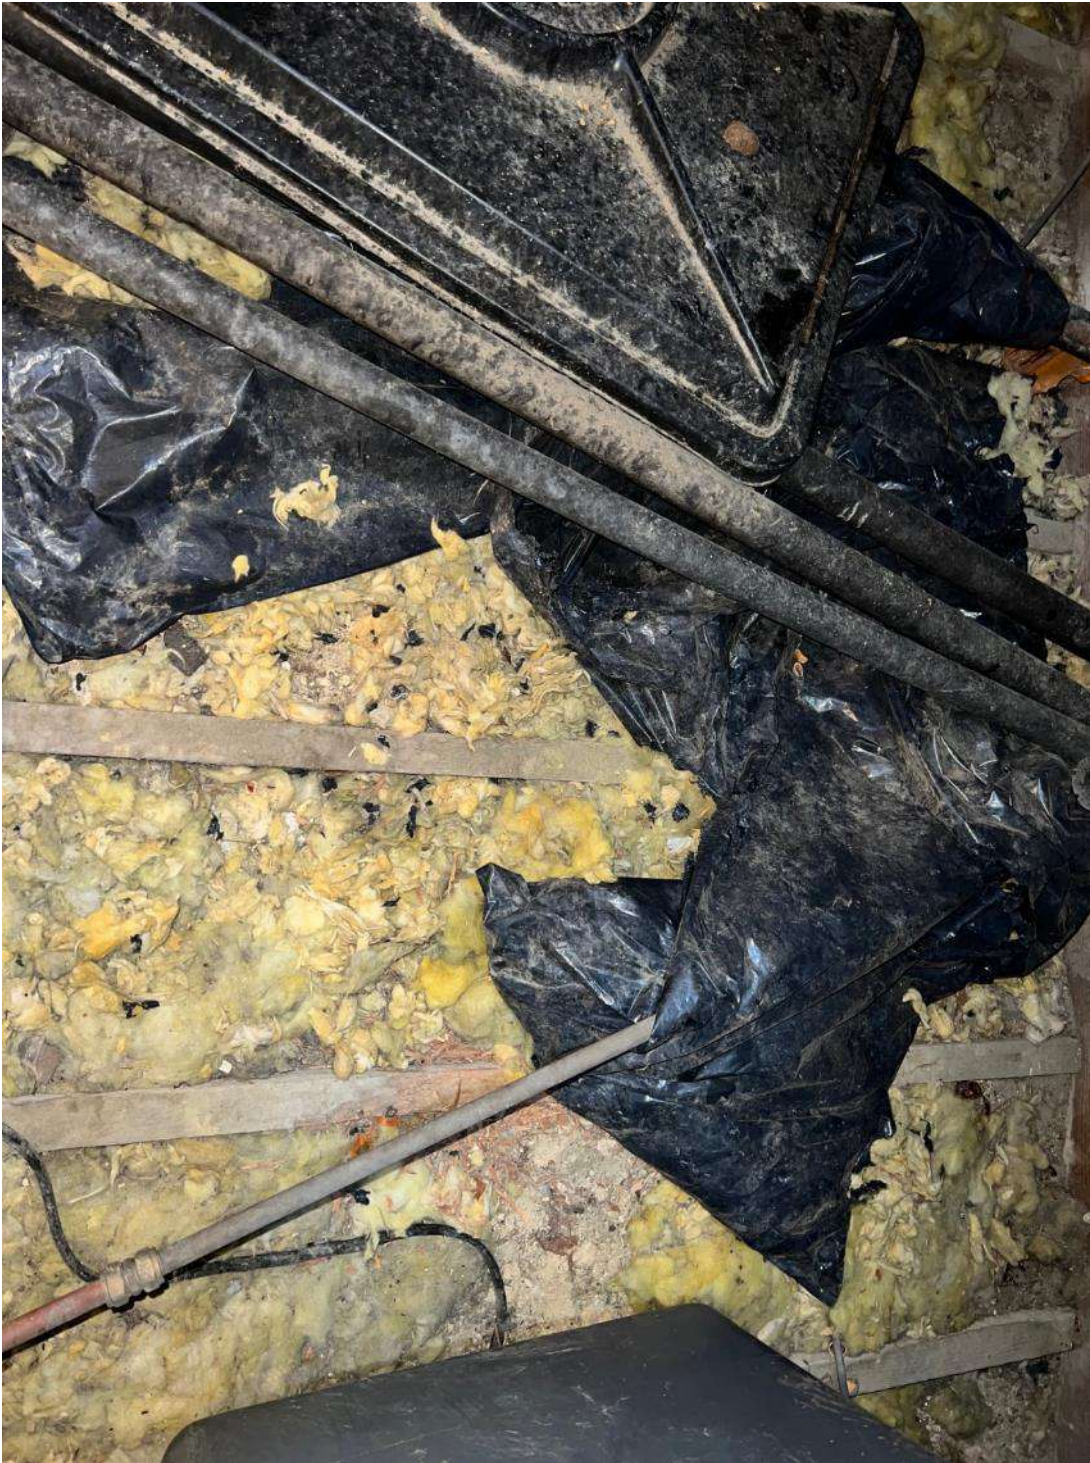
Photo 13. Building section 2 (ref B2A). Likely evidence of squirrel damage. A squirrel has been seen to enter the roof space of section 3 on multiple occasions during the survey visits.

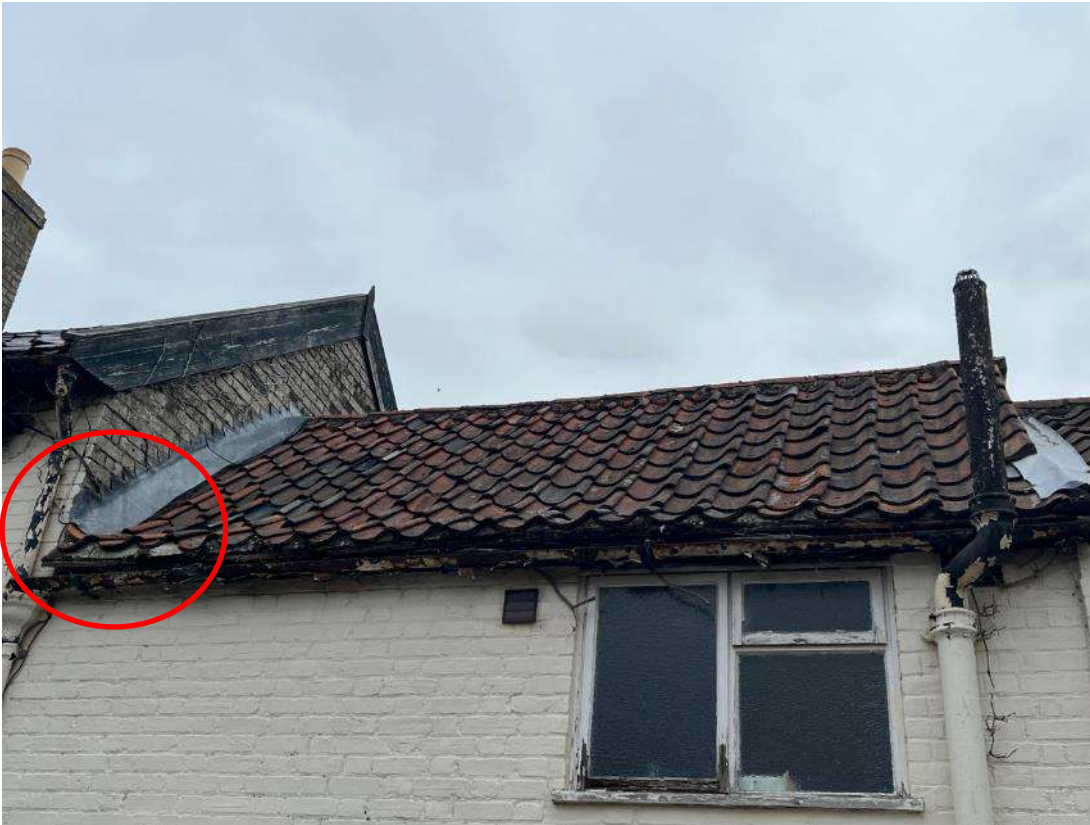
Photo 16. Building section 3 (ref B3A). Shows gap under lead flashing where section B3A adjoins section B2A as identified by red circle. Most of the gaps beneath the pan tiles are all mortar filled. West aspect.

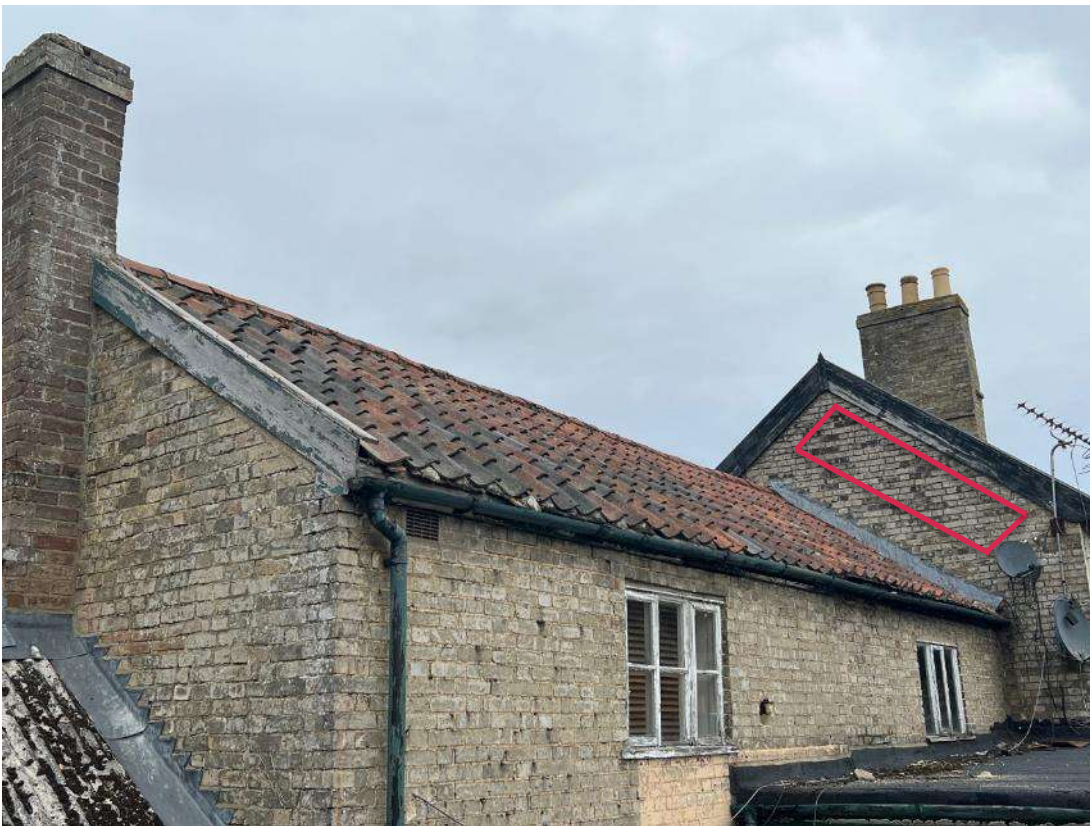
Photo 17. Building section 3 (ref B3A) adjoining section B2A. East aspect. Recommended location of bat boxes as outlined in red.

As a result of the proposed Scheme, there will likely be a loss of roosting features for bats. Therefore, three bat boxes are recommended to compensate for the losses. Compensation bat boxes must be installed prior to the commencement of construction works as required by the UK Bat Mitigation Guidelines¹⁰. Bat boxes should be wall mounted and of a type that does not encourage access by birds. Access apertures should be ≤17mm. Boxes should be installed at least 3m above the ground, ideally 4m above ground. An example box would be Beaumaris Woodstone Bat Box¹¹, which is ideal for crevice dwelling bats, such as pipistrelle bat species, which are the species most likely to use the tavern. Where it is not possible to install them onto the building, bat boxes can be installed on trees. An example box would be 2F Schwegler Bat Box¹².

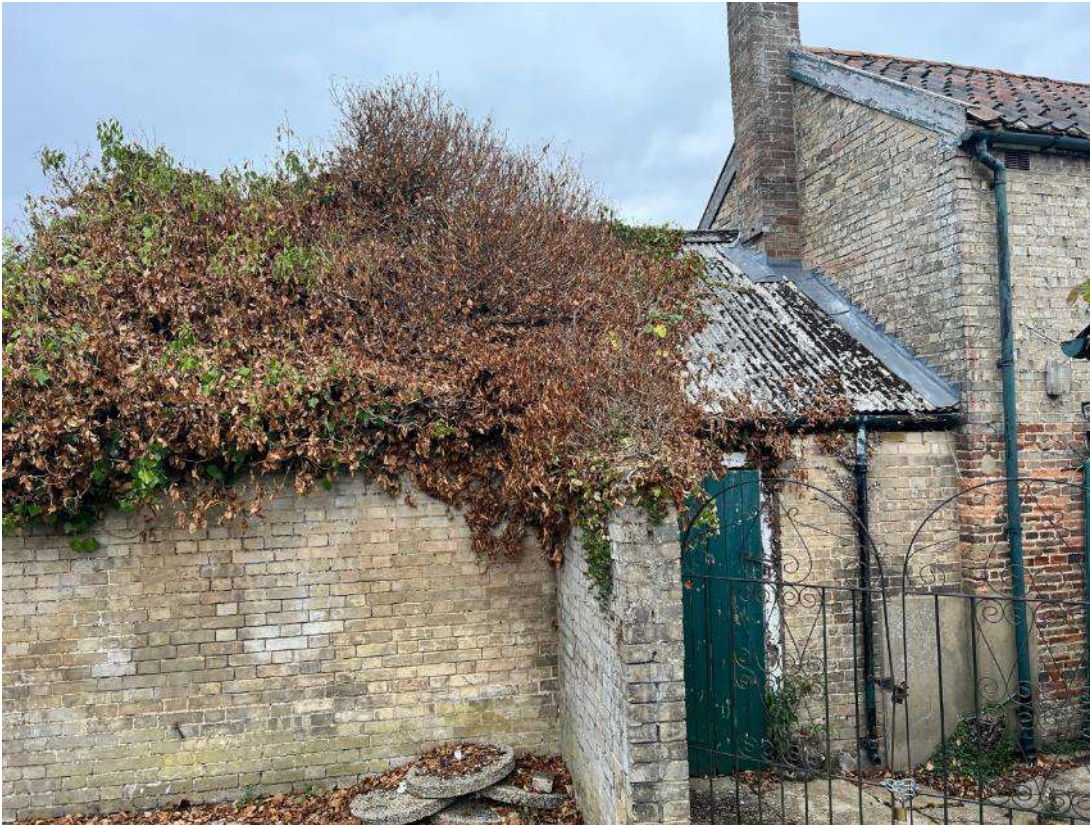
Photo 22. Building section 4 (ref B4). Shows section 4 adjoining section B3A. Most of the roof is covered in dense ivy growth (ref TN2).

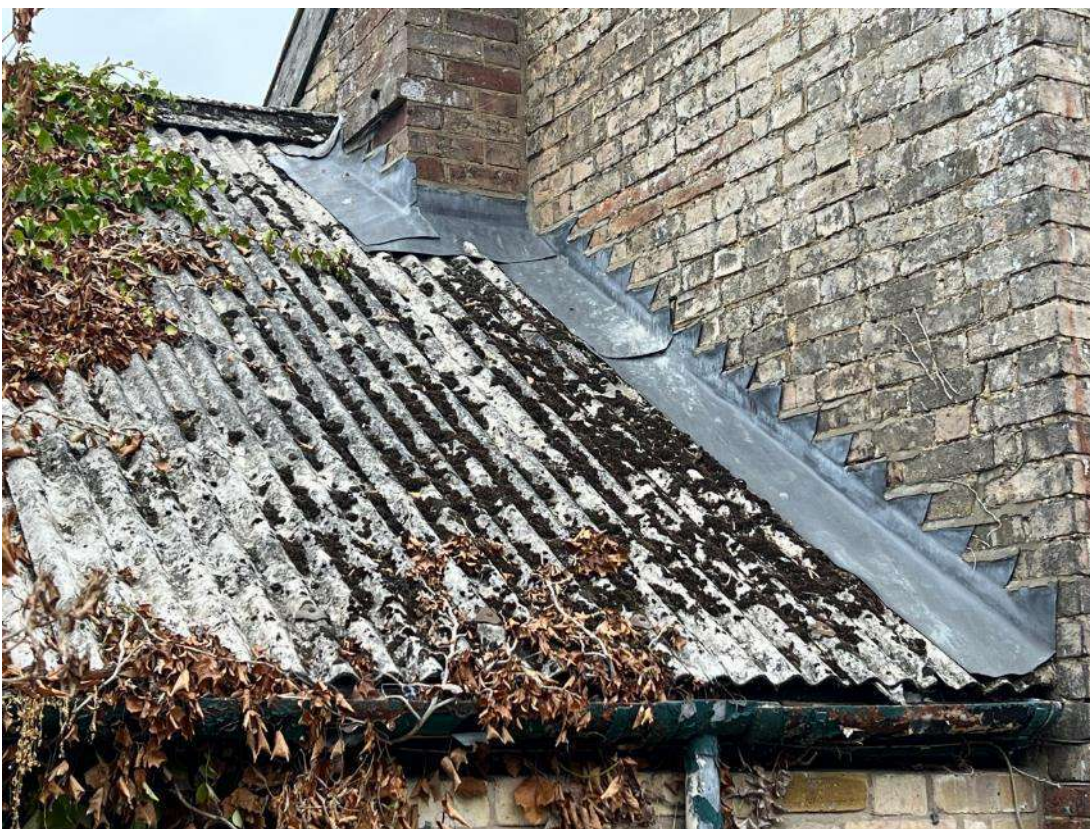
Photo 23. Building section 4 (ref B4). Shows gaps between roofing material and brick work. There are also gaps under corrugated ridge.

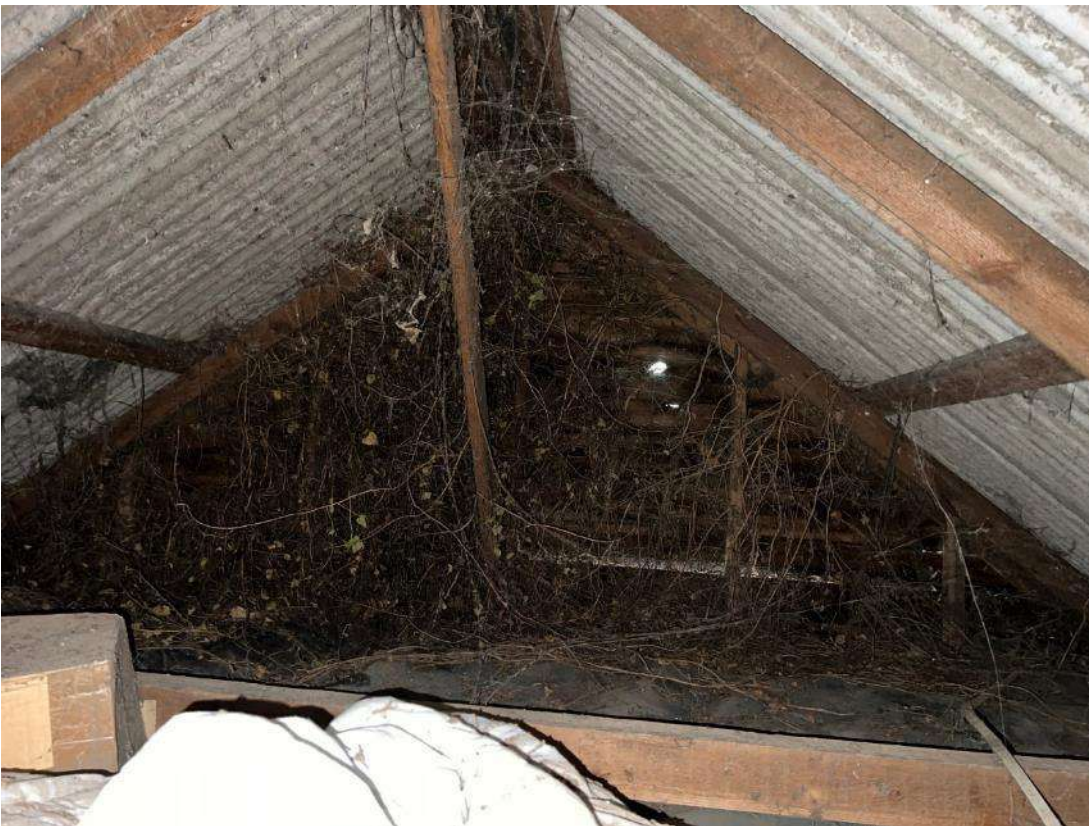
Photo 25. Building section 4 (ref B4). Internal view, looking towards southern gable. Shows dense ivy growth within roof space and exposed corrugated sheeted roof.

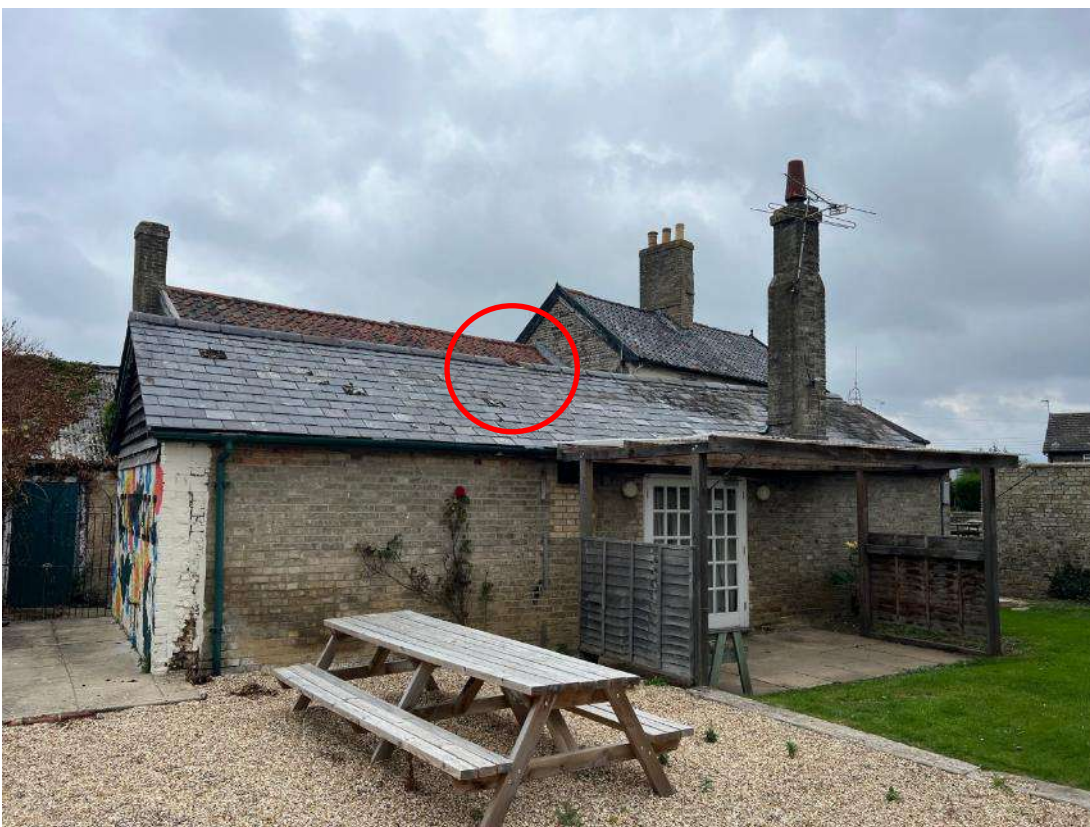
Photo 26. Building section 5. Shows eastern aspect of building along with pergola and patio area. Red circle outlines damaged ridge tile.

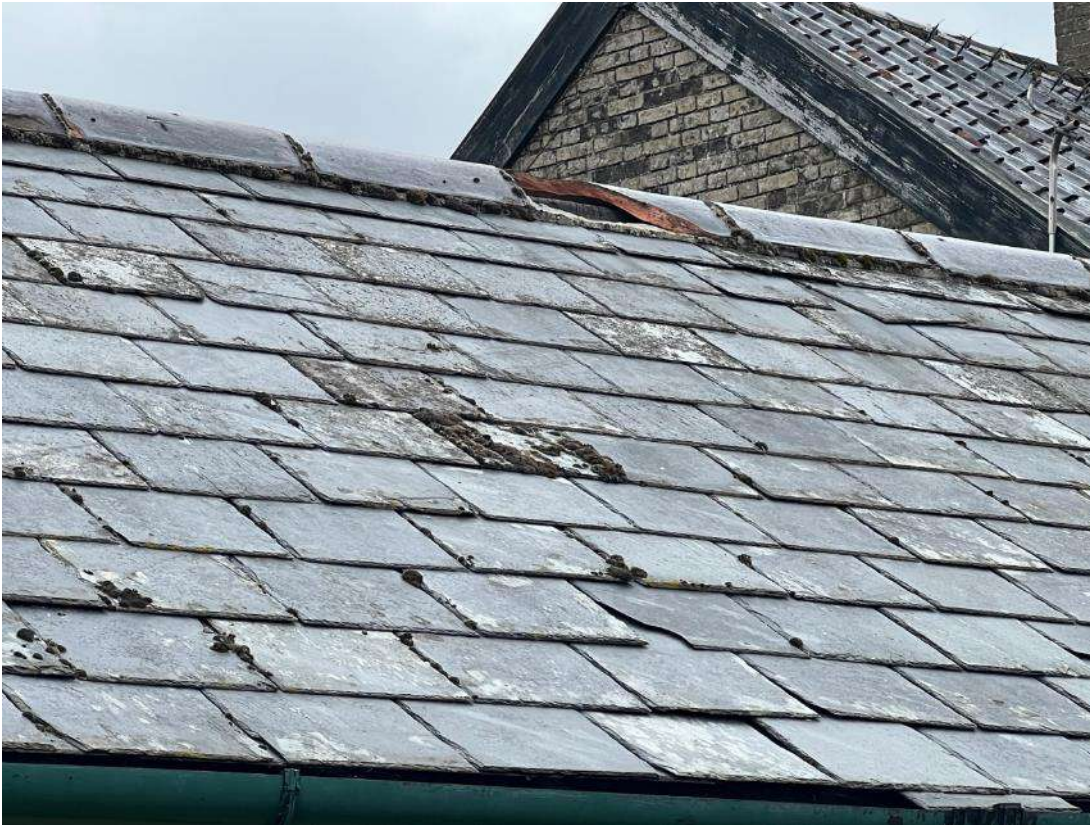
Photo 27. Building section 5. Shows close up of damaged ridge tile identified in photo 26.

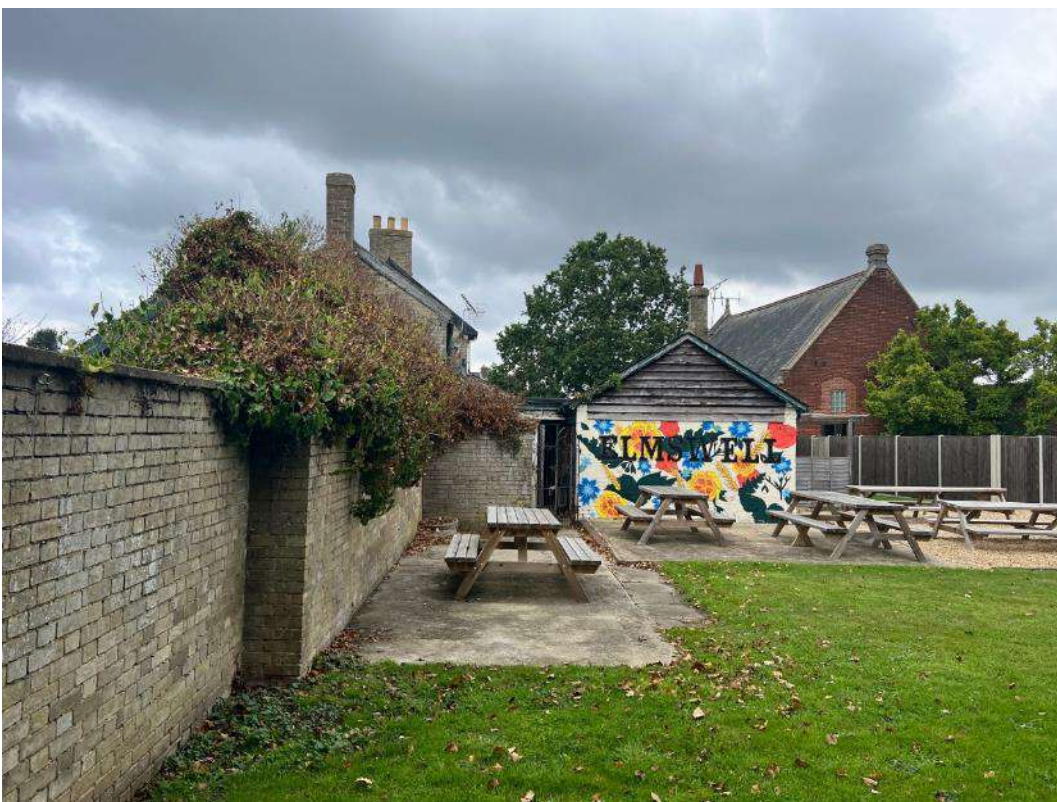
Photo 40. Taken alongside internal brick wall boundary to south of garden. Shows dense ivy growth at rear of section 4 (ref TN2).
