Lindenwood
Chineham Business Park
Crockford Lane
Basingstoke
Hampshire
RG24 8QY

Preliminary Bat Roost Assessment

Ref: R3319/a

December 2022

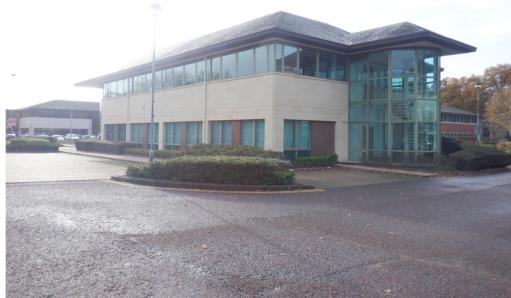
- 4.2.1** The southeast commercial building was primarily used as an office space with blockwork walls, large windows on the second storey, a hipped roof, and a flat roof within the centre (**Photographs 1 & 2**).

1. Front of commercial Building 1, viewed from the northeast.

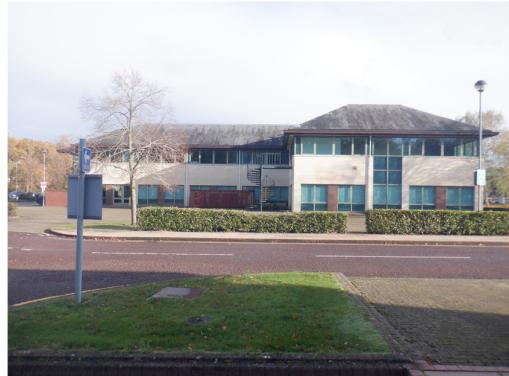
2. Rear of commercial Building 1, viewed from the west.

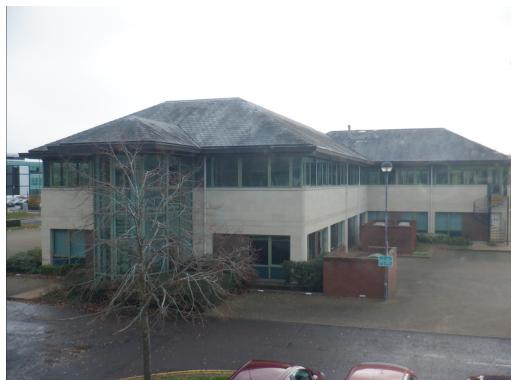
- 4.2.2** The hipped roof was covered with flat slate tiles which were occasionally missing on the northern side elevation; however, the resulting gaps were superficial (**Photograph 3; Target note 1**). Furthermore, whilst hip tiles were occasionally missing or had slipped on the western side elevation, underlying lead flashing meant that no crevices were available (**Photograph 4; Target notes 2 & 3**). The lead flashing that joined the hipped section to the metal flat roof was tight along the roof tiles and around the southern flue pipes (**Photographs 5 & 6; Target notes 4 & 5**). In addition, the edge of the roof was capped off with metal underneath the roof tiles which was sealed tightly against the timber soffit (**Photograph 7; Target note 6**). The timber soffit that ran around the entirety of the building was mostly intact and tight to the wall, however, an open gap was situated within the soffit on the western side elevation which was closely inspected with a high-powered torch and showed no signs of use by bats (**Photograph 8; Target notes 7 & 8**).

3. Occasionally missing slate roof tiles on Building 1 with superficial crevices, viewed from the north.

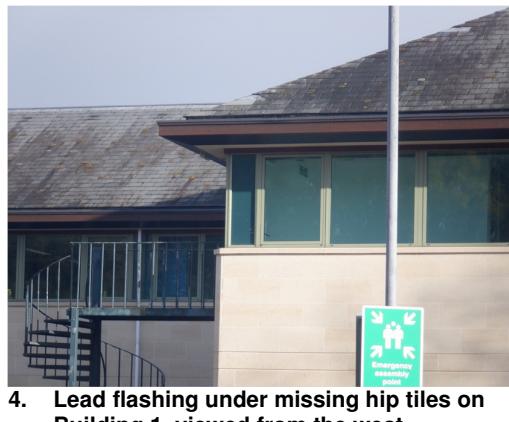
4. Lead flashing under missing hip tiles on Building 1, viewed from the west.

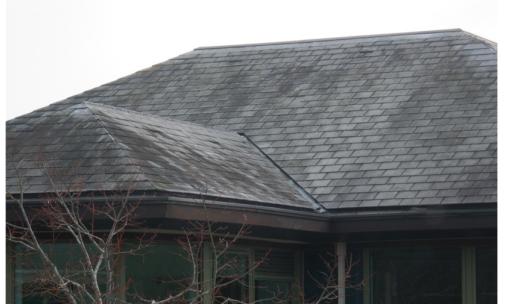
5. Lead flashing between hipped roof and flat roof tight to the slate tiles on Building 1, viewed from the north.

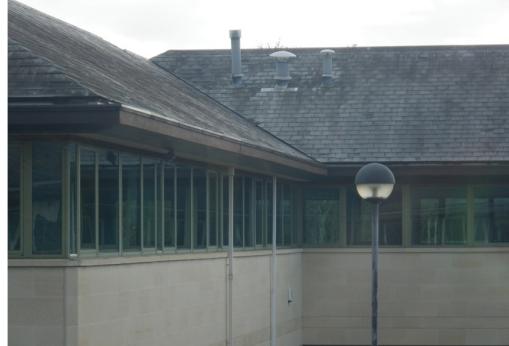
6. Tight lead flashing under flue pipes on Building 1, viewed from the north.

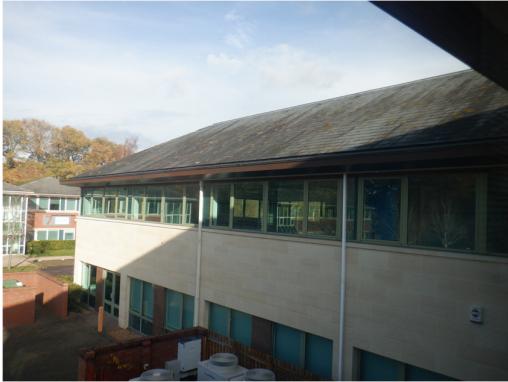
7. Edge of the roof capped off with an underlying metal plate on Building 1, viewed from the southwest.

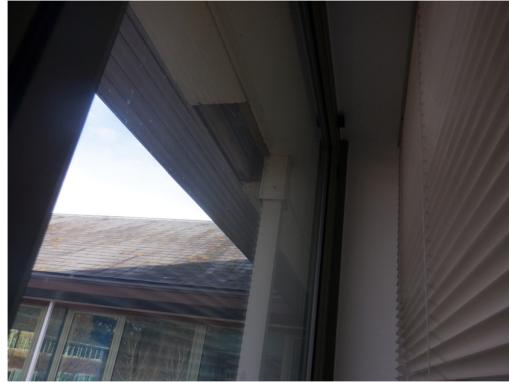
8. Open gap within the timber soffit on Building 1, viewed from the west.

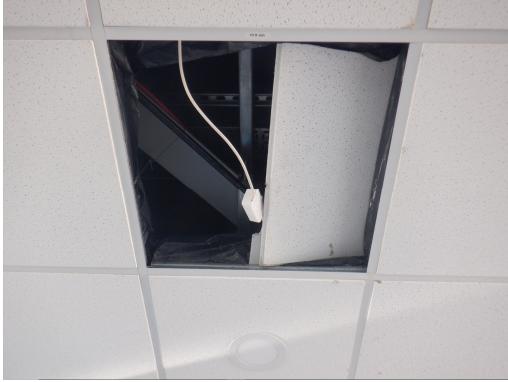
- 4.3.1** The commercial building consisted of a false ceiling which was occasionally damaged to allow partial access to the void which covered the footprint of the building (**Photograph 9; Target note 9**).

9. Damaged section within the false ceiling of Building 1, allowing partial access to the void above.

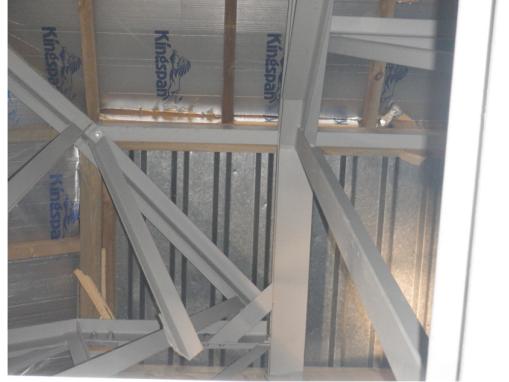
4.3.2 The hipped section of the roof was lined with foil-covered insulation boards which were tight to the central metal flat roof and timbers (**Photograph 10; Target note 10**).

10. Hipped section of Building 1 lined with foil-covered insulation boards.

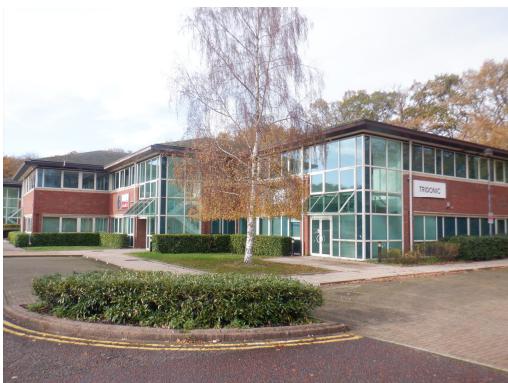
4.4.1 The southwest, west, and northern commercial buildings were all very similar in design with the same features observed during the external survey. All buildings were primarily used as office spaces with modern cavity walls, large windows on both storeys and hipped roofs (**Photograph 11**). The three buildings in the northeast were attached (**Photograph 12**).

11. Front of the attached northeast buildings (Buildings 5, 6 & 7), viewed from the southeast.

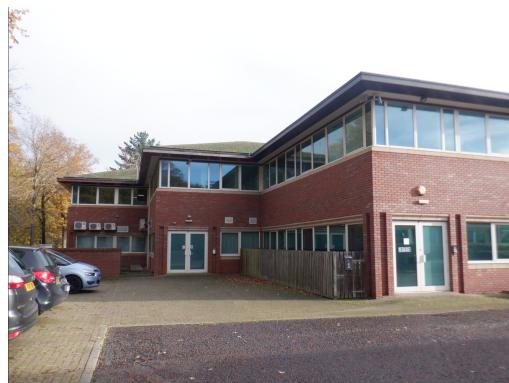
12. Rear of the attached northeast buildings (Buildings 5, 6 & 7), viewed from the west.

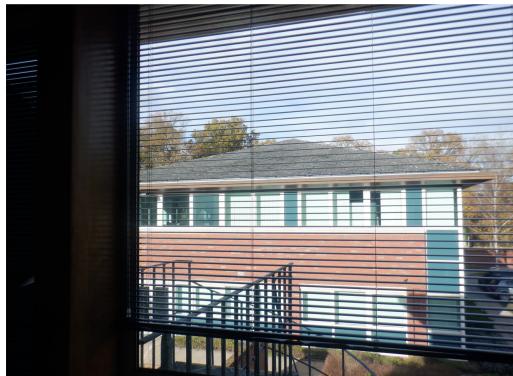
4.4.2 The hipped roofs on all buildings were covered with flat slate tiles which were tight and covered in moss on all elevations (**Photograph 13; Target note 11**). Furthermore, the ridge and hip tiles were also all in place and tight to the flat slate tiles (**Photograph 14; Target note 12**). A timber soffit ran around all buildings with a black mesh material between the soffit and the wall (**Photographs 15 & 16; Target notes 13**). With that said, an open gap was situated within the soffit on the northern building (Building 4) which was closely inspected with a high-powered torch and seen to be unsuitable for use and access by bats (**Photograph 17; Target note 14**). Bird droppings were commonly observed on the second storey windowsills on all buildings (**Target note 15**).

13. Flat slate roof tiles sealed to the roof on Building 4, viewed from the east.

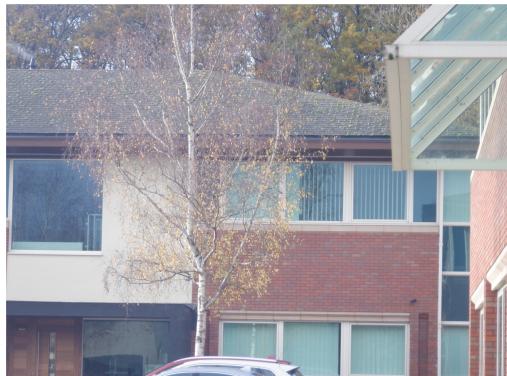
14. Ridge and hip tiles tight to the adjoining slate roof tiles, viewed on Building 3 from the east.

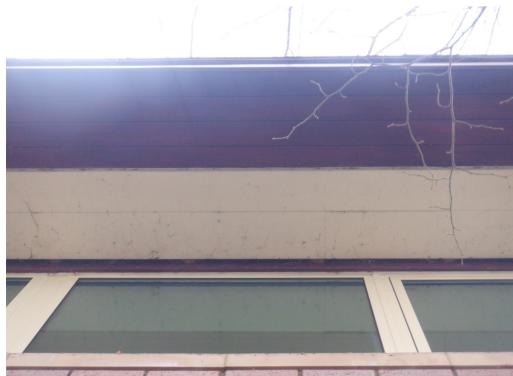
15. Black mesh material between the timber soffit and the wall, viewed on Building 4 from the north.

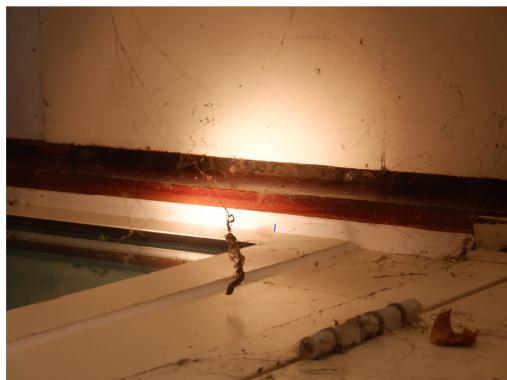
16. Black mesh material between the timber soffit and the wall, viewed on Building 4 from the north.

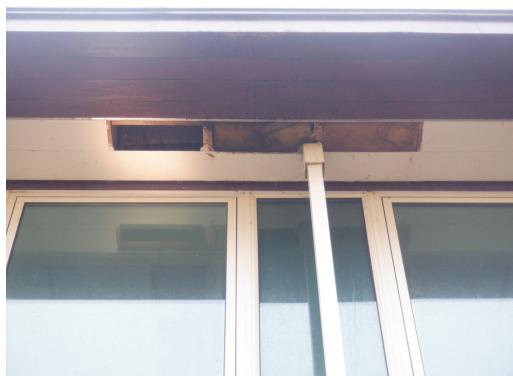
17. Open gap within the timber soffit of Building 4, viewed from the north.

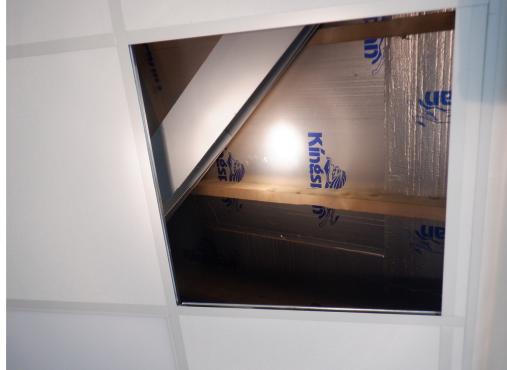
4.5.1 Whilst the western commercial building (Building 3) was inaccessible during the internal survey, all other buildings consisted of false ceilings which were occasionally damaged to allow partial access into the void (**Target note 16**). The voids were lined with foil-covered insulation boards which were tight to the visible timbers (**Photograph 18; Target note 17**).

18. Damaged section within the false ceiling of Building 6 allowing partial access to the void above where foil-covered insulation boards are tight to the timbers.
