Arboricultural Consultancy for Lloyds Bank

Insured	Mr Richard Hammond	Address	55 Gellatly Road, New Cross, SE14 5TU		
Client	Subsidence Management Services	Contact	Ian Domigan	Claim No.	IFS-LBG-SUB-22-0102990
ES Ref	SA-250953	Consultant	Kirk Thompson		
Report Date	18/11/2022

55 Gellatly Road, New Cross, SE14 5TU

TP/BH1 Foundation Detail and Borehole Log

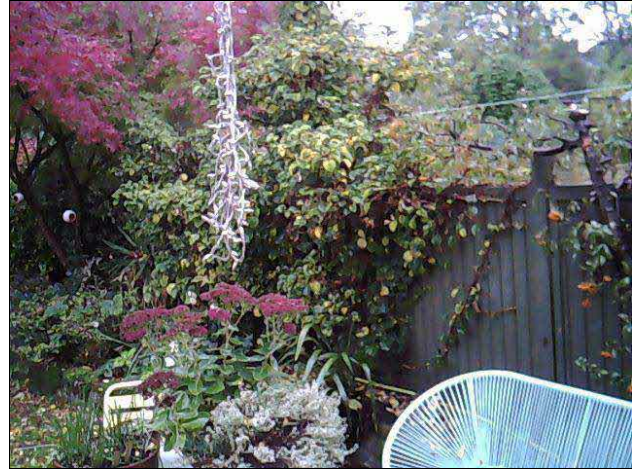
C1 - Hydrangea

Tree No.	Species	Age Cat	Approx. Height (m)	Distance to Building (m) *	Ownership	Action	Requirement
C1	Hydrangea	1	2.5	5	C - Insured	No action	No works.
C2	Passion Flower	1	1.3	0.1	C - Insured	Action to avoid future risk	Maintain at broadly current dimensions by way of regular pruning.
C3	Wisteria	1	3.5	0.1	C - Insured	Action to avoid future risk	Maintain at broadly current dimensions by way of regular pruning.
S1	Pyracantha	1	2	2.5	C - Insured	Action to avoid future risk	Maintain at broadly current dimensions by way of regular pruning.
T2	Acer	1	4	8.5	C - Insured	Action to avoid future risk	Maintain below 6.5m max height / spread by way of regular pruning.
T3	Birch	1	14.5	11.5	C - Insured	Action to avoid future risk	Maintain at broadly current dimensions by way of regular pruning.
T5	Pittosporum	1	6	11	A - Third Party	No action	No works.

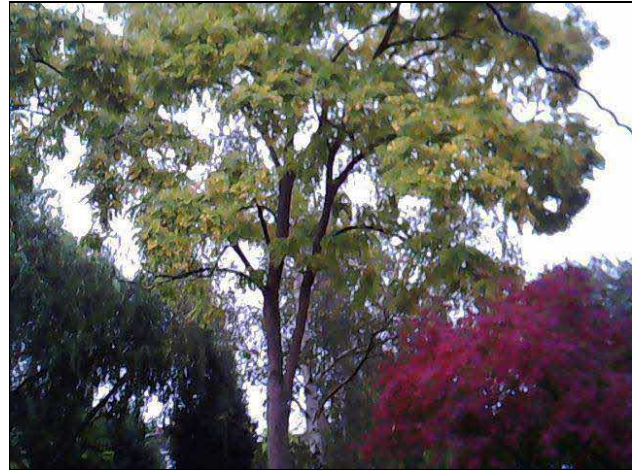
T1 - False Acacia

With due regards to species profile, size and proximity, T1 (False Acacia) and T4 (Willow (Contorted)) are considered the dominant features proximate to the focal area of movement and accordingly, where vegetation is confirmed as being causal, we have identified them as the primary cause of the current subsidence damage.

The size and proximity of the above vegetation is consistent with the advised location of damage and it is our opinion, on balance of probability, that roots from the above vegetation will be in proximity to the footings of the insured property.

Tree No.	Species	Age Cat	Approx. Height (m)	Distance to Building (m) *	Ownership	Action	Requirement
T1	False Acacia	1	13.5	9	C - Insured	Remove	Remove close to ground level and treat stump to inhibit regrowth.
T4	Willow (Contorted)	1	13	15.5	A - Third Party	Remove	Remove close to ground level and treat stump to inhibit regrowth.

Consequently, we have advocated the complete removal of T1 (False Acacia) and T4 (Willow (Contorted)) as it will offer the most certain arboricultural solution likely to restore long-term stability.

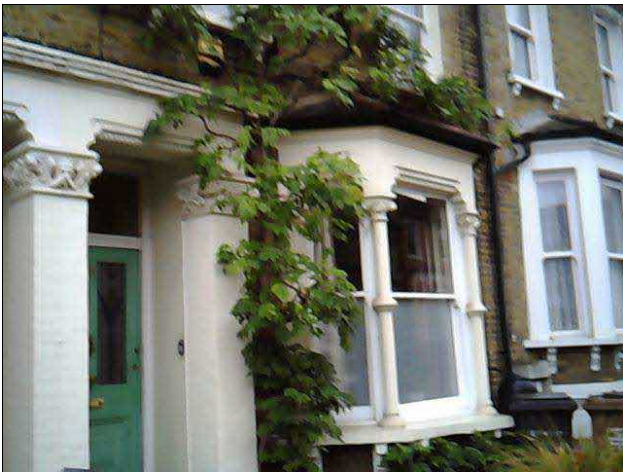
C3 - Wisteria

Leguminosae spp. include laburnum, Robinia (false acacia or locust), broom, the pagoda tree and the climber wisteria.

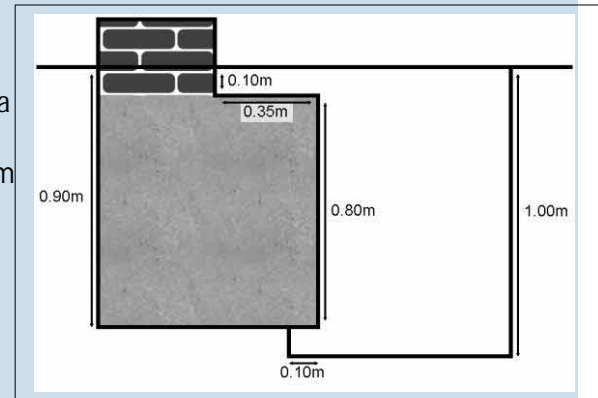
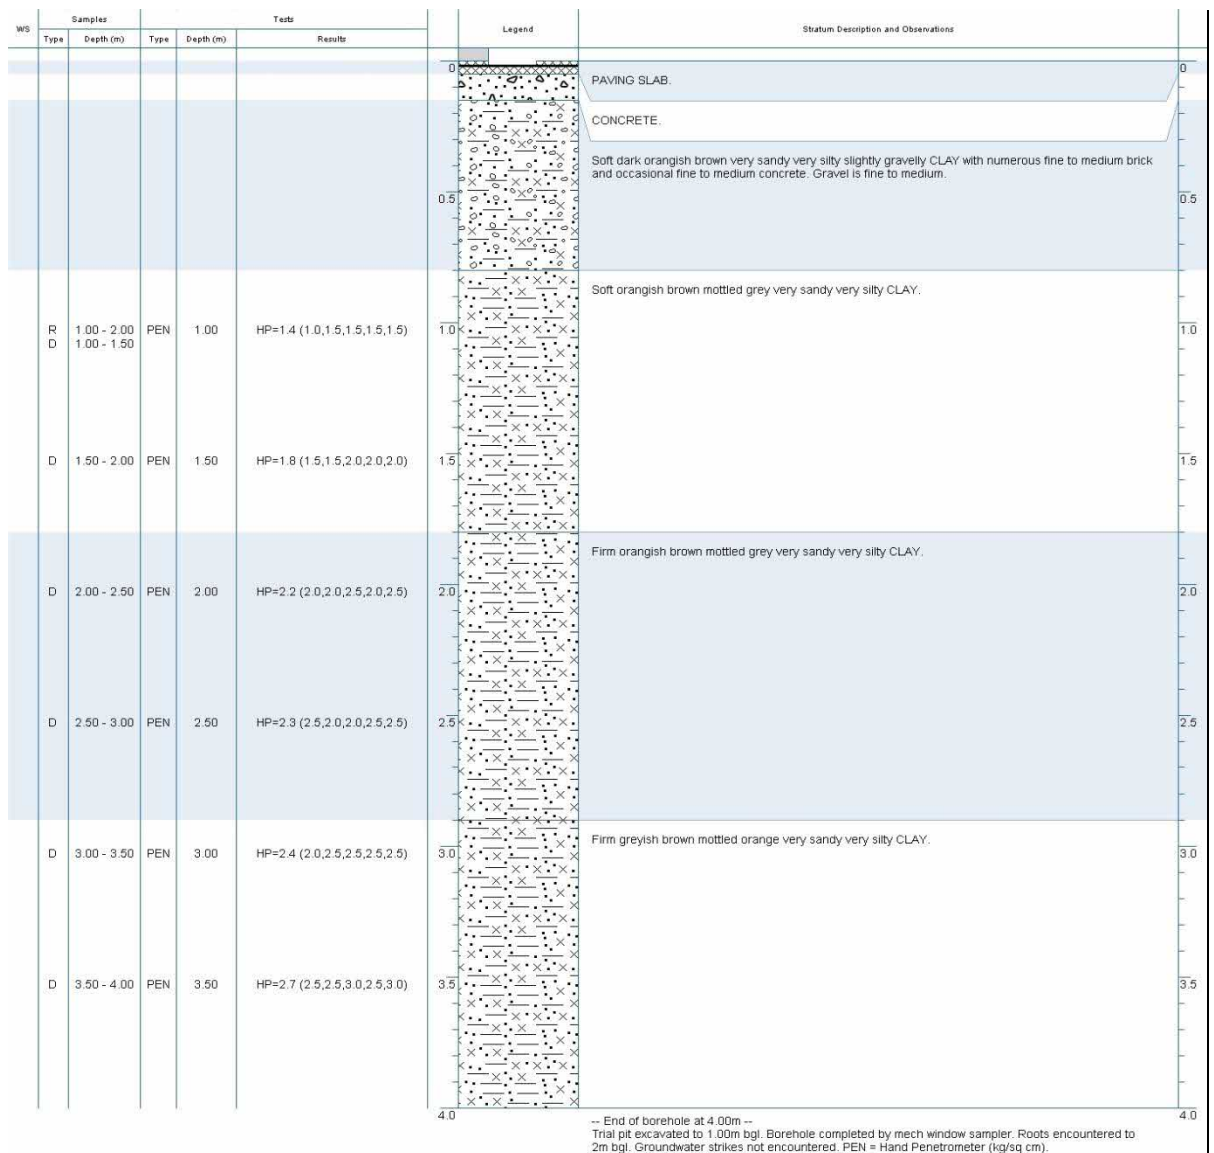
Addition foundation comprised of brick wall to 100mm bgl, bearing on concrete to 900mm bgl, with a total projection of 350mm from the elevation. Underside of foundation (USF) was exposed to 100mm back from the face of the foundation and probed 500mm back from the face of the foundation.

Addition foundation was exposed and the underside of foundation (USF) recorded to be 0.9m bgl (TP/BH 1).

Roots encountered to 2m bgl (TP/BH 1).
