Tree Condition Report

**The Old Cemetery, Cross Lane, Bodmin and the
New Cemetery, Helland Road, Bodmin.
(September 2023)**

Prepared for; Bodmin Town Council

Date: September 2023

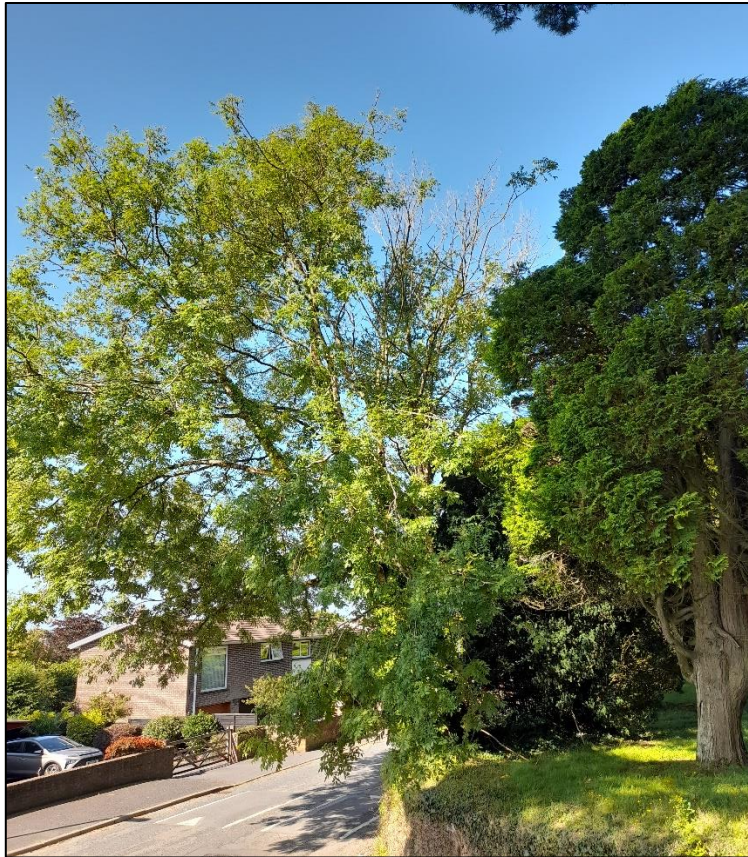
2. Ash Dieback (*Hymenoscyphus fraxineus*) is now common in the ash stock of the cemetery; (T106), (T108), (T172), (T174), (T175), (T181), (T185) and (T185a) and in Groups; (G3), (G5), (G9), (G13). This varies from early stages of infection, with 0-25% of crown dieback to more significant infections of 75%+ of the crown. The crown dieback can increase quite rapidly. Felling of all but the smaller stock, is recommended, to remove any possible risk from falling dead branches, etc. to the park users and staff. (G9) is recommended for removal as soon as possible, given its location close to the road and to parked cars and pavements.

Fig 1: Significant Ash Dieback in Group (G9), Old cemetery.

173	Western Red Cedar (<i>Thuja plicata</i>)	1	17.5	600	5	Mature	Good	Dead patches throughout whole crown. Possible thuja blight or corynium canker	Condition improving
G9	Common Ash (<i>Fraxinus excelsior</i>)	1	15	250	3	Young	Good	Western 4 stems 50-75% crown dieback ADB.	Fell four stems aasap. Remaining 2trees monitor condition

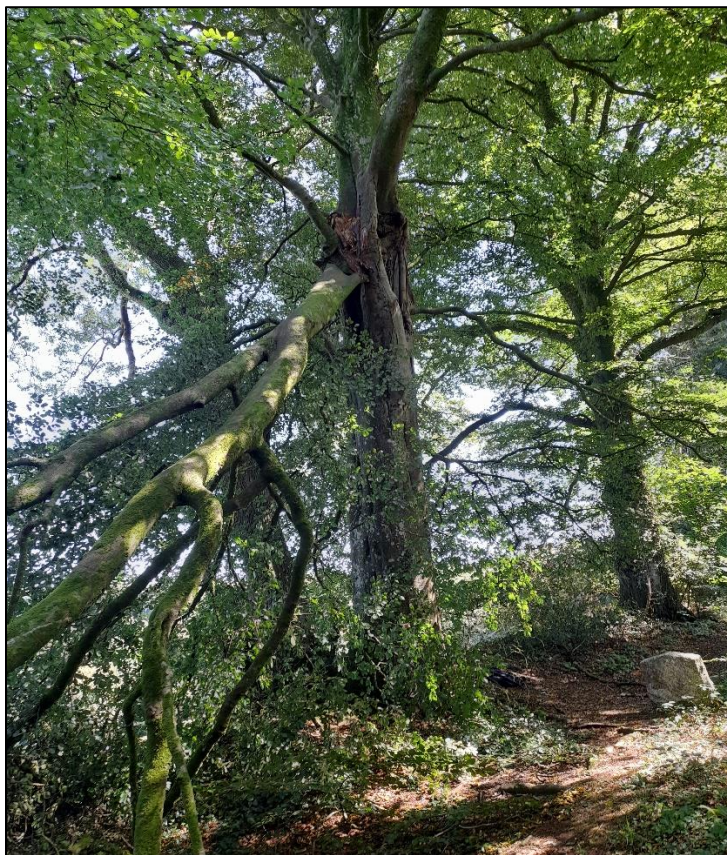
3. Several of the large, mature beech trees in the cemetery have sustained some significant storm damage over the summer; (T148), (T169), (T170) and (T189). This may be due to their similar ages, sizes and maturity. This species in the tree stock will need to be carefully monitored, in the future, for structural stability,

Fig 2: Large split-out branch on beech (T148)

although fork weakness/decay can often be very difficult to assess easily from the ground, given the characteristic 'tight nature' of many forks in a mature beech. Beech (T148) has quite recently lost a large limb/branch – now propped up between the ground and the tree. This should be carefully dismantled. A climbing inspection to assess the remaining stem at the split-out point is recommended, with a probable reduction/pollard to heavily reduce future risk from collapse. (T169) has also lost a large limb and is also recommended for a heavy reduction as it also has significant Ganoderma infection in sections of its main stem. (T189) growing over the road between the two cemeteries has a historical split out of a large limb, leaving some extended branches growing over the road. These are recommended for reduction to reduce the possibility of storm damage/split out in the future.

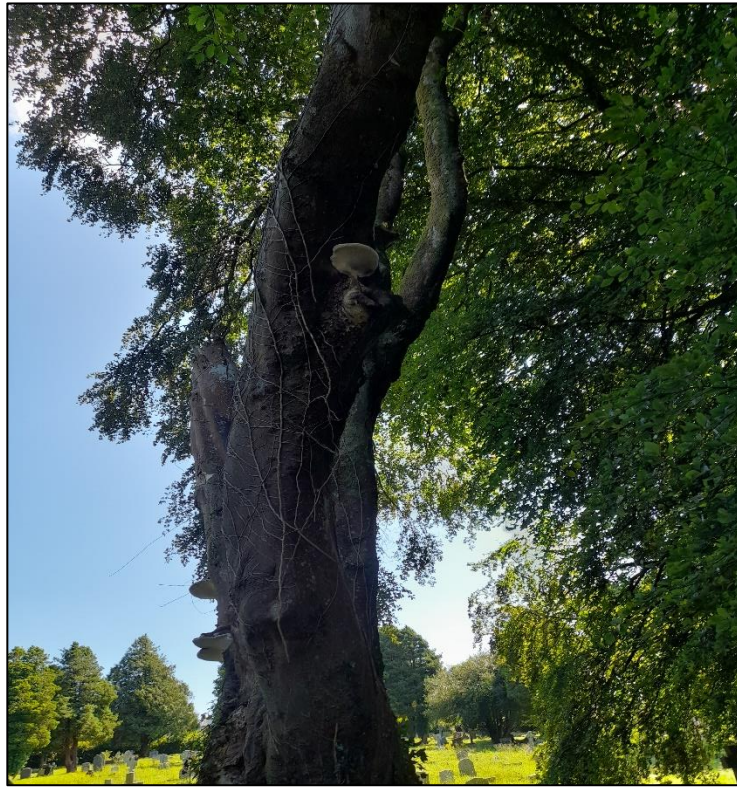
Fig 3: Ganoderma brackets on storm damaged beech (T169) – recommended for pollarding.

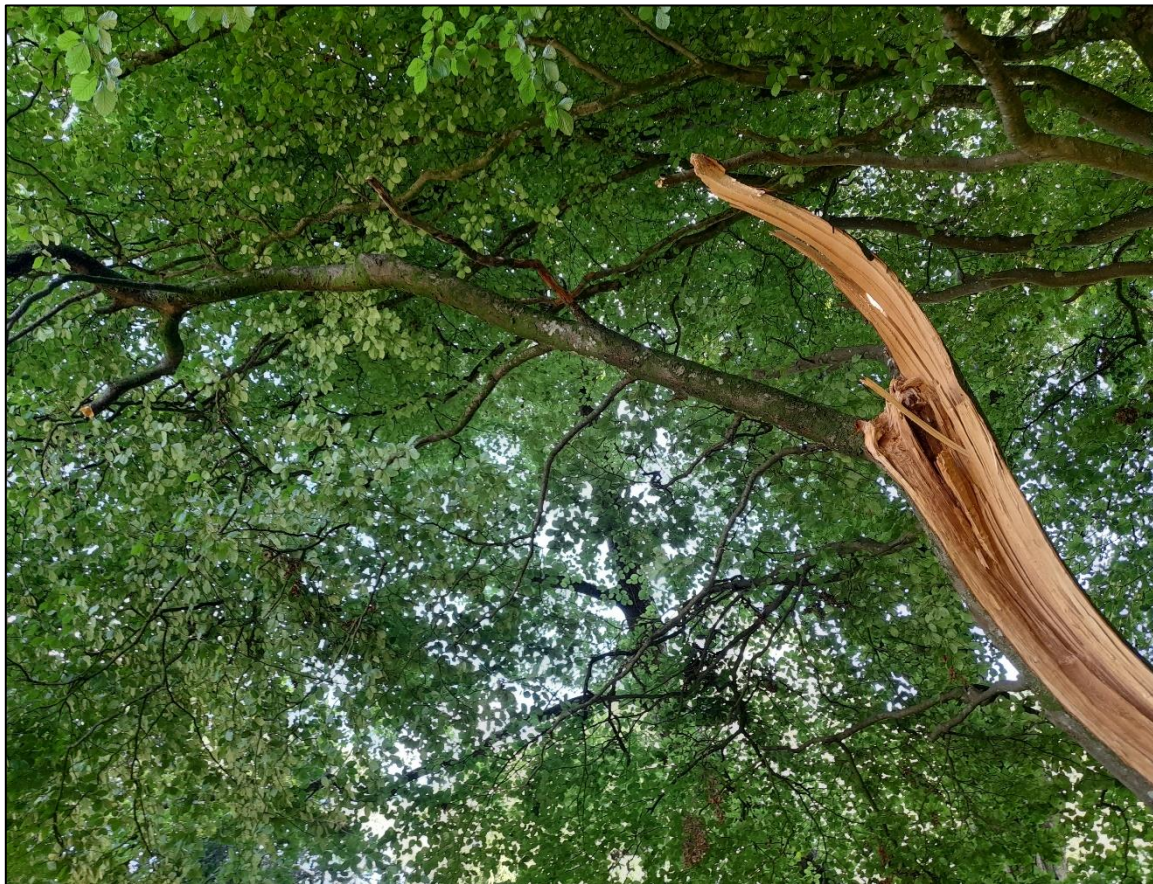
Fig 4: Damaged limb on beech (T170) – Recommended for removal.

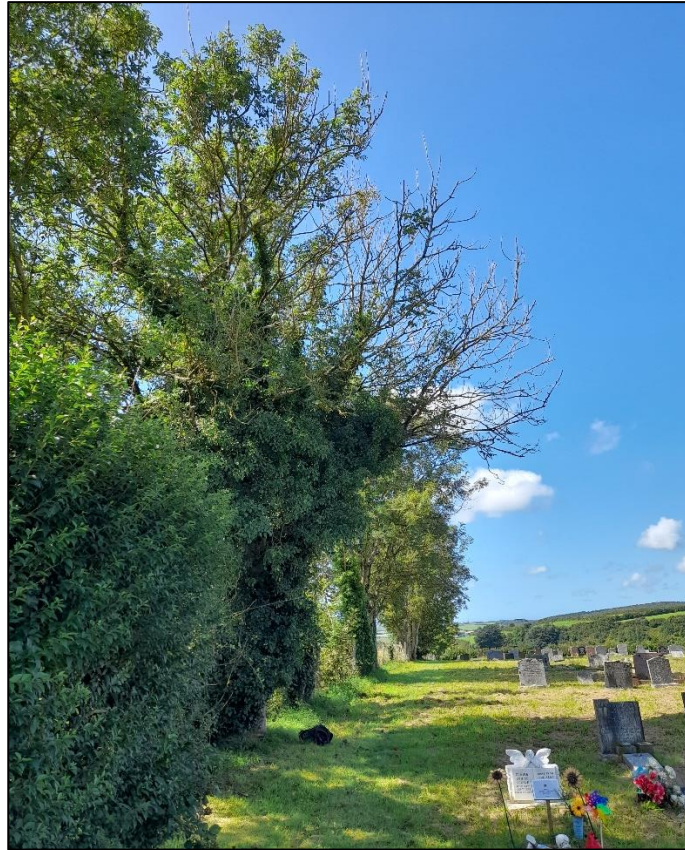
4. There is again Ash Dieback (*Hymenoscyphus fraxineus*) in ash trees in Groups (G16) and (G23). This varies from early stages of infection, with 0-25% of crown dieback to more significant infections of 75%+ of the crown. The crown dieback can increase quite rapidly. Monitoring of the ash stock in (G16) is recommended, given their location close to the entrance and above the road. The Ash of (G23) are smaller and on the southern boundary and so possible risk is low and seen as currently with acceptable limits. (T901) in this group is close to the graves and is recommended for removal.

Fig 5: Significant ash dieback in ash (T901) in New Cemetery

901	Common Ash (<i>Fraxinus excelsior</i>)	1	8	400	3	Semi-mature	Poor	50% ash dieback. Close to graves	Fell (3mths)

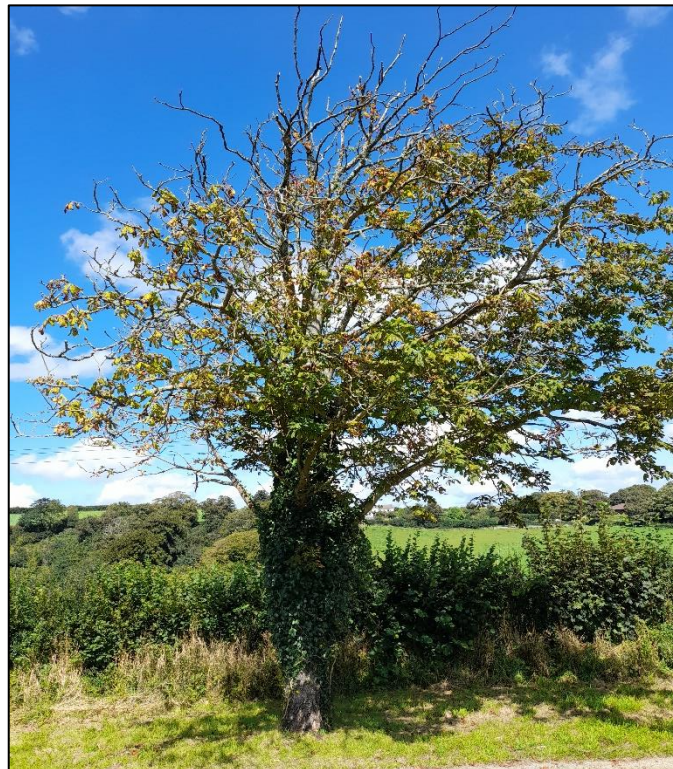
3. Similarly, the Horse chestnut trees of (G18), and especially (T194), have signs of bleeding canker of Horse chestnut (*Pseudomonas syringae* pv. *aesculi*) e.g., cracked bark and dieback in crowns. (T194) is now in poor condition and an assessment of the cemetery usage in this area will decide whether the tree now needs to be removed

Fig 6: Infected Horse chestnut (T194) – assess risks to inform removal.
