Failand Hill Farm
Horse Race Lane, Failand
Bristol BS8 3TY

Client: Pippa Stables
Date: Oct 2023
Project No: 120055
Rev: 0
Author: Mahara Booshanam BE(Hons) CEng MStructE MICE
Checked: Andrew Griffiths BEng(Hons) CEng FICE

EXECUTIVE SUMMARY

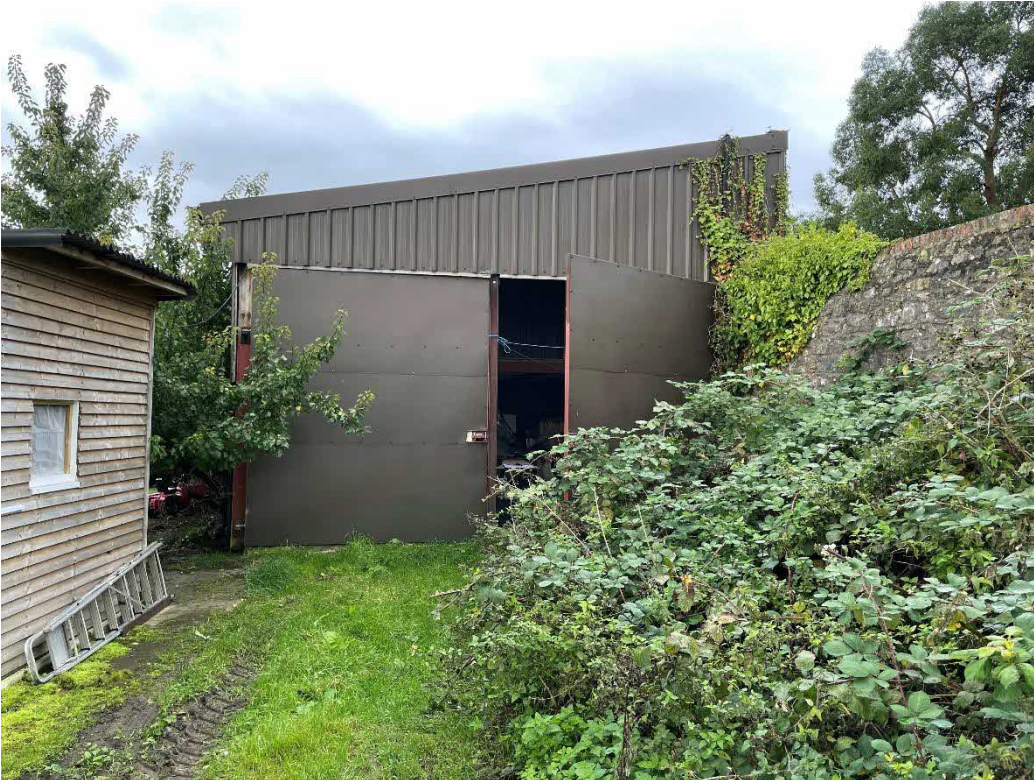
Photo 1 Gable end View of the Barn from the right-hand side

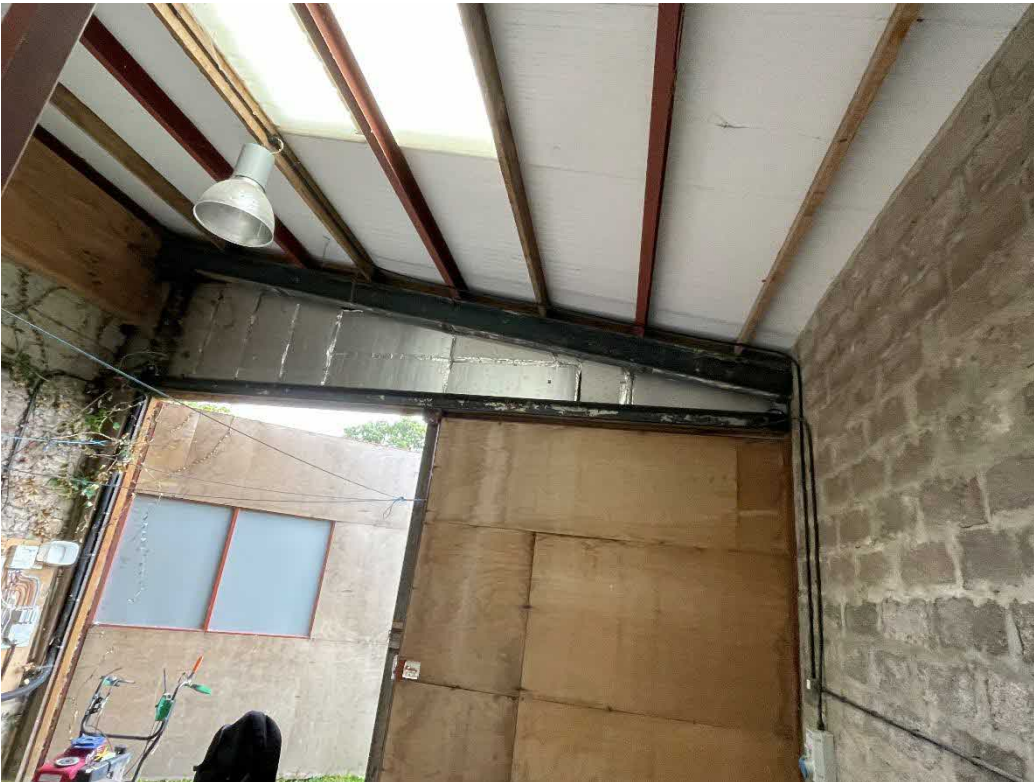
Photo 2 Inside View of the structure along the gable

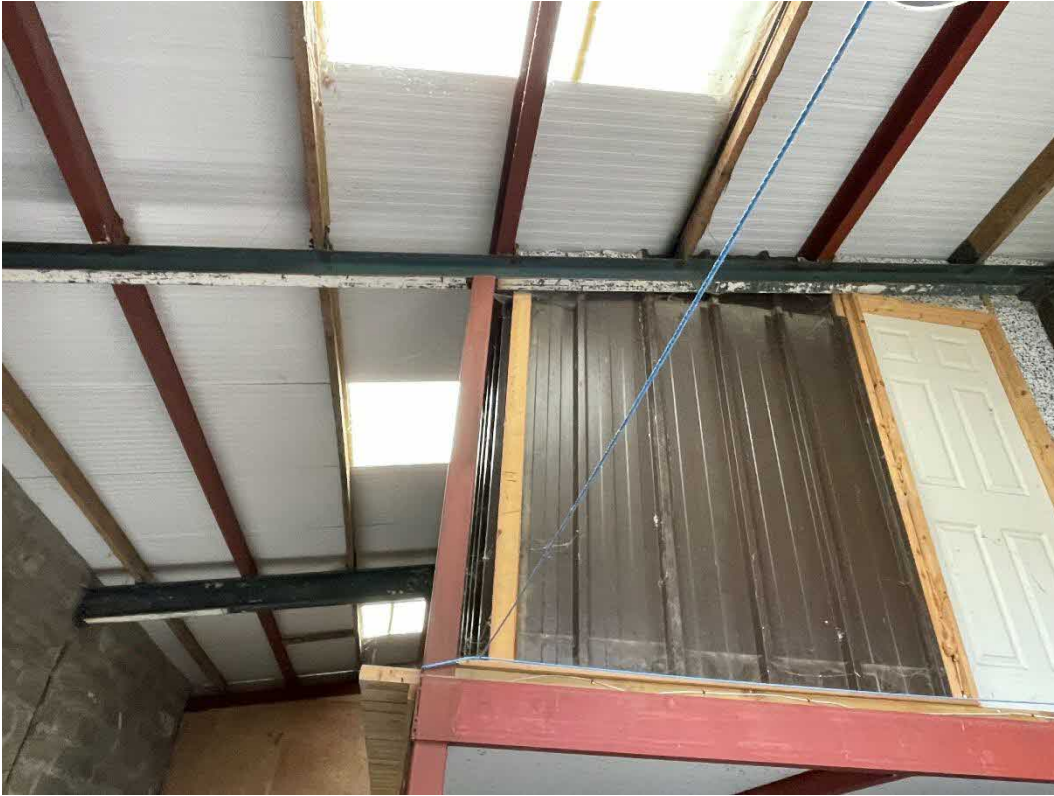
Photo 3 Part inside View of the Barn

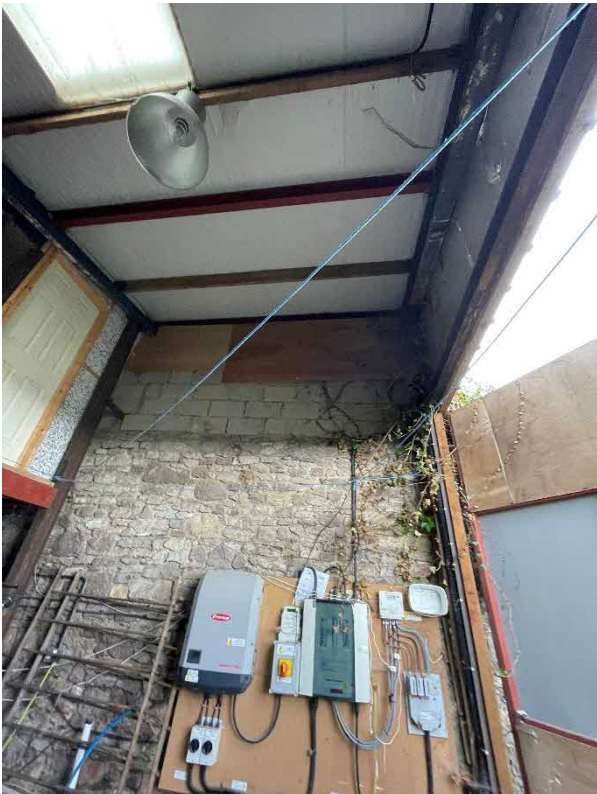
Although not supporting the frame, the rear wall is a retaining wall and could not be fully viewed due to obstructions. From what little could be seen towards the gable end, it appeared in reasonable condition.

Photo 4 Part view of rear wall
