Tree condition survey of 2 trees

14 Curtis Road, Alton, Hampshire, GU34 2SD

> Report date 18th November 2023

Report reference J1513

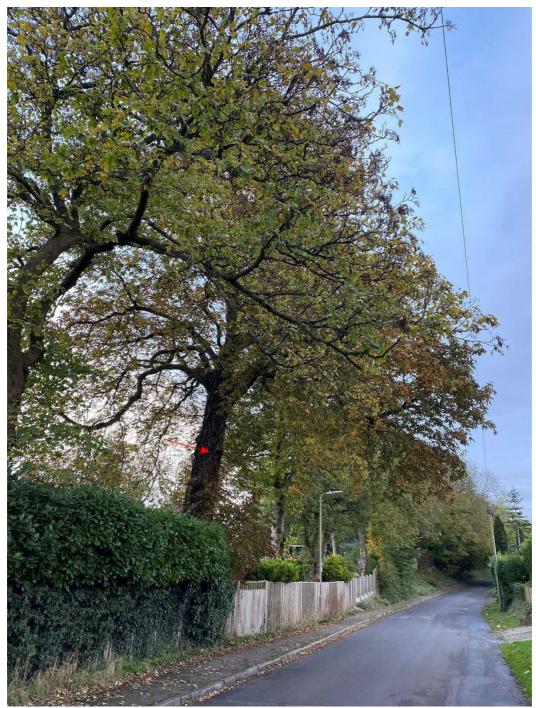
SAL2 T1 horse chestnut (identified by red arrow) with over long branches over the highway. T2 sycamore to the far left of the image.

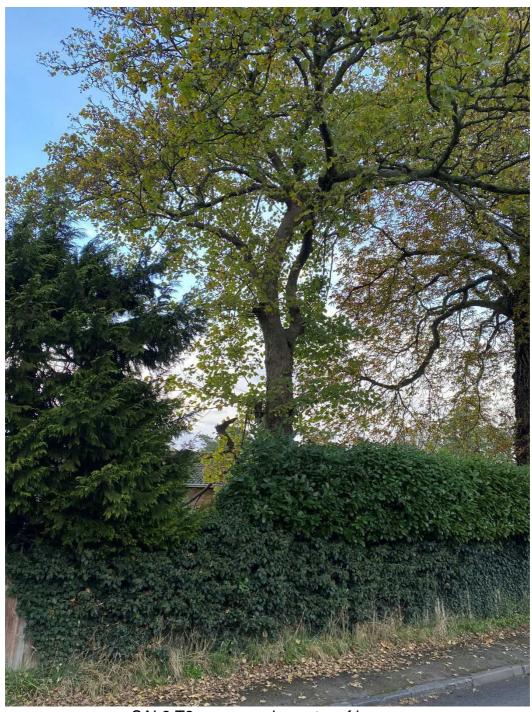
SAL3 T2 sycamore in centre of image.

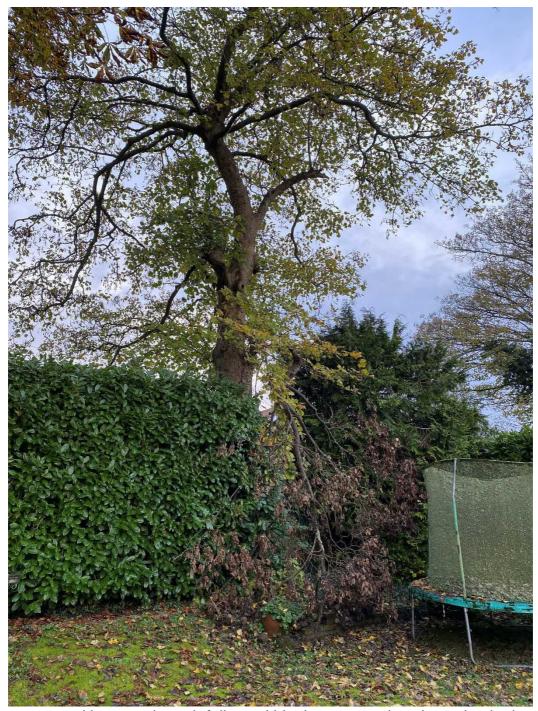
SAL4 T2 sycamore with recent branch failure within the rear garden shown by the brown leaves.

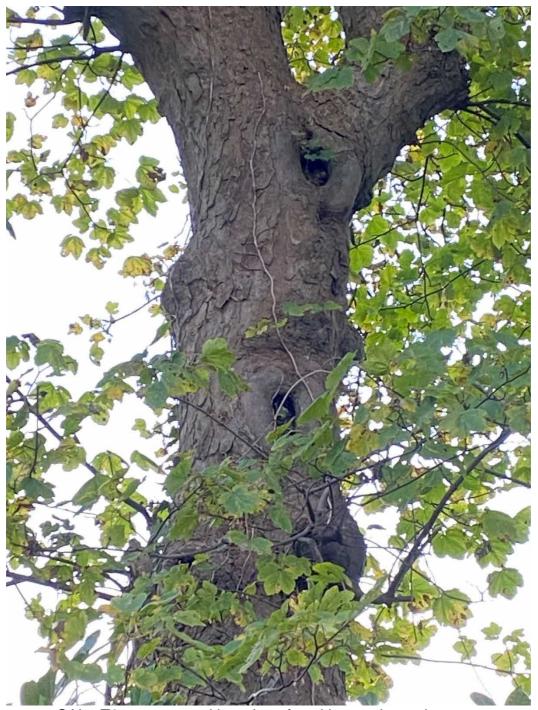
SAL5 T2 sycamore with series of cavities on the main stem.
