Tree Survey & Arboricultural Impact Assessment

Hallgarth The Manor House
High Pitington
Durham
DH6 1AB

6th May 2023

We Care Tree Care Arboricultural Services
wecaretrecare@live.co.uk / Tel: 07814030916

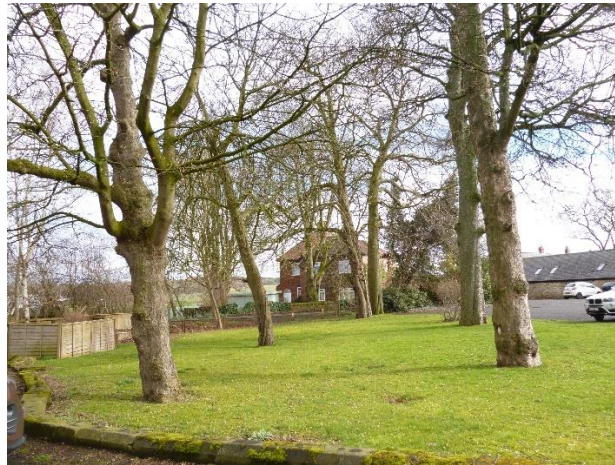
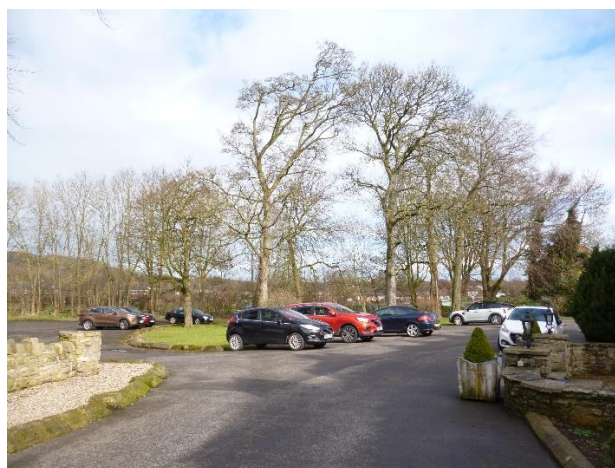
Photograph 2a & b – The trees growing on green space north east of the hotel (numbered 634 to 638)

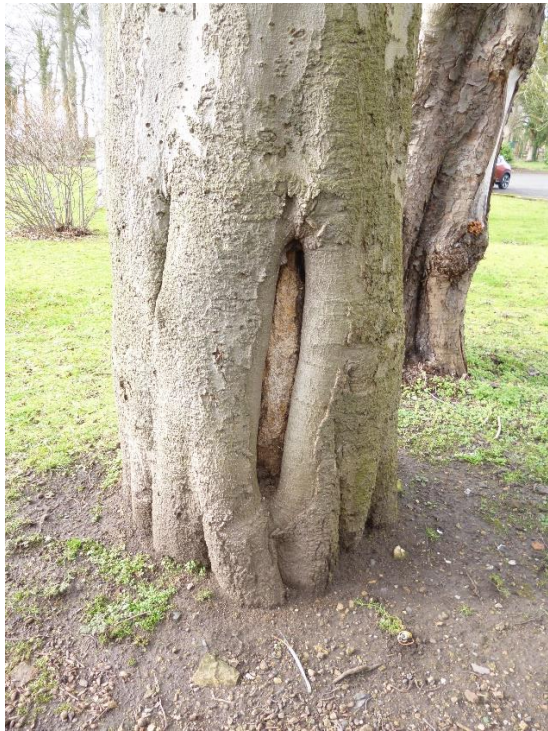
Photograph 4 – Tree 634 and the wound on the trees trunk

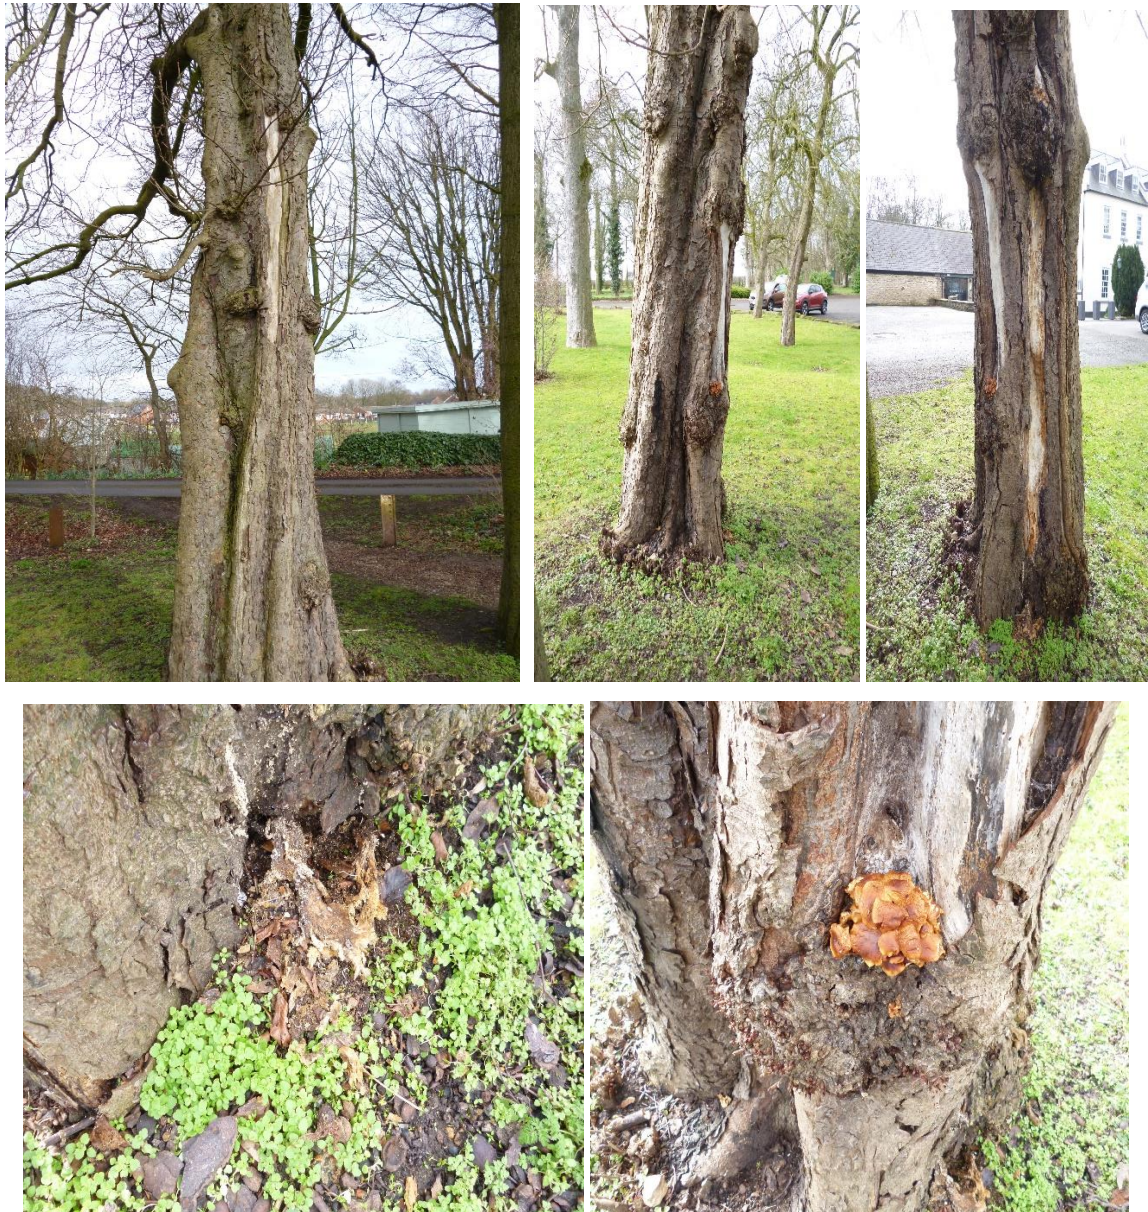
Photograph 5a to e – Tree 635 and the various defects

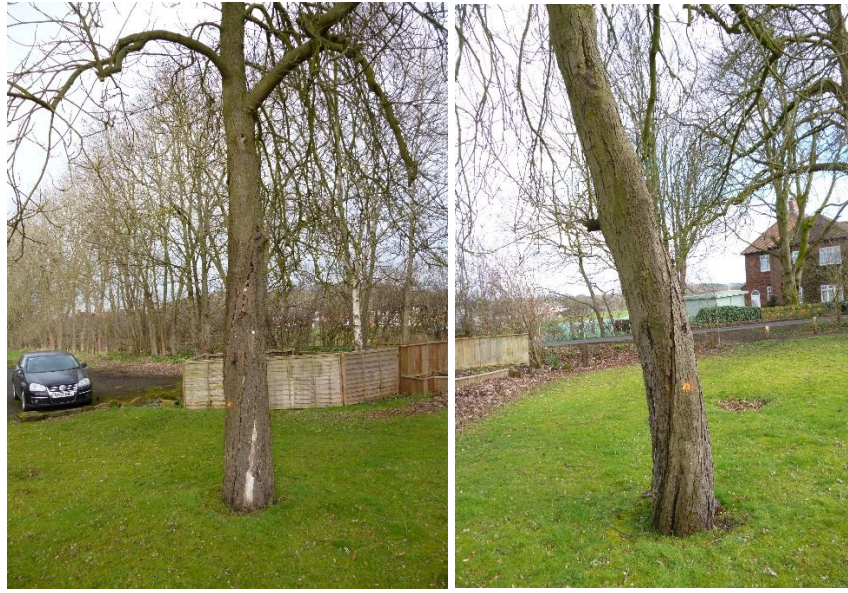
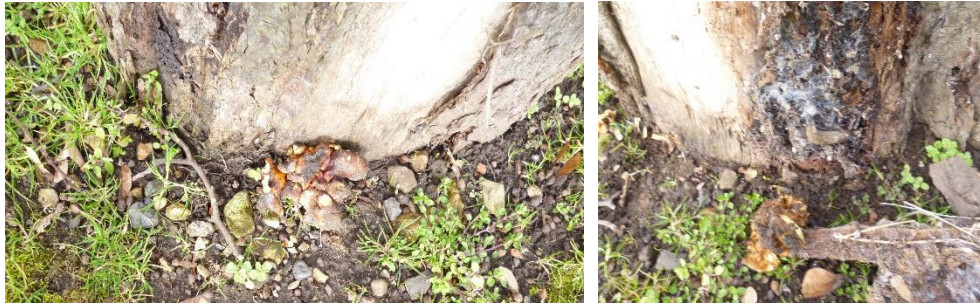
Photograph 6a to e – Tree 639 and the various defects

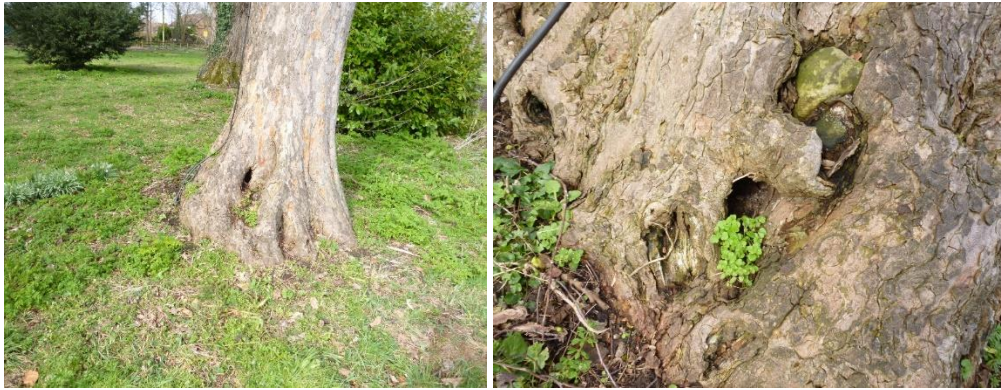
Photograph 8a & b – Tree 668

668	Sycamore	Mature	75	16	4 6 5 4	4	3m north	Red	<10	Poor	Poor	Cavity at base on western side that extends into the tree's stem. Target wounds with minor decay. Epicormic growth at base.	Undertake decay detection work to establish extent of decay and structural integrity of tree.	9.0
669	Ash	Over-mature	120	20	7 9 11 10	8	8m north west	Green (A1)	20-40	Fair	Fair	Dominant tree of high value. Large buttress root growing out to the north. Clear, upright stem to 5m where into codominant stems are formed. Canopy is heavier to the east. Evidence of branch failure in past - snapped limbs	Remove epicormics and lower water shots.	14.4

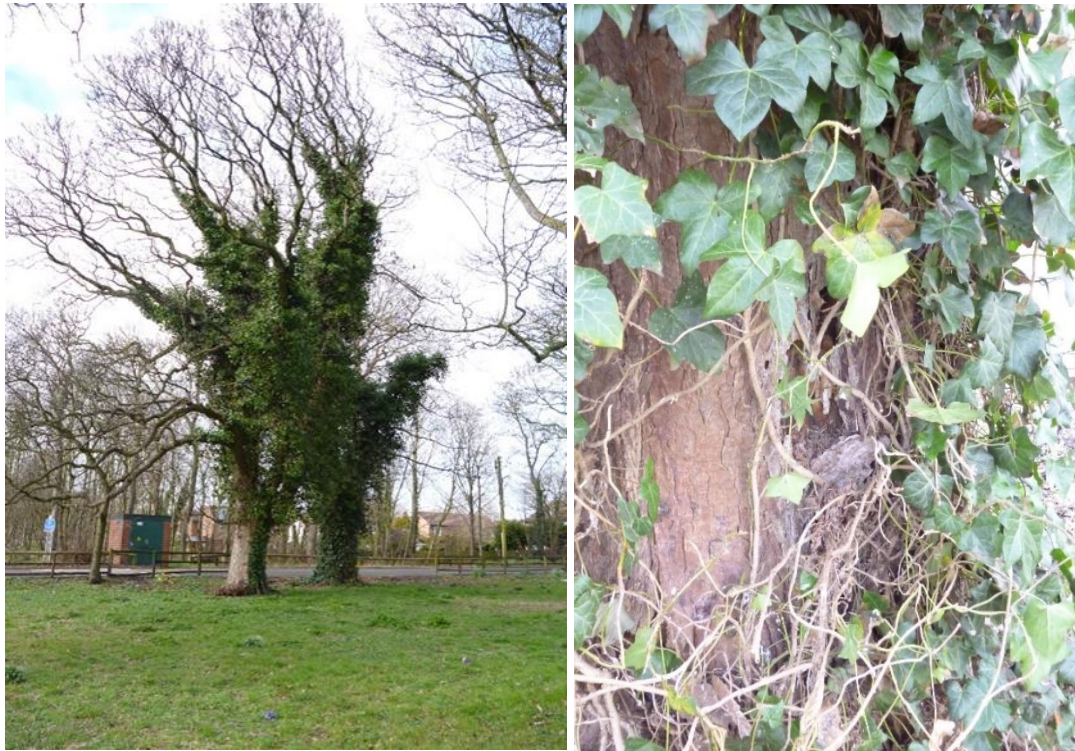
Photograph 9a & b – The large Sycamores at the northern end of the site (covered in Ivy).
The image to the right shows the decay / wound on the stem of tree 675

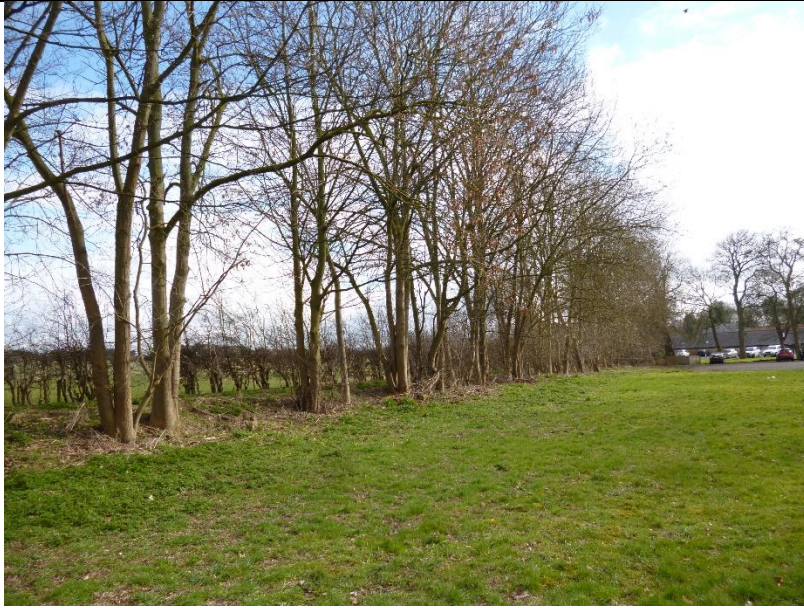
Group 1 trees, growing in a row across the north eastern side of the site (north / south direction) consist of low quality, self-seeded trees growing in competition, however they are of a greater collective value.

Photograph 10 – G1 trees

It will be necessary to raise the canopies of G1 on their western side, to facilitate the work and avoid damage to low, overhanging branches. Providing the tree works are undertaken
