The Sizewell C Project

Application for Listed Building Consent
Upper Abbey Farm, Hay Barn and Cart Lodge
Farm Buildings at Upper Abbey Farm. Leiston, Suffolk:
Heritage Asset Assessment

Farm Buildings at Upper Abbey Farm, Leiston, Suffolk

Heritage Asset Assessment

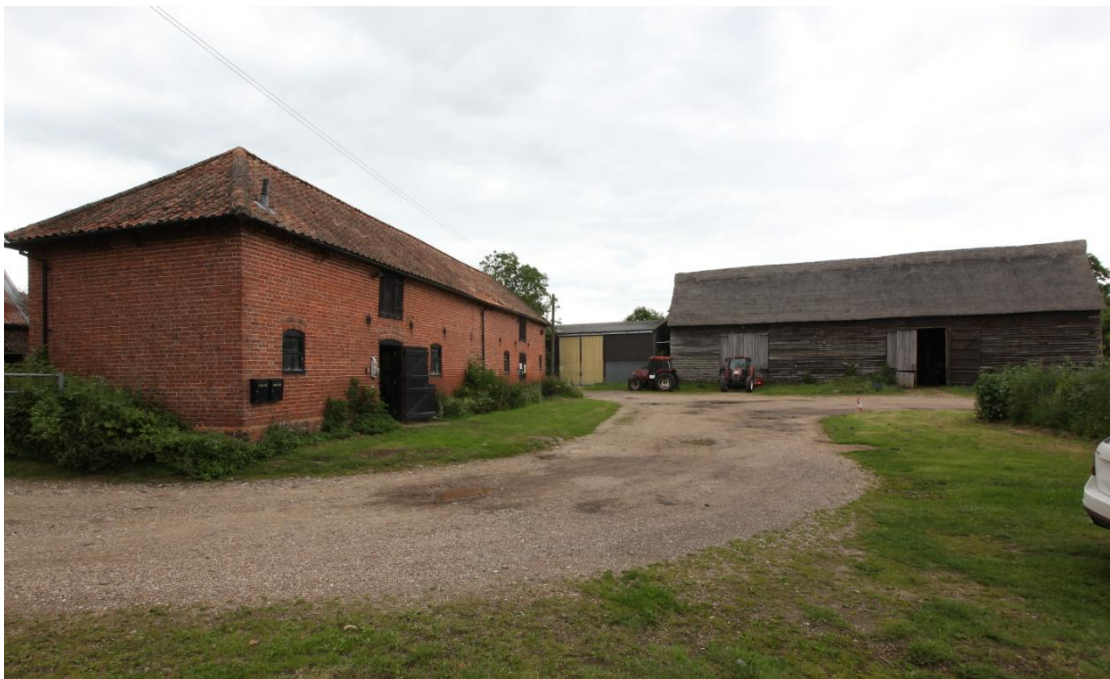
Illus. 2. The main yard from the south showing the brick stable (2) and the thatched and weatherboarded barn (1). Note the asymmetry of the barn's facade, with one of its two sets of entrance doors in the second bay from the left and the other in the third bay from the right. Although of traditional braced construction both doors are in excellent condition and appear to be 20th century replacements. The steel-framed shed to its left is modern.

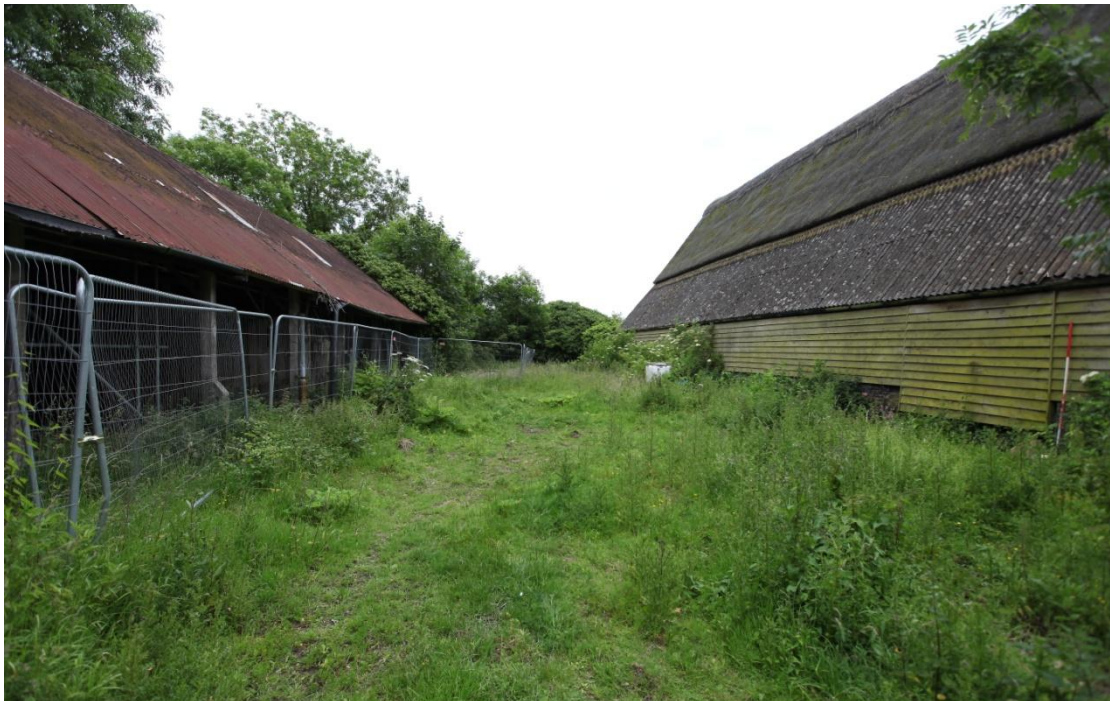
Illus. 4. The narrow yard to the rear (north) of the barn as seen from the west. The long shelter-shed (7) is overgrown and largely inaccessible but the section to the left was largely rebuilt in softwood and corrugated iron during the 20th century. The barn's rear aisle has been re-roofed in corrugated asbestos and clad in modern softwood but original thatch survives above. The outline of a blocked rear doorway opposite the western entrance is visible to the left of the scale rod with another hidden by vegetation in the rear.

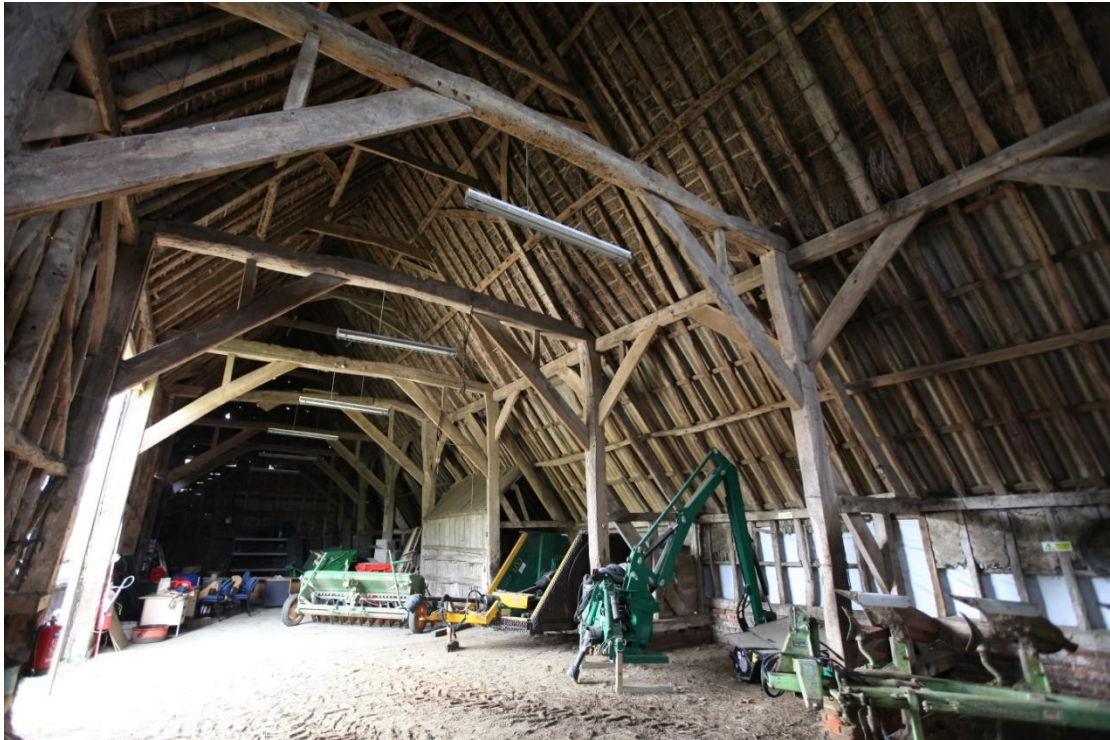
Illus. 5. A general view of the barn's interior from its south-eastern corner (1). All seven bays are visible along with the floor of loose earth with no trace of the threshing floors onto which the two southern entrances would have opened. The rear aisle to the right was initially replicated on the left but the structure is otherwise exceptionally intact with only one missing tie-beam brace. The aisle is not a later addition as stated in the listing as there are no stud mortices for an earlier back wall in the arcade-plate.

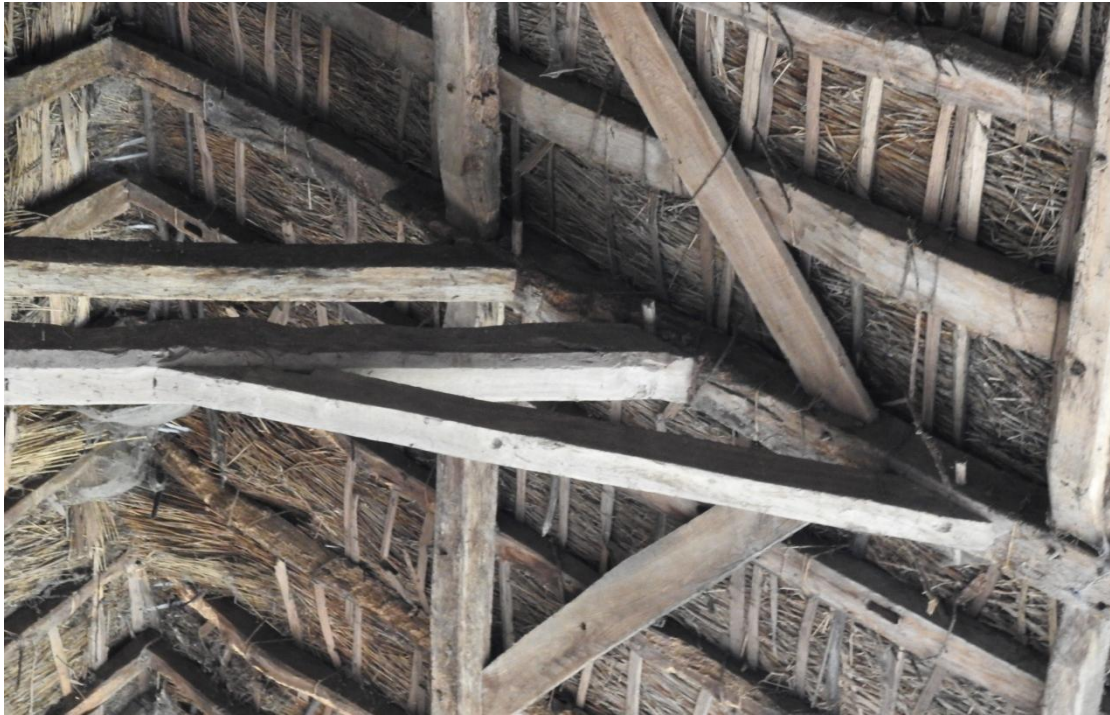
Illus. 7. A detail from the west of the unique central truss of the barn's roof, with double collars and a pair of diagonal soulaces. Trusses of this kind are normally found only in high quality 13th and 14th century roofs. Note the step in the principal rafter above the upper collar which indicates it was re-used from a clasped-purlin roof, and the empty mortices in the common rafter to the left which also indicate re-use.

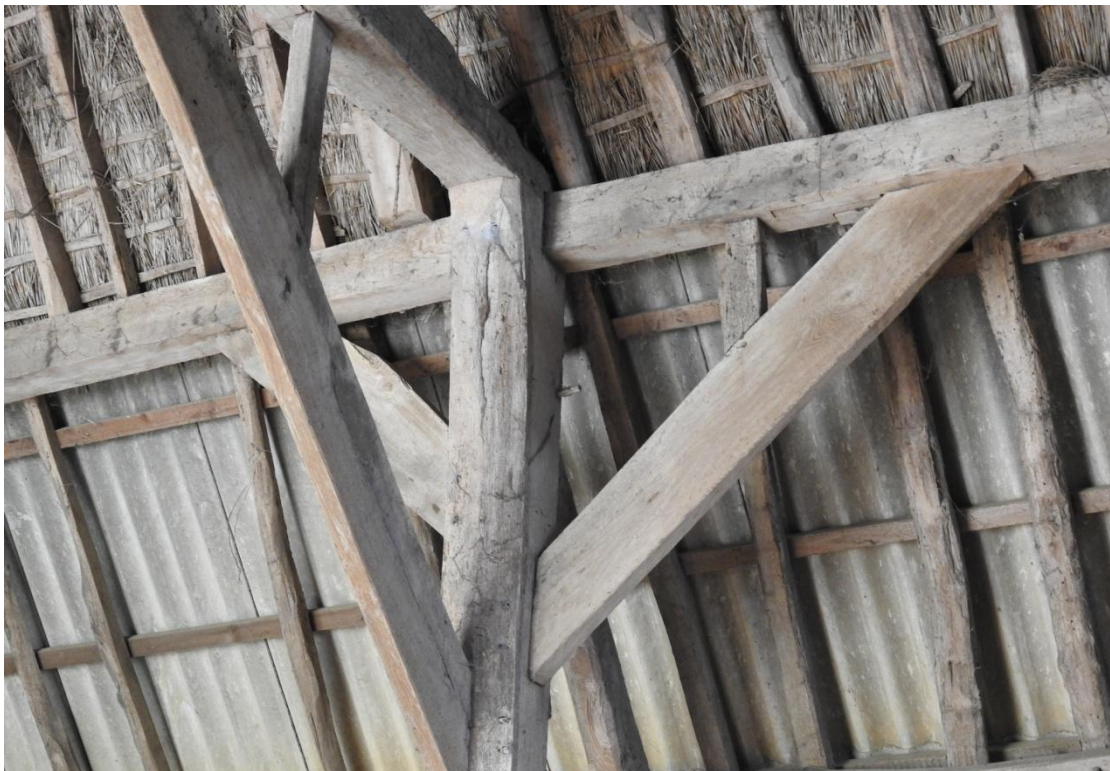
Illus. 8. The arcade post to the right of the easternmost entrance showing its exceptional spandrels struts and the smaller arcade brace to the threshing bay. Every tie-beam brace contains identical struts but the barn contains only two arcade-brace struts – both beneath scarf joints and both flanking a threshing bay. The struts are re-used timbers.

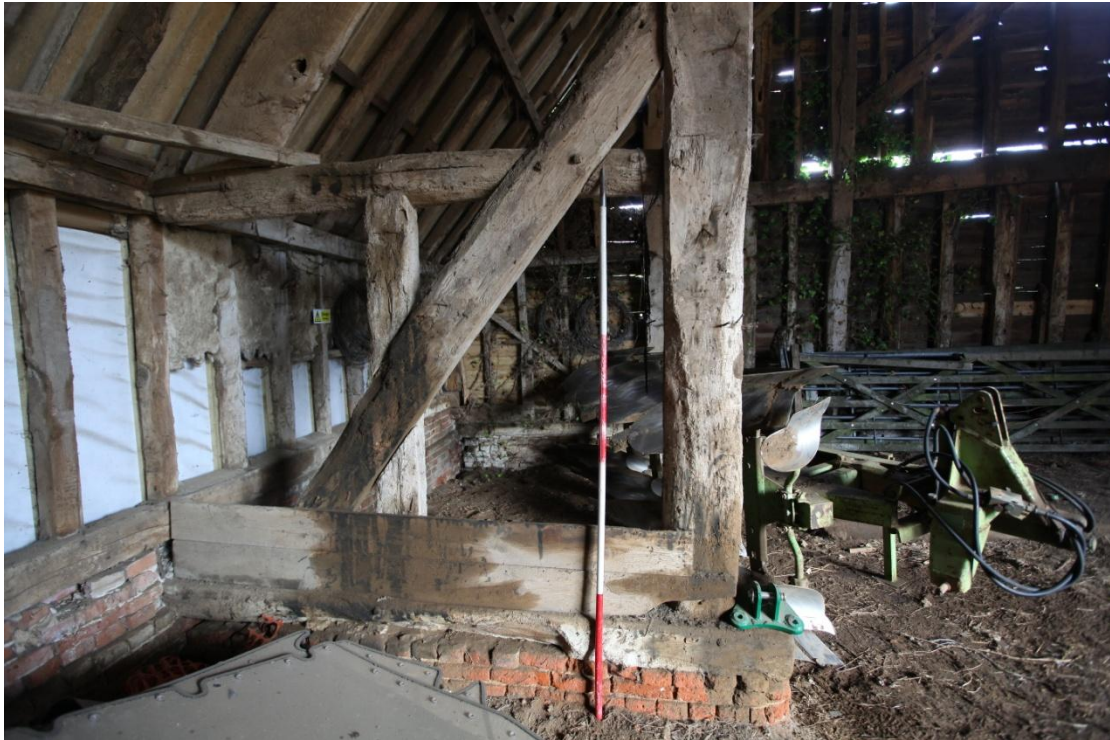
Illus. 9. The easternmost truss of the barn's aisle (1) as seen from the west. The single, large stud and thick, slightly waney aisle brace and tie-beam with hewn surfaces are typical of the Middle Ages and contrast with the sharp-edged, uniform timber of the upper braces and other key elements such as the arcade-plates. A truncated mortice for a jowled wall post in the left-hand end of the aisle tie proves that the wall framing has been rebuilt or the timbers have been re-used – or both.

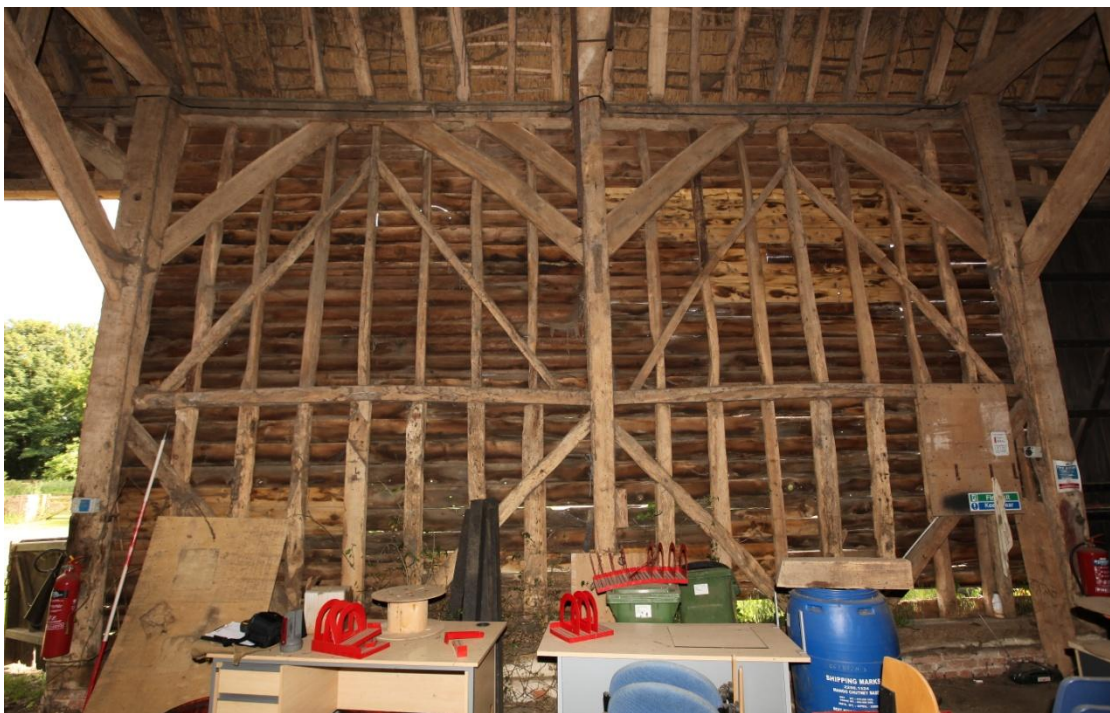
Illus. 10. The central bays of the barn's southern wall (1) showing the arcade braces of a missing front aisle. The framing beneath consists of mid-rails and vertical studs cut by diagonal primary braces all nailed in place in the style of the 19th century. Note the unique inner brace to the left of the central post, possibly designed to support a scarf.

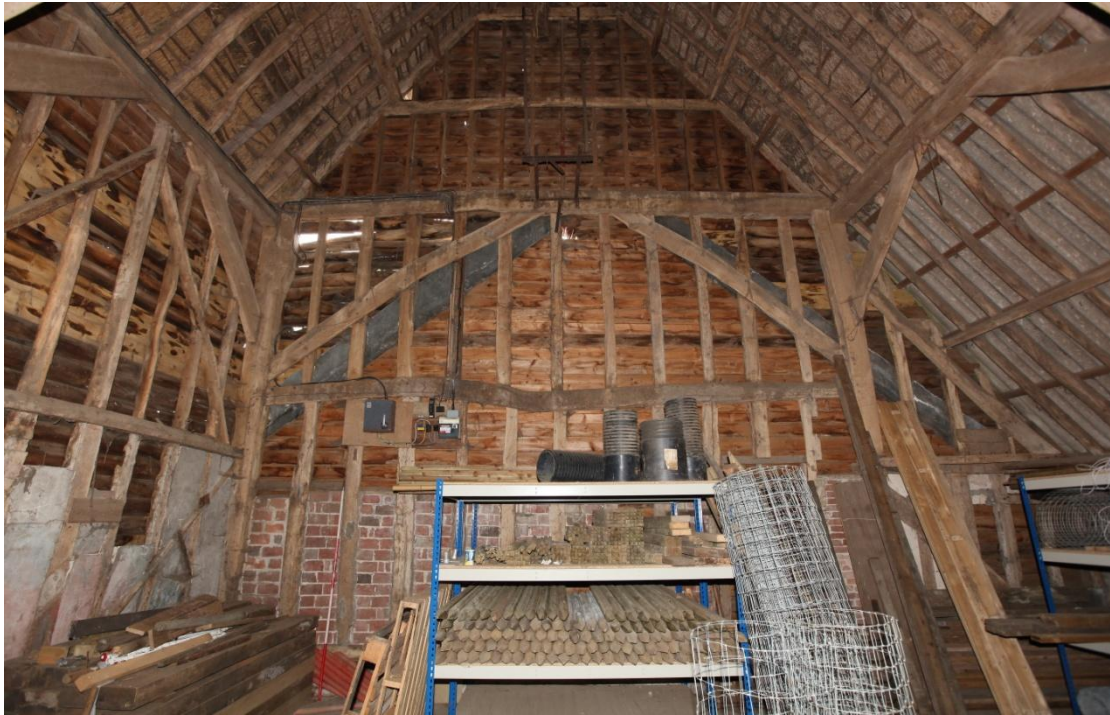
Illus. 11. The barn's symmetrical western internal gable (1) with a waney mid-rail, trenched braces and chiselled carpenter's numerals. This contrasts with the eastern gable where the mid-rail is interrupted by an additional post to the rear of its centre. The corner post on the left contains pegged mortices for an identical aisle tie-beam and brace to those on the right.

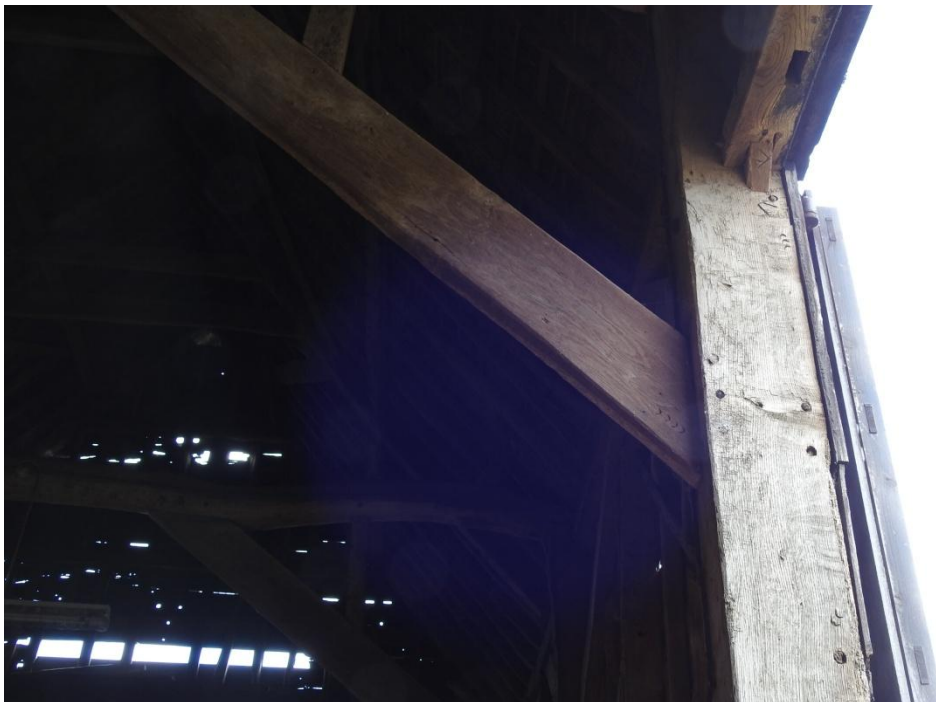
Illus. 12. The eastern storey post of the barn's eastern entrance (1) showing pegs for three mortices in the external face of the timber – two of which bear crescent-shaped carpenter's numerals reflecting that of the tie-beam brace. These mortices are at different heights to those of the rear arcade posts and the rest of the southern posts but match those of the other three door posts –indicating they secured missing porches. Crescent-shaped numbers were cut with a curved race-knife and are not uncommon.

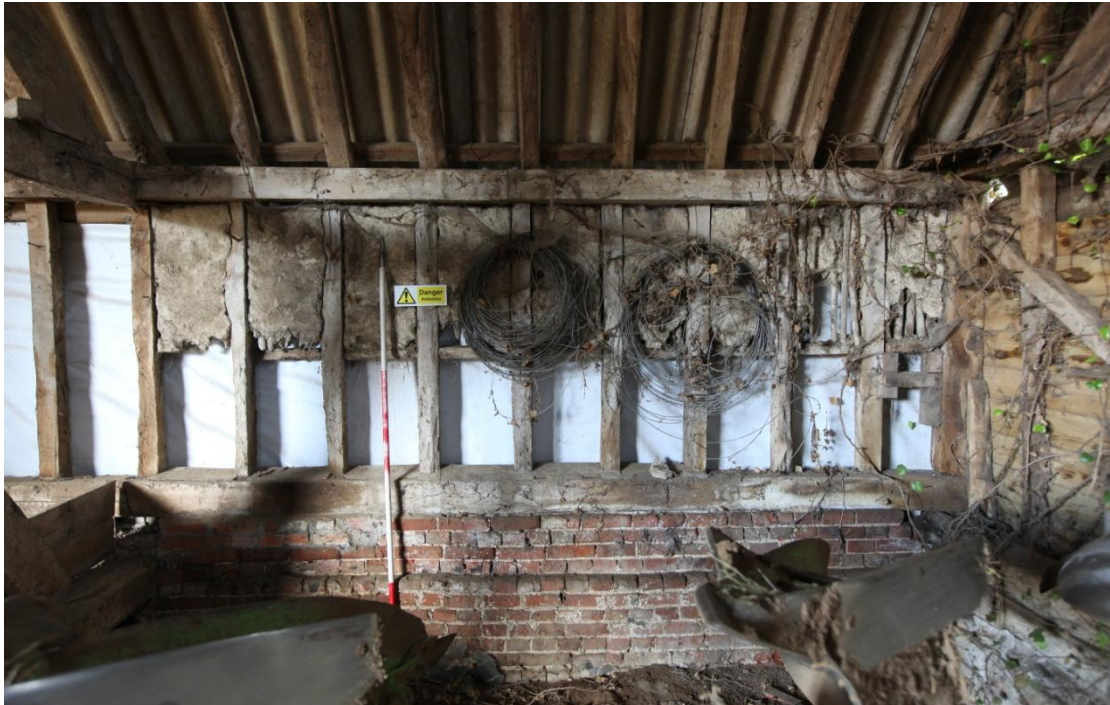
Illus. 13. The back wall of the easternmost bay (1). The narrow studs are tenoned to the roof-plate and sill but only every third stud is pegged. Framing of this kind indicates a date in the 18th century, as does the uniform brickwork of the tall brick plinth, although the diagonal primary brace in the gable to the right is more consistent with the 19th – as is the fact that the internal aisle tie-beams are butt-jointed and strapped to the roof-plates. The wattle-and-daub between the studs is an original feature.

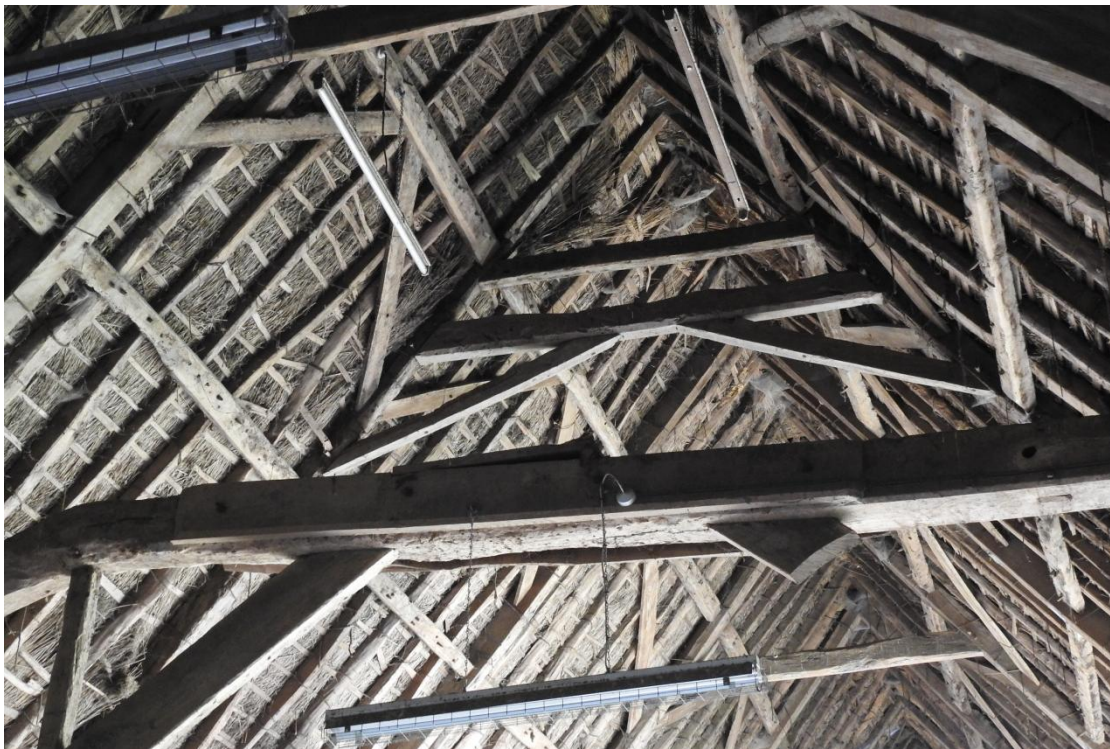
Illus. 14. The unique double collared truss in the centre of the roof with medieval-style diagonal soulaces to the chamfered lower collar. The roof is otherwise typical of the mid-17th century but the principal rafters are stepped for clasped rather than butt-purlins and the purlins themselves contain irrelevant peg and nail holes indicating re-use.

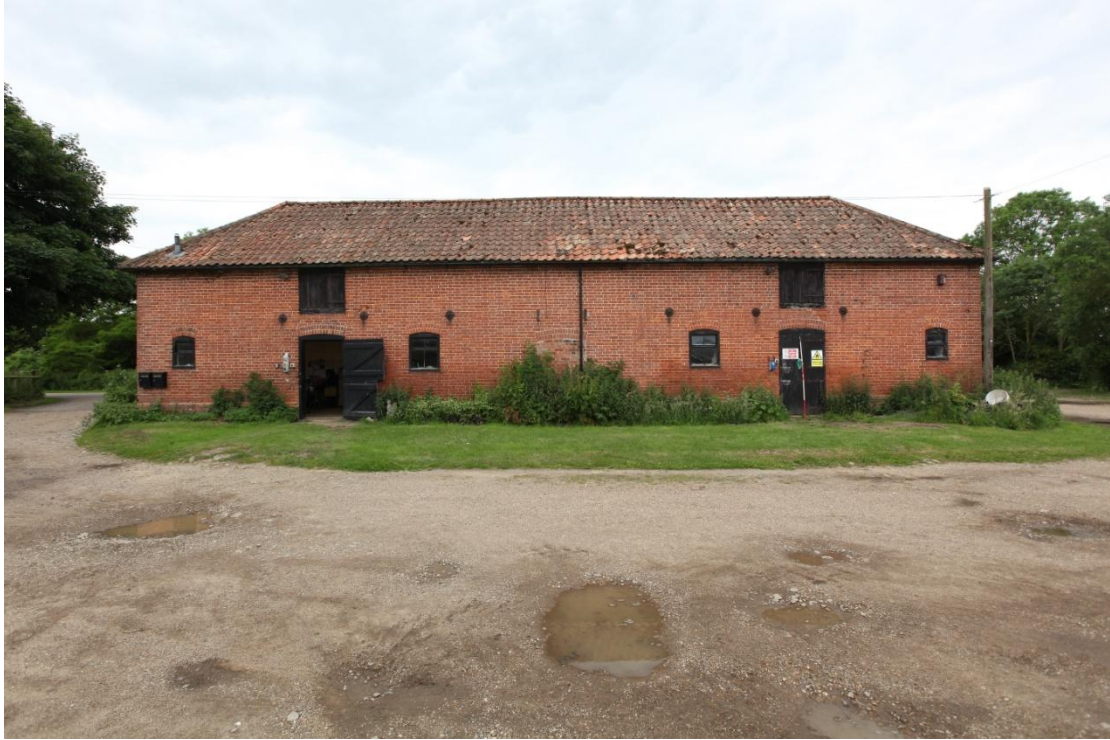
The main stable is now divided into two compartments, 2a and 2b, of which the former operates as a farm office, but there is evidence of an additional central door in the eastern facade (illus. A2 15 & 16). This door appears to have opened into a narrow tack room that was probably also linked to the stable on the north, but may have served a missing internal stair to the loft as the present joists are jointed above a series of empty partition mortices (illus. A2. 16). An identical series of mortices indicates a missing tack room against the southern gable, although some of the ceiling timbers have been re-used and some empty mortices elsewhere relate only to previous buildings. The two main stables were arranged in the usual manner, with central entrances flanked by windows in the facade and hay racks above mangers against the 'blind' rear wall. The racks and mangers have been removed but the positions of the hay drops in the ceiling which allowed the racks to be filled from the loft are indicated by the short inserted boards with which they are blocked – the joints of which are misaligned with those in the rest of the ceiling. These inserted boards are secured by the rails of hay racks with holes for missing tines. Original wooden harness hooks still project from the gable and eastern wall of the well preserved northern stable (2b), secured by wooden rails set into the brickwork (illus. A2. 16). Ostensibly original internal loft ladders also survive in the front internal corners of both stables (illus. A2. 17), but the present internal partition is a later insertion that probably relates to the office conversion. Original hatches lie above each of the stable doors allowing the loft to be loaded from the exterior, and the paint scar of a demolished lean-to shown on late-19th century maps is visible against the back wall. This lean-to was not keyed to the brickwork and was probably a later addition.

Illus. 15. The eastern facade of the pantiled brick stable (2) showing its symmetrical twin entrances, loft hatches and windows. The outline of a third blocked door is visible in the centre. This would normally have opened onto an internal loft stair, but there is no obvious evidence of this in the ceiling and it probably served a tack room.

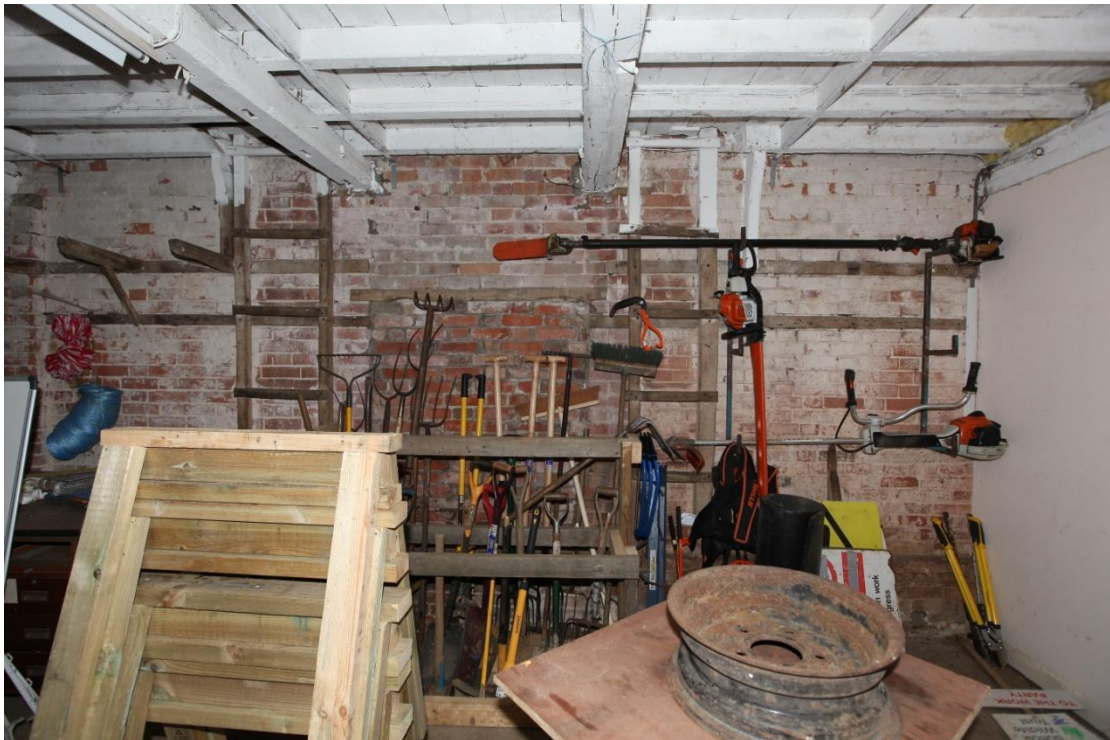
Illus. 16. The eastern interior of the stable's northern section (1b) showing the blocked central door between the two ostensibly original loft ladders with original wooden harness hooks on the left (and wooden rails set into the brickwork for others on the right). The principal joist to the left of the door contains empty mortices for a missing partition but there is no counterpart to the right.

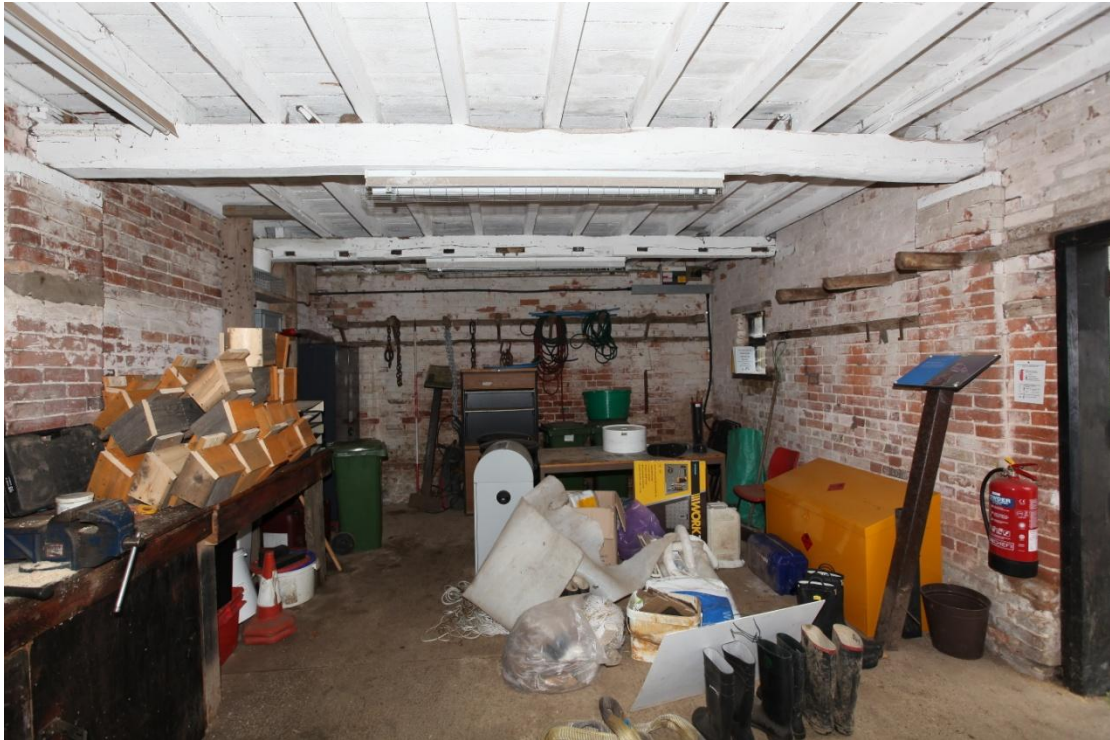
Illus. 17. The northern section of the stable (2b) as seen from the south showing a good series of original wooden harness hooks lining the walls with a blocked hay drop to the left. The floorboards above this drop are short insertions that are aligned differently to the boards elsewhere in the ceiling. The hay racks and mangers have been removed. The bind joist in the rear is a re-used timber with irrelevant empty mortices.

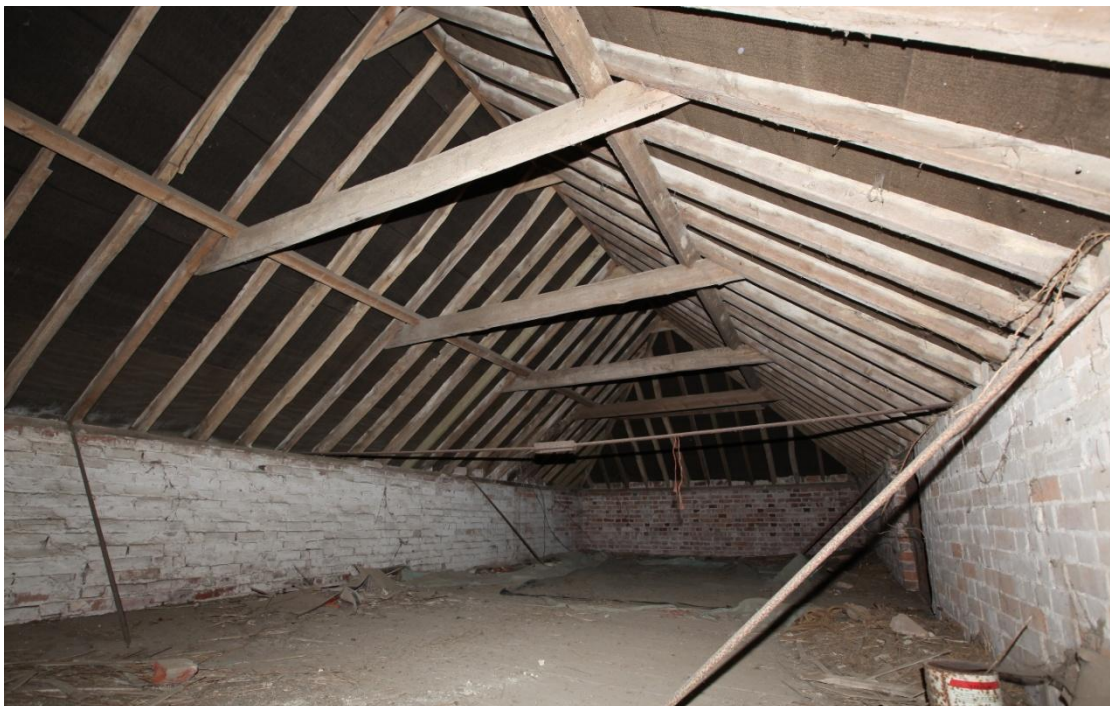
Illus. 18. The undivided hay loft above the stable looking towards its northern gable (2). A number of probably original iron tie-rods span the walls and secure the roof-plates to the floor joists in the absence of tie-beams. The clasped-purlin roof structure consists of uniformly sawn softwood with a ridge-board and nailed collars in the manner of the mid-19th century.

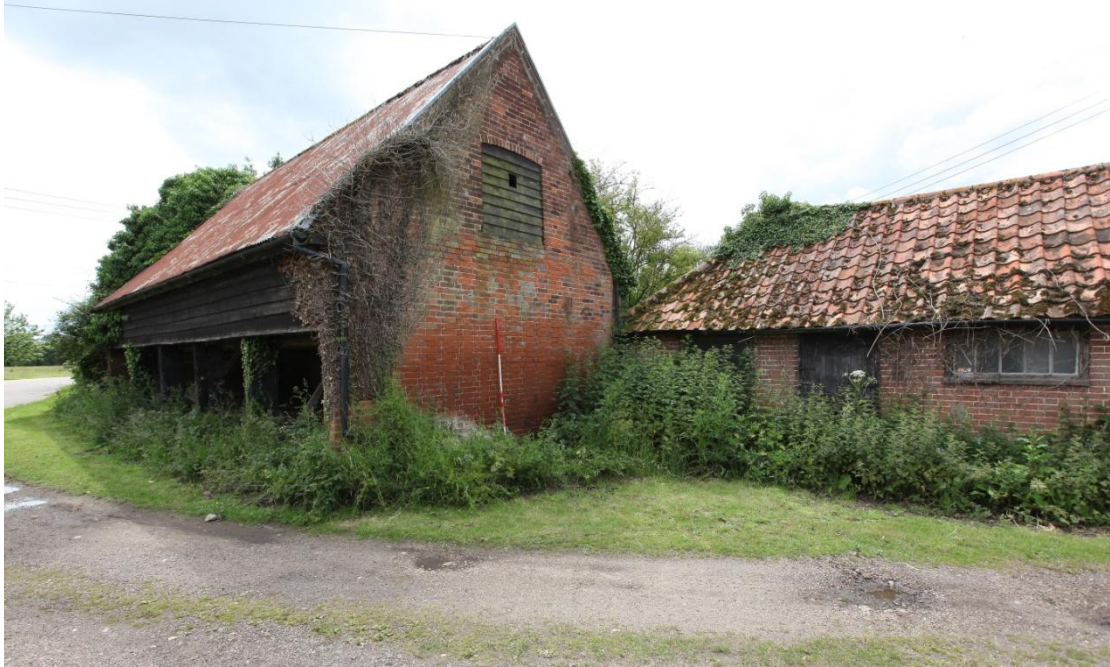
Illus. 19. The cart lodge (3) from the north-east showing the blocked granary loading hatch or louver in its gable with the small cart shed and stable (4) on the right. Four sets of initials lie at vertical intervals to the right of the scale rod, three of which are dated 1797.

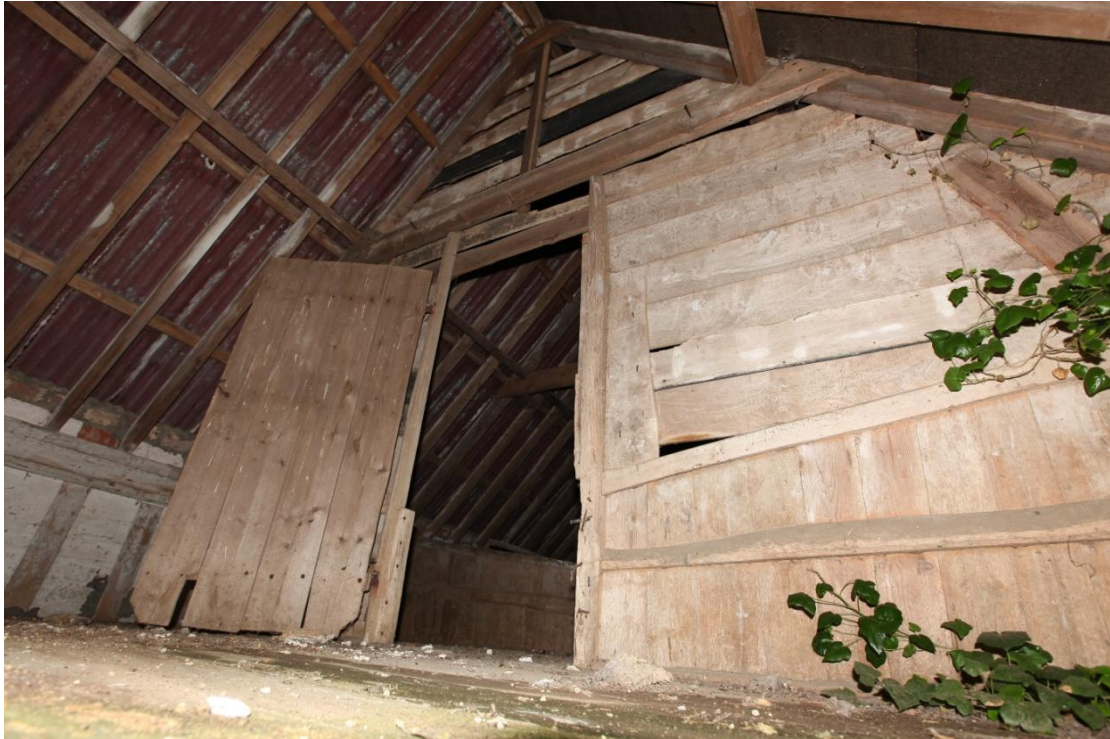
Illus. 21. The cart lodge's loft seen from the north (3) showing a boarded partition with grain bins visible through the door and substantial studs pegged to the roof-plate on the left. The narrow softwood rafters of the clapsed-purlin roof with nailed collars are typical of the mid- to late-19th century and appear to be replacements. The loft was inaccessible at the time of inspection and this image was taken through the floorboards.

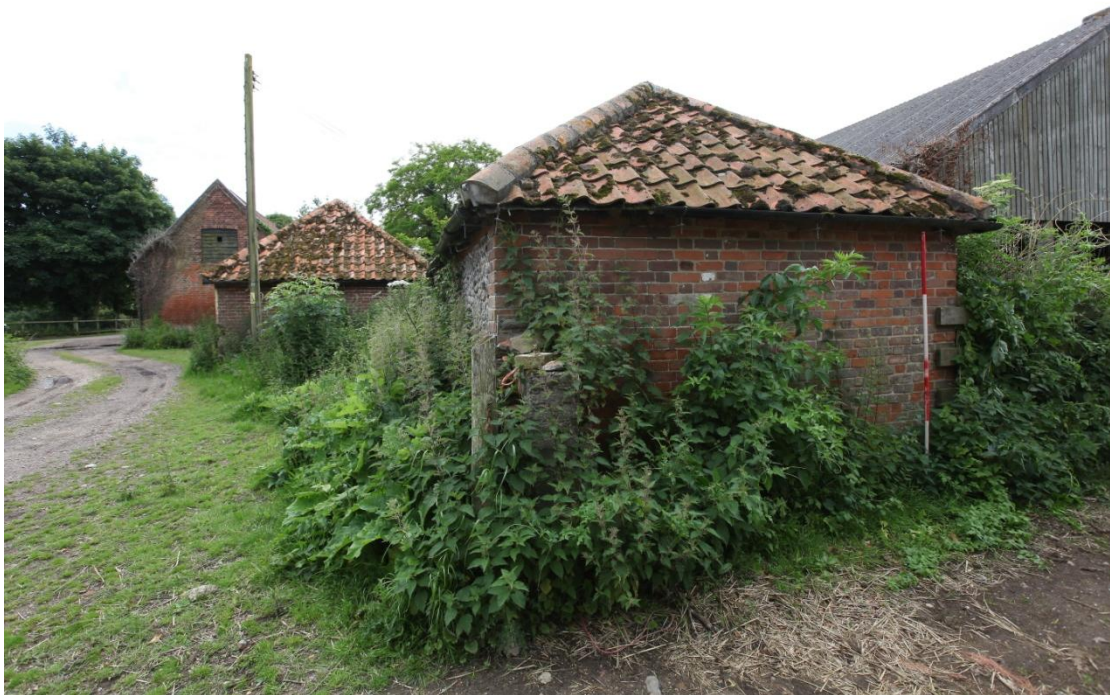
Illus. 22. A detail of the partly rebuilt northern external gable of the small shelter-shed (5) with the cart lodge (3) and cart shed (4) in the rear. The shed's eastern wall consists of flint-rubble with red-brick dressing but the gable has always been of brick. The open-arcade to the west (right) is overgrown and was not fully accessible.

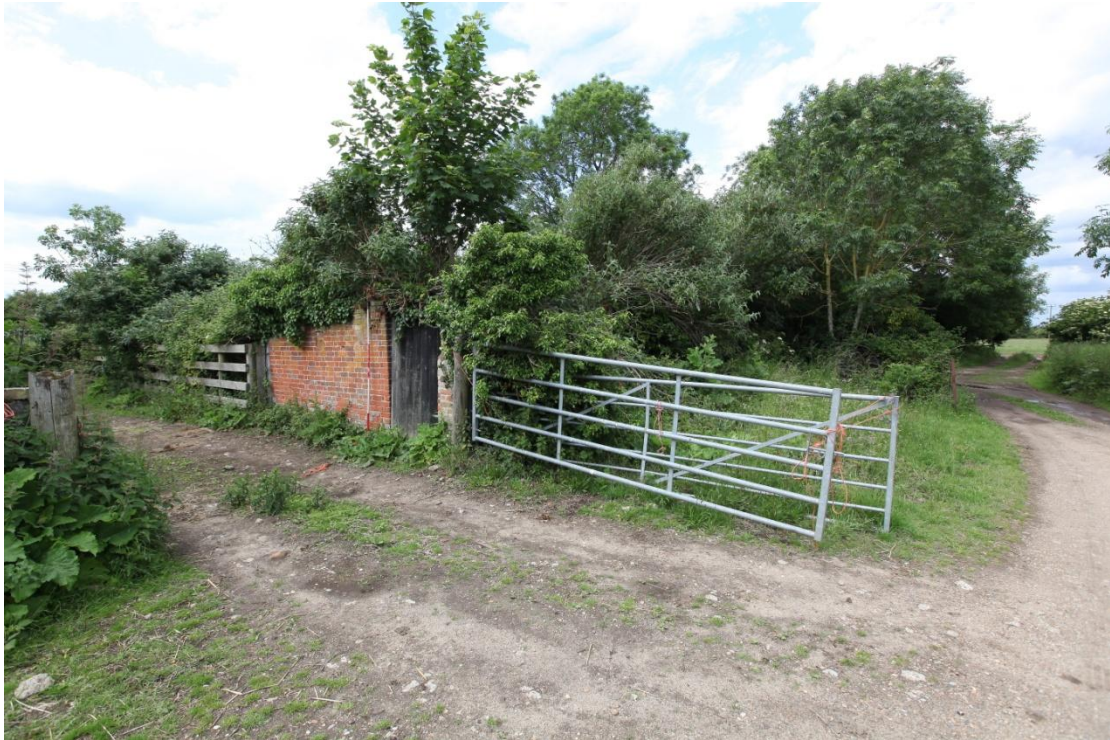
Illus. 23. The largely collapsed northern cattle shed viewed from the south-east (6) with its dated plaque to the left. Fragments of a flint-rubble eastern wall with red-brick dressing are hidden in the undergrowth and the doorway to the right of the scale rod is an original feature respected by closers – as is the former gateway on the left.

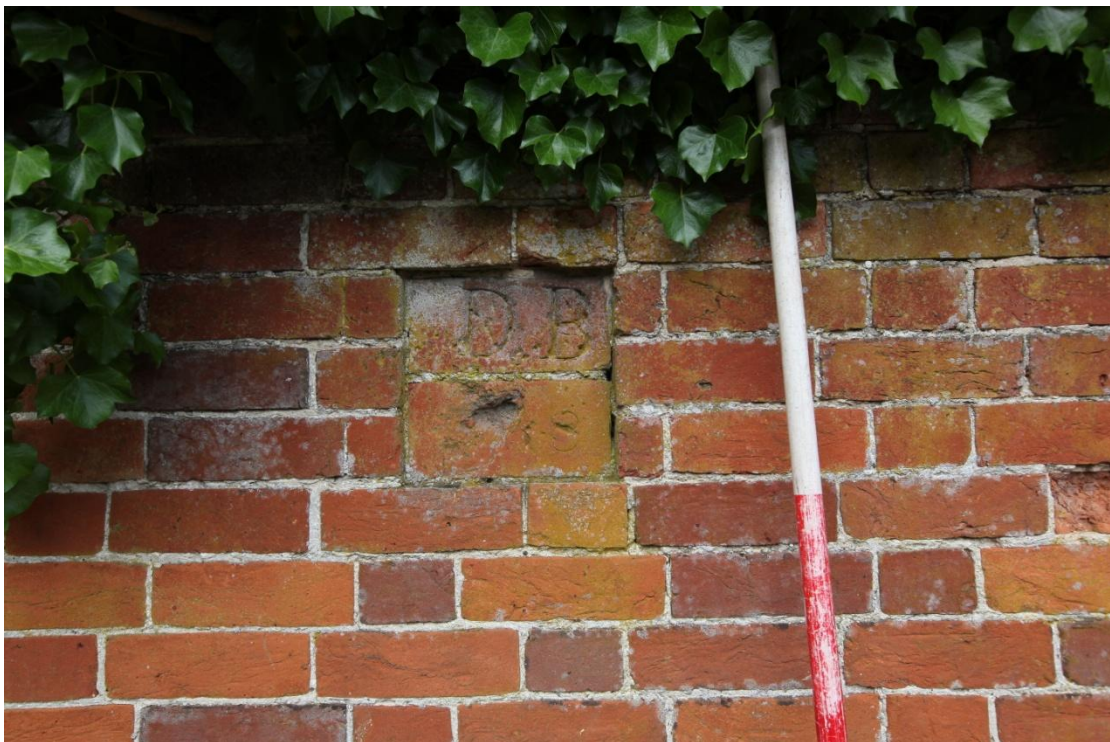
Illus. 24. A detail of the plaque to the southern exterior of the largely collapsed northern shed (6) showing the initials 'D B' with an illegible date ending in '8' – probably 1858 but possibly 1838. The initials are probably those of Daniel Barker was listed as a farmer in Leiston in White's Directory for 1844 and 55 and whose surname was added to the 1786 map.
