Project Name	Project Number	Project Date
10793 Barrington Close Kingswood Report	10793	04/10/2023

Street: Barrington Close
Town or City: Kingswood
County: Bristol
Post Code: BS15 4QD

Company: Solum Surveying Ltd
Contact: Adam Smothers
Department: Operations Manager
Street: The Old Stables, Pines Courtyard
Town or City: Stone
County: Berkeley
Post Code: GL13 9LE
Phone: 01454 568725
Email: asmothers@solumsurveying.com

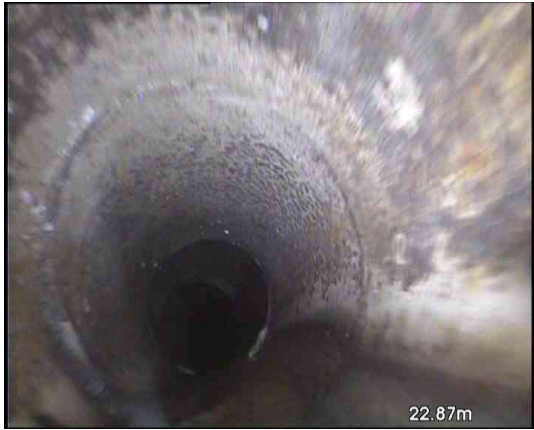
MH4X_6a5e938b-03c7-4156-a8c1-0e94677db67a_20231004_150639_924.jpg, 00:01:04, 22.87 m
Broken pipe at joint from 7 o'clock to 9 o'clock

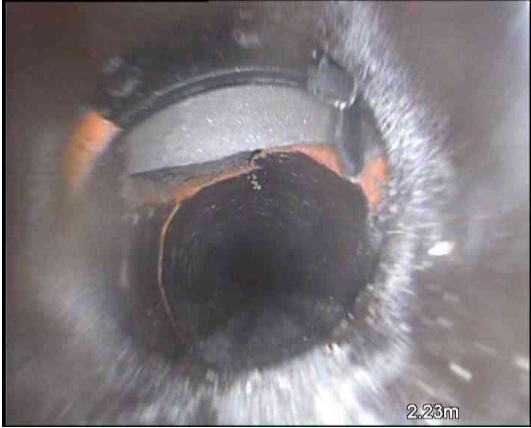
MH16X_6743155c-b319-4636-a4e1-6ab9b0ba6bbe_20231005_092050_334.jpg, 00:00:15, 2.29 m
General remark, POSSIBLE HOLE OR CONNECTION AT 12 O CLOCK

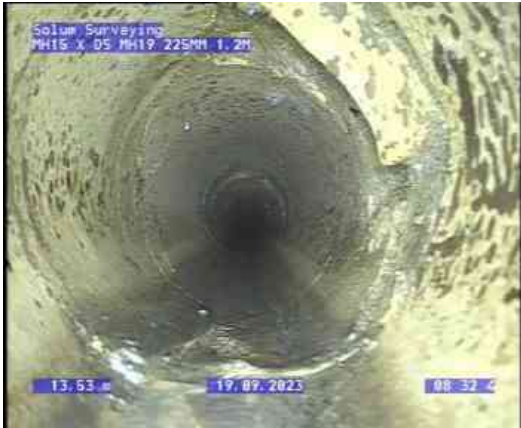
MH15X_d63fadcb-f4bc-4ce1-bf2c-d67bd93a6ca3_20231005_093226_393.jpg, 00:01:33, 13.53 m
 Connection defective, connecting pipe is intruding at 2 o'clock, 150mm dia, intrusion: 10%

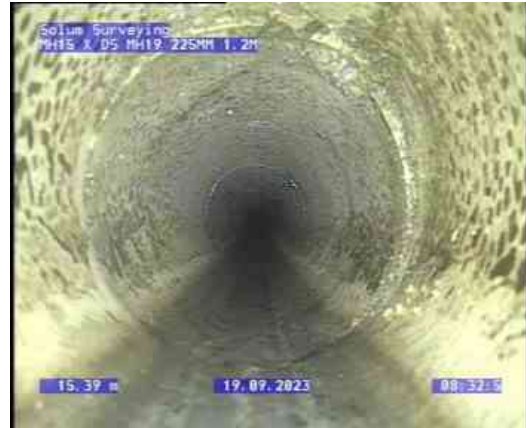
MH15X_416a6b17-5e09-4cf9-8eb4-2279ff69c08e_20231005_093340_645.jpg, 00:01:44, 15.39 m
 Broken pipe at joint from 11 o'clock to 2 o'clock

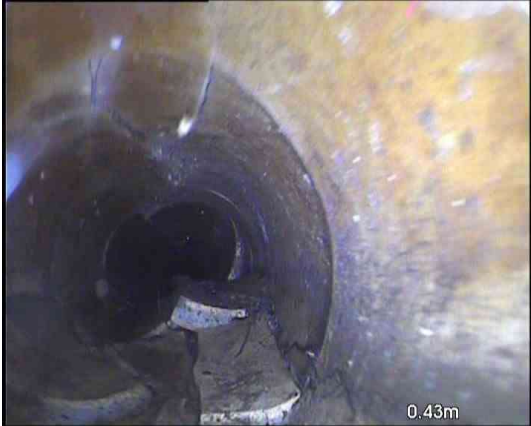
MH18X_588d93d8-0691-423b-9591-348c62ca6498_20231005_095307_681.jpg, 00:00:09, 0.43 m
Broken pipe from 12 o'clock to 12 o'clock, start

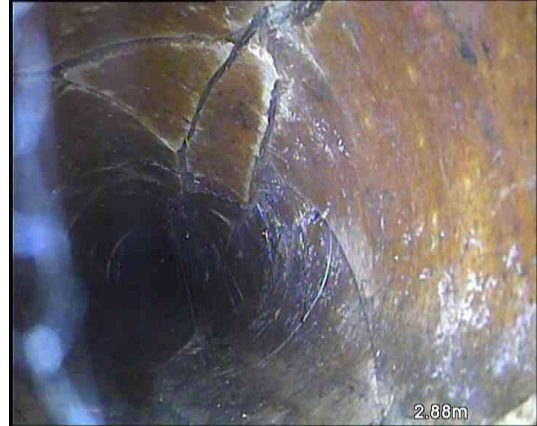
MH18X_51db5a45-6395-4f44-8e17-cb4a92bb53c2_20231005_095448_313.jpg, 00:00:21, 2.89 m
Broken pipe from 12 o'clock to 12 o'clock, start

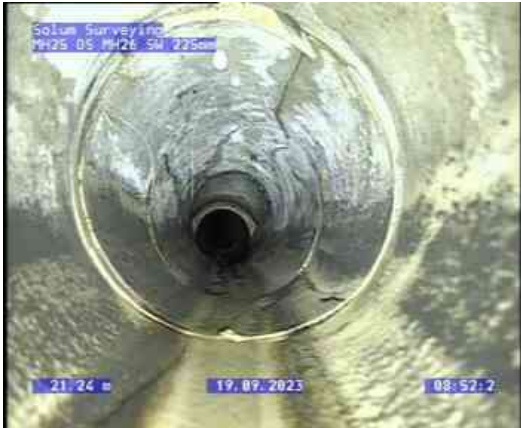
MH25X_8f274589-b94c-46e7-b1d7-ca2fcd8f8a65_20231005_132932_738.jpg, 00:01:38, 21.24 m
Broken pipe at joint from 11 o'clock to 2 o'clock

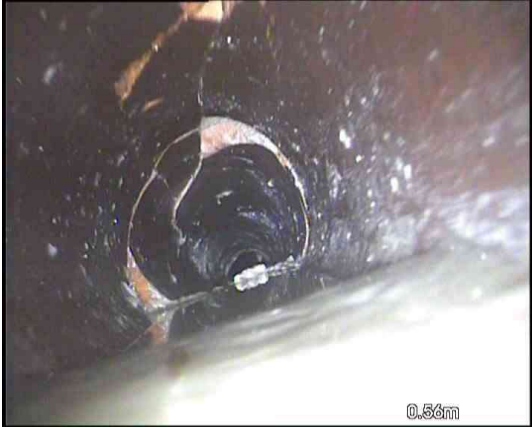
MH27X_db4a563b-b4b5-4986-9509-74b73bd5f2af_20231005_134650_419.jpg, 00:00:08, 0.56 m
Broken pipe from 9 o'clock to 3 o'clock, start

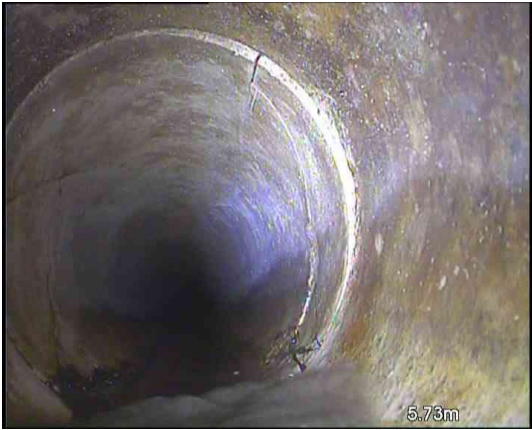
MH28X_a1b8e47f-44b9-4217-b8c7-c67eff98a3eb_20231005_140825_157.jpg, 00:00:26, 5.73 m
Broken pipe at joint from 1 o'clock to 5 o'clock

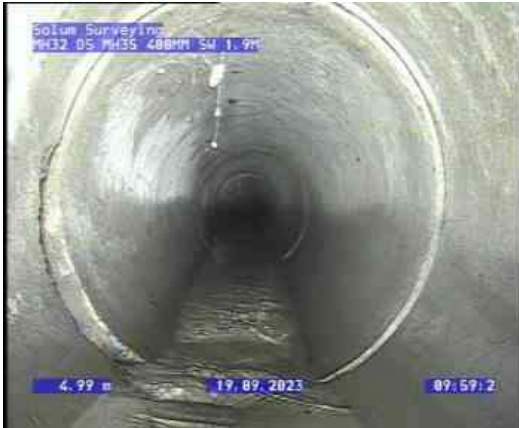
MH32X_bb127f40-8b4d-4311-a8cb-ed932acd47ee_20231009_112338_379.jpg, 00:00:32, 4.99 m
Broken pipe at joint from 7 o'clock to 9 o'clock

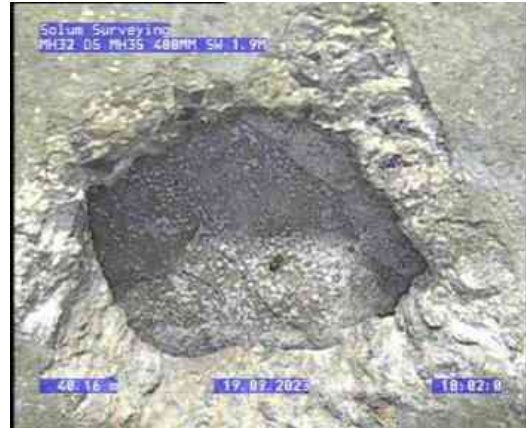
MH32X_38f532f4-52d5-430e-b97b-07a4197883f7_20231009_112625_027.jpg, 00:03:06, 40.16 m
Hole in drain or sewer at 12 o'clock

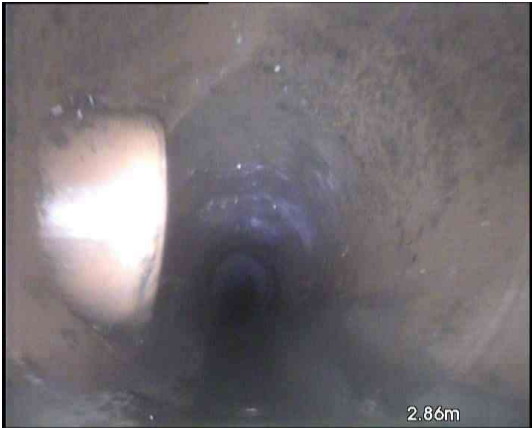
MH40X_b2c4e567-22d3-473a-81bf-3acf1dde1ad3_20231009_115330_022.jpg, 00:00:12, 2.86 m
Connection defective, connecting pipe is intruding at 9 o'clock, 150mm dia, intrusion: 15%

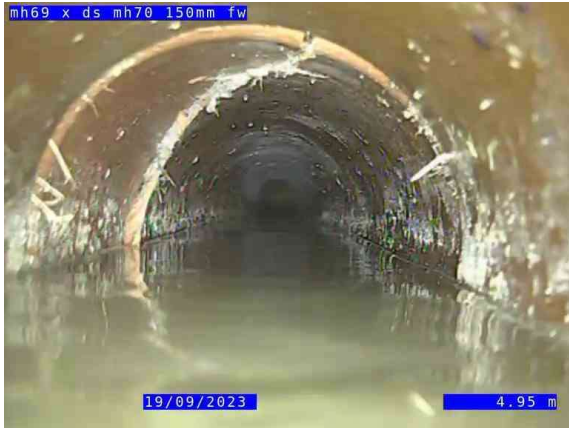
MH69X_d9ec47a4-55a2-49e9-aba4-c6384b44d033_20231009_143550_266.jpg, 00:00:31, 4.95 m
Broken pipe at joint from 9 o'clock to 1 o'clock

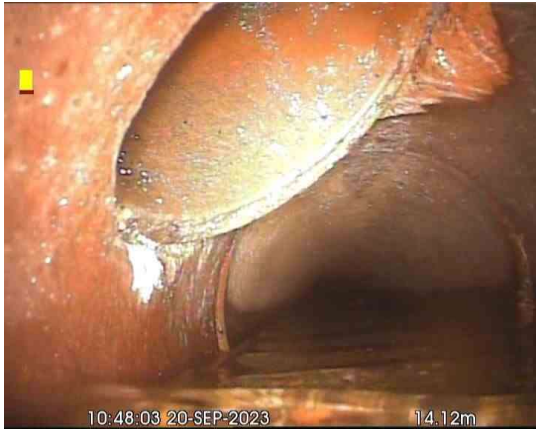
MH73X_22f6e67d-f3a7-48f1-b0f6-ed899fecf2e7_20231009_150523_113.jpg, 00:01:14, 14.12 m
Connection defective, connecting pipe is intruding at 10 o'clock, 100mm dia, intrusion: 10%

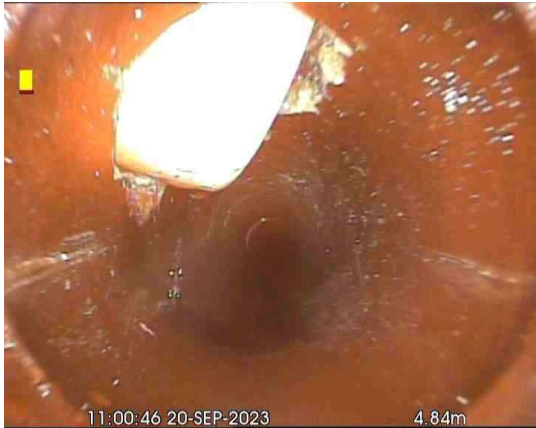
MH76X_39ae886e-d3eb-443a-ac5e-132a0f62dc9e_20231009_153203_374.jpg, 00:00:21, 4.84 m
Connection defective, connecting pipe is intruding at 10 o'clock, 100mm dia, intrusion: 10%

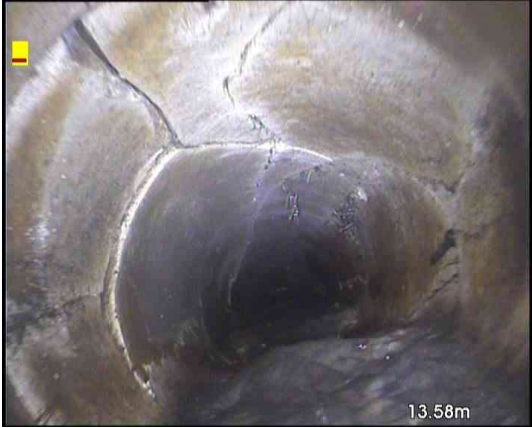
MH85X_aad4b9dc-b431-400a-b544-8d6517d1163e_20231010_085405_737.jpg, 00:00:44, 13.58 m
Broken pipe from 12 o'clock to 12 o'clock, start

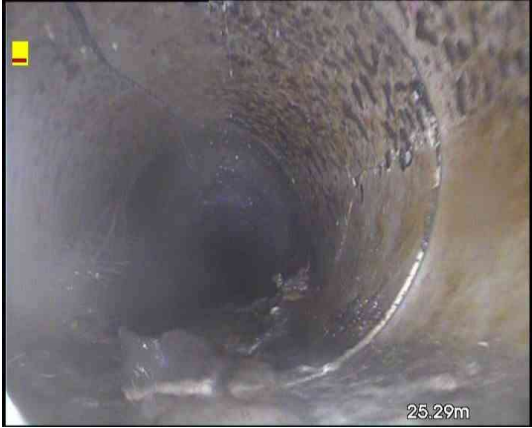
MH92X_33d811c1-21be-4341-8c1e-9bb512064dab_20231010_093544_866.jpg, 00:01:06, 25.29 m
Broken pipe at joint from 5 o'clock to 7 o'clock

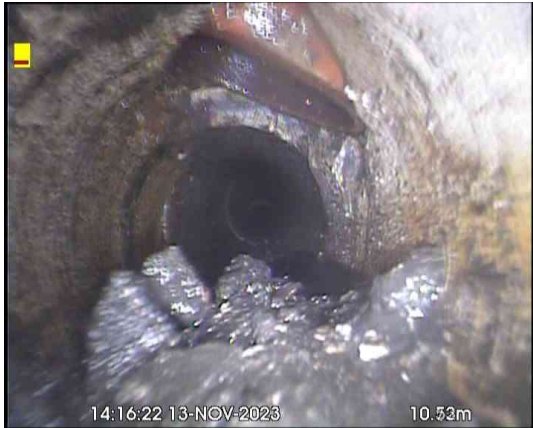
USX_f2865516-4e09-4abd-a0f9-6cf901975f0f_20231129_080052_211.jpg, 00:00:53, 10.53 m
 Connection defective, connecting pipe is damaged at 1 o'clock, 100mm dia

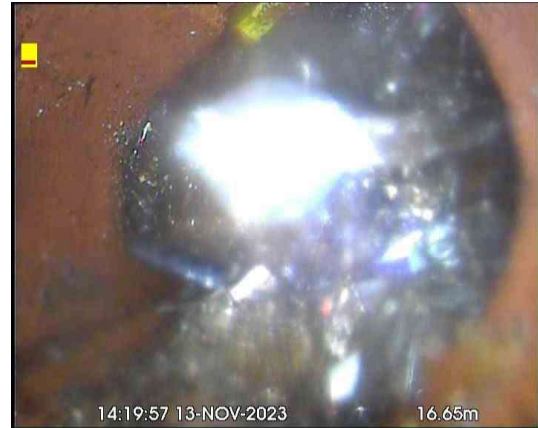
USX_d8f71e67-36f7-4359-99cd-8fe50519a856_20231129_080729_282.jpg, 00:03:19, 16.91 m
 Survey abandoned, UNABLE TO PUSH FURTHER RUN
 POSSIBLY COLLAPSED

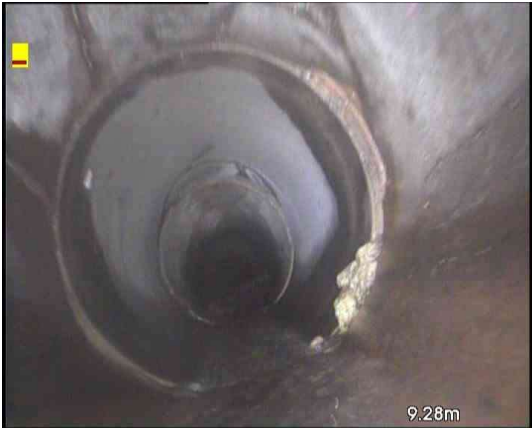
MH100X_45827f3d-dbab-42b7-94f4-a32c2b7531d5_20231010_105807_665.jpg, 00:00:28, 9.28 m
Broken pipe at joint from 1 o'clock to 3 o'clock
