Potash Farm and adjacent agricultural buildings, Holbrook, Suffolk.

Heritage Report, Summer 2023

By J Parker MSc.

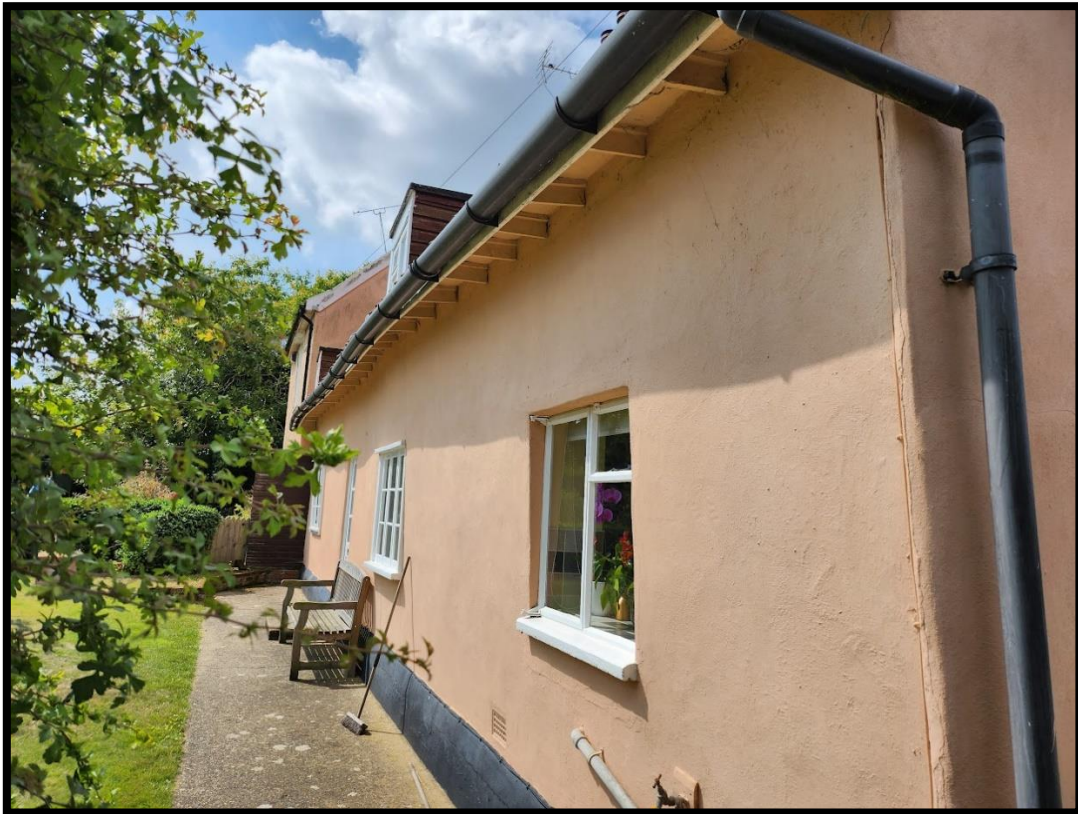
Front elevation.

Starting at the base and working upwards. The concrete path is always a concern as it holds moisture at the base of the building where originally the cill beam would be, or a brick plinth designed to let moisture escape from the lime mortar joints. Additionally, it allows rain to splash up against the lower section of the building.

At the base of the wall is a black painted plinth, this evidence of a now superseded C20 repair, cementing over the brick plinth then painting in a bituminous paint. In practice this held more moisture in the exterior wall making the problem worse. Current practice is to remove the cement to reveal the red brick plinth wall, remove any cement mortar and replace it with a breathable lime mortar, allowing the interstitial moisture to evaporate away as originally intended.

Above the plinth the wall is rendered then painted in a waterproof/plasticised paint further reducing the buildings' ability to breath. Looking through what appears to be the kitchen window, the reveal is deeper than expected for a timber frame or solid 9" wall. This suggests the building has seen some gentrification works to the front wall at least. The forward set windows and deep walling implies a brick outer wall has

been built in front of an earlier timber frame, resulting in the depth of the wall. The air brick above the plinth further supports this.

Windows. In the 1 ½ storey section of the building the windows are all timber casements except the Kitchen window that is a steel framed Crittall type, single glazed window. All appear in good condition. The thickness of the materials and use of the modern window cill as a prentice board suggest these are C20 items.

The 2-storey section has a pair of Georgian style sliding sash windows with 8 panes per sash. The lack of horns on the sashes is commonly associated with the windows being original or well-made replicas. Without closer inspection it is not possible to know.

In the 1 ½ storey section the curve in the rafter feet is repeated in the ridge suggesting movement in the roof. As the rafters have pushed out this would result from a tie beam being cut out to aid access to the first floor when it was adapted, following the availability of economically viable machined floorboards and chimneys. This may also be the result of poor fitting of the dorma windows. The roof is covered in clay pantiles. Beneath the eaves is a white painted fascia with timbers underneath that look as though they were to have a soffit attached yet have been decorated and the gaps between the rafters filled. There are Black plastic gutters serving the whole building.

If the wall is solid brickwork or timber frame the conservation advice would be the same. Remove the waterproof paint to investigate the render material. Should the render be lime, either limewash or decorate with a breathable paint to allow the wall to breath out any trapped moisture.

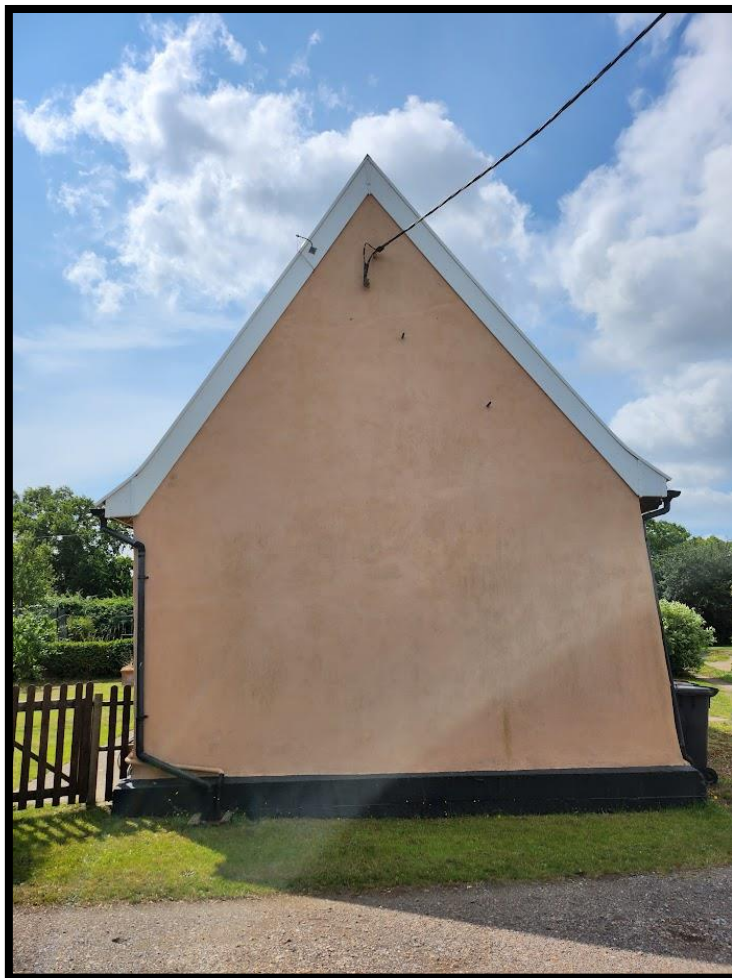
Right Elevation.

Starting at the base of the building the plinth protrudes further than the front and rear elevations. This may suggest the end wall may not have had an additional brick outer wall installed. The plinth has the same treatment as the front elevation hence the same advice applies.

The wall has signs of large crack repairs prior to being painted. The cracking suggests a cement render beneath. As cement render holds moisture in the building the timber frame will be suffering. It is recommended the cement render is carefully removed and replaced with timber laths prior to being rendered in a minimum of 2 coats of lime render prior too coats of fine lime that is then decorated in either colour matched lime was or breathable paint.

The barge boards and end covers are UPVC, it is recommended these are removed and replaced with PSE softwood boards, treated, and painted in white exterior paint.

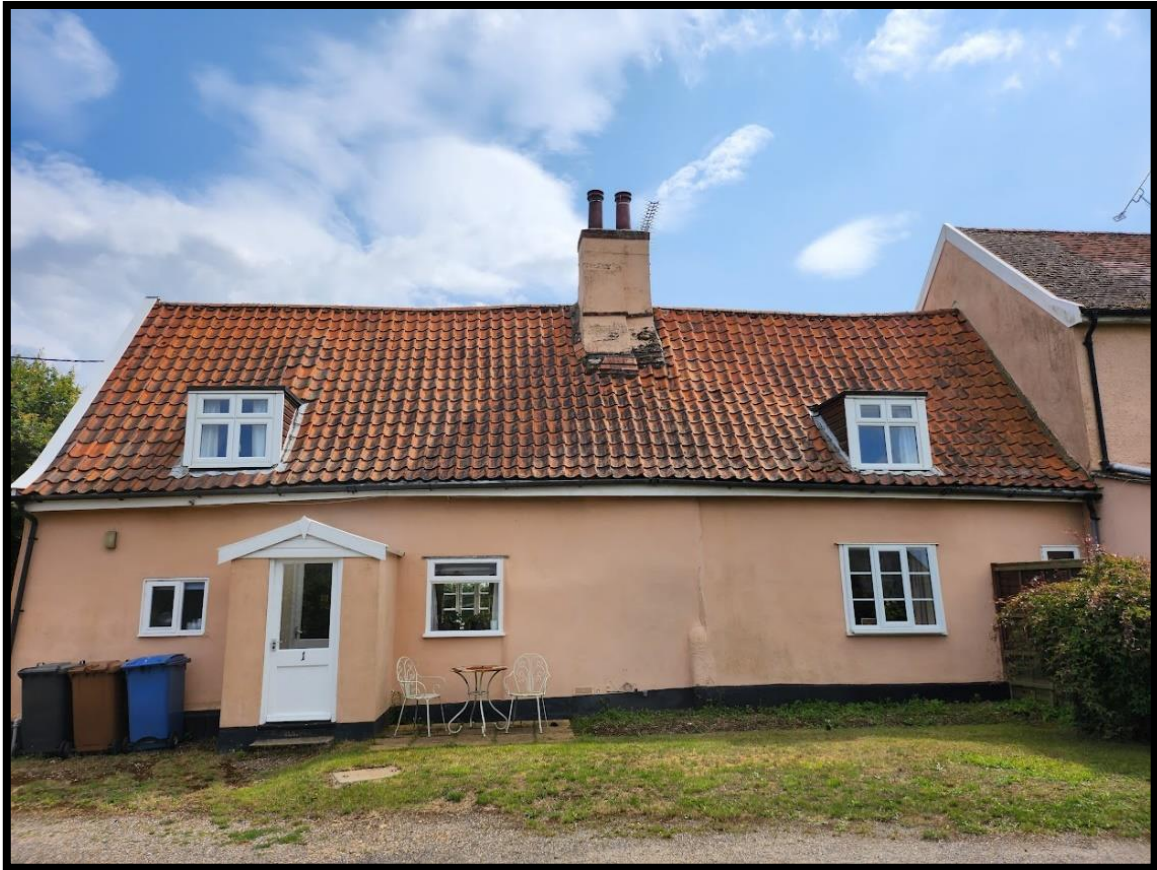
Rear Elevation.

Once again, starting from the base of the 1 ½ storey section to the left of the chimney. Thankfully, there is no concrete path, just a small patio.

Above is the black painted plinth as before. To the right of the chimney the plinth juts out with what appears to be a rendered over buttress of some kind, the wall above leans back suggesting a previous repair following what is referred to as a Rot & Roll. This is caused by trapped moisture allowing decay/rot to set in on the outer side of the cill beam, eventually the force of the studs and weakness of the decayed beam allow the beam to roll outward, changing the angle of the wall, rather than attempting to lift the whole building and return the wall to upright, it was common practice to simply build a secondary plinth wall with a new cill beam to accommodate the stud wall in this new position, as appears to have happened here. The buttress detail is likely to be a method of joining the cill beams to insure no further movement.

The rear ground floor fenestration consists of from left to right, C20 timber single glazed casement window with one opener and one fixed pane. Next is a later porch addition, with a 2XG timber half glazed door above which are timber barge boards with timber shiplap infill all painted white. The roof is insulated polycarbonate, behind the porch is a second 2XG timber half glazed door, both of which are single glazed. To the right of the porch is a single glazed casement window with opening fanlight and an unpainted

First floor fenestration is made up of two UPVC double glazed casement windows. The left window is two bays with top fanlight openers and bottom opening casement with white UPVC cheeks on the dormas. The right window is the same design but with only the top casements opening. The Dormas do not appear to be deep enough to be insulated which questions the insulation benefits from the double-glazed windows.

The sagging in the roof has been previously discussed, the rear of the roof in in fair condition with timber facias and soffits.

The chimneys. The corbelled brickwork of the left side of the chimney is built sooner than the right side. This may be due to several reasons yet the most likely is the right side is a later addition or the left side required additional support due to earlier failure.

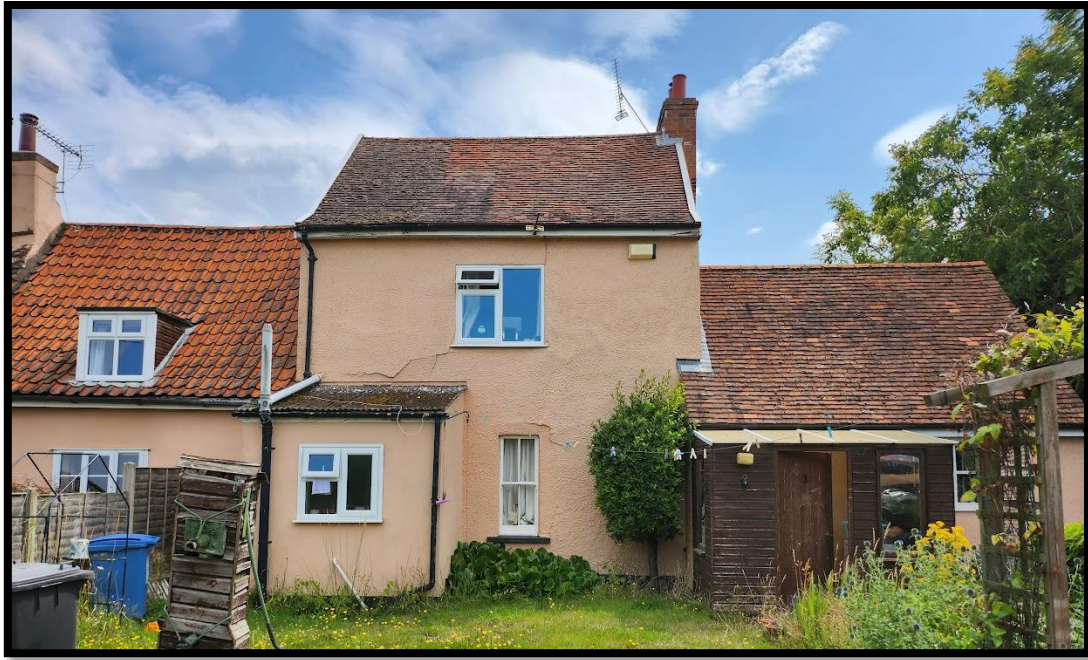
Building 2. The 2 Storey section and C20 extension.

From the base upward. We have the now familiar black painted rendered plinth. The exterior of this section is in brickwork, yet the change of pitch suggests it be similar to the listed building with a timber frame later gentrified, it may just have been built this way to match the existing building, without further investigation we cannot be sure. The main section of the building has been covered in rough and pebbled render that is in the process of failing. It appears the render has detached from the wall most likely due to the moisture in the wall trying to escape, then seasonal movement has formed the cracks to allow it to move away from the building.

Fenestration. From left to right, the C20 rear extension which is probably a bathroom has a UPVC double glazed casement with a side and top opener. The next window is a Victorian style, single glazed sliding sash. The sash boxes seem quite heavily buried in the render, yet being a smaller window there is a chance it doesn't have weights or it's a later window with a different slide system. On the first floor is a UPVC double glazed casement with a side and top opener and one fixed unit.

The Facias and soffit are timber and in need of repair and decoration, as decay is present at the right side.

The roof is red clay plane tiled; the ridge tiles are worn showing the cement mortar joints standing proud of the ridge tile. The chimney is C20 item evident by the brick size.

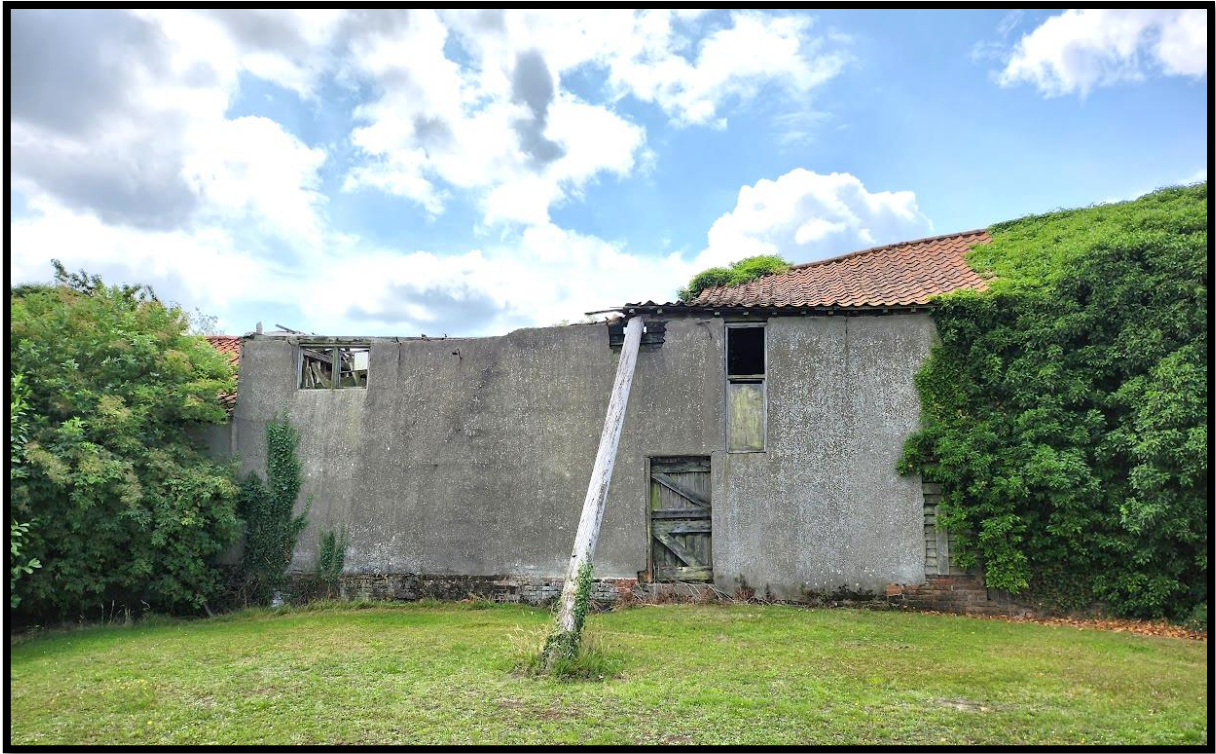
The North elevation of Building 3.

Starting from the base upward. The base of the wall is constructed in soft red brickwork in an English garden wall bond with lime mortar.

A large proportion of the wall needs repointing. Small sections have been repointed in cement that has caused spalling of the bricks.

Above the plinth wall is timber frame that has had cement render applied directly onto the feather-edge boarding, though this has proved detrimental to the building the finish is smooth. The render has added additional weight to the wall which has aided its failure by trapping water in the timber frame which has then weakened the timber behind. The collapsing of the roof destabilised the wall requiring the large timber post to be utilised as a brace.

As is common in farm buildings items not necessarily made for the building have been utilised to adapt the building to its changing requirements in the form of the timber window frames, most likely installed to provide daylight inside the barn.

The plinth wall will benefit from any cement mortar being carefully removed and replaced with the correct lime mortar, preferably using local sand to get a colour match.

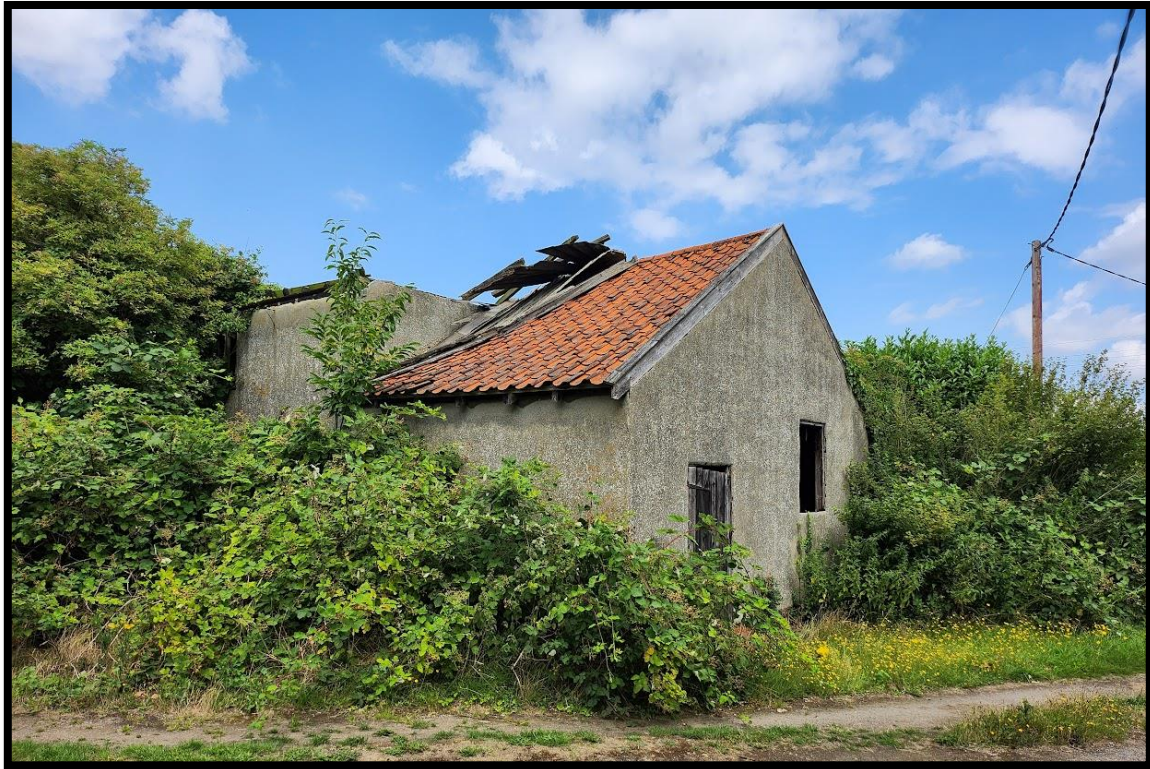
The East elevation of Building 3.

Starting from the base upward. The base of the wall is constructed in soft red brickwork in a current stretcher bond as this section of the barn is a C20 addition to the larger barn behind. The wall is in overall acceptable condition.

Once again, above the plinth wall is modern timber frame that has had cement render applied directly onto the feather-edge boarding, the finish is smooth.

The fenestration consists of a door/gate that is in the process of collapsing and an open timber window frame.

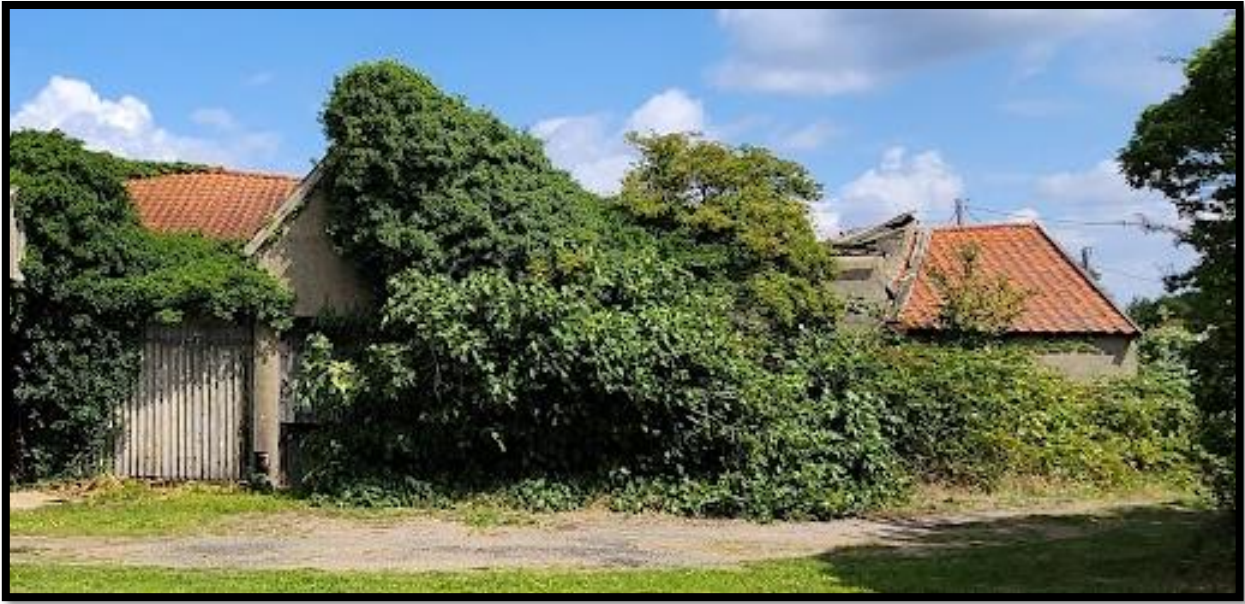
The South elevation of Building 3.

Behind the vegetation is the Midstrey serving the barn.

Starting from the base upward. The base of the wall is constructed in soft red brickwork but is hardly visible as the land is raised to the opening and the inside floor has been concreted only showing the top course of bricks.

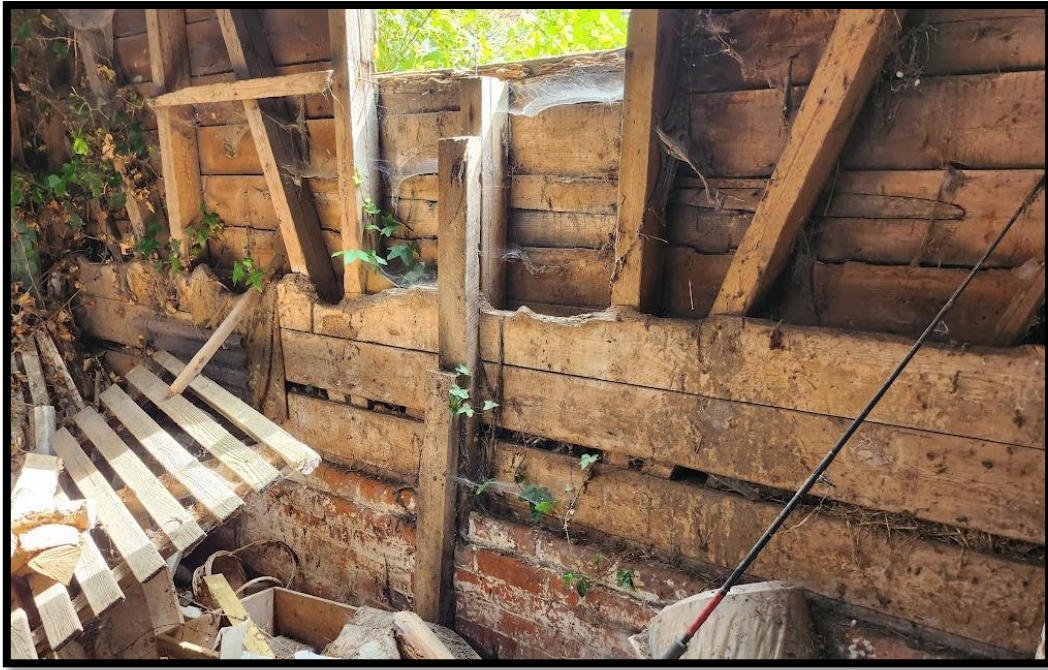
The top rail has been chewed to this shape.

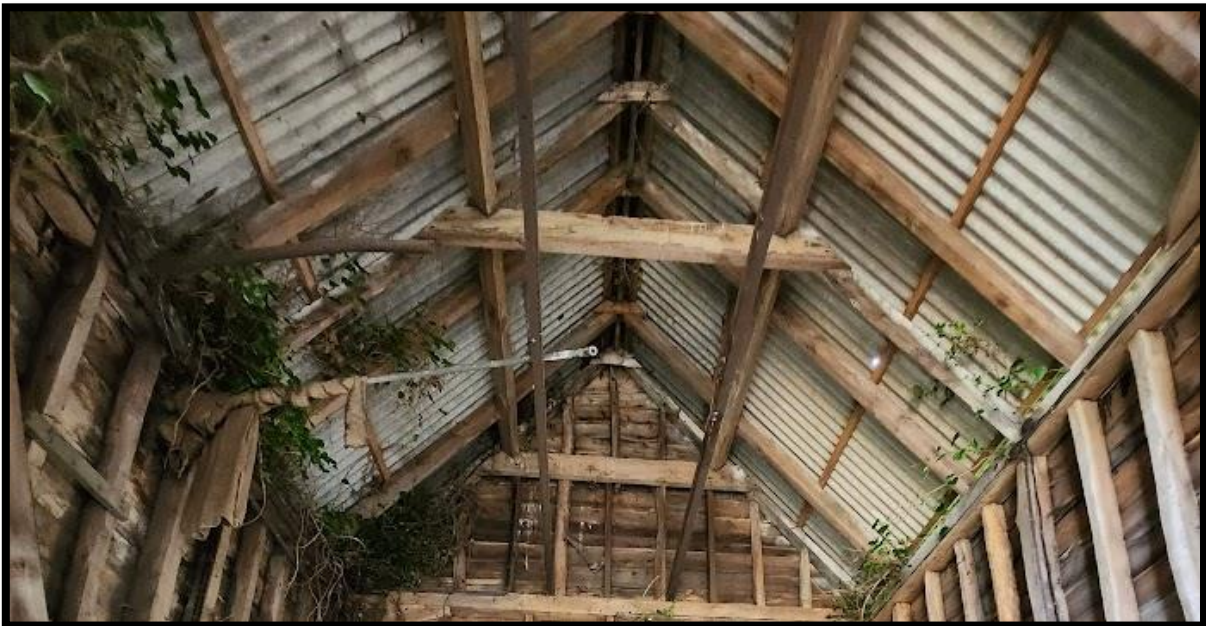
The timbers are all relatively modern machined softwood with rafter spacings to only support a corrugated sheeted roof.

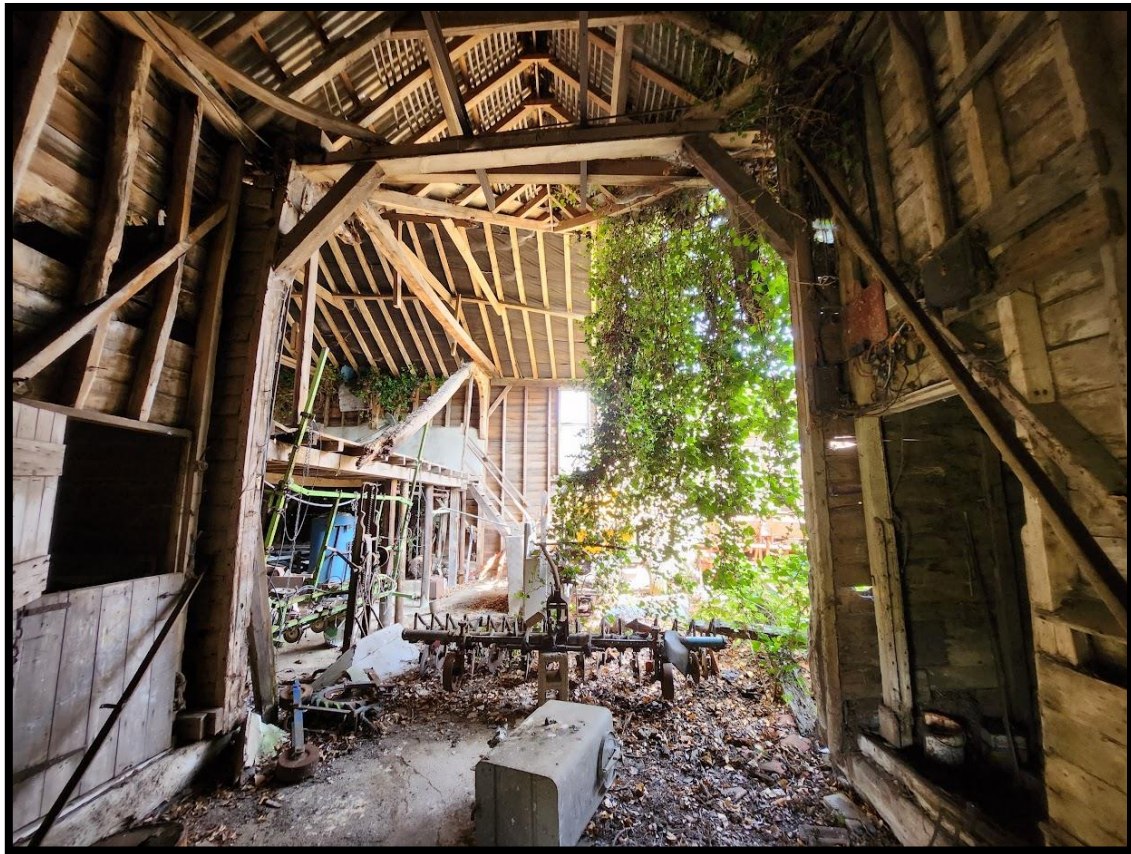
In the image above we see the start of the remaining roof, a C20 replacement that has catastrophically failed. A timber mezzanine floor has also been installed on the left.

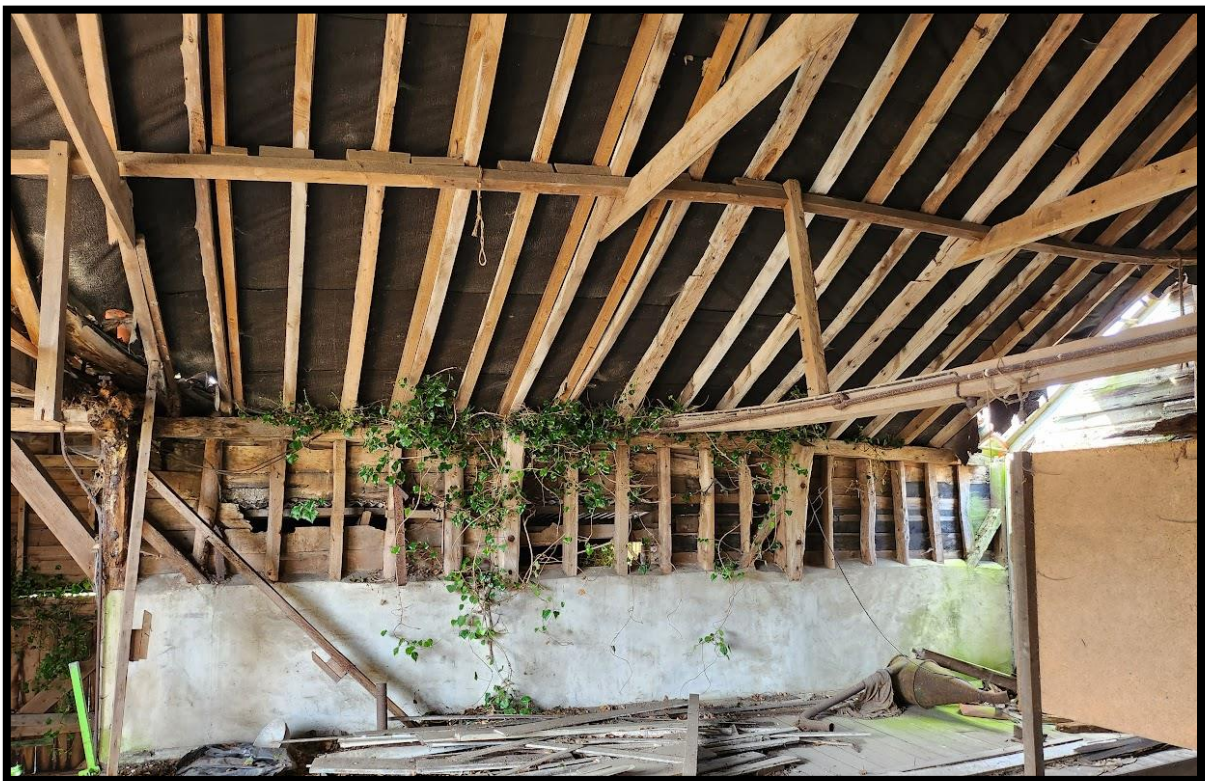
In the above picture we see 3 kneelers that have been cut off to accommodate the new roof. Each one of the kneelers would have been attached to a tie beam, whereas the new roof only has 1 tie beam with a steel tie bar which is only fixed to the wall plate with no post beneath it. There are collars above this, but these will not provide the strength of a tie beam. This and the additional weight of the cement render is clearly a huge contributing factor to the collapse of the roof structure. The weight of the Pan tiles would push the roof down and with little strength in tie beams, the walls were pushed outward facilitating the collapse when the tie beams give way. Additional weight from snow or even the vegetation would put additional stress on an already weakened roof. So once again C20 ingenuity has resulted in failure of an older building.

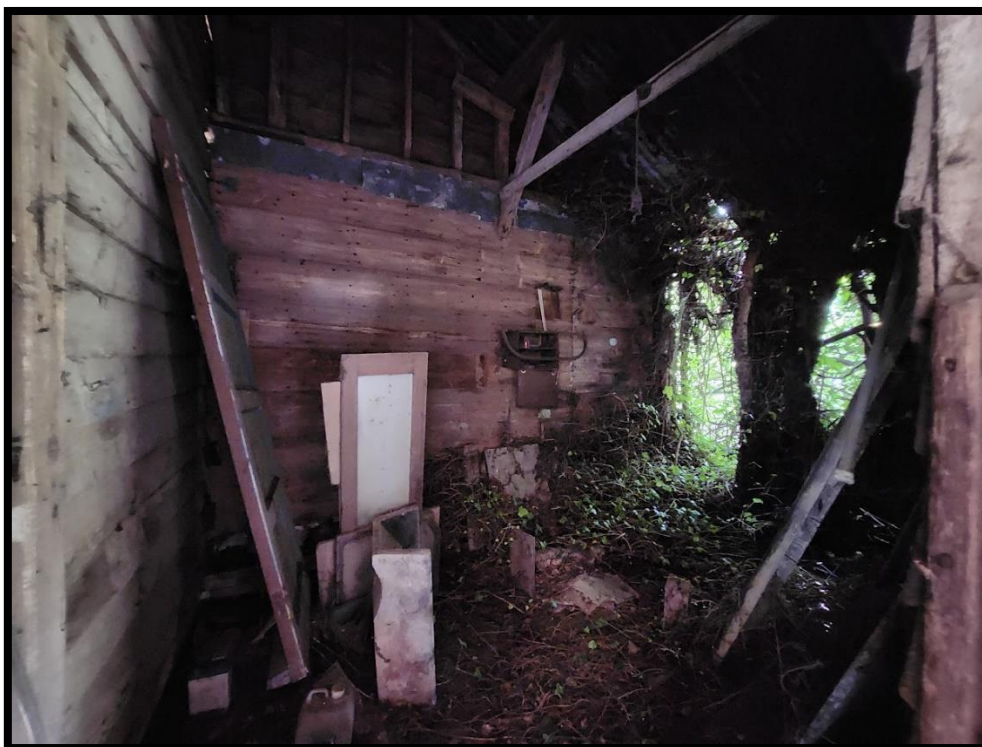
Right room.

To call this a room is probably a stretch as it appears the tree growing in front of the building is forming a front wall. The three walls are the exterior of the Midstrey, the exterior of the main barn and a C20 wall built to form the space. The C20 corrugated metal lean-too roof is a continuation from the main barn providing cover. The side door in the Midstrey suggests its purpose was connected to the processes of the main barn.

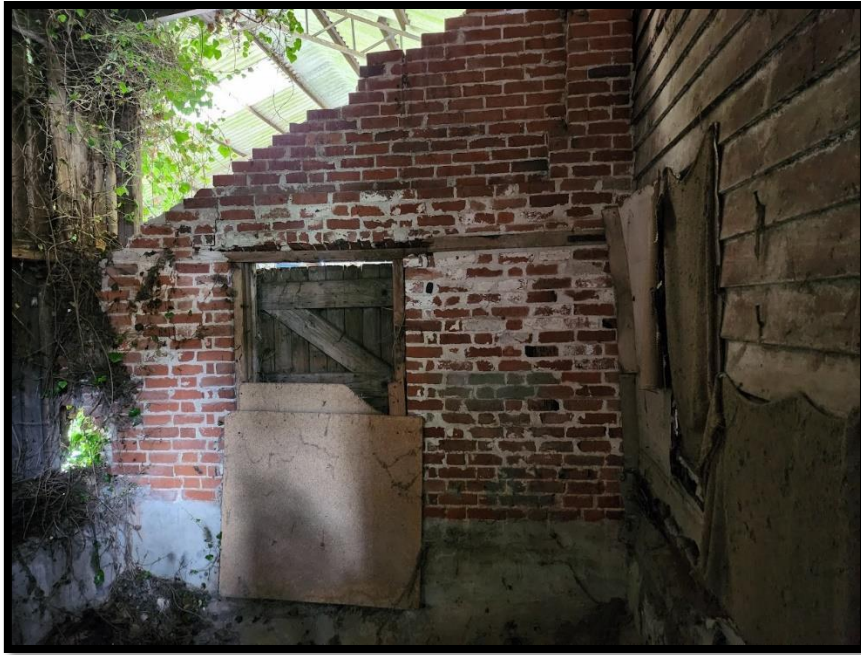
A

Pic A. The far wall looking from the side door in the Midstrety.

A. The wall in this picture started as a Soft Red brick solid 9" with a wall plate on top. Above this is later stretcher bond brickwork that would have been built up to accommodate the end of a lean-to roof, yet currently the room is served by a C20 flat roof in corrugated metal sheeting.

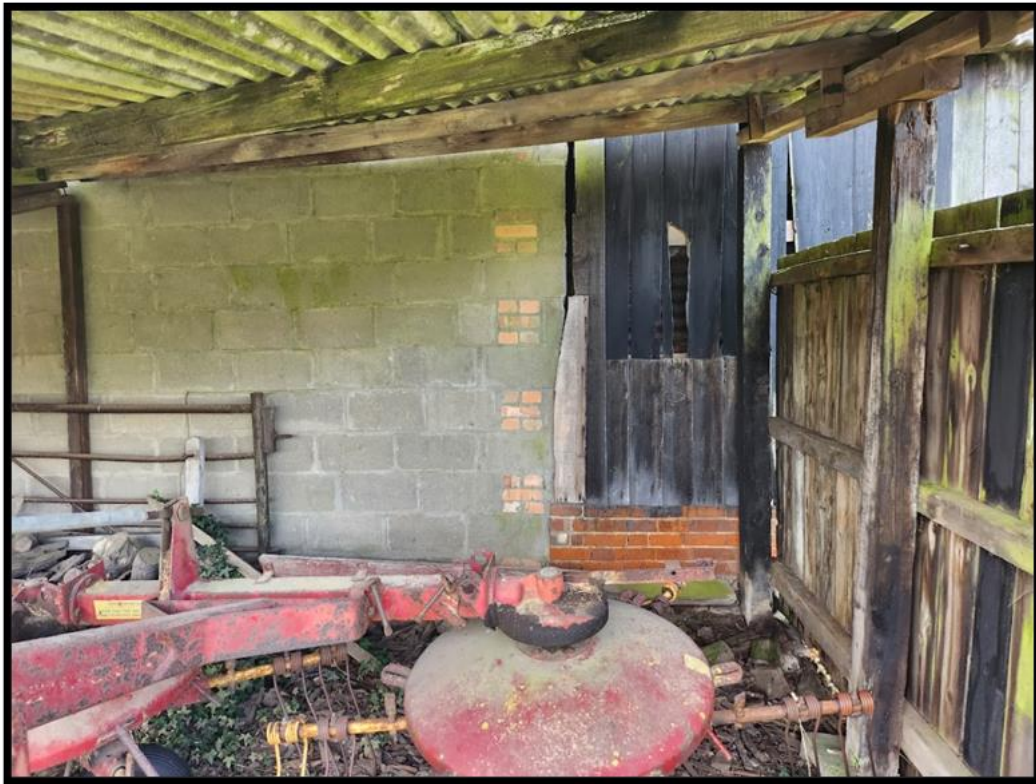
Building 4.

From the base the walls have been replaced in concrete blockwork up to the wall plate. The roof is timber construction covered in red 3 radius pantiles.

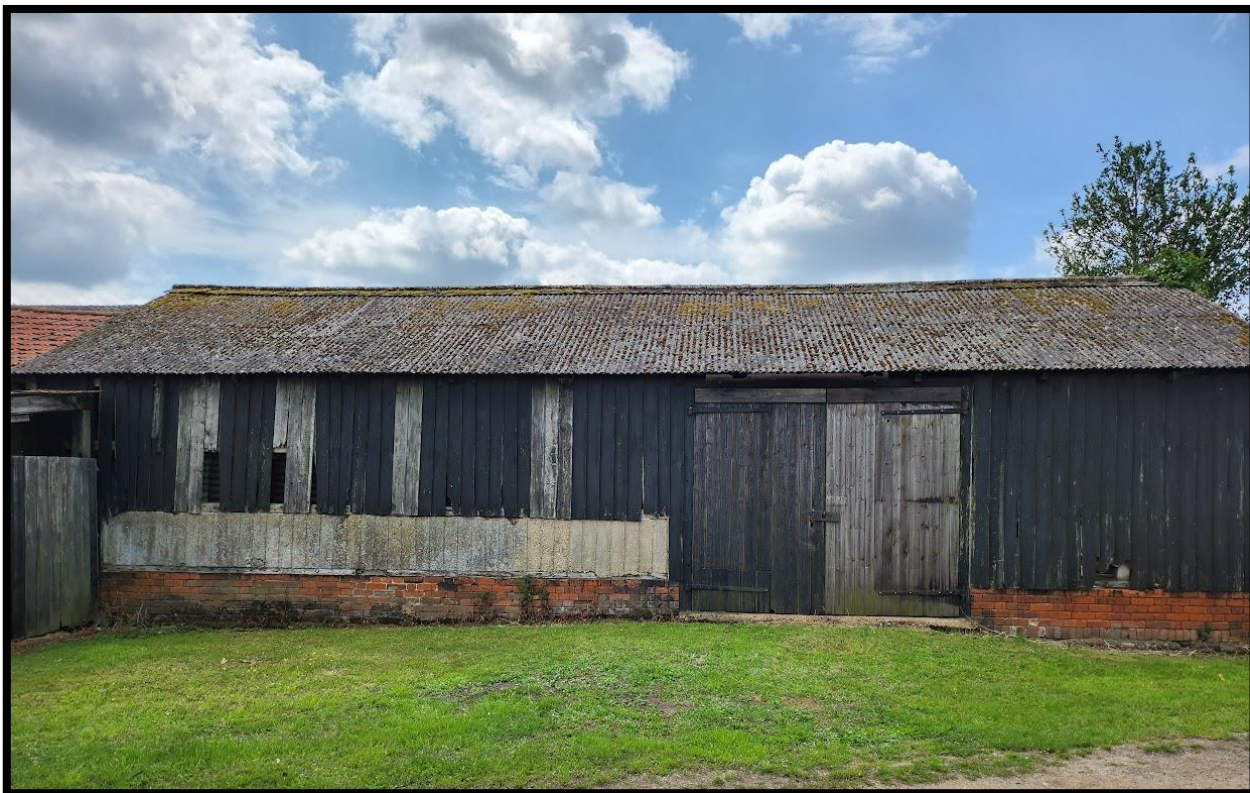
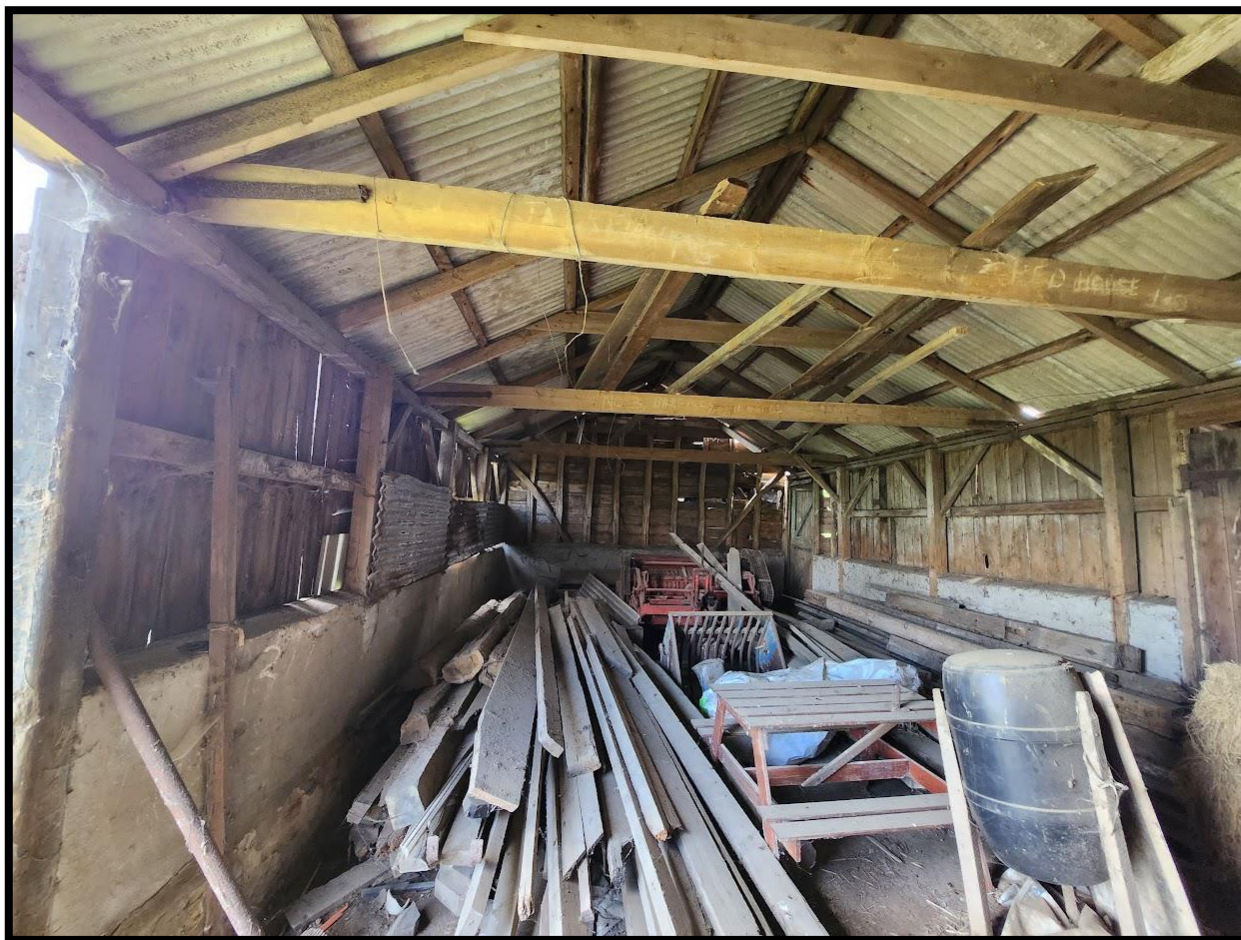
Building 5. Timber framed Barn.

At the base of the building is the original plinth wall built in soft red bricks in Monk's bond with an upturned header course at its base. Above this is what appears to be a shuttered concrete walling between the timber posts of the bay construction. The change in materials suggest this is a later building that replaced an older barn. The current construction is mid C20 with machined timbers and a shallow pitched roof that is designed to support the corrugated cement sheeted roof.

The walls above the shuttering are timber stud with the weather boardings fixed vertically.

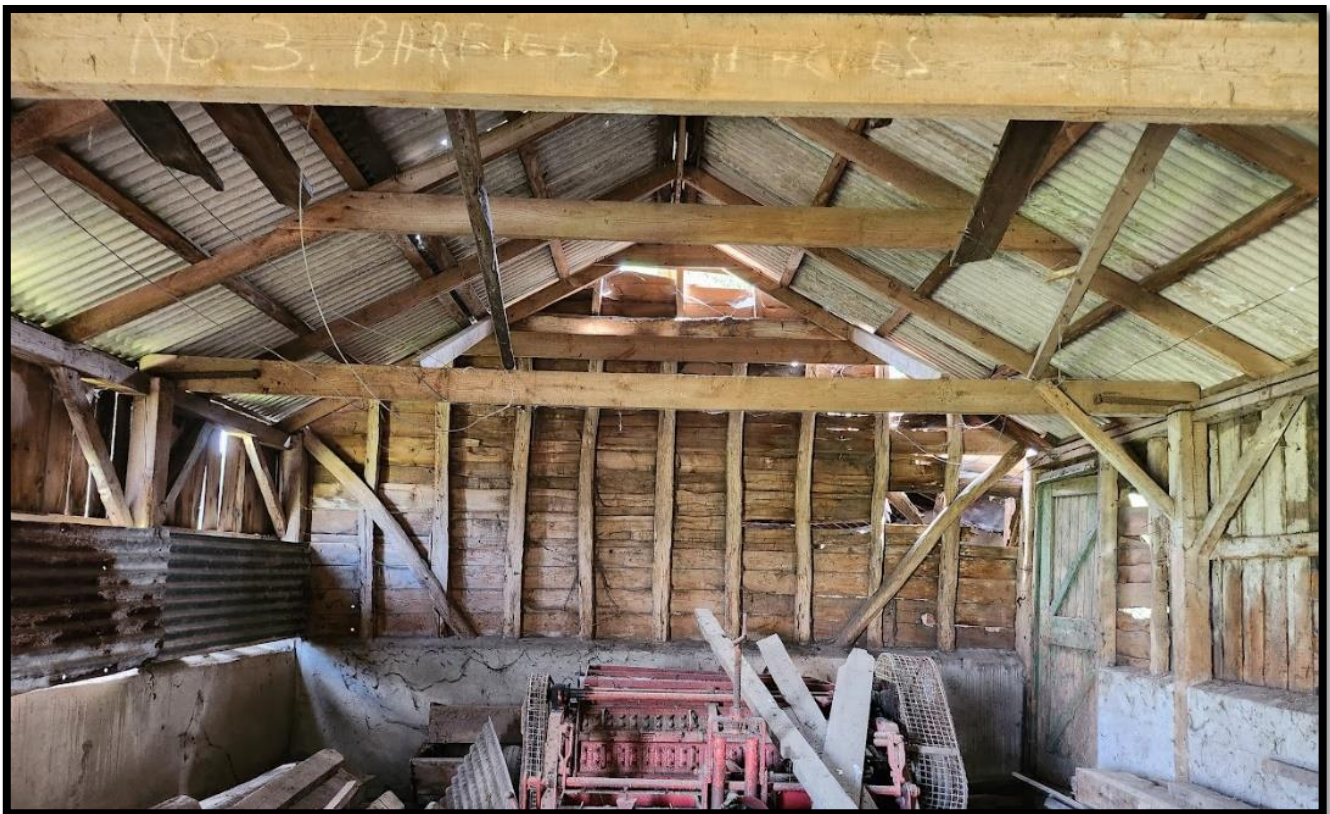
The end wall nearest building 3 is built in an older style of carpentry with cut in diagonal braces shown below. This supports the suggestion that the current building is a replacement of a former structure.

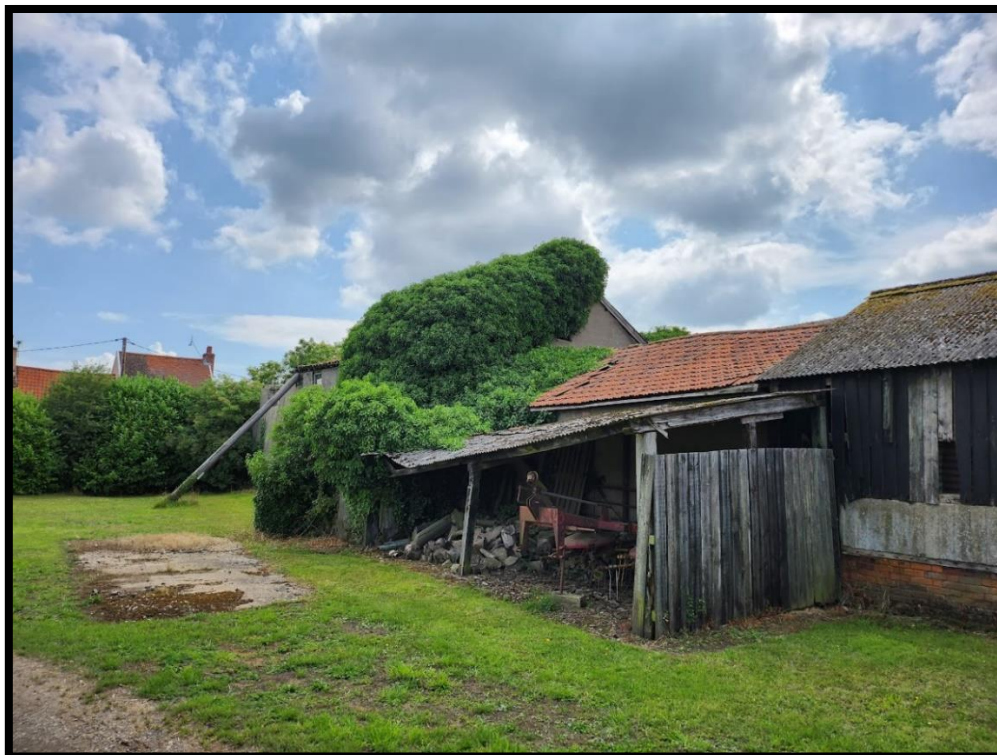
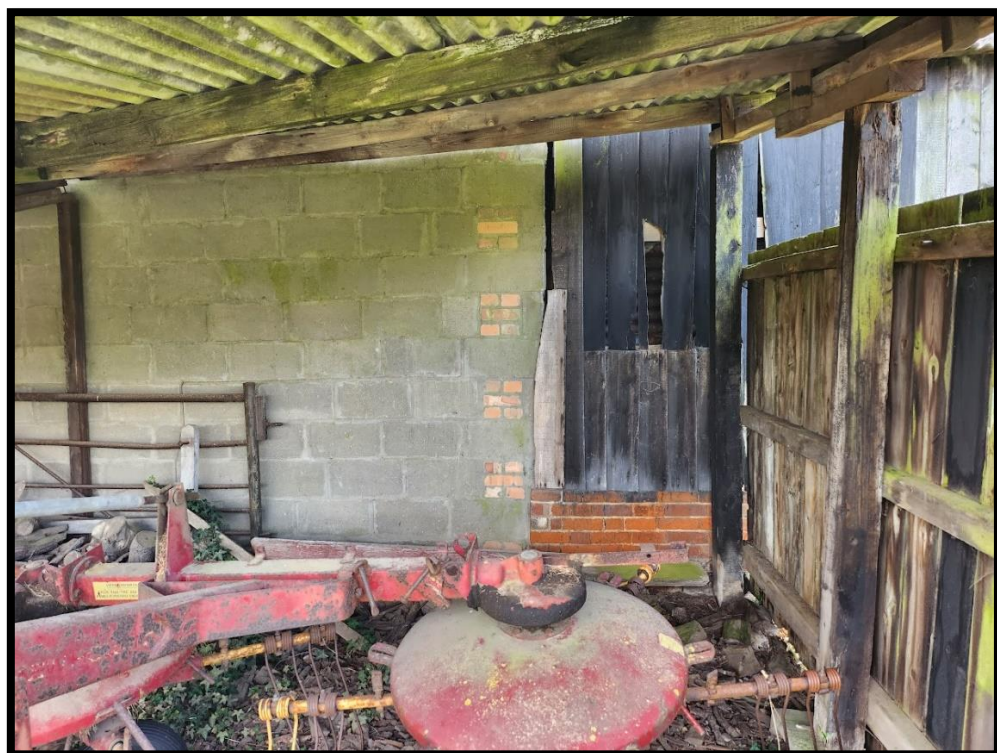
Building 6.

Building 6 is a collapsing timber lean-to shelter, abutted to Building 4. It is a C20 studwork frame with evidence of previous budget repairs. To the left is a section almost completely covered in foliage, it appears to have been a large cupboard.

The roof is timber construction covered in corrugated asbestos type sheeting.

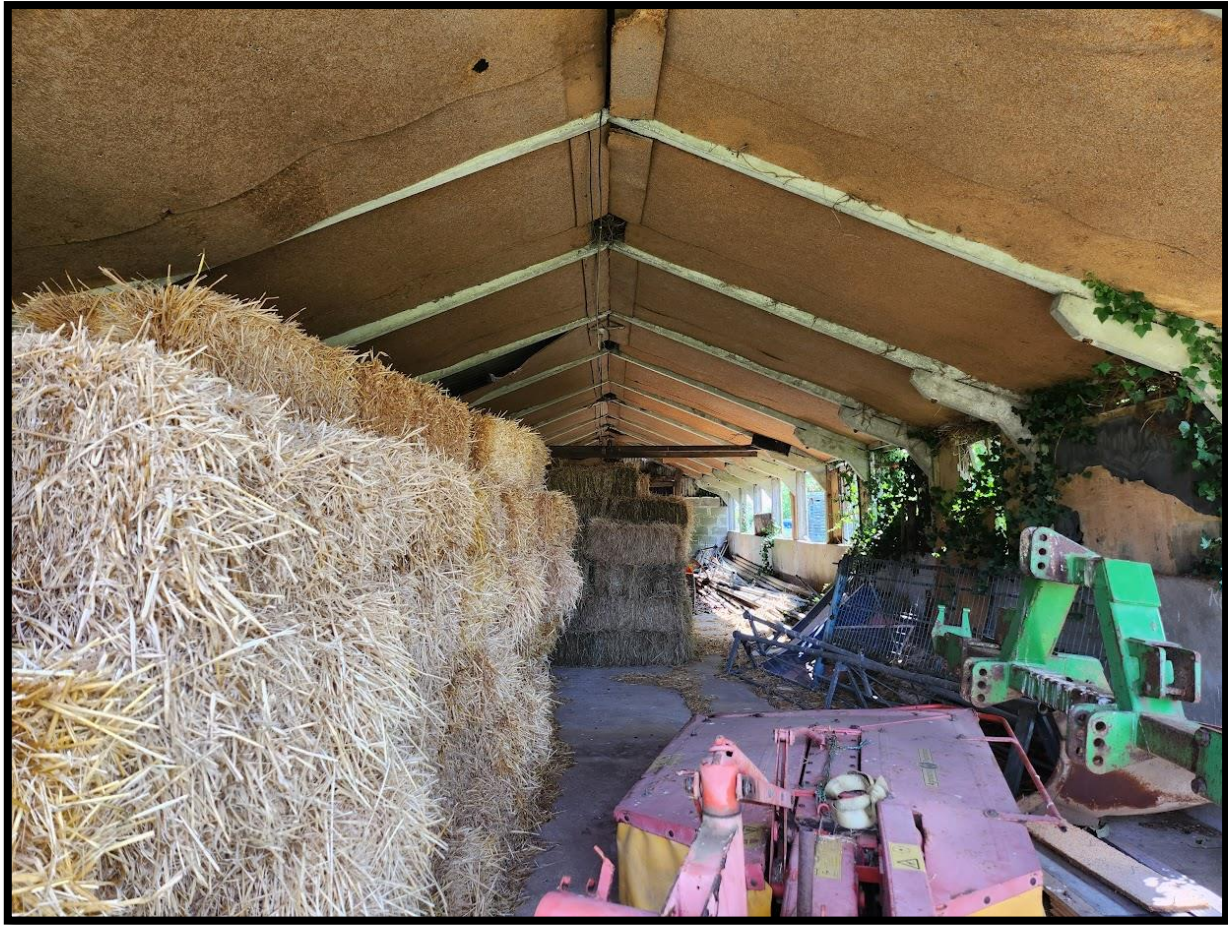
Interior view of building 8.

Building 8 from the base upward. The building is sat on a concrete slab with what appears to be a drainage channel in the centre running the full length of the building.

The structure of the building is concrete bolt together frames with concrete kneeler bracing forming bays. Between the bays are a mix of full and half height blockwork walls that are cement rendered on the interior of the building. Beyond this in some of the bays are the remains of timber stud walling. A few of the bays also have cement render applied to them. There are also the remains of timber casement windows in a Victorian style with top horizontal openers. These have all lost their glazing and are economically beyond repair.
