STRUCTURAL APPRAISAL

CONVERSION OF LARGE BARN

POTASH FARM

JOB NO: R3217

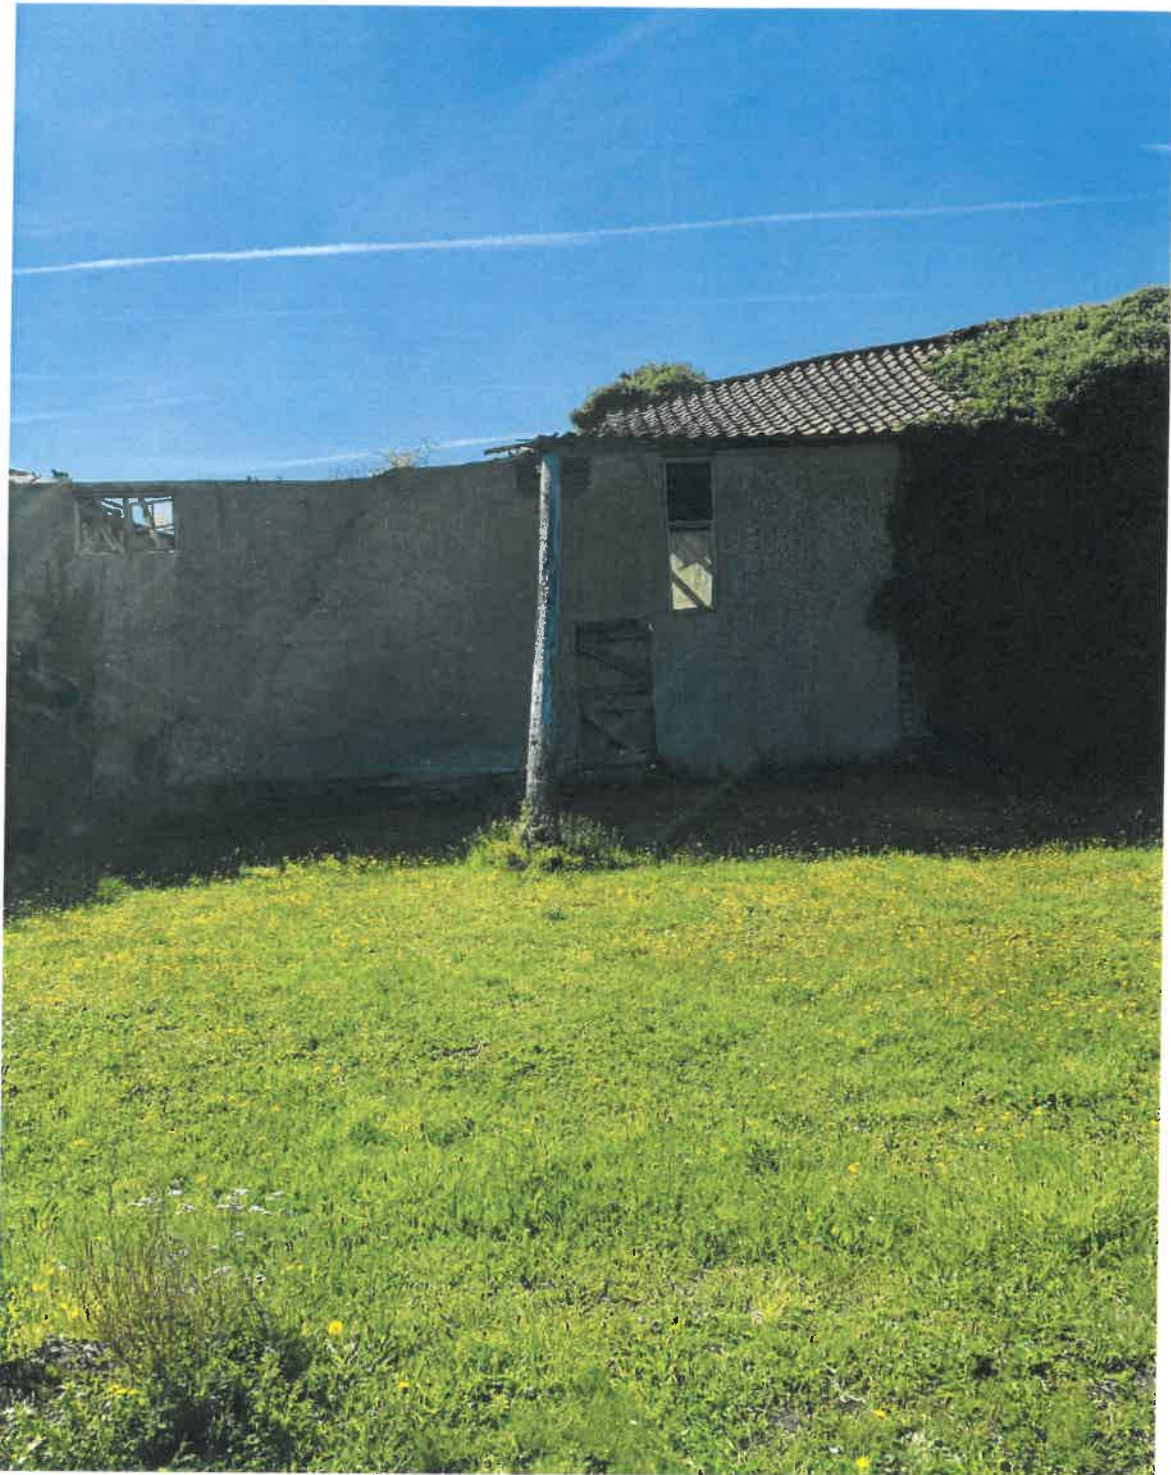
Photograph 1

Showing the missing roof and timber rafter to stabilise the wall.

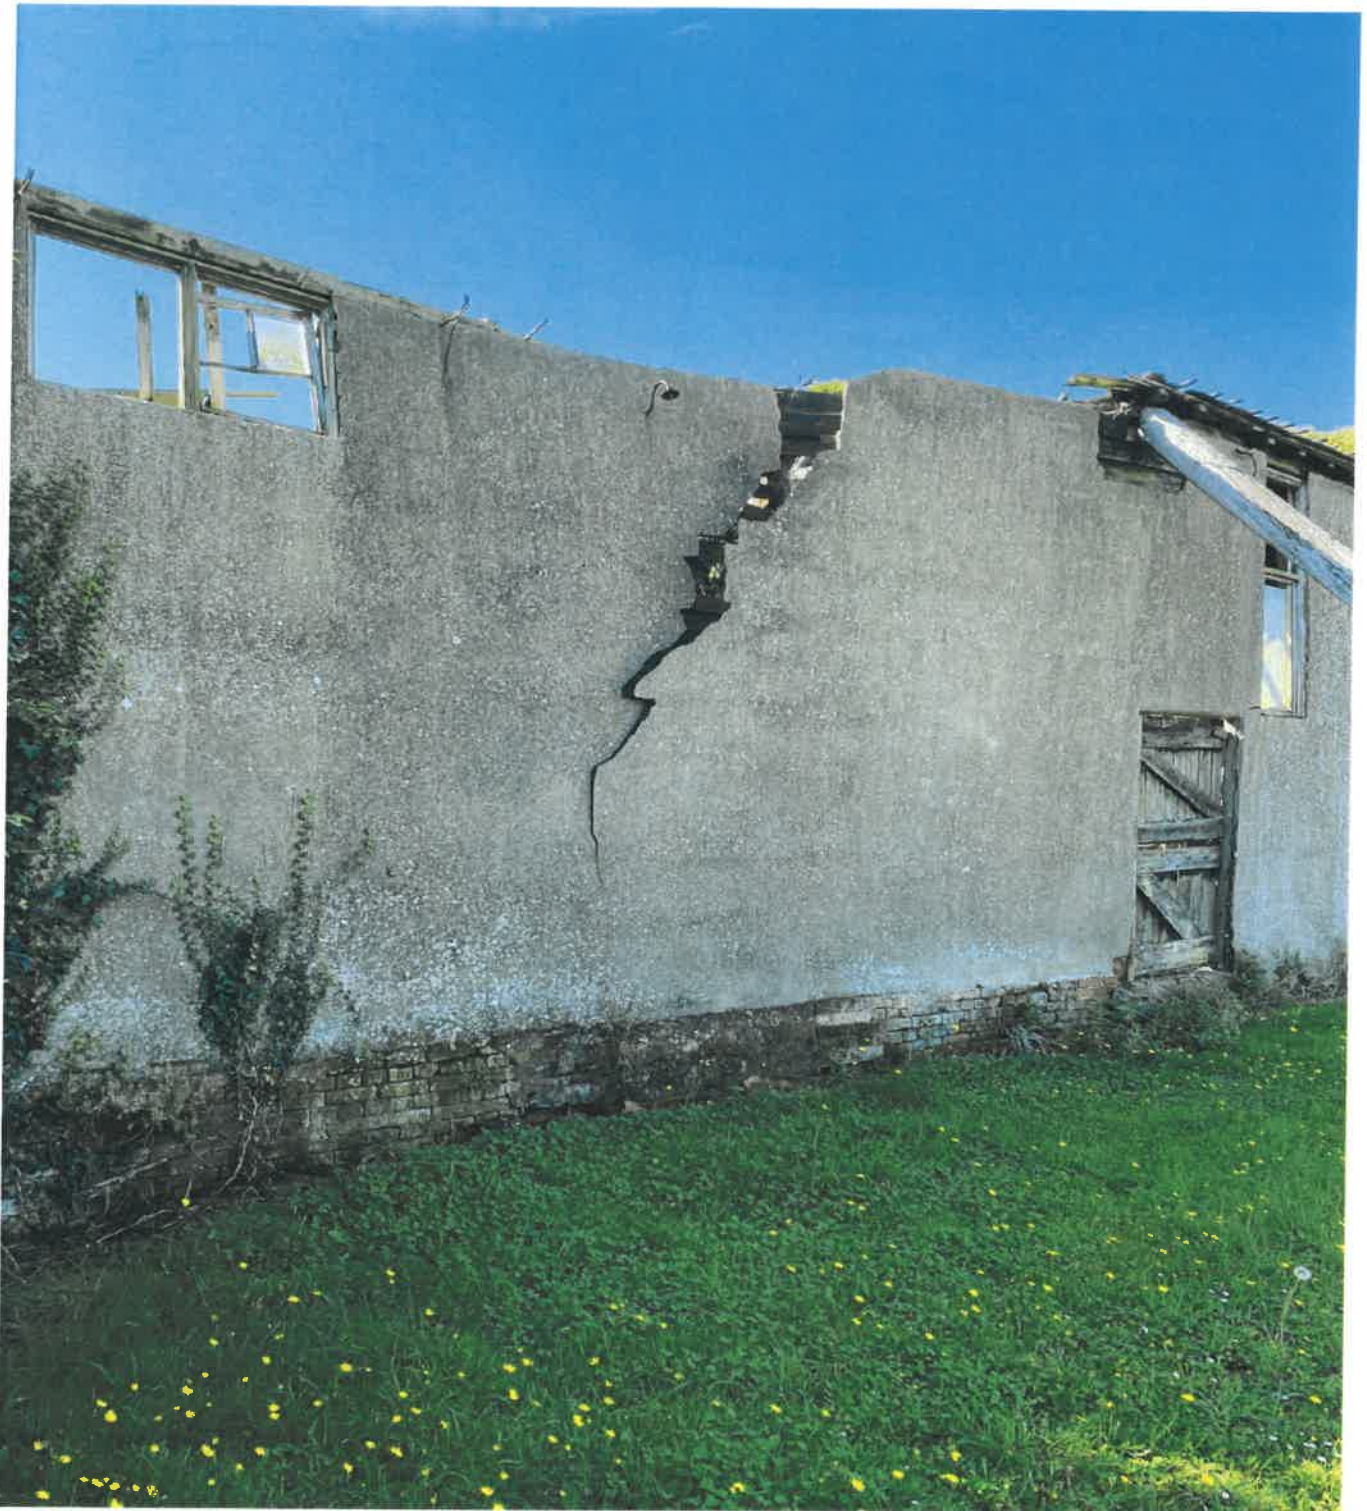
Photograph 2

Showing crack damage and distortion to rear external wall.

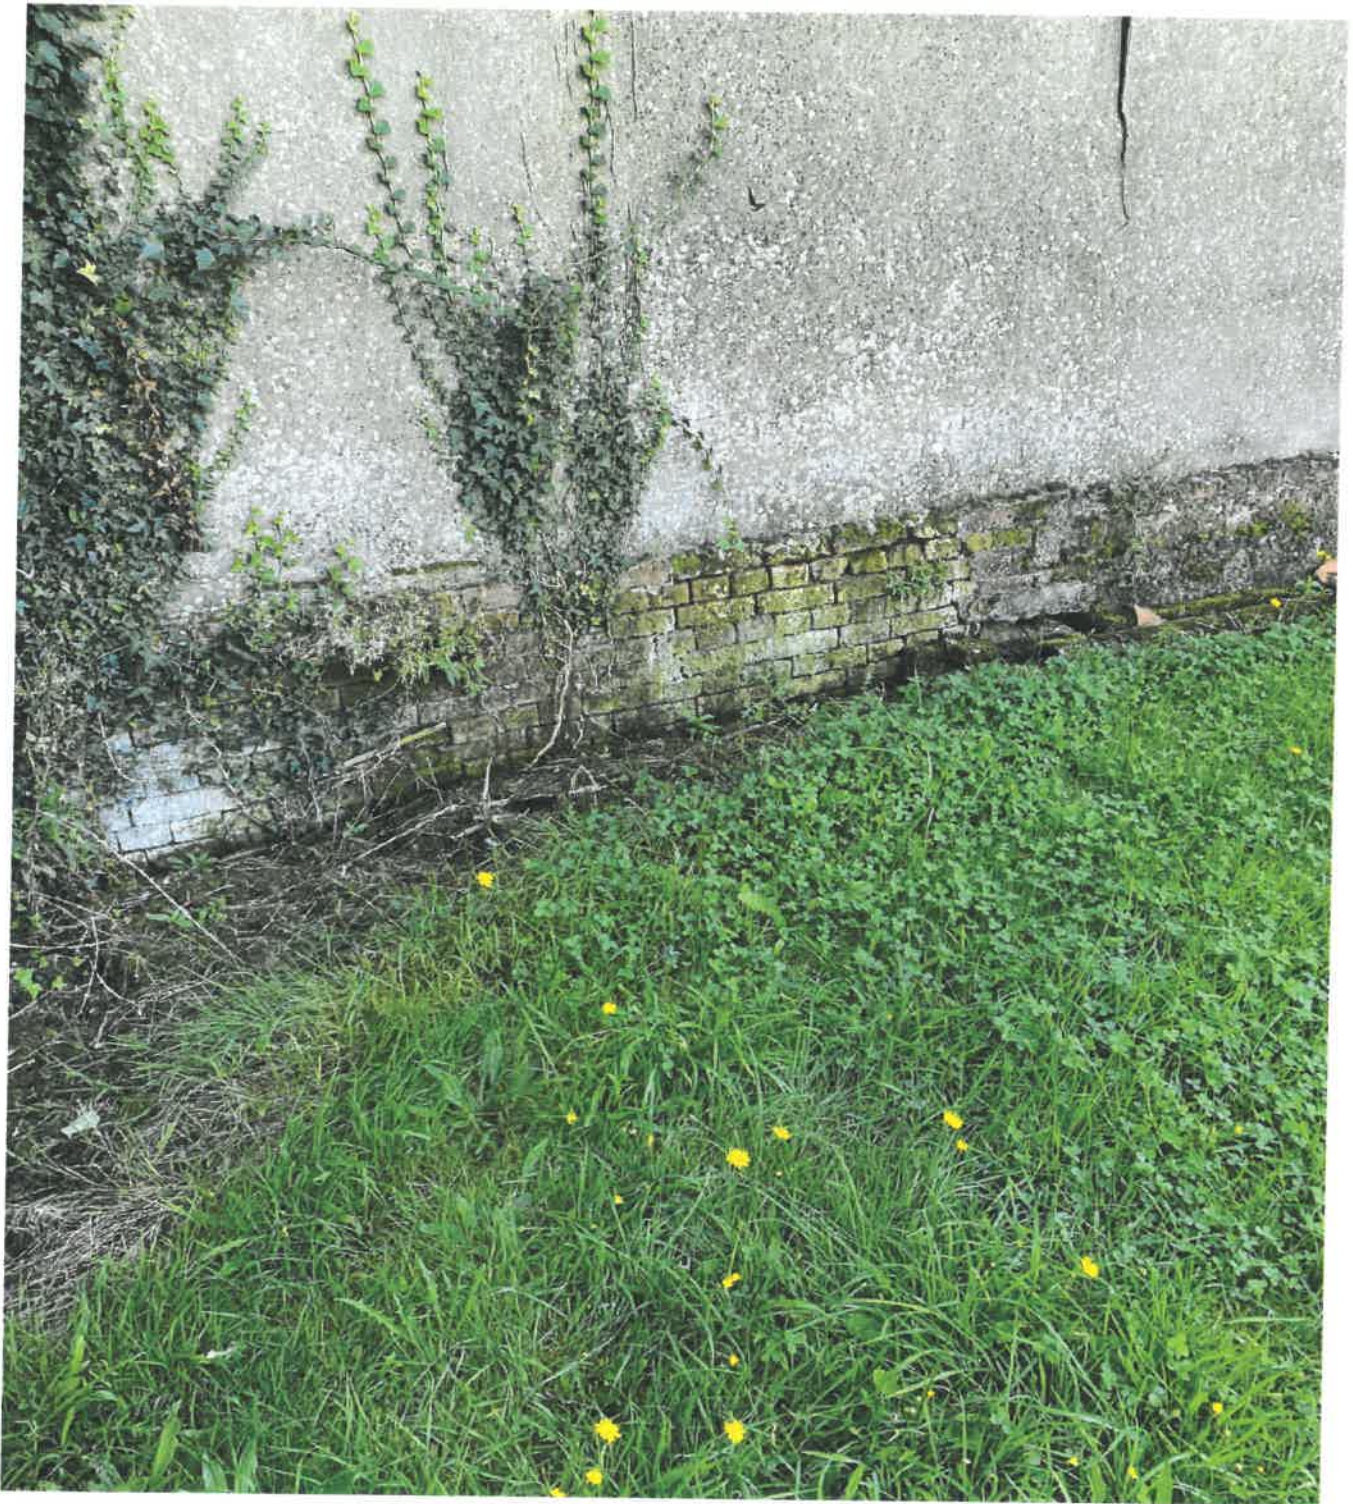
Photograph 3

Showing weathering in brick plinth.

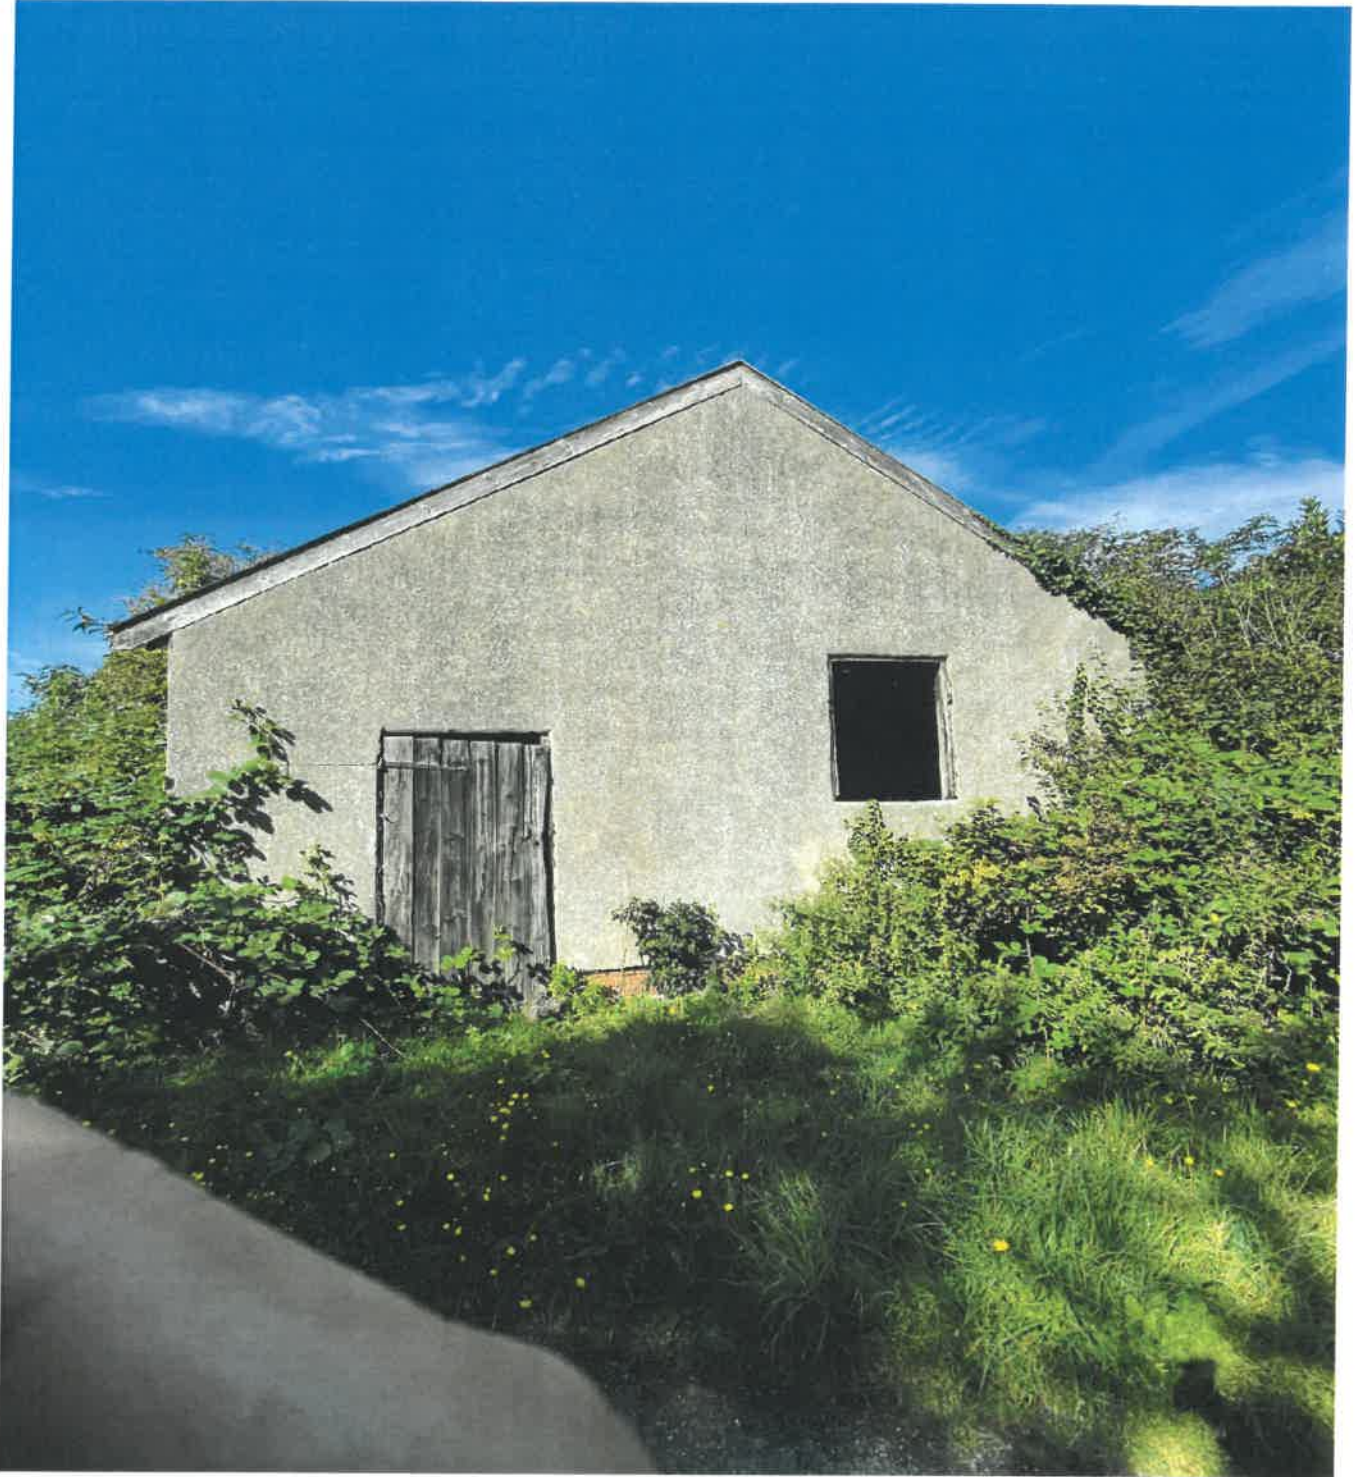
Photograph 4

Showing lefthand flank wall.

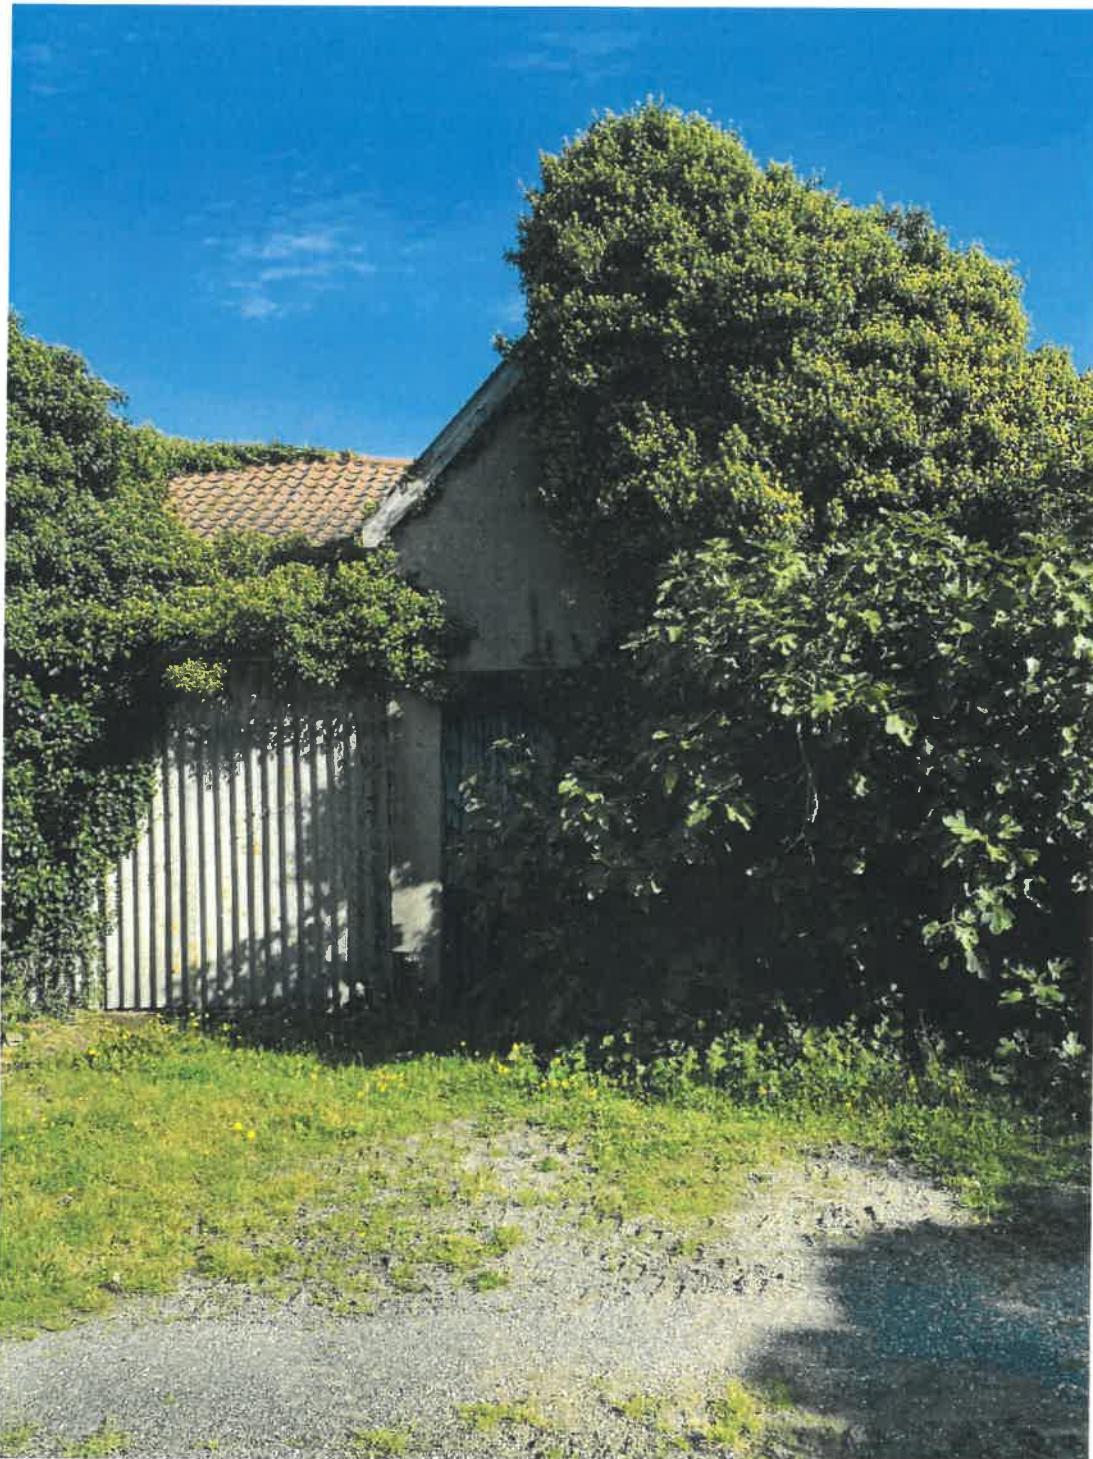
Photograph 5

Showing entrance to the barn covered in overgrown vegetation.

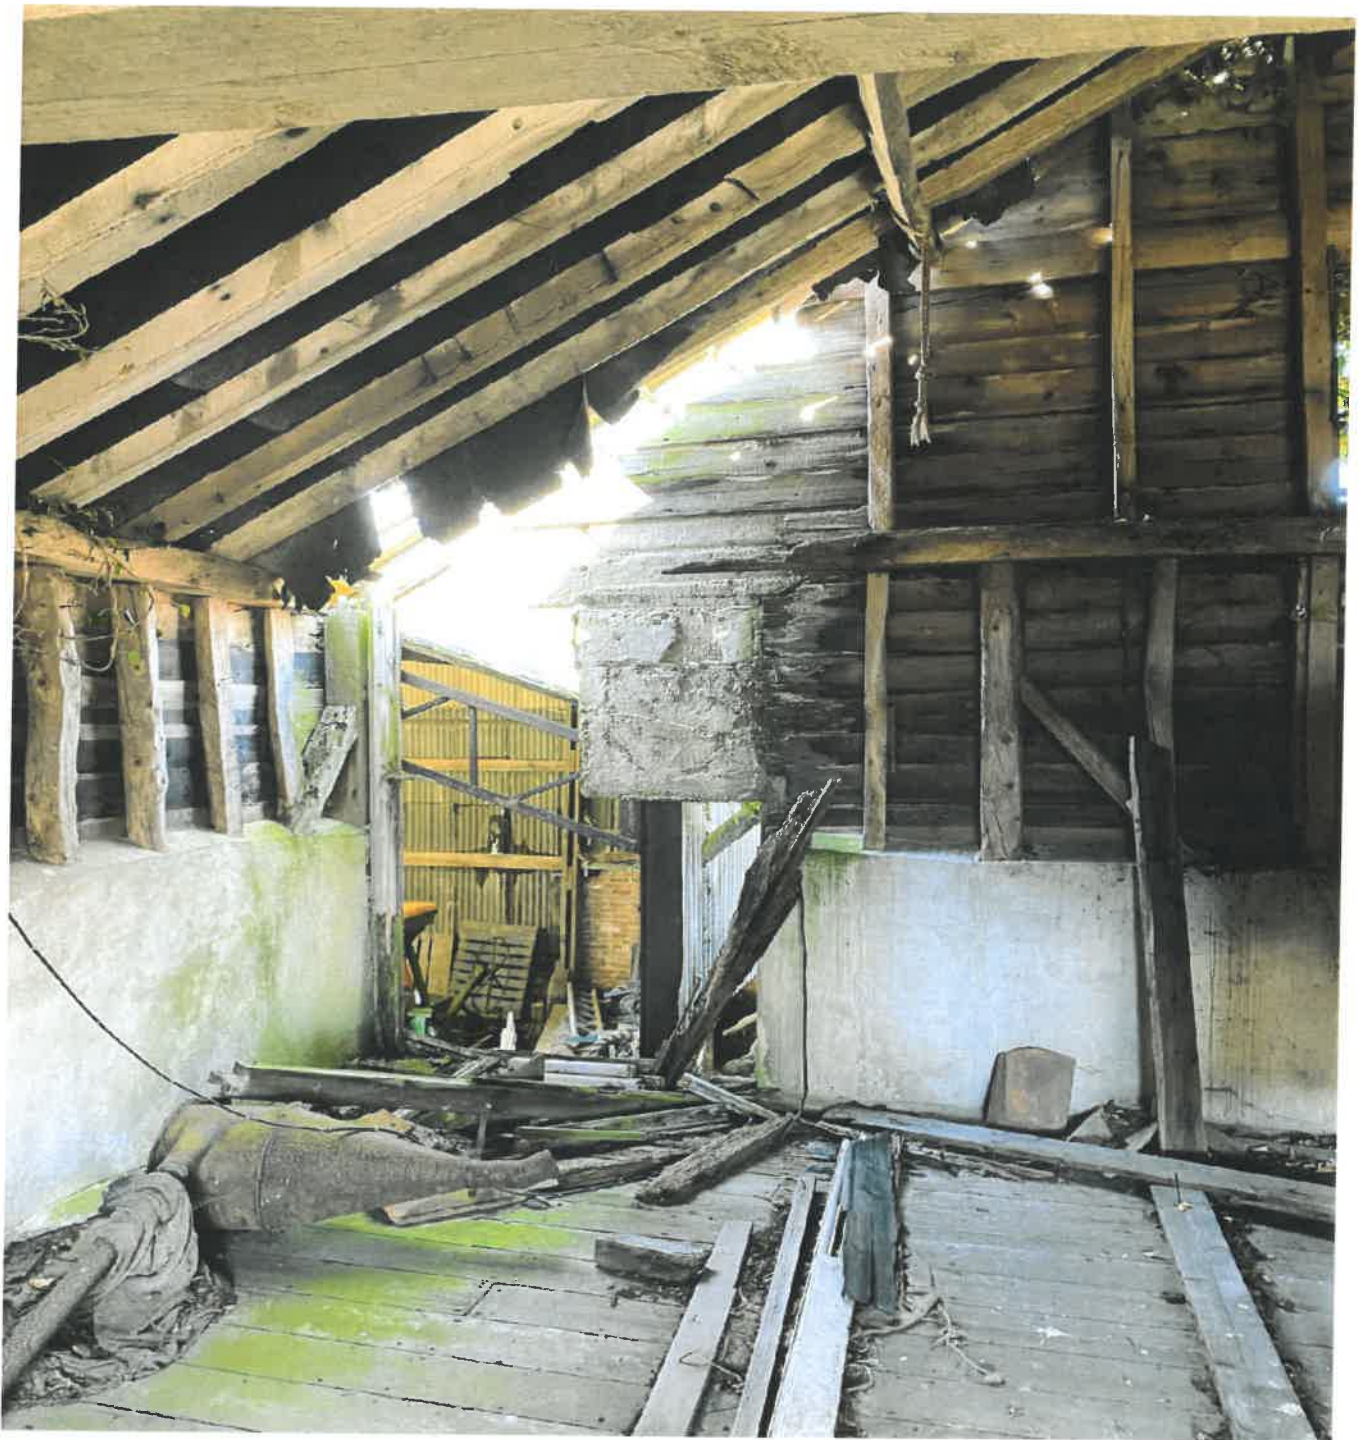
Photograph 6

Showing missing section of lefthand end wall at first floor of mezzanine.

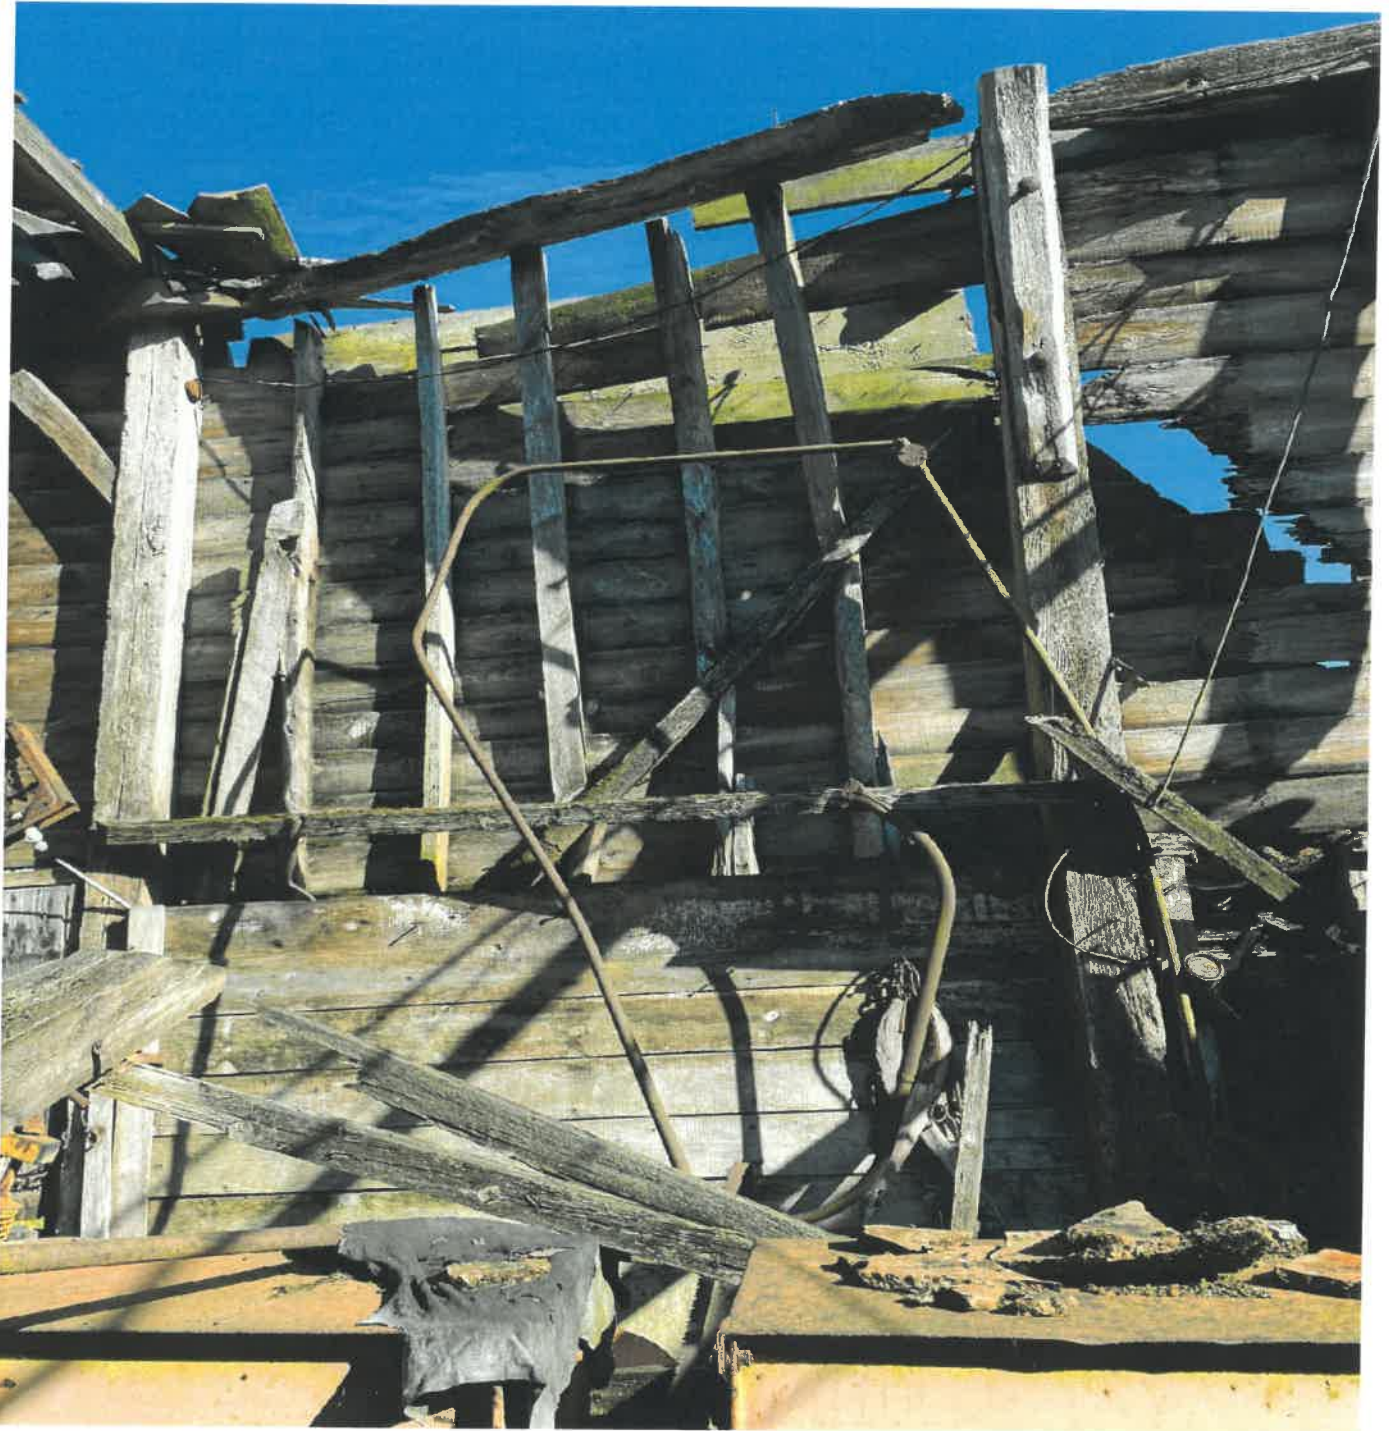
Photograph 7

- a) The general condition of the barn is fairly poor with 50% of the roof collapsed and external stud walls at the front and rear appear to be free standing and in an unstable condition due to loss of lateral ties provided by the roof.
- b) The current roof structure over the entrance and the mezzanine floor also has significant distortion.
- c) The rear and part of the front wall is free standing with significant lateral distortion and is considered to be unstable.

Showing missing roof and extensive distortion/damage to rear wall.

We feel that conversion is not possible and severe weather, such as a storm, may cause further collapse and suggest demolition and reconstruction using salvaged materials.

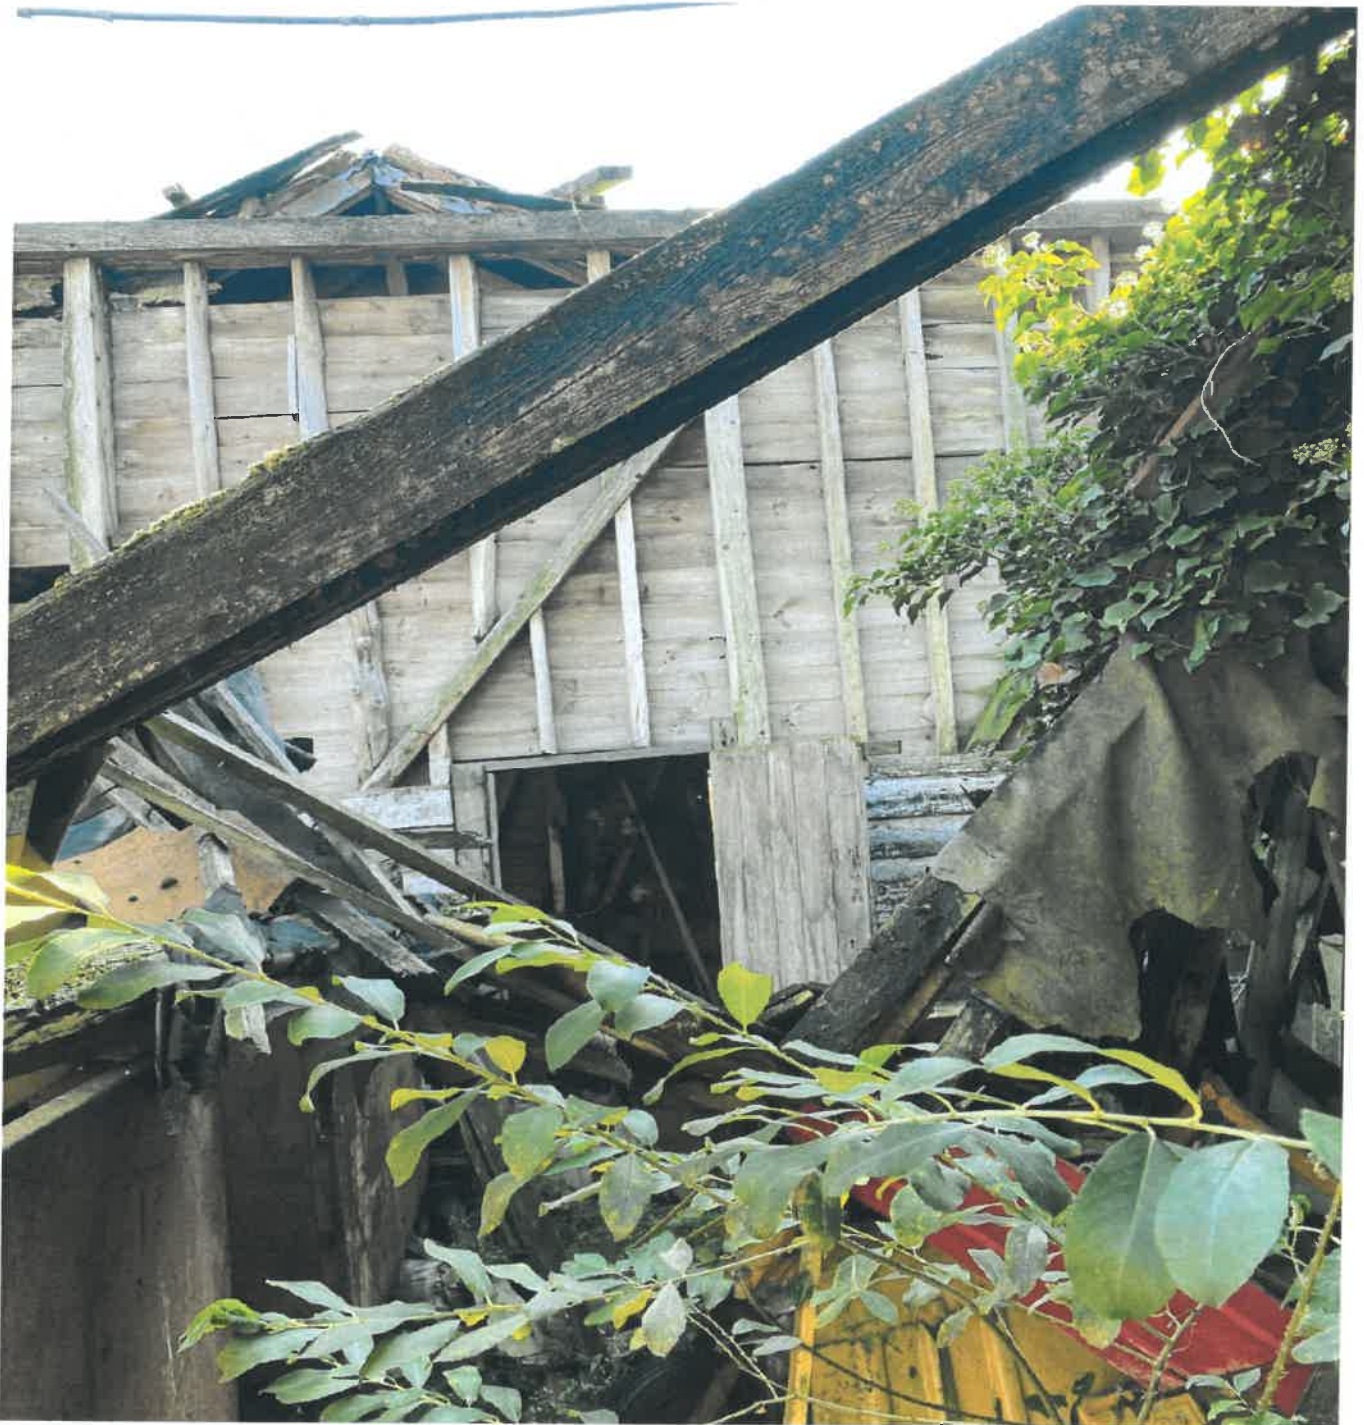
Photograph 8

Showing collapsed roof.

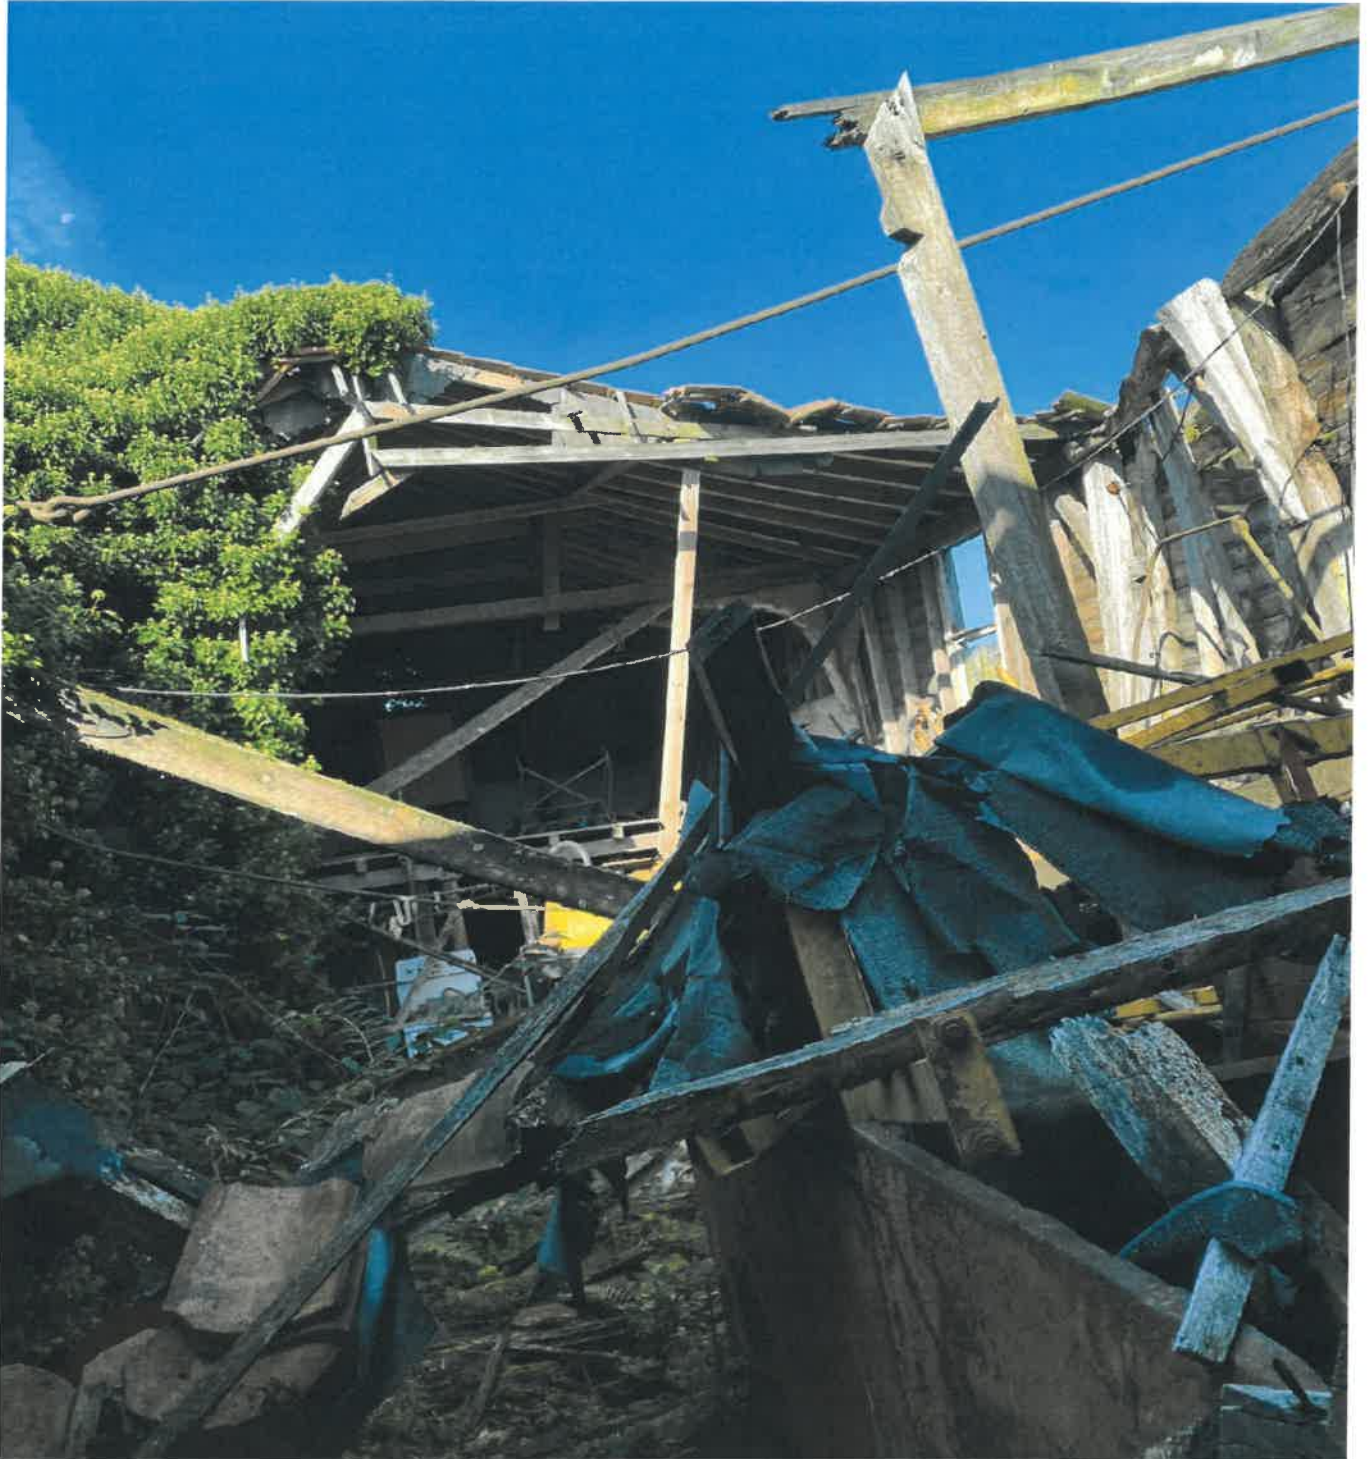
Photograph 9

Showing existing roof over the mezzanine floor overhanging.

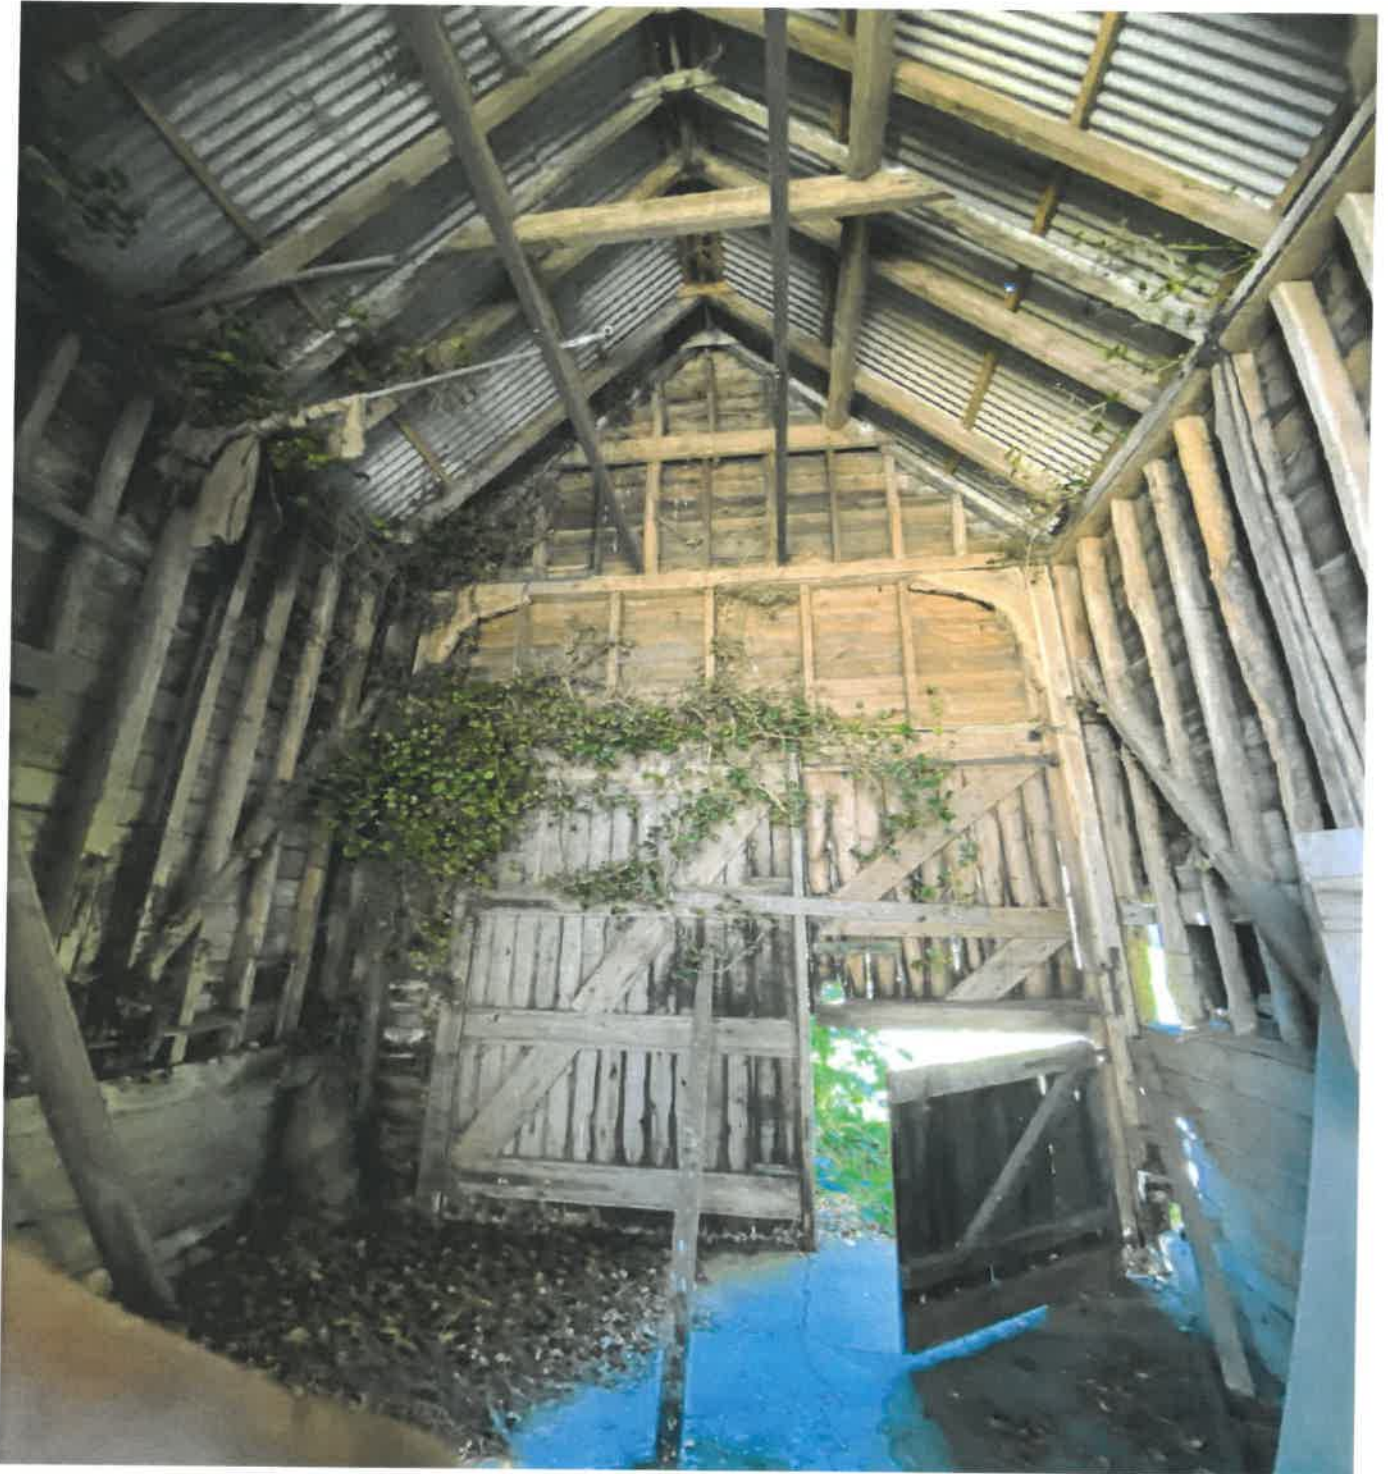
Photograph 10

Showing extensive distortion to the entrance roof.

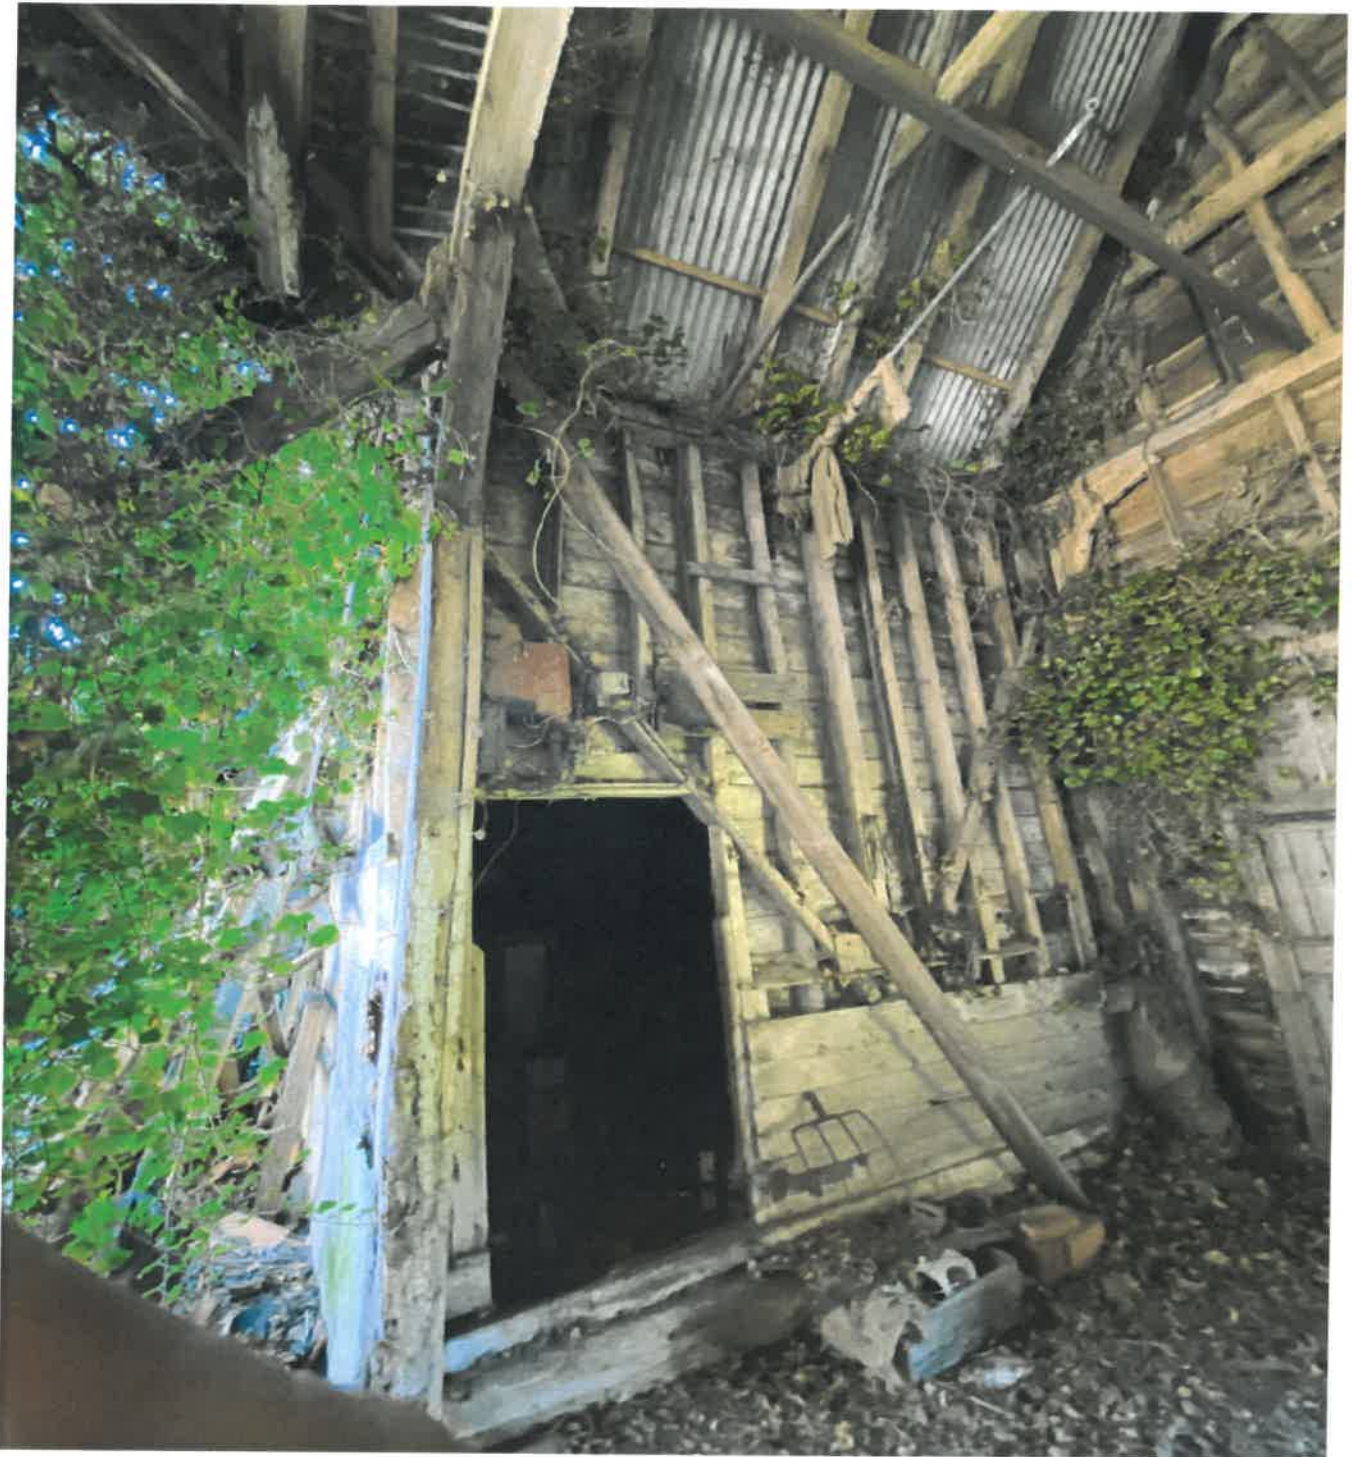
Photograph 11

Showing side walls of the entrance projection leaning outward.
