STRUCTURAL APPRAISAL

CONVERSION OF LARGE BARN

POTASH FARM

JOB NO: R3217

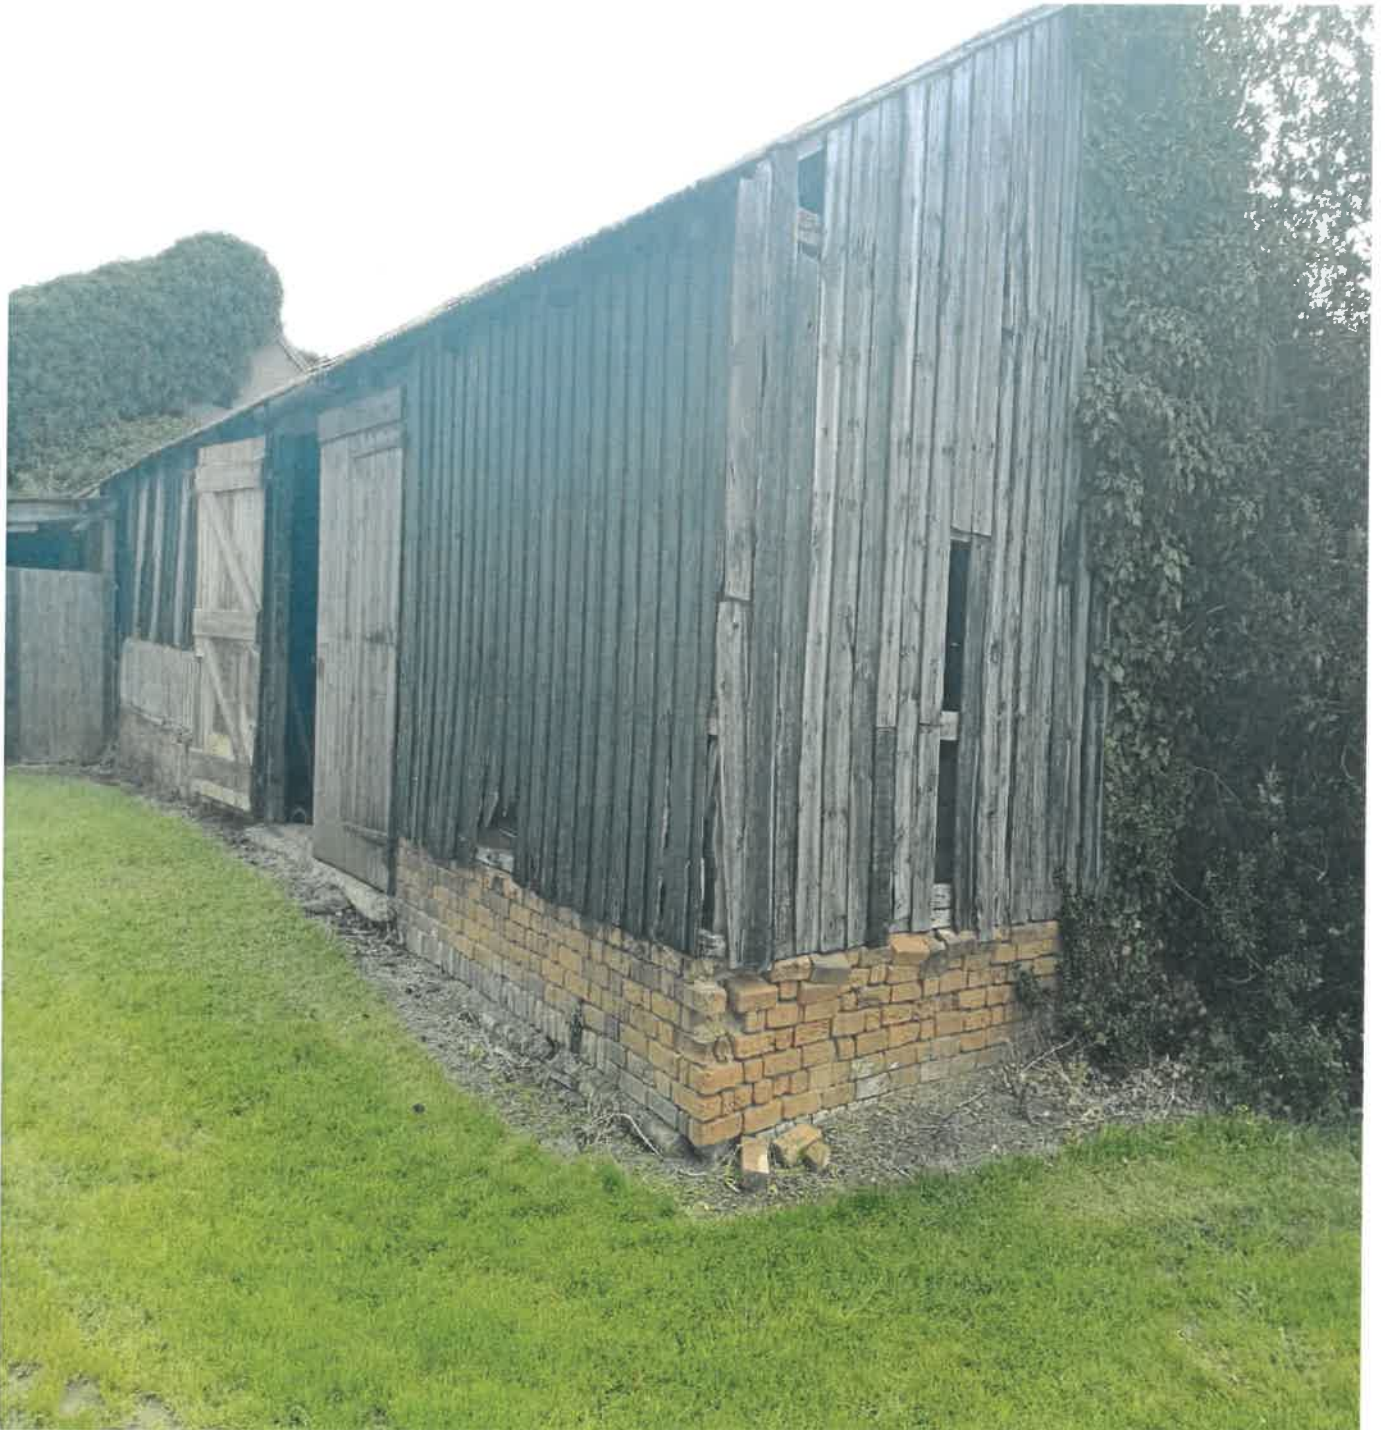
Photograph 15

The general condition of the barn is reasonable, with feet of the studs encased in concrete and there is significant evidence of weathering of the brickworks along all elevations.

Showing weathered brickwork with loose bricks.

- a) Existing roof structure will need to be strengthened by incorporating additional rafters and tie members to accommodate additional loading.
- b) The brick walls will need to be underpinned, as the existing footings are considered fairly shallow, weathered brickwork replaced and walls repointed.
- c) The external stud walls will need to be strengthened with additional studs and decayed studs replaced.
- d) Additional lintels and timber framing will be required for the new openings.

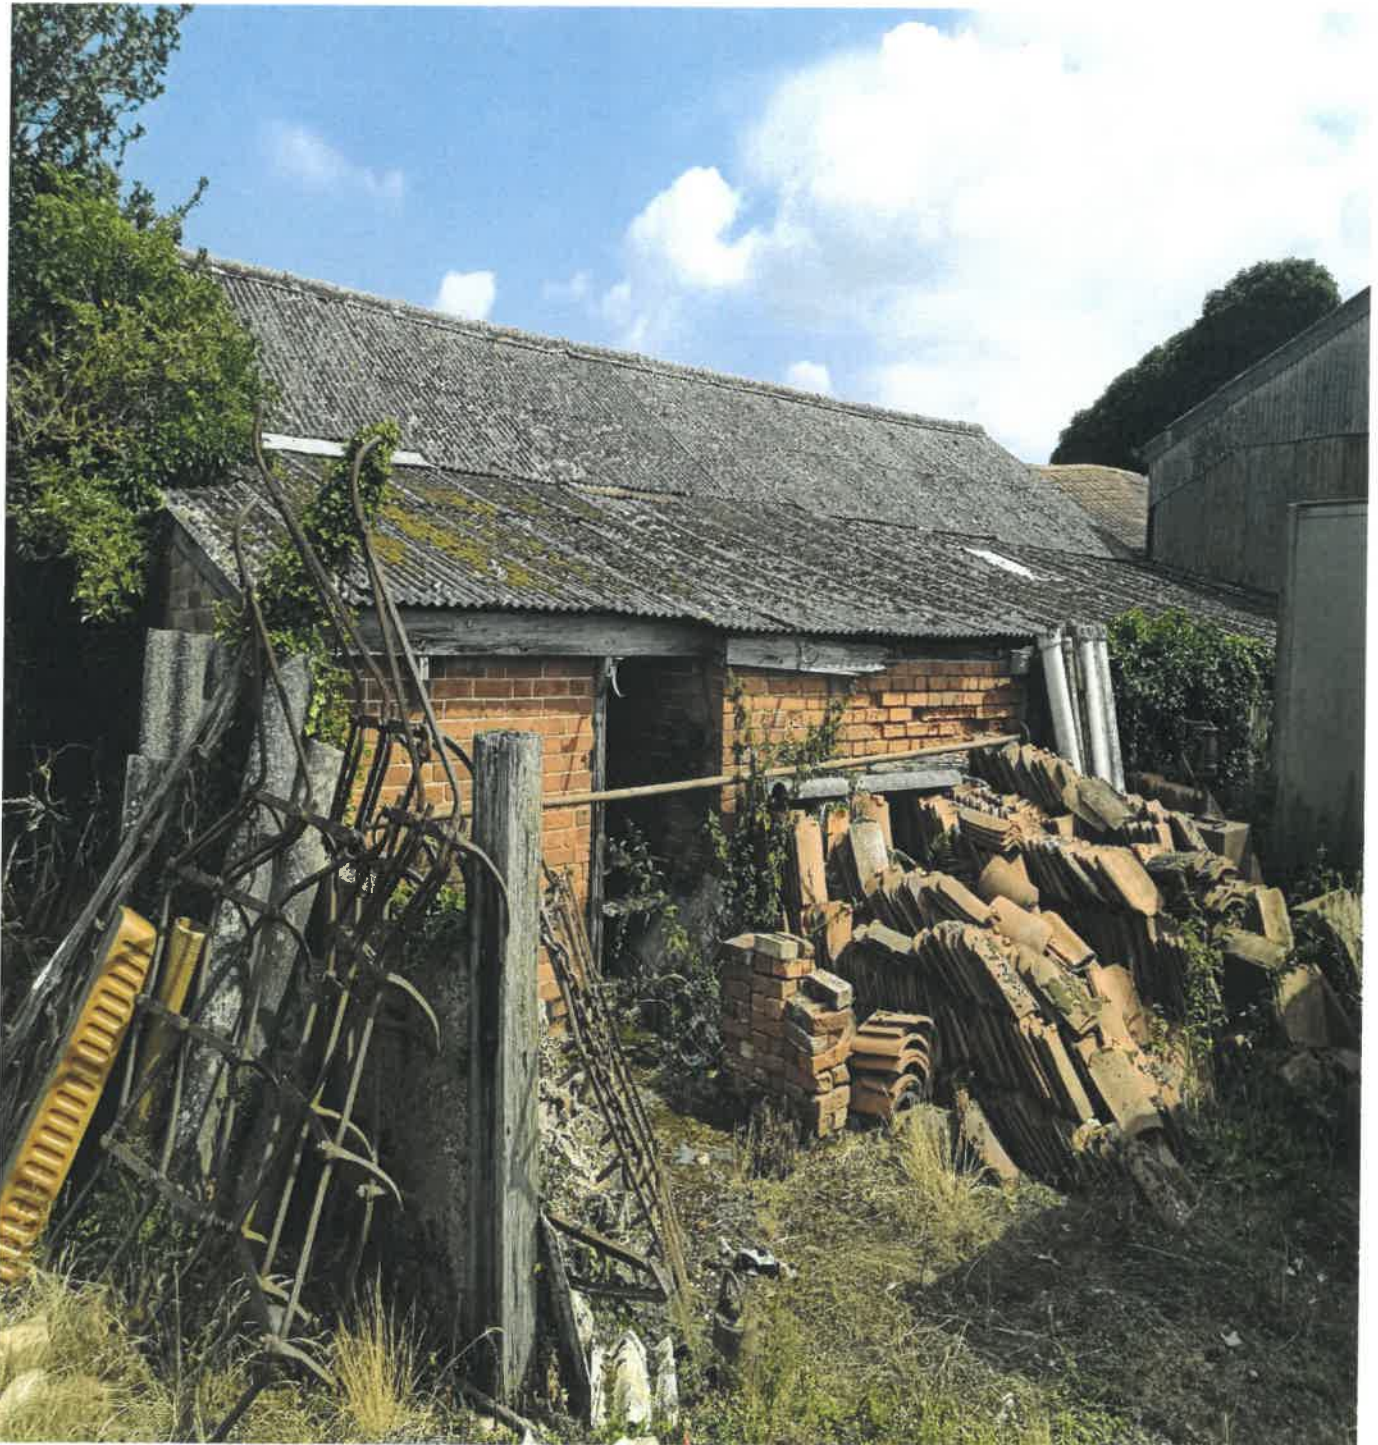
Photograph 17

Showing rear wall housing weathered bricks.

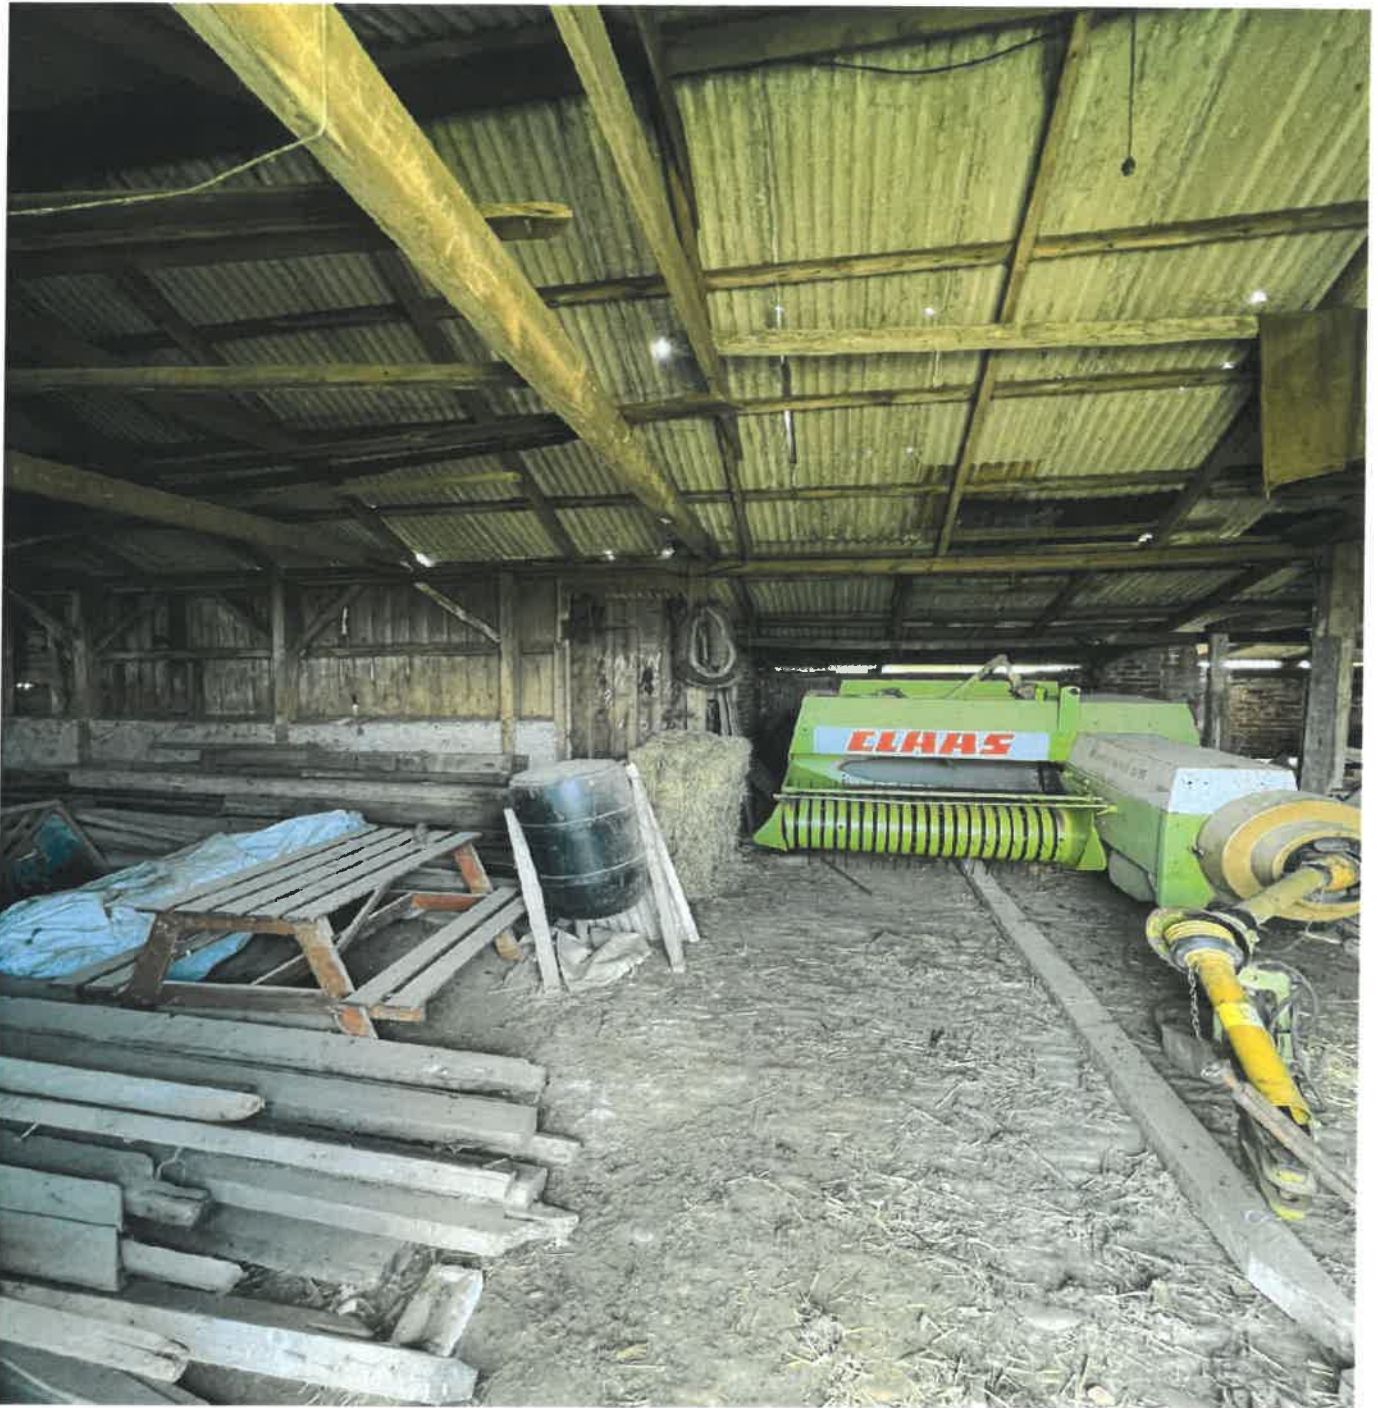
Photograph 19

There is slight distortion to the roof structure, but it is considered to be in reasonable condition.

Showing existing roof arrangement.
