**PROTECTED SPECIES (BAT) SURVEY OF  
THE GINEVERS  
BAWTRY ROAD  
BLYTH  
WORKSOP  
S81 8HG**

**Derek Kitson Architectural Technologist Ltd**

**December 2019**

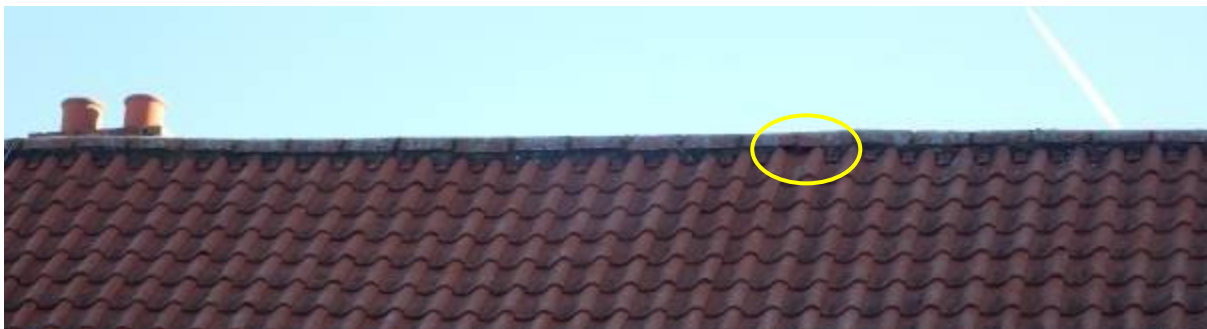
Photograph 10: Gap in beneath ridge tile at west aspect of house

It is the owner's intention to undertake minor roof repairs such as the replacement of missing or broken tiles on the house. As these features are deemed to be of low roost potential it is recommended that a minimum of one emergence and activity survey for bats is undertaken in the active season from May to end of August prior to any roof repairs.

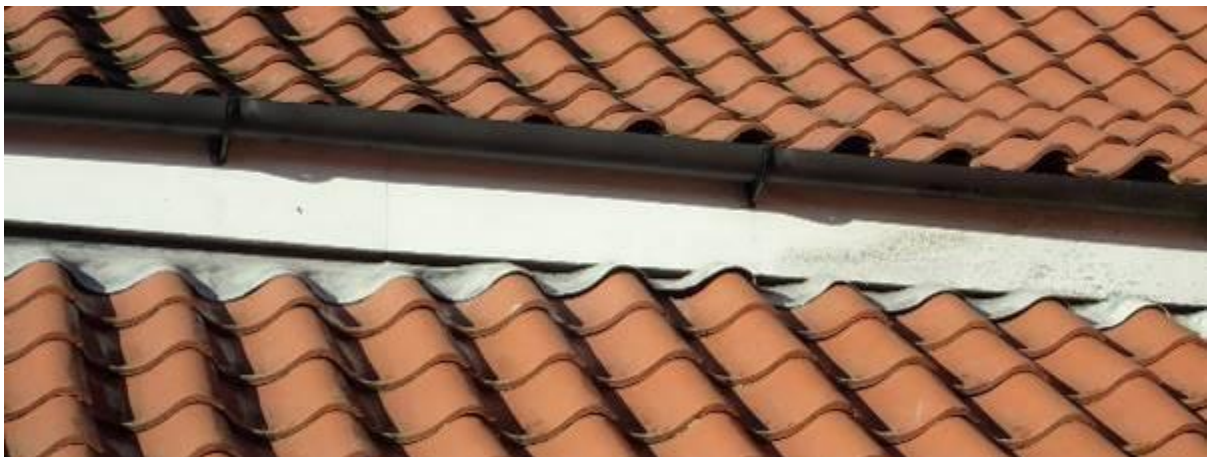
At the south elevation on the east side of the gable verge another gap was identified between the lead flashing and timber barge board.

Photograph 11: Barge board at east elevation of house

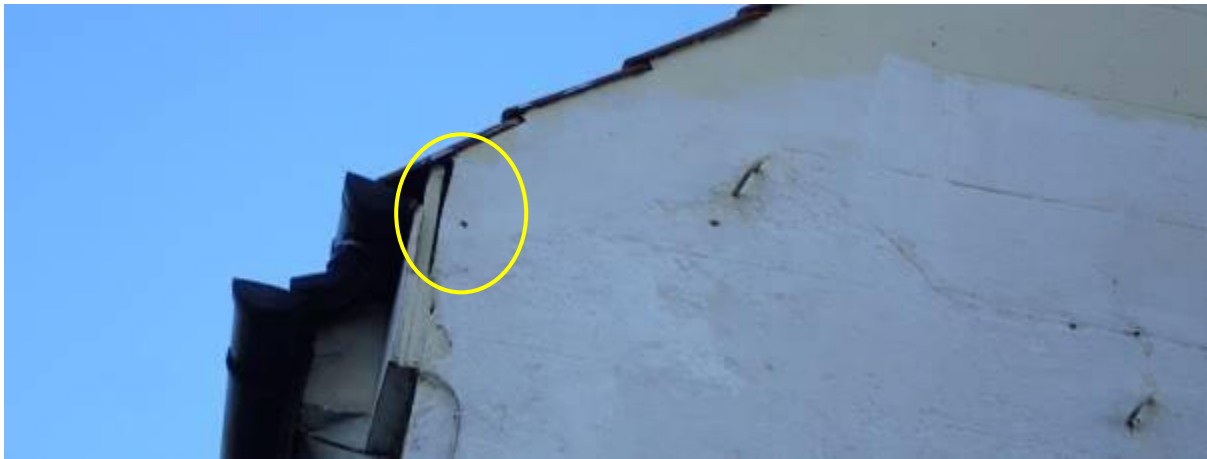
There is also a short section of barge board detail at the eaves of the west section of the building at the southern end of the elevation. The timber has lifted away from the wall resulting in a gap which has potential to be used for roosting purposes by bats.

Photograph 12: Gap behind barge board at west elevation of house

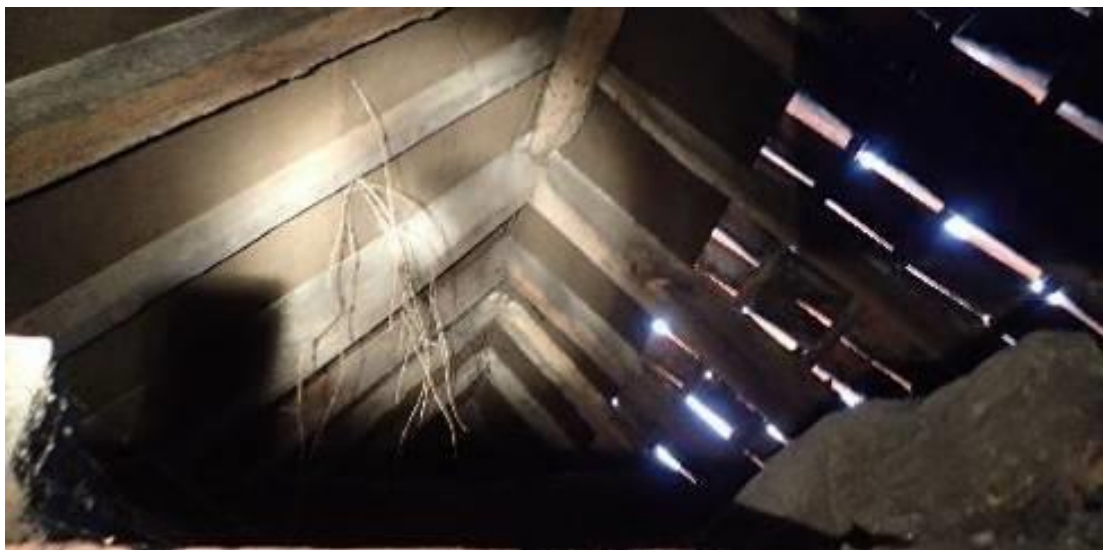
No evidence of use by bats was found during the visual inspection. The outbuilding does contain features that have potential to support roosting bats. The clay pantile roof covering has numerous gaps between the tiles enabling a bat to roost between the pantile and the bitumen felt liner where it is present. The gaps between the tiles of the unlined roof section have potential to enable access to the interior of the building. There is one area of missing roof covering in the south pitch close the ridge.

The construction of the roofing frame, resulting in a clutter free void beneath the ridge beam, is a desirable feature for attic dwelling bat species. However, no evidence of use by these species was identified. The west gable of the attic space of the outbuilding is adjacent to the family bathroom in the dwelling with the boiler situated against the chimney stack. This is likely to create a warm environment around the chimney stack and the attic space at the west end of the outbuilding. This has potential to appeal to roosting bats, particularly the Pipistrelle species.

Photograph 13: Roof void of outbuilding showing gaps between pantiles and bitumen felt liner

No evidence of use by bats was found during the visual inspection of the outbuilding. The interior and exterior of the outbuilding has features with potential to support roosting bats. No work should commence to this building until a bat emergence and activity survey has been undertaken to establish whether roosting bats are present. In accordance to the national survey guidelines emergence and activity surveys can only be carried out between May to the end of August in weather conditions that are conducive to bat activity.

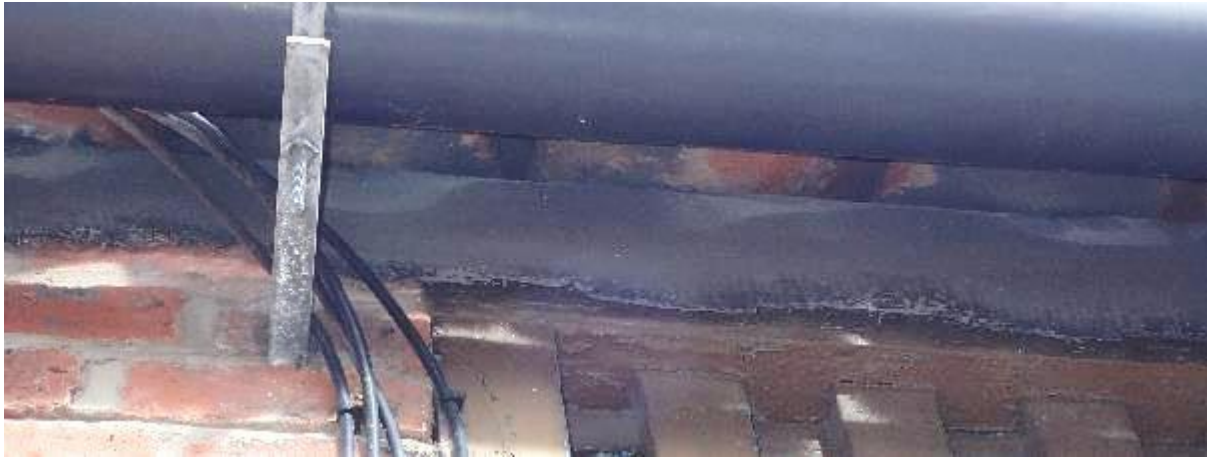
The bitumen felt liner overhangs the wall plate at the south elevation thereby creating a gap between the wall and liner. Being at the south elevation this has potential to appeal to roosting bats during summer.

**Photograph 14: Overhang of bitumen felt liner at south elevation of outbuilding**

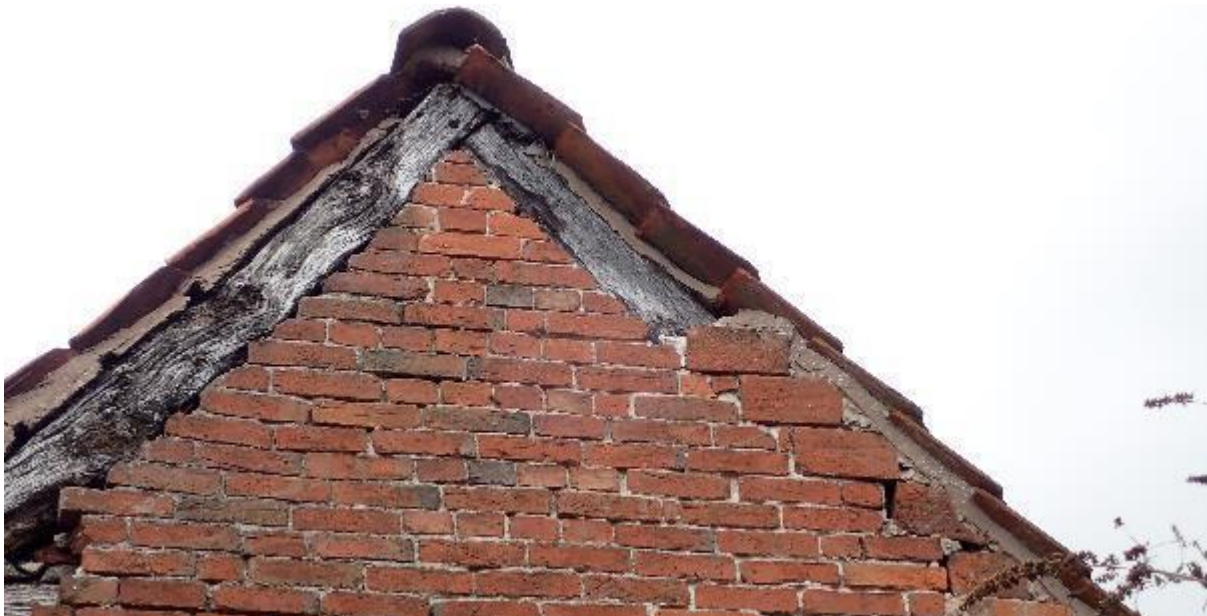
At the east gable the exposed timber roofing frame has started to shrink resulting in numerous gaps between the brickwork and timber which have potential to appeal to crevice dwelling bat species. Cracks in the brickwork and the verge mortar are also present at this gable providing more potential roosting opportunities.

**Photograph 15: East gable of outbuilding including gaps around timber roofing frame and in brickwork**

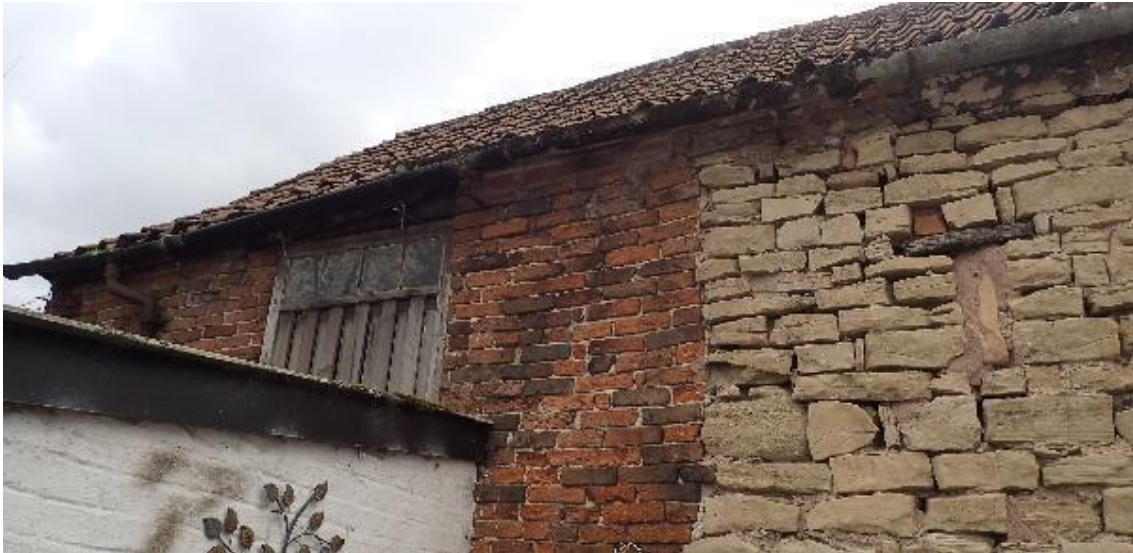
At the north elevation of the outbuilding there are numerous crevices in the stonework which offer roosting opportunities for crevice dwelling species. The brick wall that forms the north boundary and the surrounding trees have potential to provide cover for a commuting route from the survey building.

Photograph 16: North elevation of outbuilding with gaps in stonework
