Tree Condition Survey Report (VTA)

Site: Chelsfield Park Hospital, Bucks Cross Rd, Chelsfield,
Orpington, BR6 7RG

Client: BMI – Circle Health Group

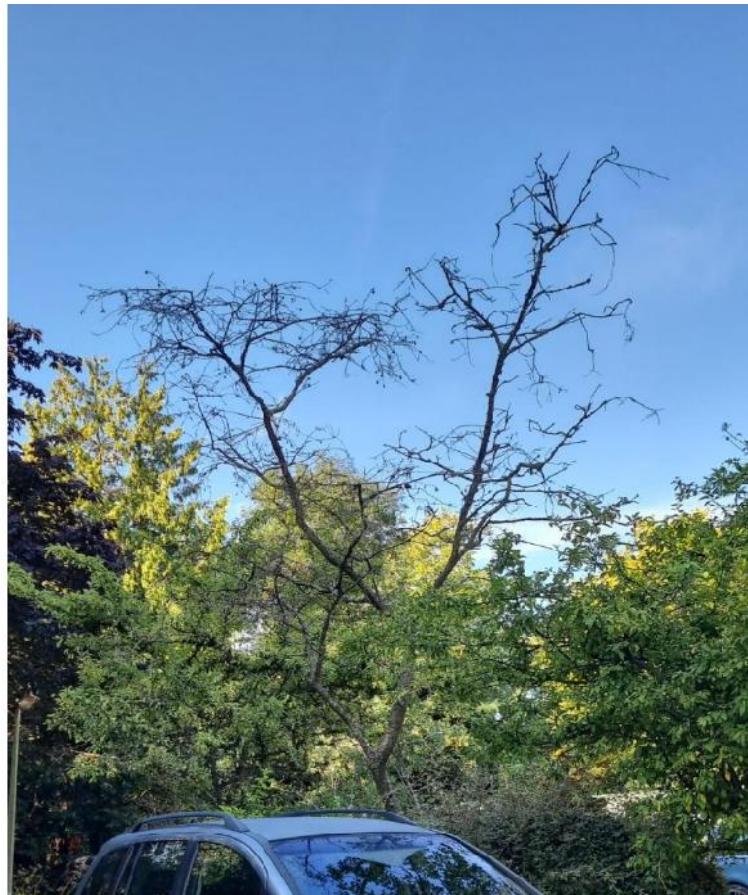
VTA	
Site:	BMI - Chelsfield Park Hospital
Tree ID:	36
Tag No:	
Status:	Alive
Common Name:	Cherry species
Scientific Name:	Prunus sp.
Tree Height (bands):	0-5m
Do not use - Stem Diameter (bands):	150-300mm
Crown Diameter [m]:	3
Family:	
Life Stage:	Early-mature
Target:	Car park
Risk Zone:	High
Physiological Condition:	Fair
Structural Condition:	Fair
Access:	Good

Tree ID	Common Name Tree	Work Task	Work Priority	Description	Tag No
36	Cherry species	Fell to Ground Level (Directional Fell)	Within 1 Month	Fell	Not tagged
44	Common alder	Fell to Ground Level (Directional Fell)	Within 1 Month	Fell to ground	1871
45	Common ash	Fell to Ground Level (Directional Fell)	Within 1 Month	Fell to ground	1873
46	Sycamore	Fell to Ground Level (Directional Fell)	Within 1 Month	Fell to ground	1870
53	Common ash	Fell to Ground Level (Directional Fell)	Within 1 Month	Fell to ground	1875
57	Common ash	Fell to Ground Level (Directional Fell)	Within 1 Month	Fell to ground	Not tagged
Group 13	Norway maple & Common Ash	Remove Dead Wood	Within 1 Month	Remove deadwood from all 8 trees	Not tagged
25	Common ash	Remove Dead Wood	Within 1-3 Months	Pollard to 9m and remove deadwood	1879
7	Horse chestnut	Remove Dead Wood	Within 1 - 3 Months	Remove all dead wood and limbs	1880
17	Cedar of lebanon	Remove Specific Branch/Limb	Within 1-3 Months		0314

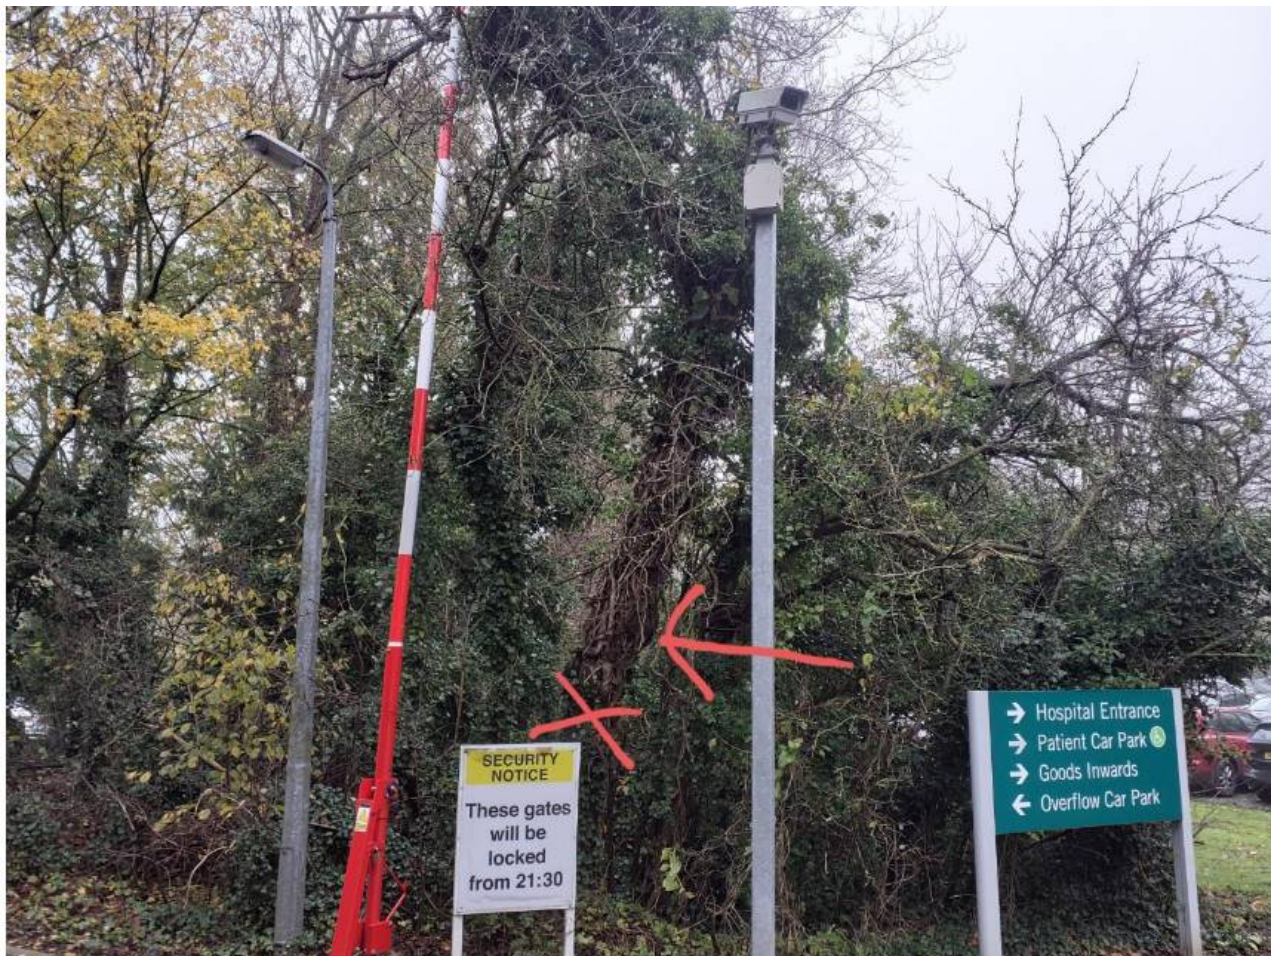
VTA	
Site:	BMI - Chelsfield Park Hospital
Tree ID:	44
Tag No:	1871
Status:	Dead
Common Name:	Common alder
Scientific Name:	<i>Alnus glutinosa</i>
Tree Height (bands):	11-15m
Do not use - Stem Diameter (bands):	300-450mm
Crown Diameter [m]:	2
Family:	Betulaceae
Life Stage:	Mature
Target:	Car park, Road
Risk Zone:	High
Physiological Condition:	Poor
Structural Condition:	Poor
Access:	No access to base/stem

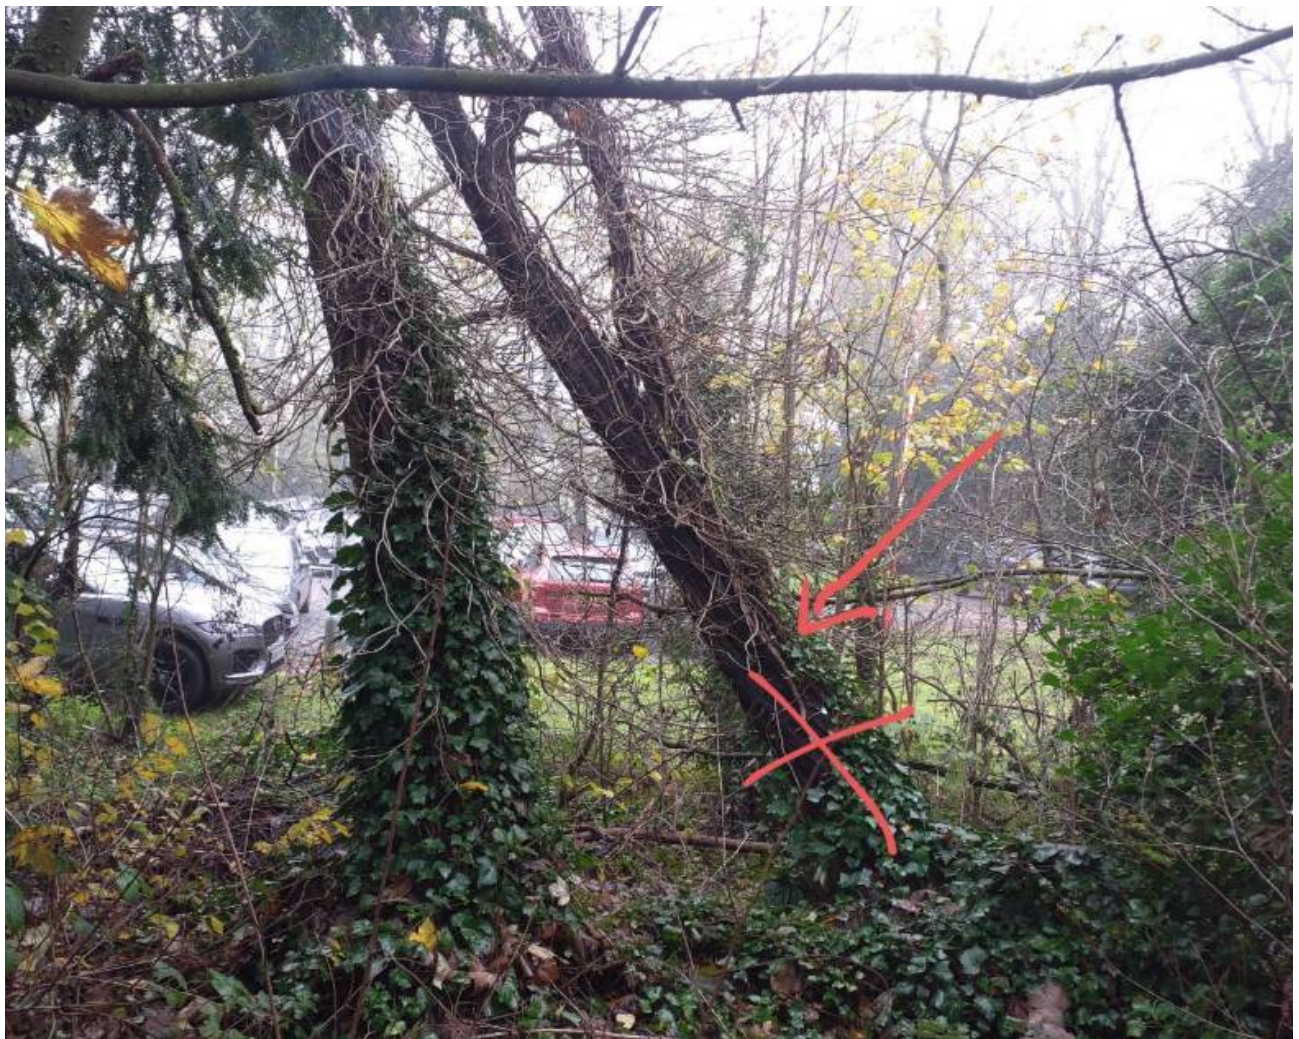
VTA	
Site:	BMI - Chelsfield Park Hospital
Tree ID:	46
Tag No:	1870
Status:	Dead
Common Name:	Sycamore
Scientific Name:	<i>Acer pseudoplatanus</i>
Tree Height (bands):	11-15m
Do not use - Stem Diameter (bands):	300-450mm
Crown Diameter [m]:	2
Family:	Sapindaceae
Life Stage:	Mature
Target:	Car park
Risk Zone:	High
Physiological Condition:	Dead
Structural Condition:	Poor
Access:	Good

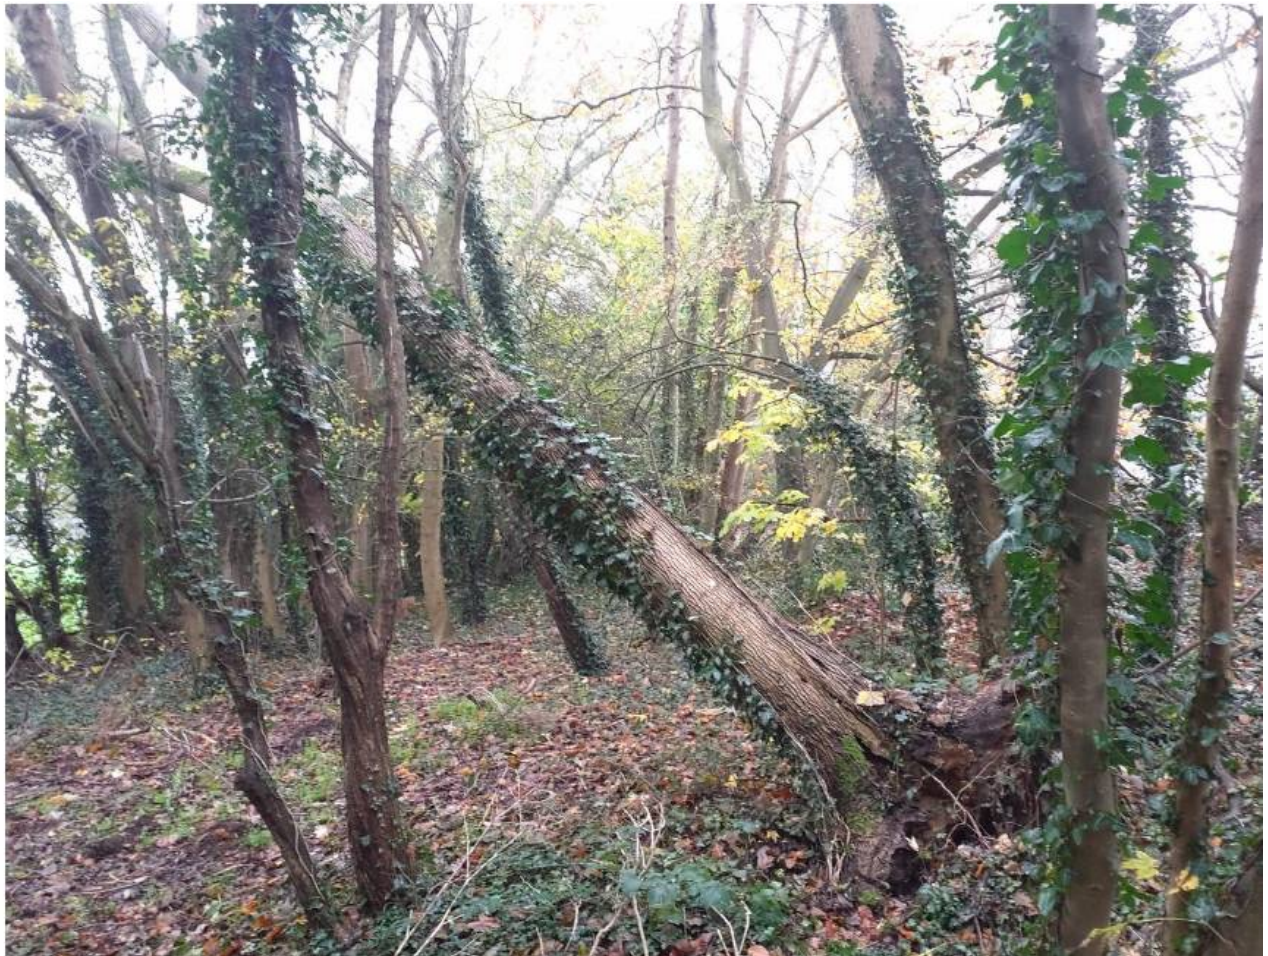
VTA	
Site:	BMI - Chelsfield Park Hospital
Tree ID:	53
Tag No:	1875
Status:	Alive
Common Name:	Common ash
Scientific Name:	Fraxinus excelsior
Tree Height (bands):	16-20m
Do not use - Stem Diameter (bands):	300-450mm
Crown Diameter [m]:	10
Family:	Oleaceae
Life Stage:	Mature
Target:	Other
Risk Zone:	High
Physiological Condition:	Poor
Structural Condition:	Poor
Access:	Good

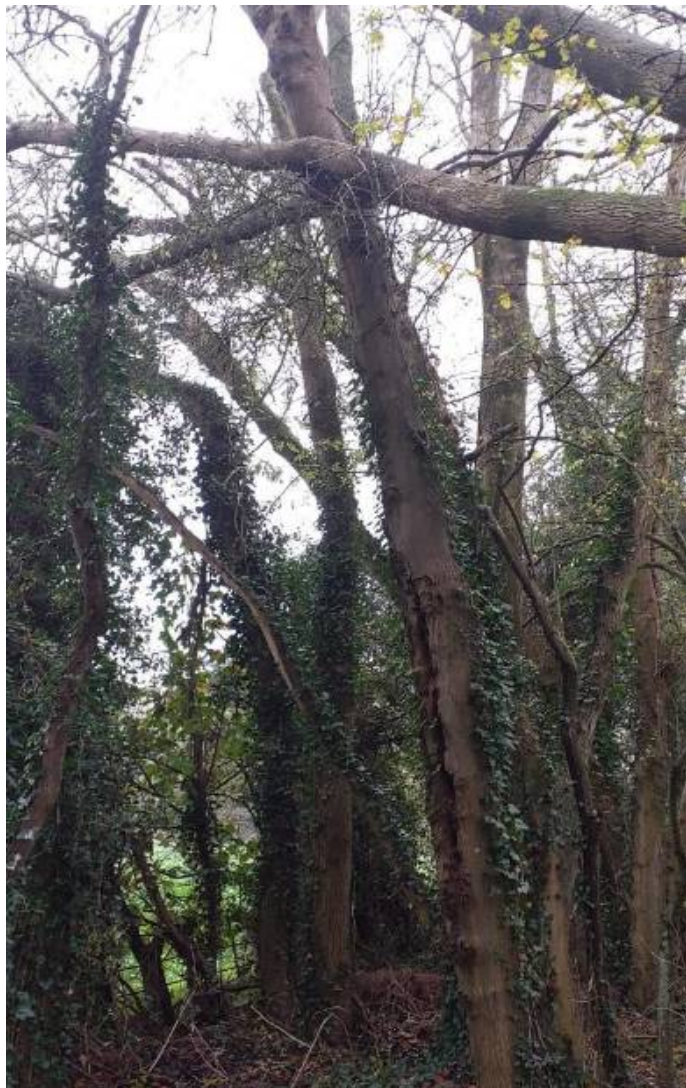
VTA	
Site:	BMI - Chelsfield Park Hospital
Tree ID:	55
Tag No:	1883
Status:	Alive
Common Name:	Common ash
Scientific Name:	Fraxinus excelsior
Tree Height (bands):	16-20m
Do not use - Stem Diameter (bands):	300-450mm
Crown Diameter [m]:	8
Family:	Oleaceae
Life Stage:	Mature
Target:	Other
Risk Zone:	High
Physiological Condition:	Poor
Structural Condition:	Poor
Access:	Good

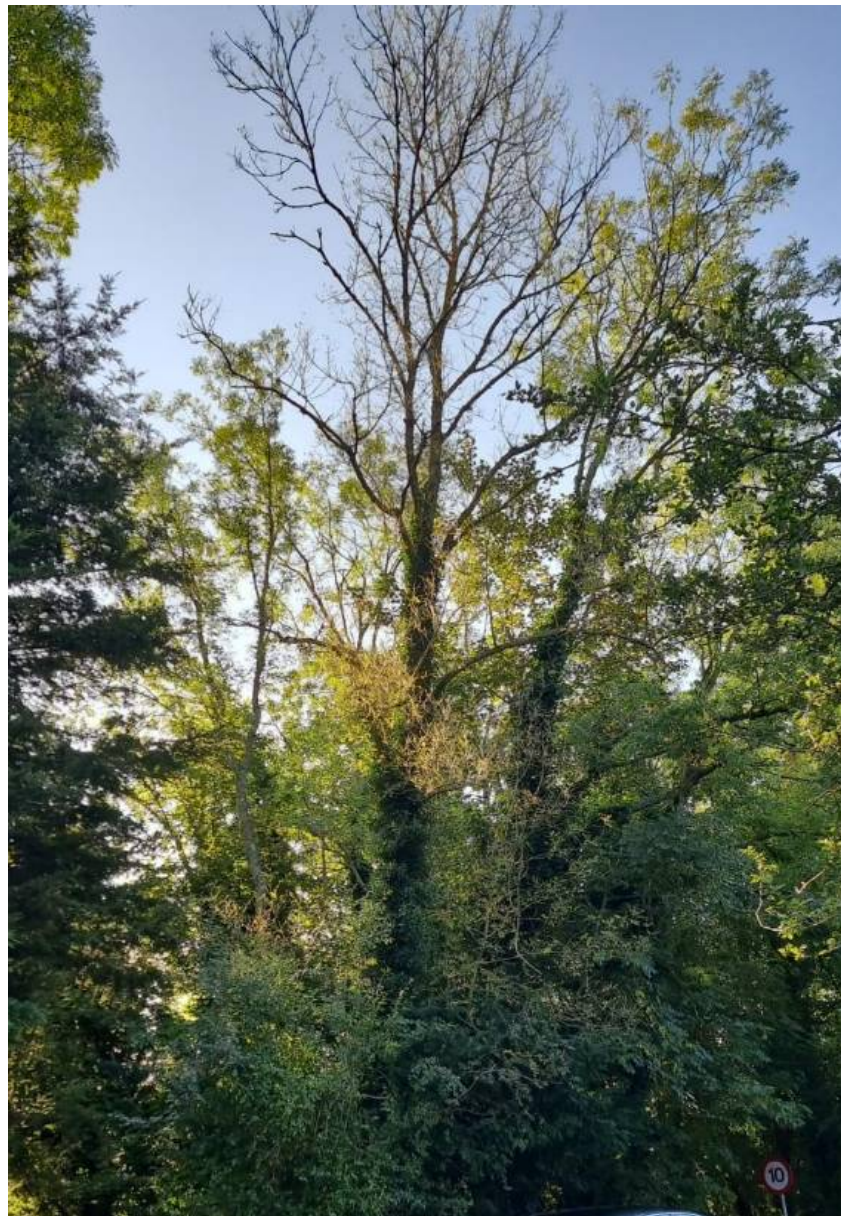
Tree ID: 57

Target: Road

Risk Zone: High

Physiological Condition: Dead

Structural Condition: Poor

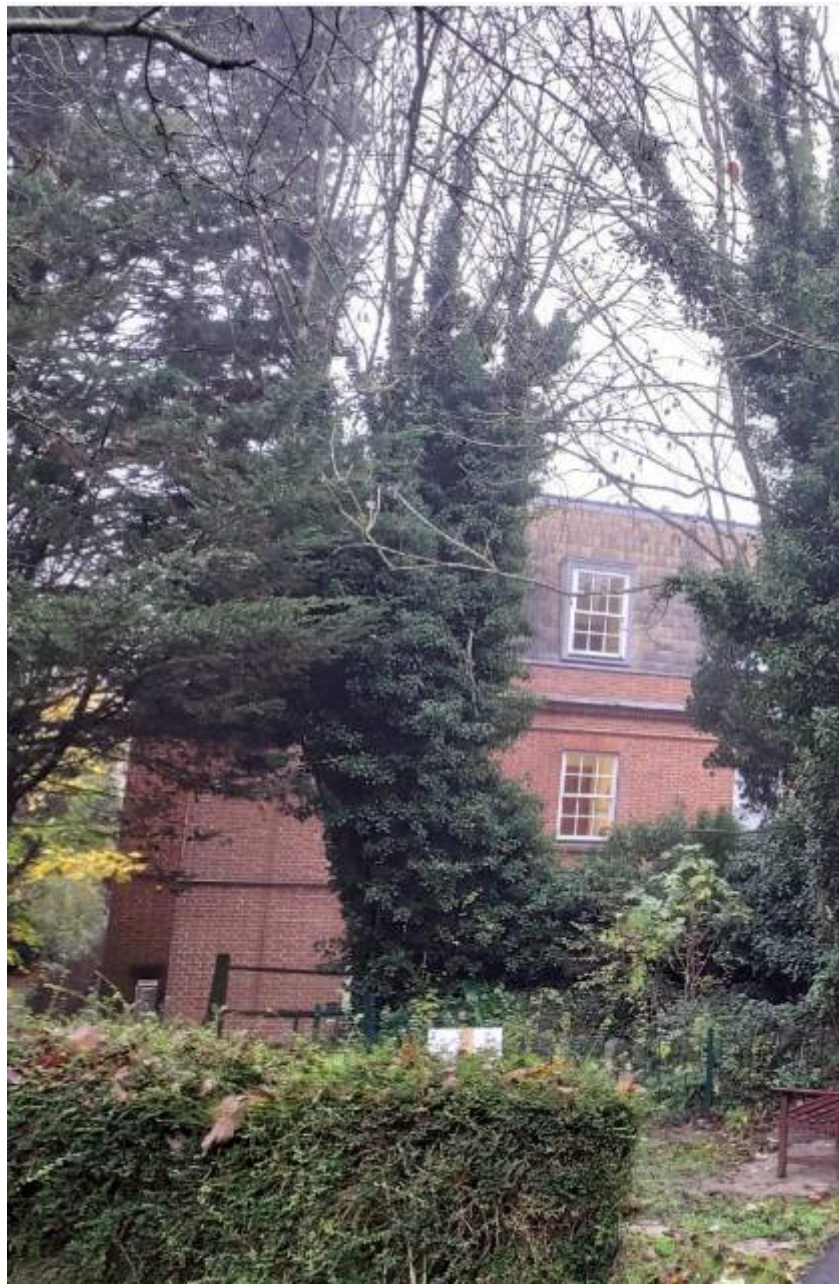
VTA	
Site:	BMI - Chelsfield Park Hospital
Tree ID:	25
Tag No:	1879
Status:	Alive
Common Name:	Common ash
Scientific Name:	Fraxinus excelsior
Tree Height (bands):	16-20m
Do not use - Stem Diameter (bands):	300-450mm
Crown Diameter [m]:	8
Family:	Oleaceae
Life Stage:	Semi-mature
Target:	Building, Footpath, Wall
Risk Zone:	High
Physiological Condition:	Fair
Structural Condition:	Fair
Access:	Good

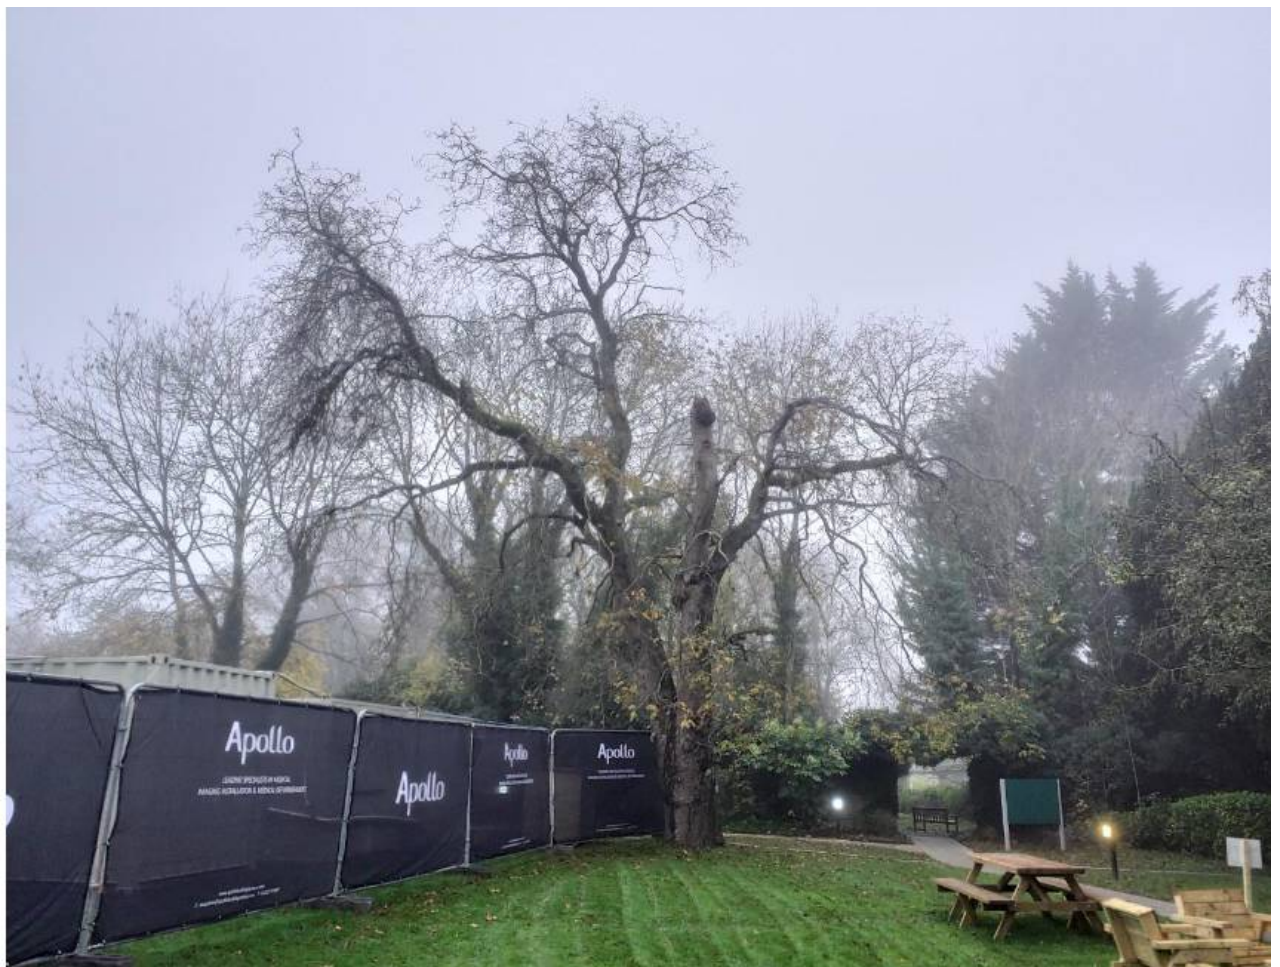
VTA	
Site:	BMI - Chelsfield Park Hospital
Tree ID:	7
Tag No:	1880
Status:	Alive
Common Name:	Horse chestnut
Scientific Name:	Aesculus hippocastanum
Tree Height (bands):	16-20m
Do not use - Stem Diameter (bands):	750-1000mm
Crown Diameter [m]:	14
Family:	Sapindaceae
Life Stage:	Mature
Target:	Footpath
Risk Zone:	High
Physiological Condition:	Fair
Structural Condition:	Fair
Access:	Good

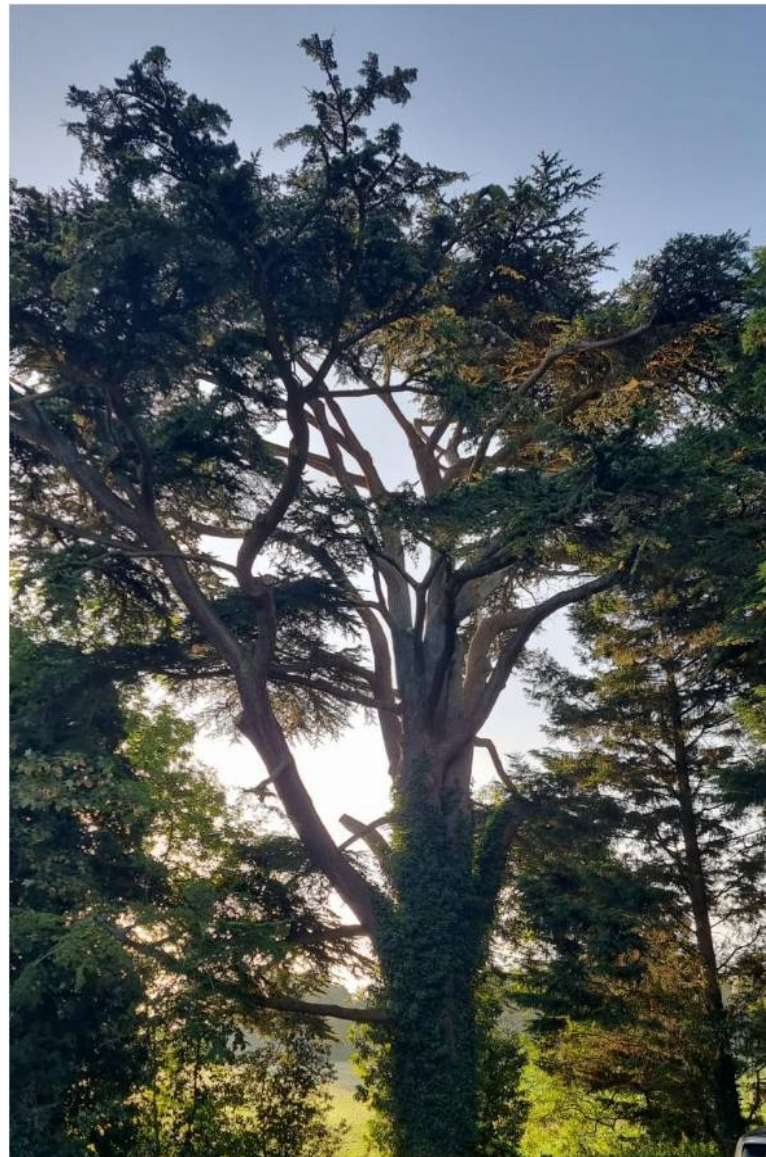
VTA	
Site:	BMI - Chelsfield Park Hospital
Tree ID:	17
Tag No:	0314
Status:	Alive
Common Name:	Cedar of lebanon
Scientific Name:	Cedrus libani
Tree Height (bands):	20+m
Do not use - Stem Diameter (bands):	1000+mm
Crown Diameter [m]:	18
Family:	Pinaceae
Life Stage:	Mature
Target:	Car park, Footpath
Risk Zone:	High
Physiological Condition:	Fair
Structural Condition:	Fair
Access:	Good

17	Cedar of lebanon	Remove Dead Wood	Within 1-3 Months		0314
20	Common ash	Prune to clear building by 2m	Within 1 - 3 Months	Prune away from building	Not tagged
21	Sycamore	Prune to clear building by 2m	Within 1 - 3 Months	Prune away from building	Not tagged
23	Sycamore	Prune to clear building by 2m	Within 1 - 3 Months	Prune away from building	Not tagged
24	Common ash	Pollard to Specified Height	Within 1 - 3 Months	Pollard to leave 8m in height	1878
26	Common ash	Remove Dead Wood	Within 1 - 3 Months	Remove major deadwood	1881
32	Common ash	Remove Dead Wood	Within 1 - 3 Months	Remove major deadwood	1877
32	Common ash	Fell, Leaving Stump Just Above Ground Level	Within 1 - 3 Months		1877
33	Common ash	Remove Dead Wood	Within 1 -3 Months	Remove major deadwood	Not tagged
50	London plane	Reduce Crown in Height (by 2m) and Shape	Within 1 - 3 Months		1885
51	Norway maple	Fell, Leaving Stump Just Above Ground Level	Within 1 - 3 Months		1872

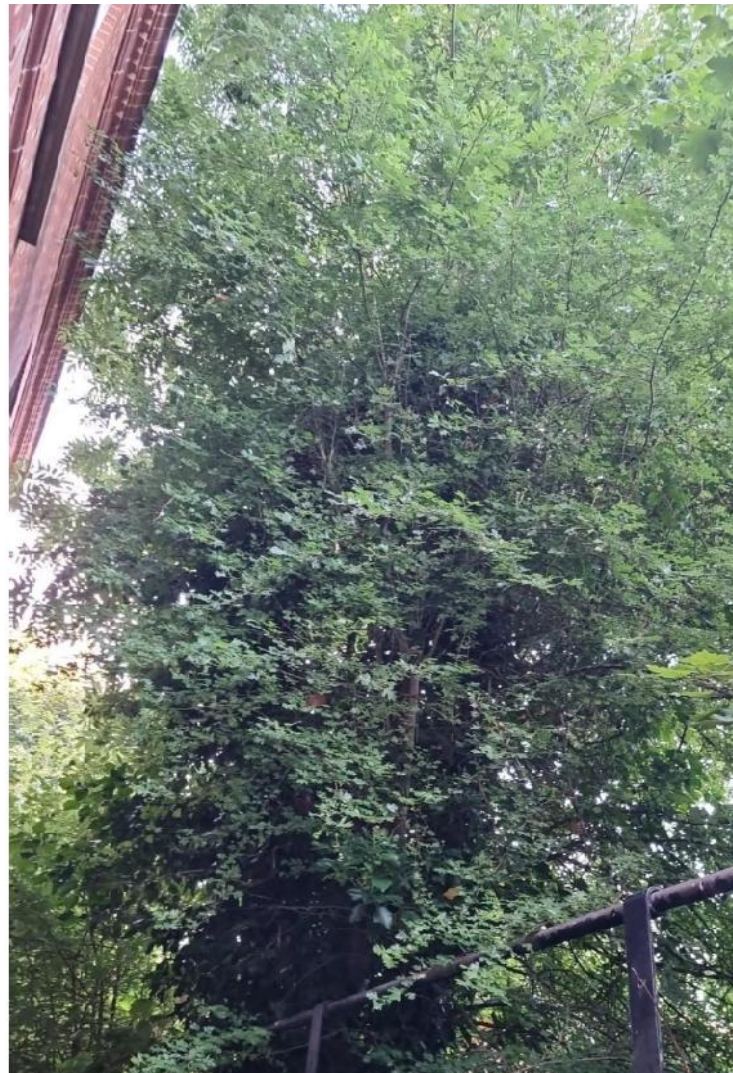
20	Not tagged	Common ash	Fraxinus excelsior	5-10m	375	Semi-mature	Fair	Fair		None Significant	Ivy Covered Stem	Crown Close to Building and/or Infrastructure, Prolific Ivy	None Observed	Building, Footpath	High	No access to base/stem	Third party

VTA	
Site:	BMI - Chelsfield Park Hospital
Tree ID:	20
Tag No:	
Status:	Alive
Common Name:	Common ash
Scientific Name:	Fraxinus excelsior
Tree Height (bands):	5-10m
Do not use - Stem Diameter (bands):	300-450mm
Crown Diameter [m]:	6
Family:	Oleaceae
Life Stage:	Semi-mature
Target:	Building, Footpath
Risk Zone:	High
Physiological Condition:	Fair
Structural Condition:	Fair
Access:	No access to base/stem

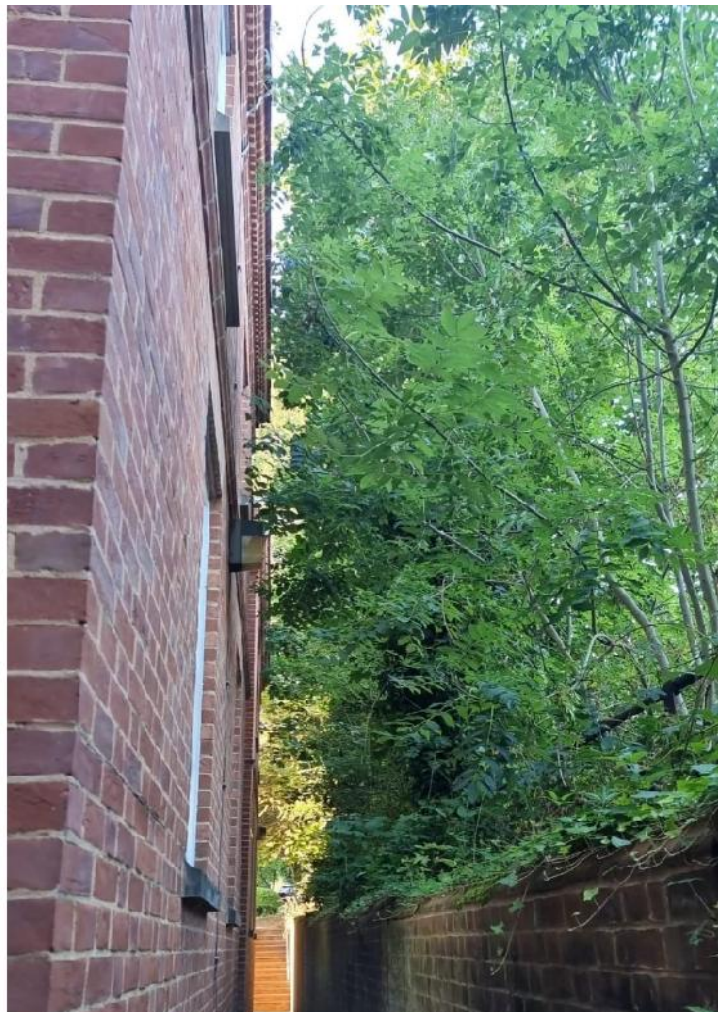
VTA	
Site:	BMI - Chelsfield Park Hospital
Tree ID:	21
Tag No:	
Status:	Alive
Common Name:	Sycamore
Scientific Name:	<i>Acer pseudoplatanus</i>
Tree Height (bands):	5-10m
Do not use - Stem Diameter (bands):	300-450mm
Crown Diameter [m]:	6
Family:	Sapindaceae
Life Stage:	Semi-mature
Target:	Building, Footpath
Risk Zone:	High
Physiological Condition:	Fair
Structural Condition:	Fair
Access:	No access to base/stem

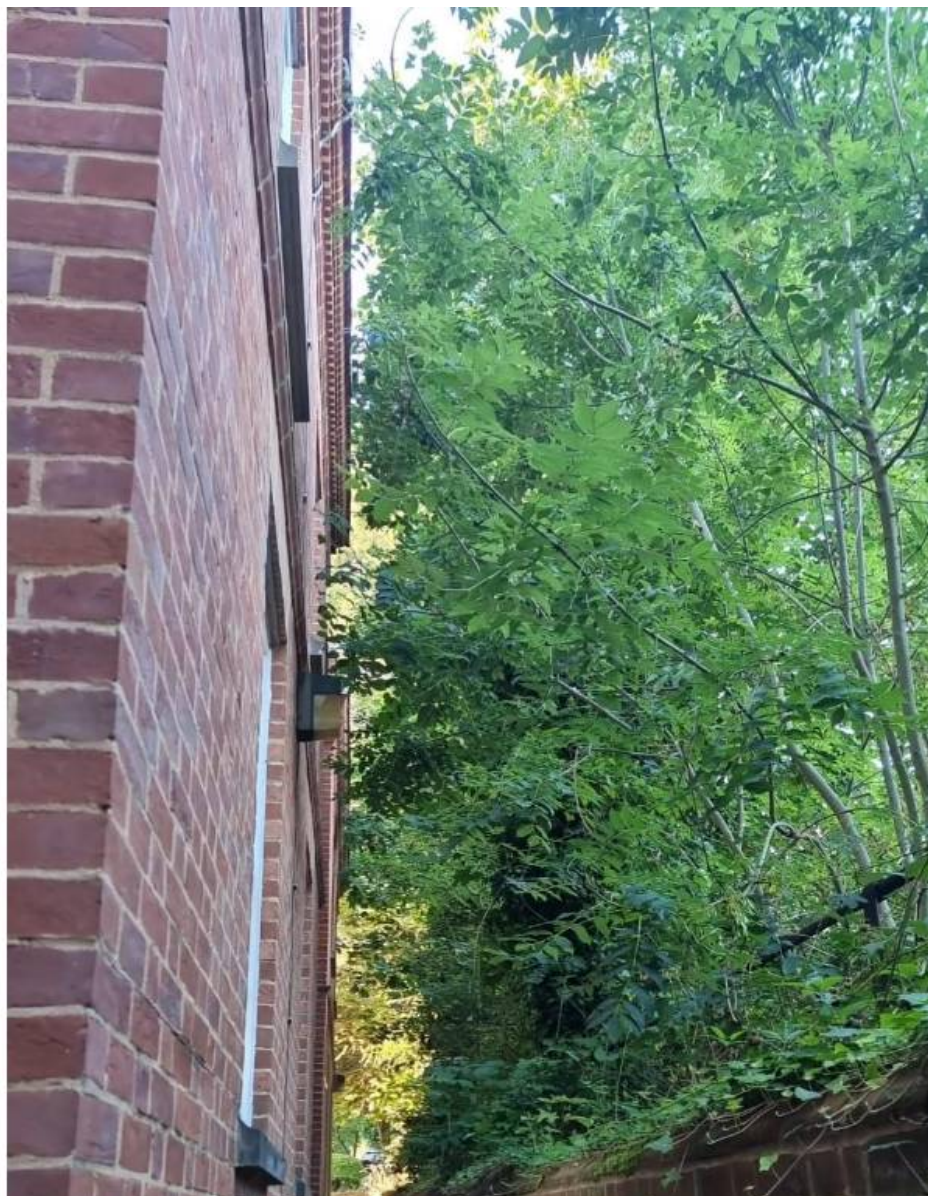
VTA	
Site:	BMI - Chelsfield Park Hospital
Tree ID:	23
Tag No:	
Status:	Alive
Common Name:	Sycamore
Scientific Name:	<i>Acer pseudoplatanus</i>
Tree Height (bands):	5-10m
Do not use - Stem Diameter (bands):	300-450mm
Crown Diameter [m]:	6
Family:	Sapindaceae
Life Stage:	Semi-mature
Target:	Building, Footpath
Risk Zone:	High
Physiological Condition:	Fair
Structural Condition:	Fair
Access:	No access to base/stem

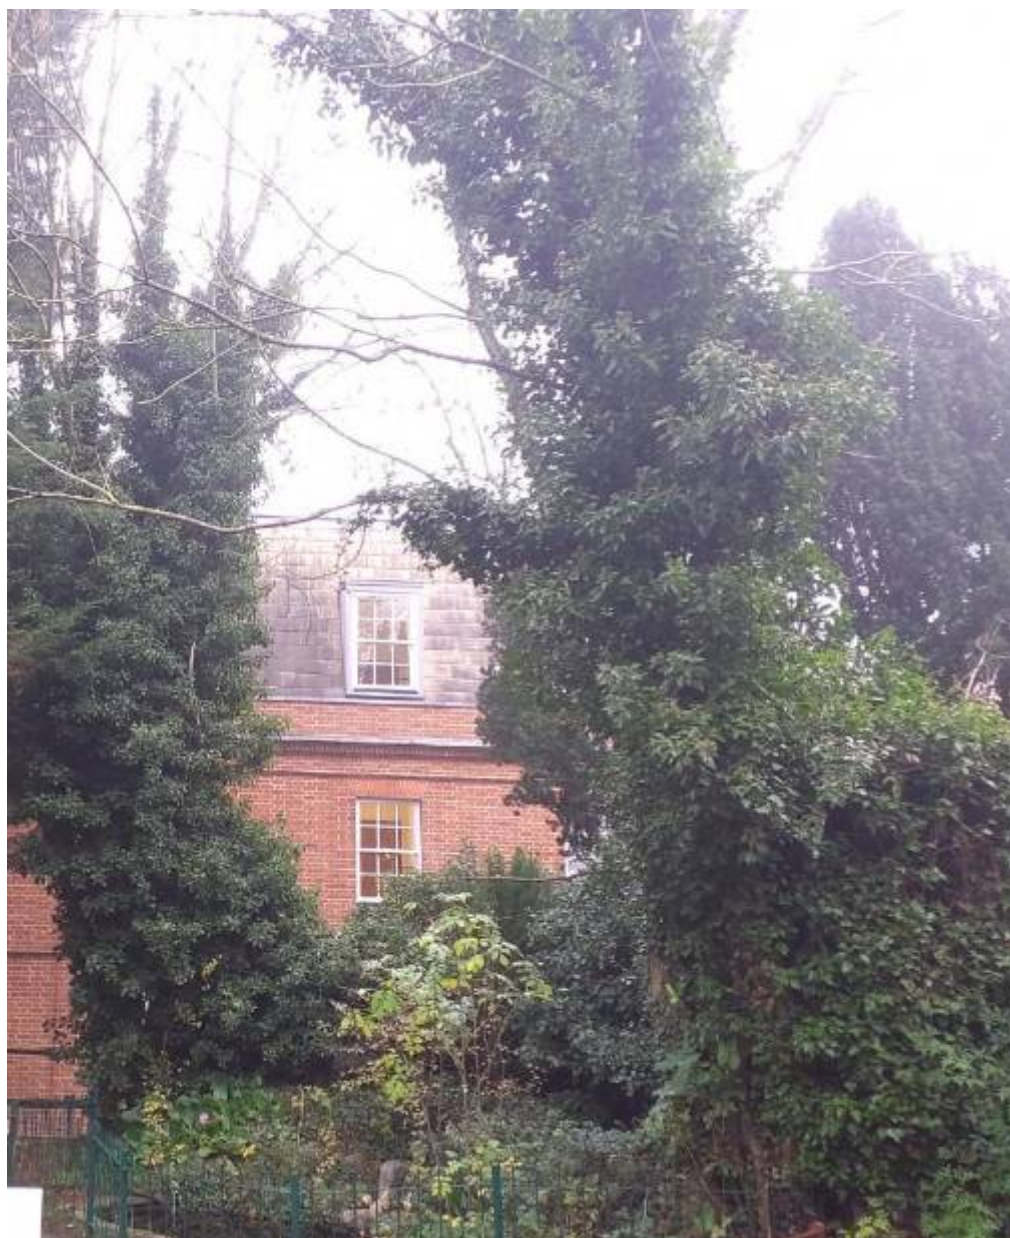
24	1878	Common ash	<i>Fraxinus excelsior</i>	16-20m	375	Semi-mature	Fair	Fair	Tree growing directly adjacent, and in contact with wall, future incremental growth will likely result in damage	None Significant	Ivy Covered Stem, Multi-Stem	Minor Dead Wood Under 50mm Diameter	None Observed	Building, Footpath, Wall	High	Good	Client
25	1879	Common ash	<i>Fraxinus excelsior</i>	16-20m	350	Semi-mature	Fair	Fair	Tree growing directly adjacent, and in contact with wall, future incremental growth will likely result in damage Dieback in crown	None Significant	Ivy Covered Stem, Multi-Stem	Crown Dieback, Minor Dead Wood Under 50mm Diameter	None Observed	Building, Footpath, Wall	High	Good	Client
26	1881	Common ash	<i>Fraxinus excelsior</i>	16-20m	450	Mature	Fair	Fair		None Significant	Included Co-Dominant Stem, Ivy Covered Stem, Multi-Stem	Crossing/Rubbing Branches, Major Dead Wood Over 50mm Diameter, Minor Dead Wood Under 50mm Diameter	None Observed	Car park, Footpath, Wall	High	Good	Client

VTA	
Site:	BMI - Chelsfield Park Hospital
Tree ID:	24
Tag No:	1878
Status:	Alive
Common Name:	Common ash
Scientific Name:	Fraxinus excelsior
Tree Height (bands):	16-20m
Do not use - Stem Diameter (bands):	300-450mm
Crown Diameter [m]:	8
Family:	Oleaceae
Life Stage:	Semi-mature
Target:	Building, Footpath, Wall
Risk Zone:	High
Physiological Condition:	Fair
Structural Condition:	Fair
Access:	Good

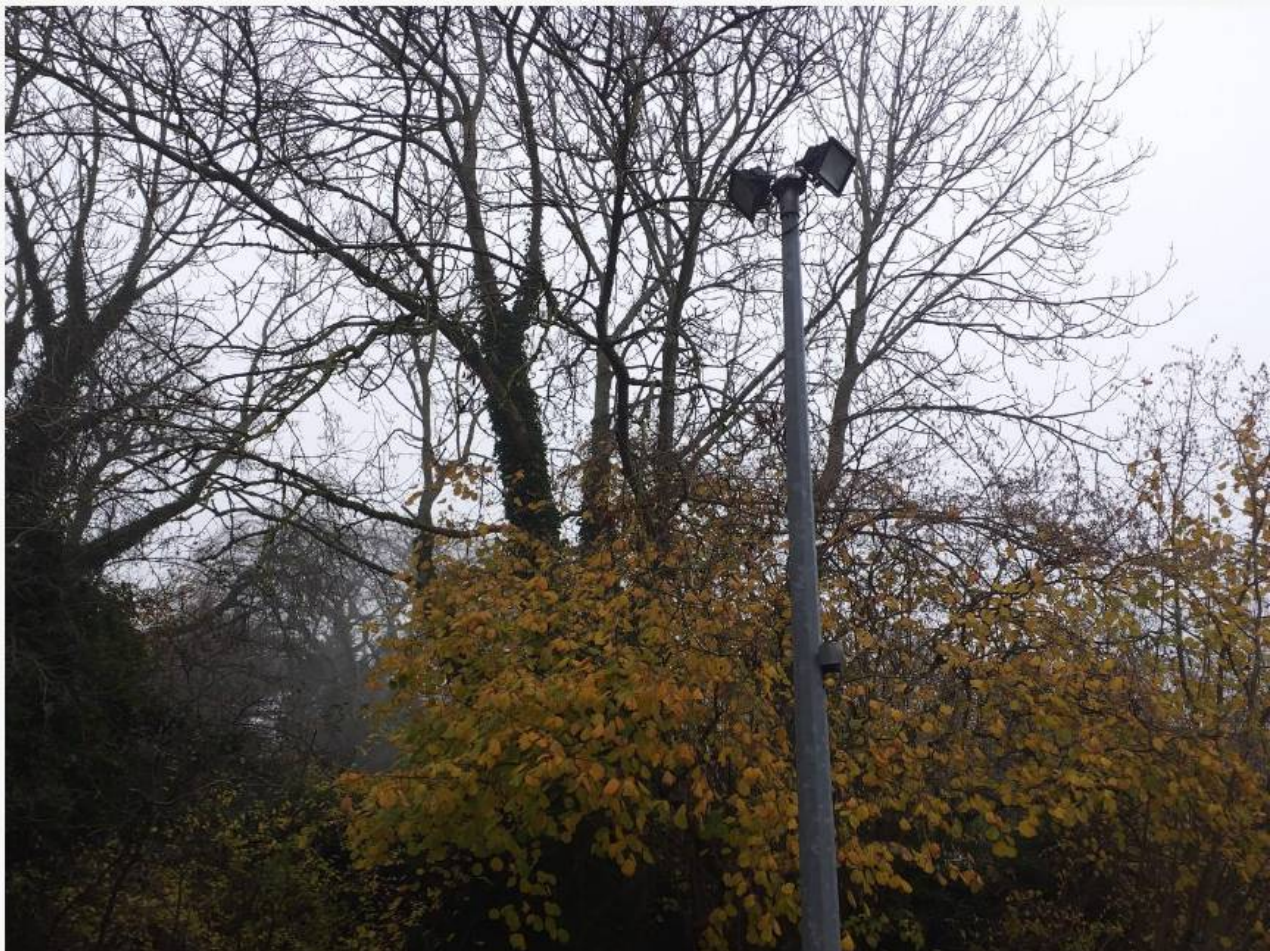
VTA	
Site:	BMI - Chelsfield Park Hospital
Tree ID:	26
Tag No:	1881
Status:	Alive
Common Name:	Common ash
Scientific Name:	<i>Fraxinus excelsior</i>
Tree Height (bands):	16-20m
Do not use - Stem Diameter (bands):	300-450mm
Crown Diameter [m]:	10
Family:	Oleaceae
Life Stage:	Mature
Target:	Car park, Footpath, Wall
Risk Zone:	High
Physiological Condition:	Fair
Structural Condition:	Fair
Access:	Good

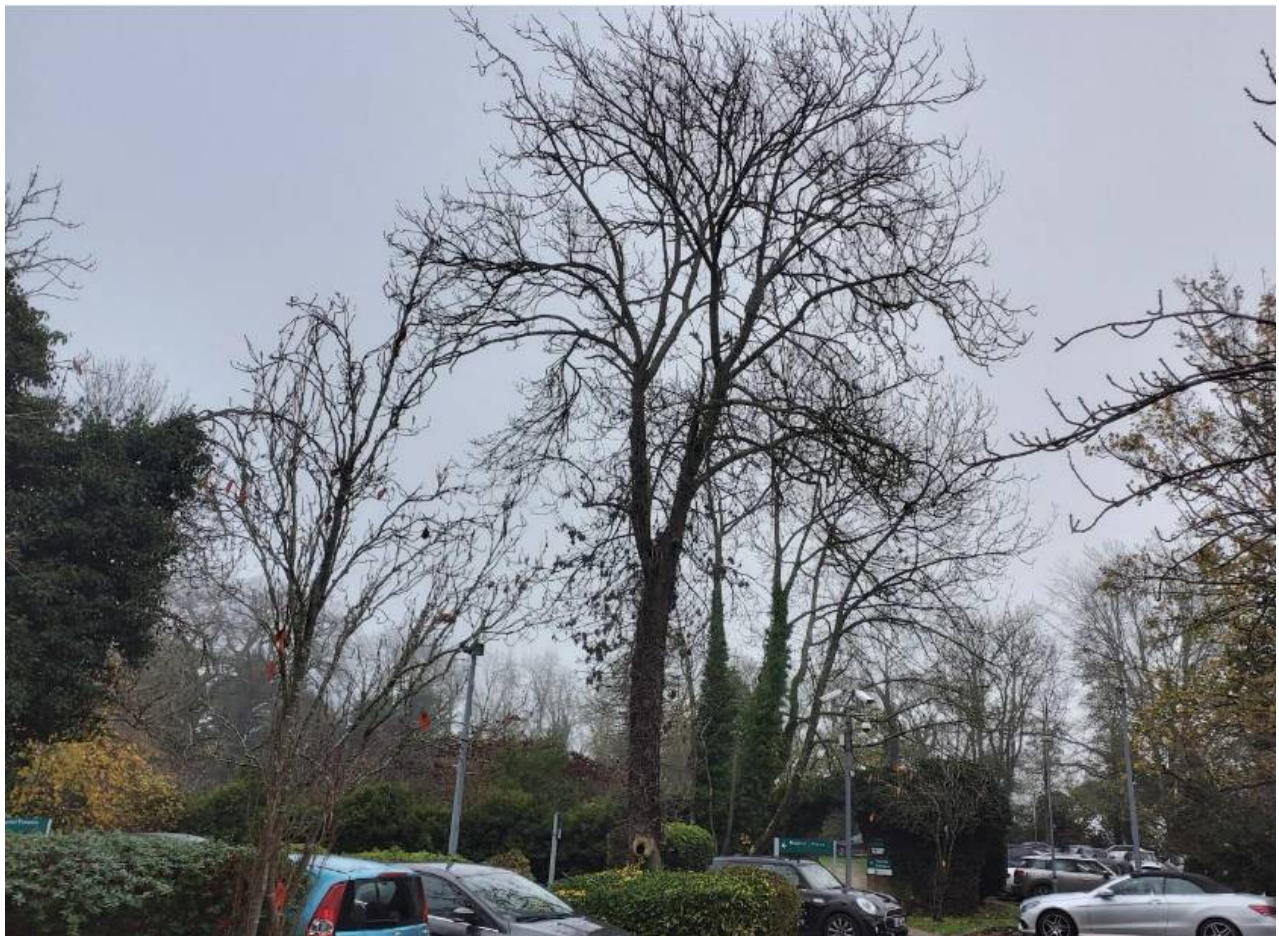
VTA	
Site:	BMI - Chelsfield Park Hospital
Tree ID:	32
Tag No:	1877
Status:	Alive
Common Name:	Common ash
Scientific Name:	<i>Fraxinus excelsior</i>
Tree Height (bands):	16-20m
Do not use - Stem Diameter (bands):	300-450mm
Crown Diameter [m]:	10
Family:	Oleaceae
Life Stage:	Mature
Target:	Car park
Risk Zone:	High
Physiological Condition:	Poor
Structural Condition:	Poor
Access:	No access to base/stem

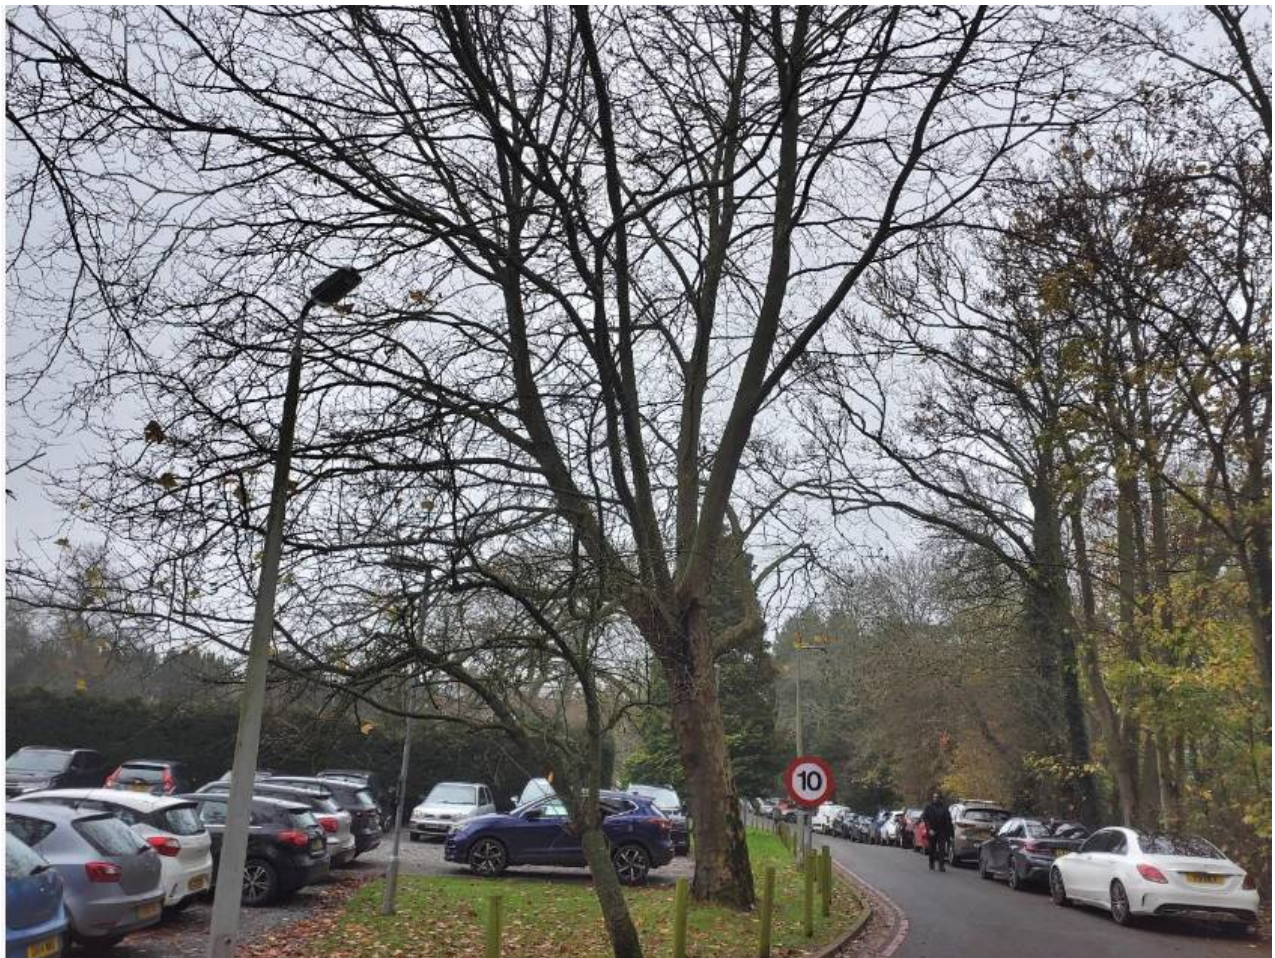
VTA	
Site:	BMI - Chelsfield Park Hospital
Tree ID:	50
Tag No:	1885
Status:	Alive
Common Name:	London plane
Scientific Name:	<i>Platanus x hispanica</i>
Tree Height (bands):	16-20m
Do not use - Stem Diameter (bands):	450-600mm
Crown Diameter [m]:	14
Family:	Platanaceae
Life Stage:	Mature
Target:	Car park, Road
Risk Zone:	High
Physiological Condition:	Fair
Structural Condition:	Fair
Access:	Good

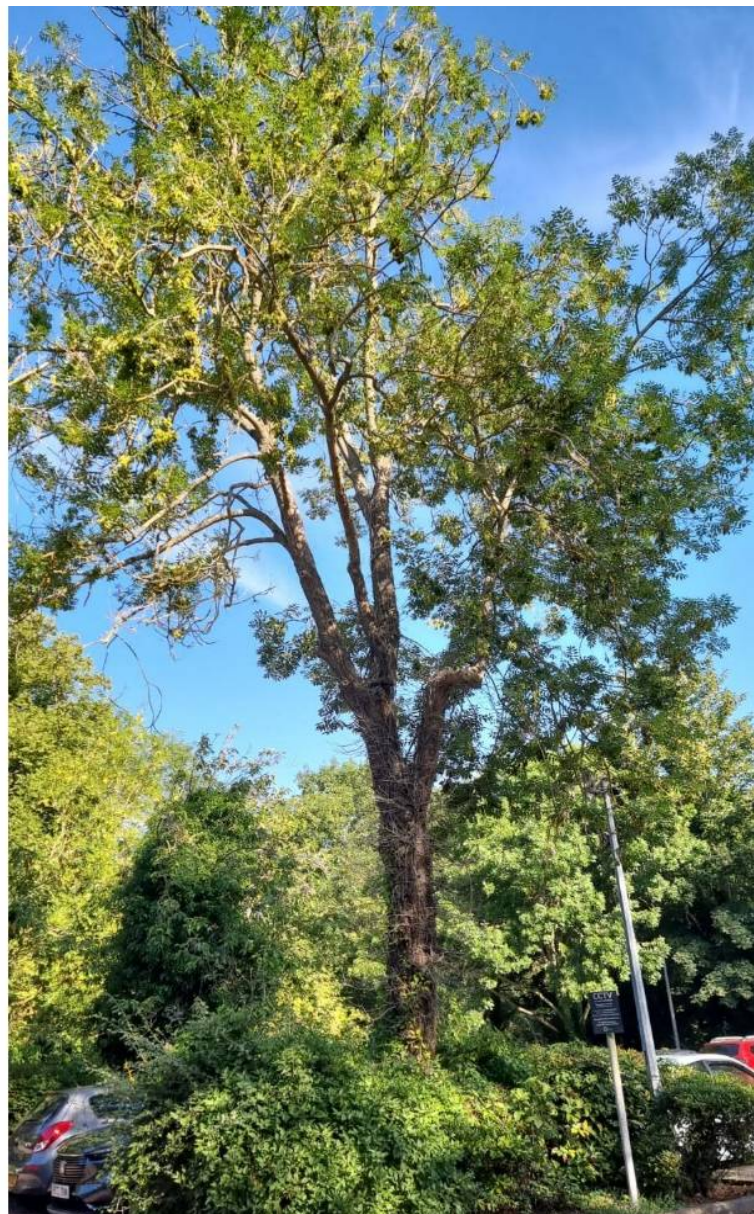
VTA	
Site:	BMI - Chelsfield Park Hospital
Tree ID:	33
Tag No:	
Status:	Alive
Common Name:	Common ash
Scientific Name:	Fraxinus excelsior
Tree Height (bands):	16-20m
Do not use - Stem Diameter (bands):	450-600mm
Crown Diameter [m]:	12
Family:	Oleaceae
Life Stage:	Mature
Target:	Car park, Footpath, Wall
Risk Zone:	High
Physiological Condition:	Fair
Structural Condition:	Fair
Access:	Good

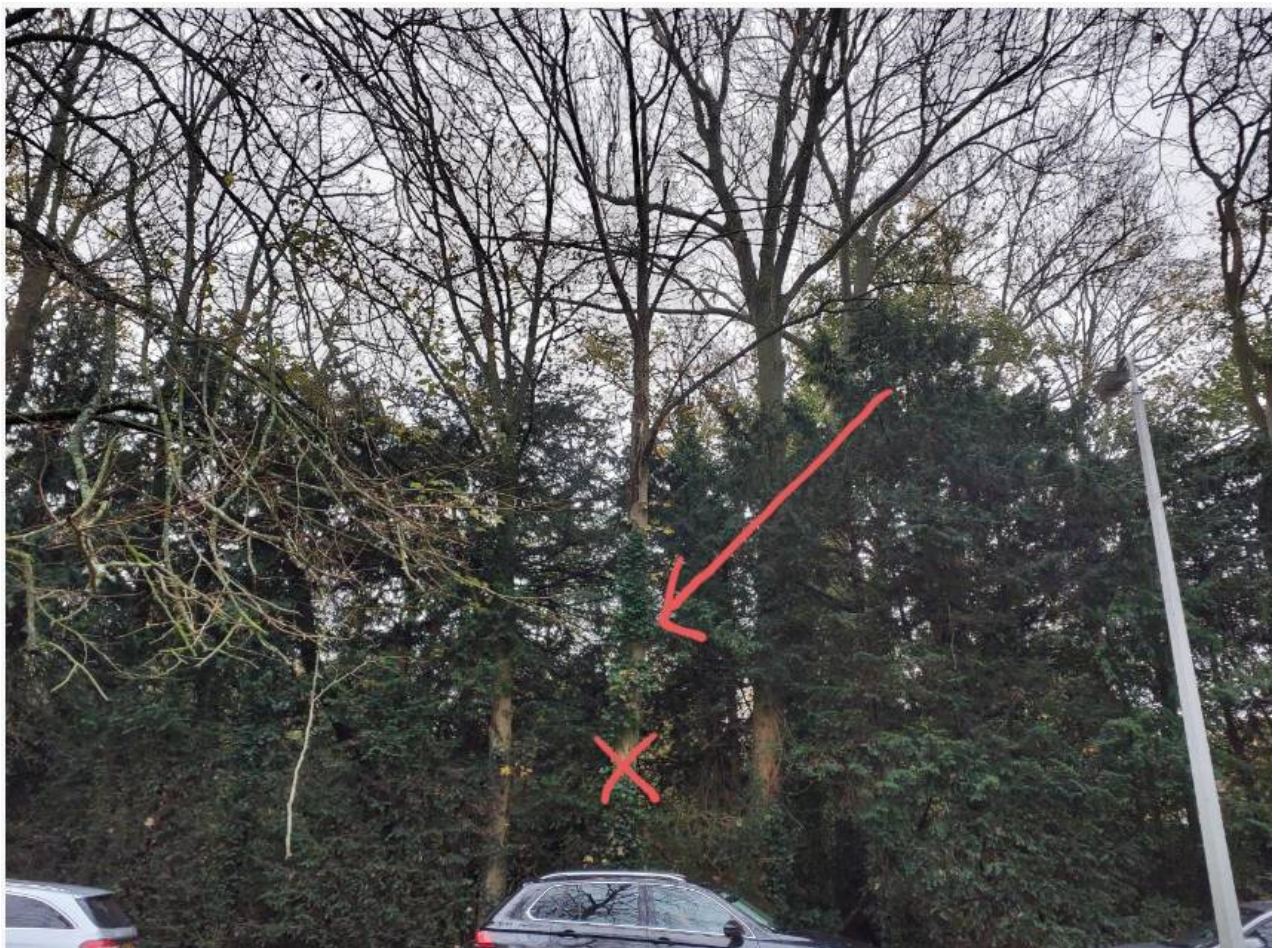
VTA	
Site:	BMI - Chelsfield Park Hospital
Tree ID:	51
Tag No:	1872
Status:	Alive
Common Name:	Norway maple
Scientific Name:	Acer platanoides
Tree Height (bands):	16-20m
Do not use - Stem Diameter (bands):	300-450mm
Crown Diameter [m]:	6
Family:	Sapindaceae
Life Stage:	Early-mature
Target:	Car park, Road
Risk Zone:	High
Physiological Condition:	Poor
Structural Condition:	Poor
Access:	Good
