Tree Condition Survey Report (VTA)

Site: Chelsfield Park Hospital, Bucks Cross Rd, Chelsfield,
Orpington, BR6 7RG

Client: BMI – Circle Health Group

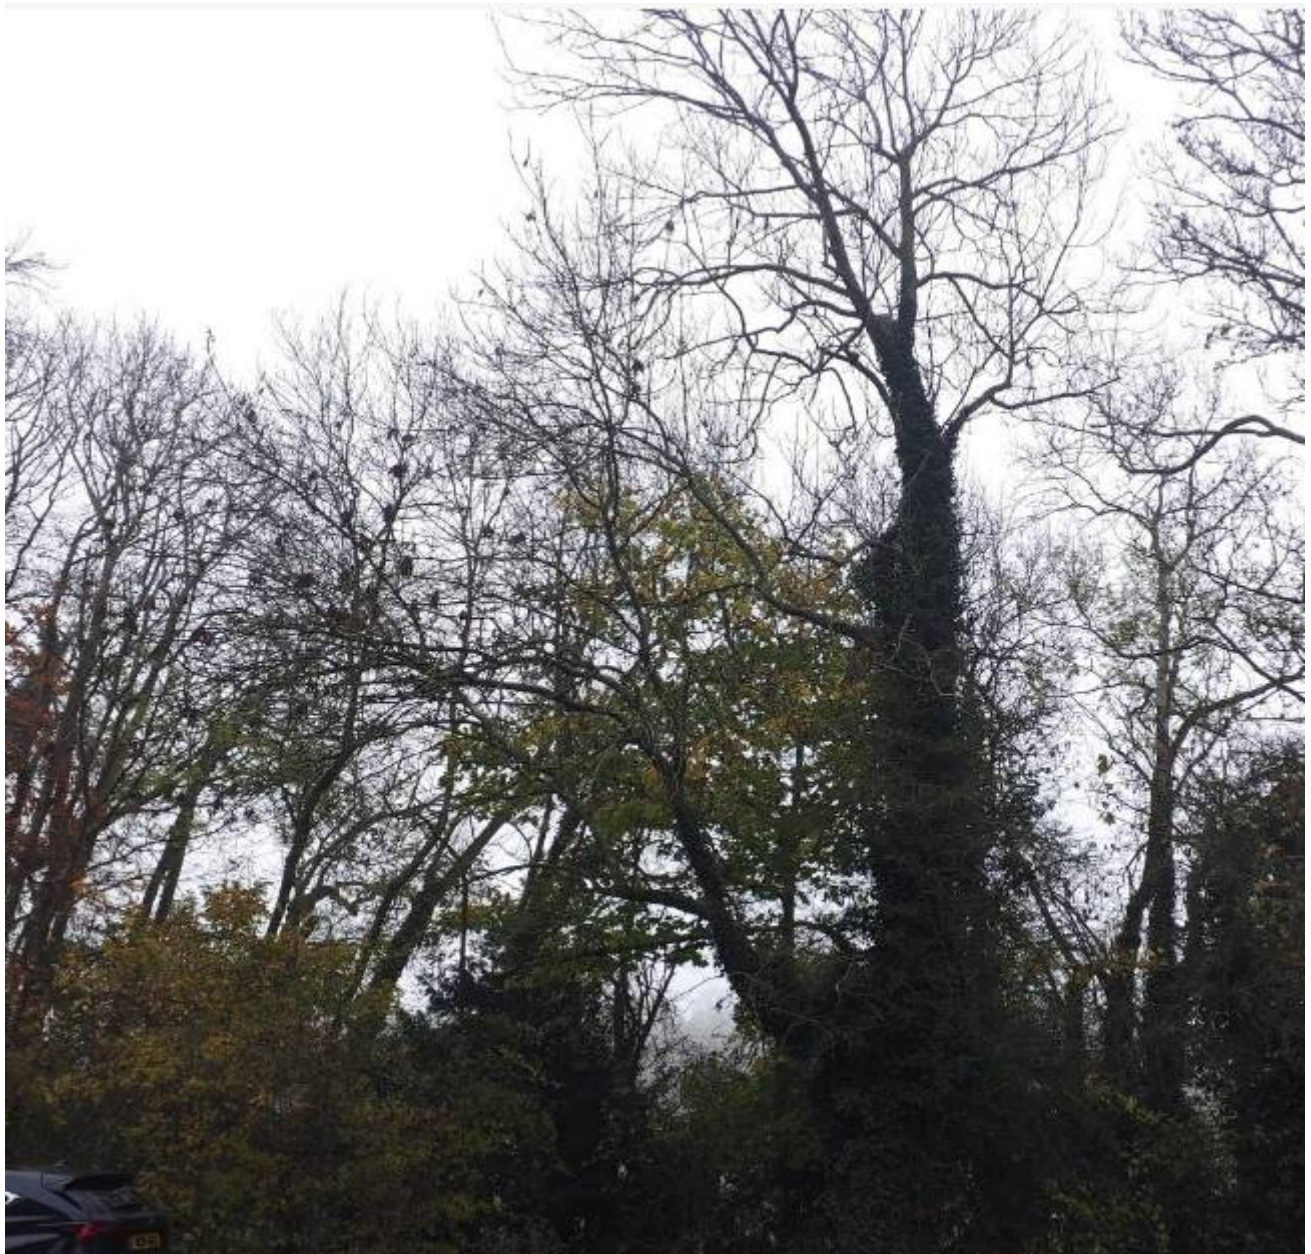
52	1874	Common ash	Fraxinus excelsior	16-20m	475	Mature	Fair	Poor		None Significant	Ivy Covered Stem, Multi-Stem	Minor Dead Wood Under 50mm Diameter	Fungus - Inonotus	Car park, Road	High	Good	Client
53	1875	Common ash	Fraxinus excelsior	16-20m	375	Mature	Poor	Poor		Root-plate Failure	Stem Failure	Minor Dead Wood Under 50mm Diameter	Fungus - Inonotus	Other	High	Good	Client
54	1876	Common ash	Fraxinus excelsior	16-20m	300	Mature	Poor	Poor		None Significant	Decay on Stem, Decay Column	Minor Dead Wood Under 50mm Diameter	Fungus - Inonotus	Road, Other	High	Good	Client
55	1883	Common ash	Fraxinus excelsior	16-20m	325	Mature	Poor	Poor		None Significant	Decay on Stem, Decay Column	Minor Dead Wood Under 50mm Diameter	None Observed	Other	High	Good	Client
56	1884	Common ash	Fraxinus excelsior	16-20m	400	Mature	Fair	Poor		None Significant	Cavity at Base, Decay Column, Ivy Covered Stem	Minor Dead Wood Under 50mm Diameter	None Observed	Other	High	Good	Client

VTA	
Site:	BMI - Chelsfield Park Hospital
Tree ID:	52
Tag No:	1874
Status:	Alive
Common Name:	Common ash
Scientific Name:	Fraxinus excelsior
Tree Height (bands):	16-20m
Do not use - Stem Diameter (bands):	450-600mm
Crown Diameter [m]:	10
Family:	Oleaceae
Life Stage:	Mature
Target:	Car park, Road
Risk Zone:	High
Physiological Condition:	Fair
Structural Condition:	Poor
Access:	Good

52	Common ash	Crown Reduce in Height by Specified Amount & Shape	Within 1 - 3 Months	Height reduced by 6m	1874
54	Common ash	Fell, Leaving Stump Just Above Ground Level	Within 1 - 3 Months		1876
55	Common ash	Fell, Leaving Stump Just Above Ground Level	Within 1 - 3 Months		1883
56	Common ash	Fell, Leaving Stump Just Above Ground Level	Within 1 - 3 Months		1884
Group 7	Common Ash	Remove Dead Wood	Within 1 - 3 Months	Dead wood all ash	Not tagged
3	Copper beech	Reduce Crown in Height (by 5m) and Shape	Within 6 - 12 Months	Reduce weight and height	325

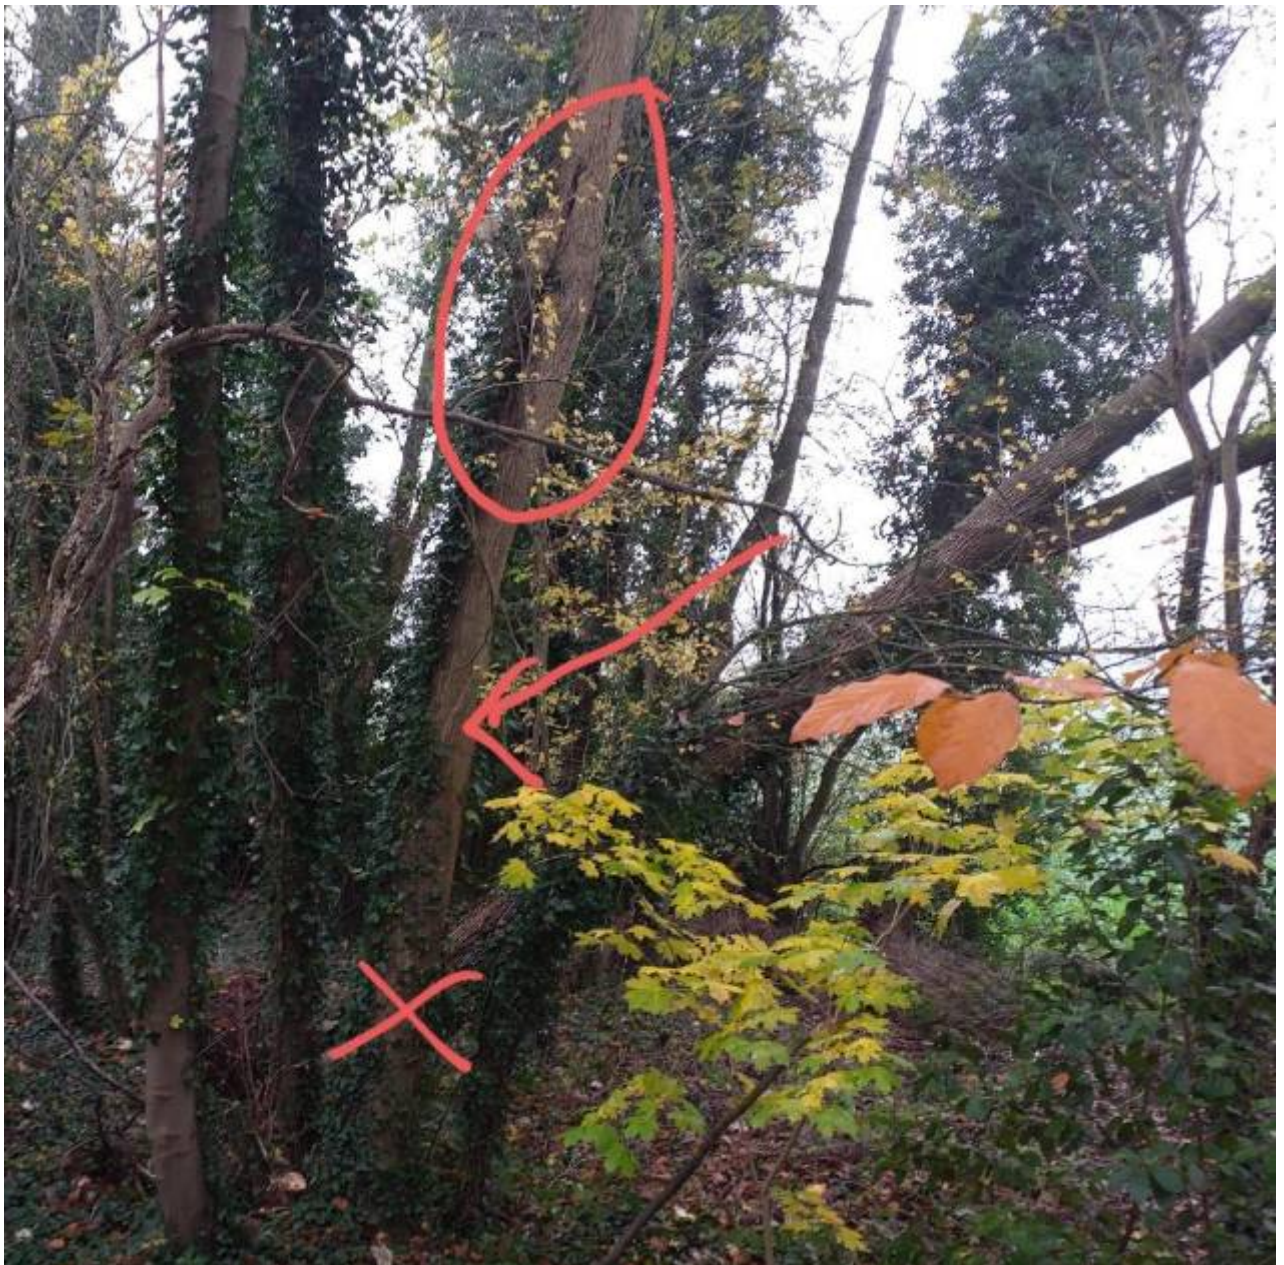
VTA	
Site:	BMI - Chelsfield Park Hospital
Tree ID:	54
Tag No:	1876
Status:	Alive
Common Name:	Common ash
Scientific Name:	Fraxinus excelsior
Tree Height (bands):	16-20m
Do not use - Stem Diameter (bands):	300-450mm
Crown Diameter [m]:	8
Family:	Oleaceae
Life Stage:	Mature
Target:	Road, Other
Risk Zone:	High
Physiological Condition:	Poor
Structural Condition:	Poor
Access:	Good

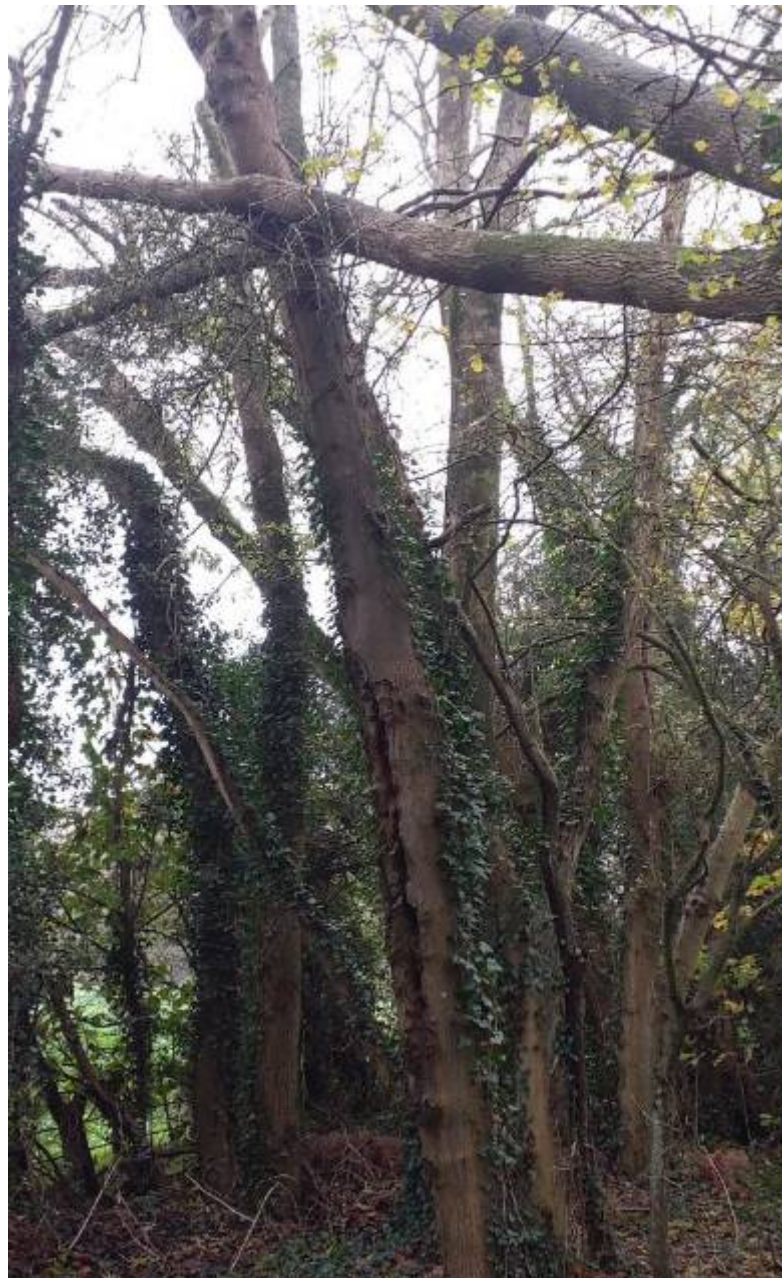
VTA	
Site:	BMI - Chelsfield Park Hospital
Tree ID:	55
Tag No:	1883
Status:	Alive
Common Name:	Common ash
Scientific Name:	Fraxinus excelsior
Tree Height (bands):	16-20m
Do not use - Stem Diameter (bands):	300-450mm
Crown Diameter [m]:	8
Family:	Oleaceae
Life Stage:	Mature
Target:	Other
Risk Zone:	High
Physiological Condition:	Poor
Structural Condition:	Poor
Access:	Good

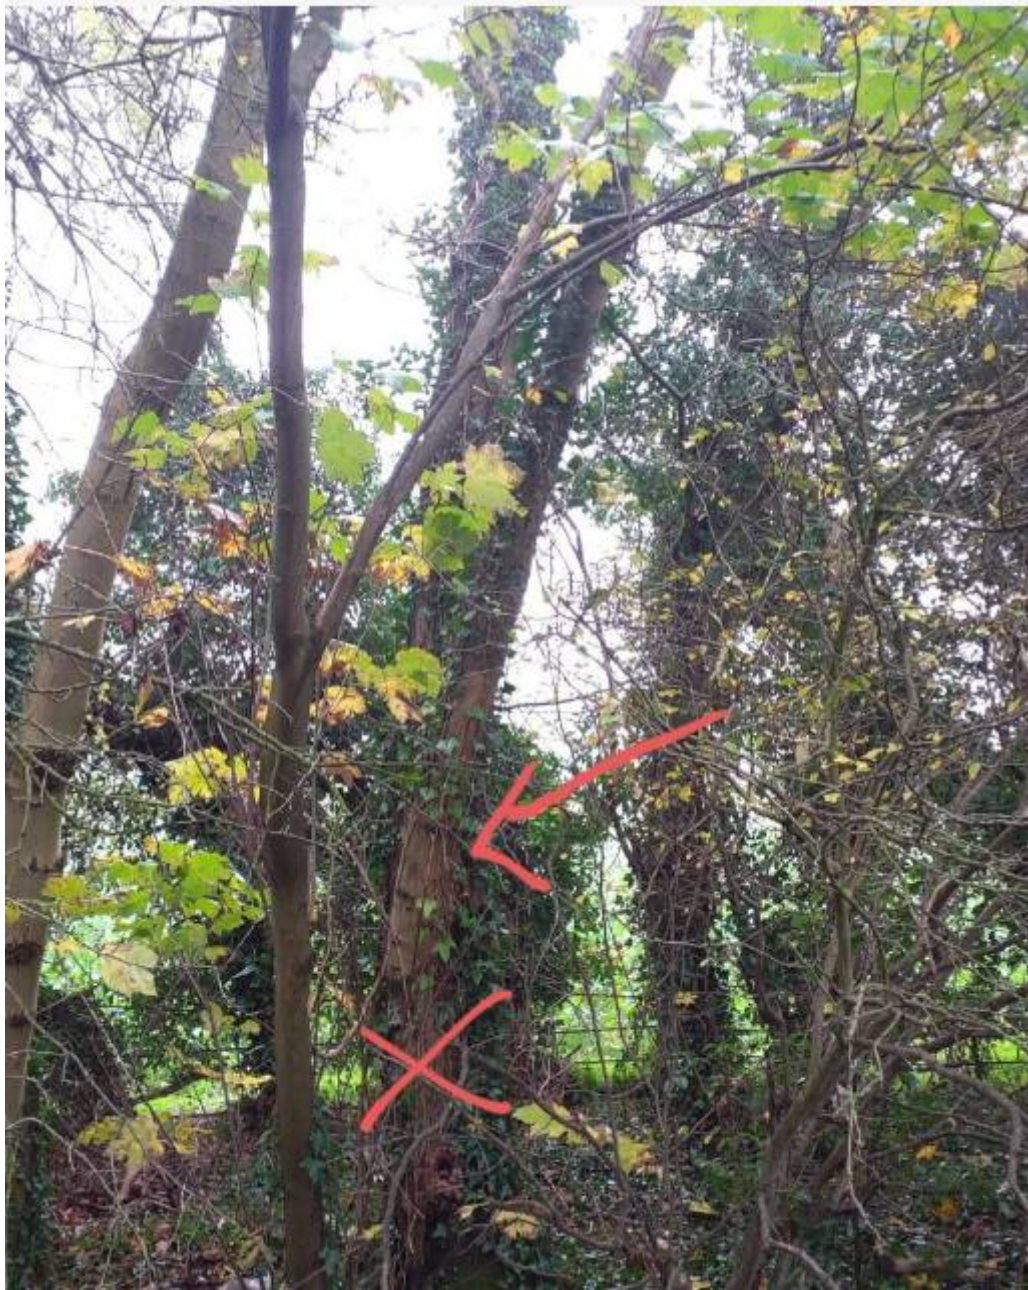
VTA	
Site:	BMI - Chelsfield Park Hospital
Tree ID:	56
Tag No:	1884
Status:	Alive
Common Name:	Common ash
Scientific Name:	Fraxinus excelsior
Tree Height (bands):	16-20m
Do not use - Stem Diameter (bands):	300-450mm
Crown Diameter [m]:	8
Family:	Oleaceae
Life Stage:	Mature
Target:	Other
Risk Zone:	High
Physiological Condition:	Fair
Structural Condition:	Poor
Access:	Good

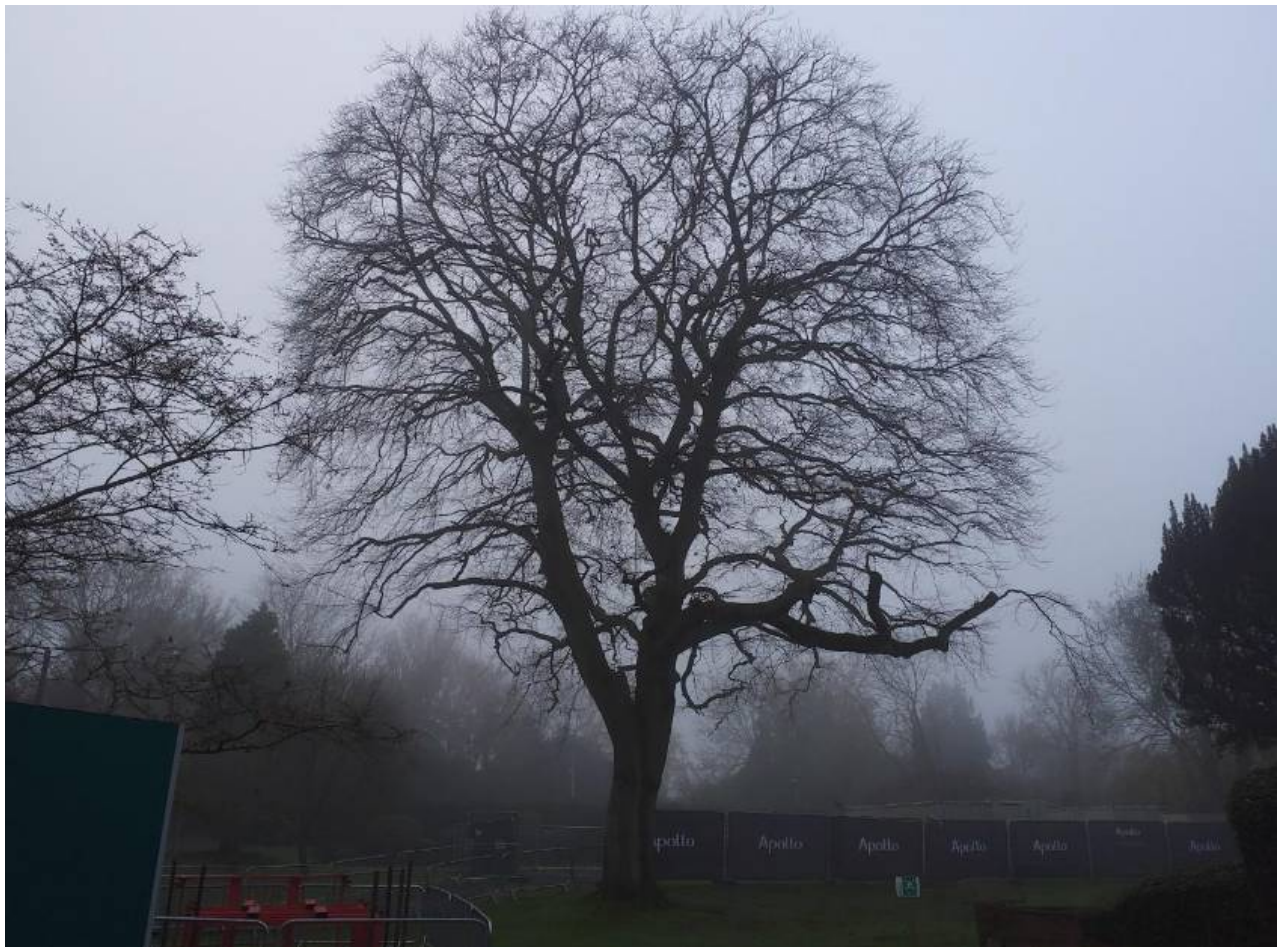
VTA	
Site:	BMI - Chelsfield Park Hospital
Tree ID:	3
Tag No:	0325
Status:	Alive
Common Name:	Copper beech
Scientific Name:	<i>Fagus sylvatica f. purpurea</i>
Tree Height (bands):	20+m
Do not use - Stem Diameter (bands):	1000+mm
Crown Diameter [m]:	18
Family:	
Life Stage:	Mature
Target:	Building, Footpath, Road
Risk Zone:	High
Physiological Condition:	Fair
Structural Condition:	Poor
Access:	Good
