CCTV Inspection Report

**MILLFIELD HOUSE
LINLEY AVENUE
HAXBY
YORK
YO32 3NF**

20/04/2023

Job Number: 7663

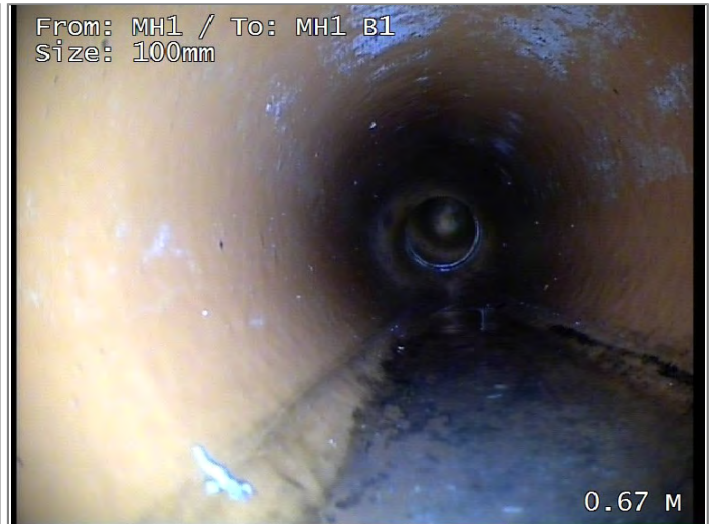
Junction at 9 o'clock, diameter 100mm - Remark: JUNCTION SERVES GULLY AT FRONT OF HOUSE.

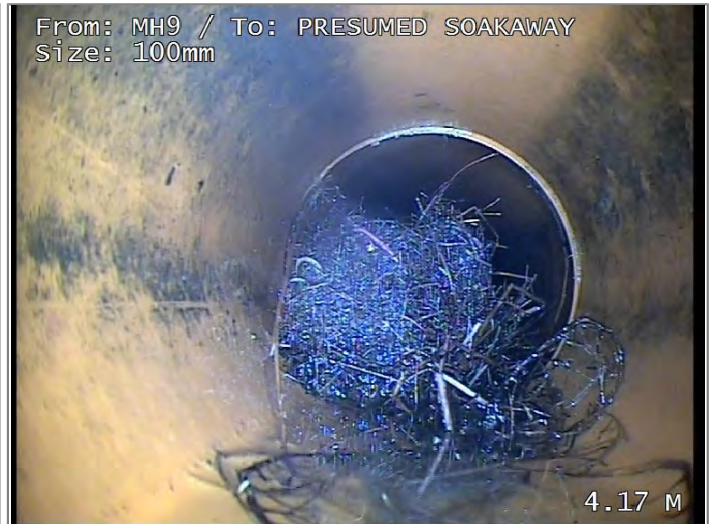
Manholes: **MH9 to PRESUMED SOAKAWAY**
Pipe Length: **22.05 metres**
Structural Grade: **4**
Service Grade: **3**
Material: **Polyvinyl chloride**
Pipe Size: **100mm**
Use: **Surface water**

Roots mass 5% cross-sectional area loss

REMOVE ROOTS FROM LINE AND INSTALL 1X 100MM NO DIG STRUCTURAL REPAIR.

ROOT CUT AND INSTALL 1X NO DIG STRUCTURAL REPAIR.

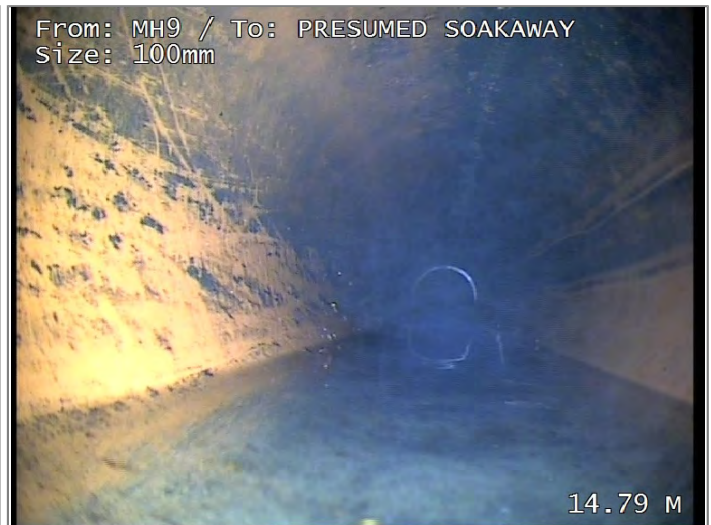
Open joint 10mm

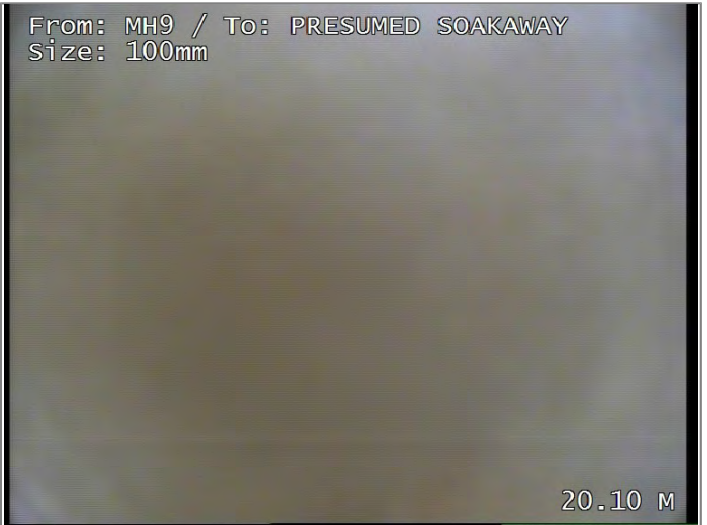
THE SOAKAWAY IN THE FIELD IS PARTIALLY BLOCKED AT APPROX 22M WITH ROOTS. WE WOULD SUGGEST AN EXCAVATION AT THIS POINT TO REMOVE THE ROOTS, CLEAN THE LINE AND SURVEY FURTHER DOWNSTREAM TO PIN POINT EXACT LOCATION OF THE SOAKAWAY. MINI DIGGER UPTO 1 DAY, SONDE AND RESUVEY

Loss of vision, camera under water

FOR THE BUDGET COST OF £800.00 PLUS VAT.
