**Arboricultural
Report to BS
5837:2012**

217 Eastfield Road
Louth
LN11 7AS

15th November 2023

231109

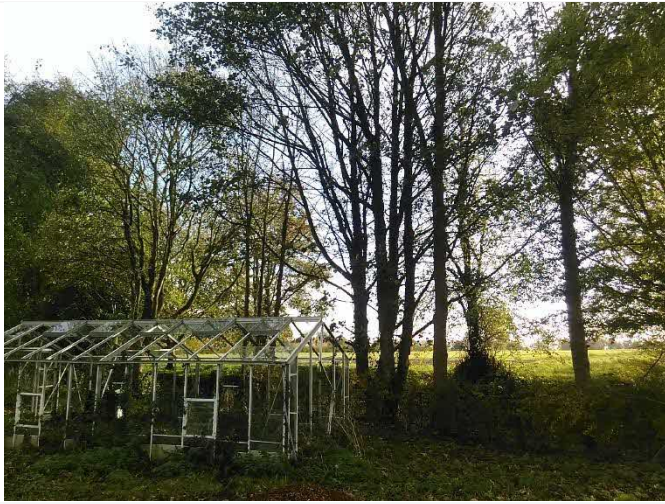
Image 1 – Left to right G4, T9, G3, T8, G2, T7

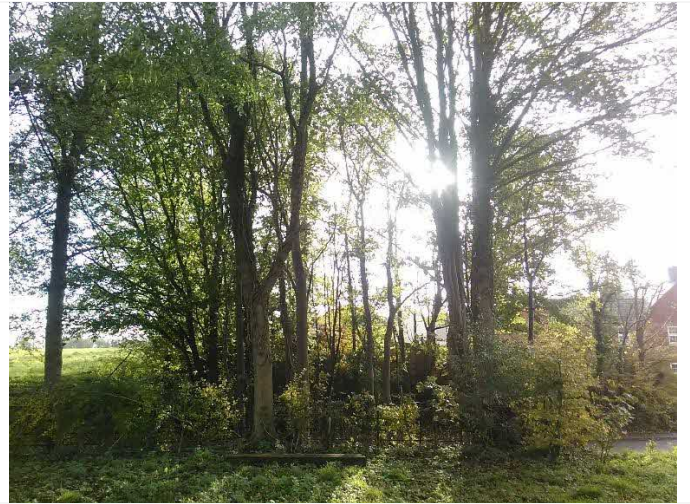
Image 2 – Left to right T7, G1, T6, T5, T4, T3, T2, T1

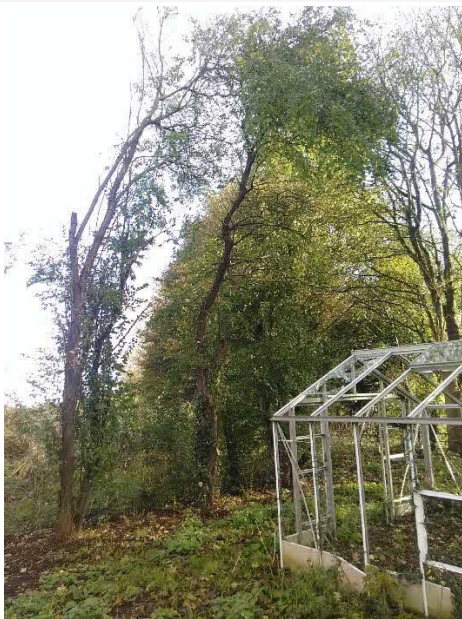
Image 3 – Left to right G5 & T9, with G4 in background

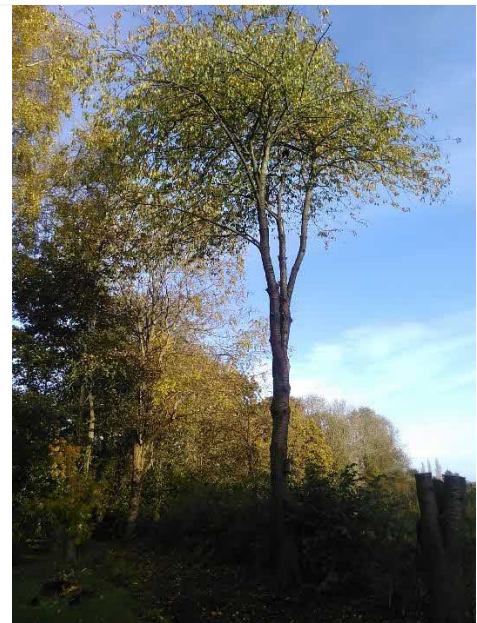
T10	Wild Cherry	Early-mature	10	500				6.0	4	6	3	5	Fair	C2	20 to 40 yrs	Fair / Good	Small Gannoderma sp. fruiting body at base to W, good buttress root flare present. Dead primary limb at 1.5m to E, decay initiated at main union. Very high crown break with minor deadwood in lower canopy.	n/a

Image 4 – Left to right G6 (western portion) & T10

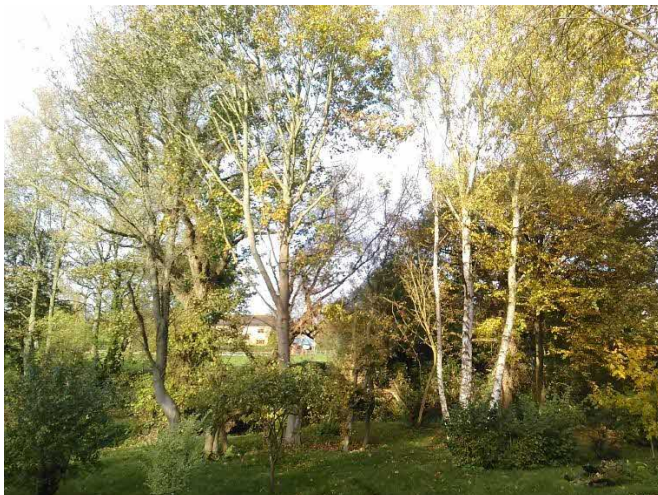
Image 5 – G6 (central & eastern) showing T13, T12 & T11 (left to right)

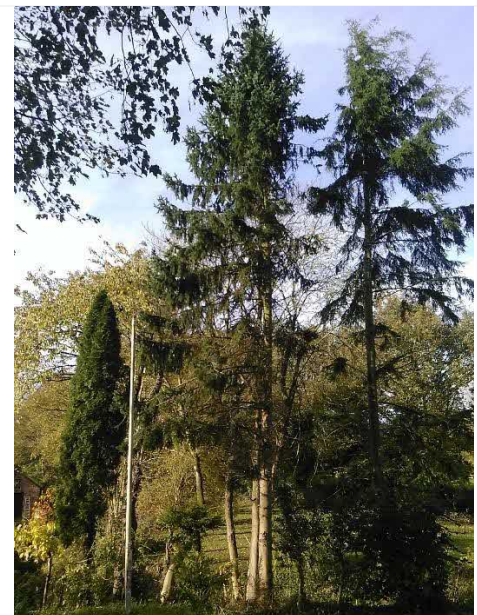
Image 6 – Left to right T14 & G8

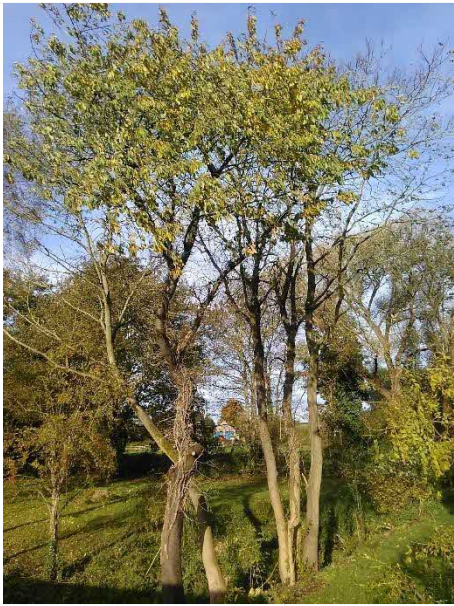
Image 7 – Left to right G9
