16 KNOSSINGTON ROAD, BRAUNSTON Pre-Development Tree Survey Report

Karen Nagel

November 2023

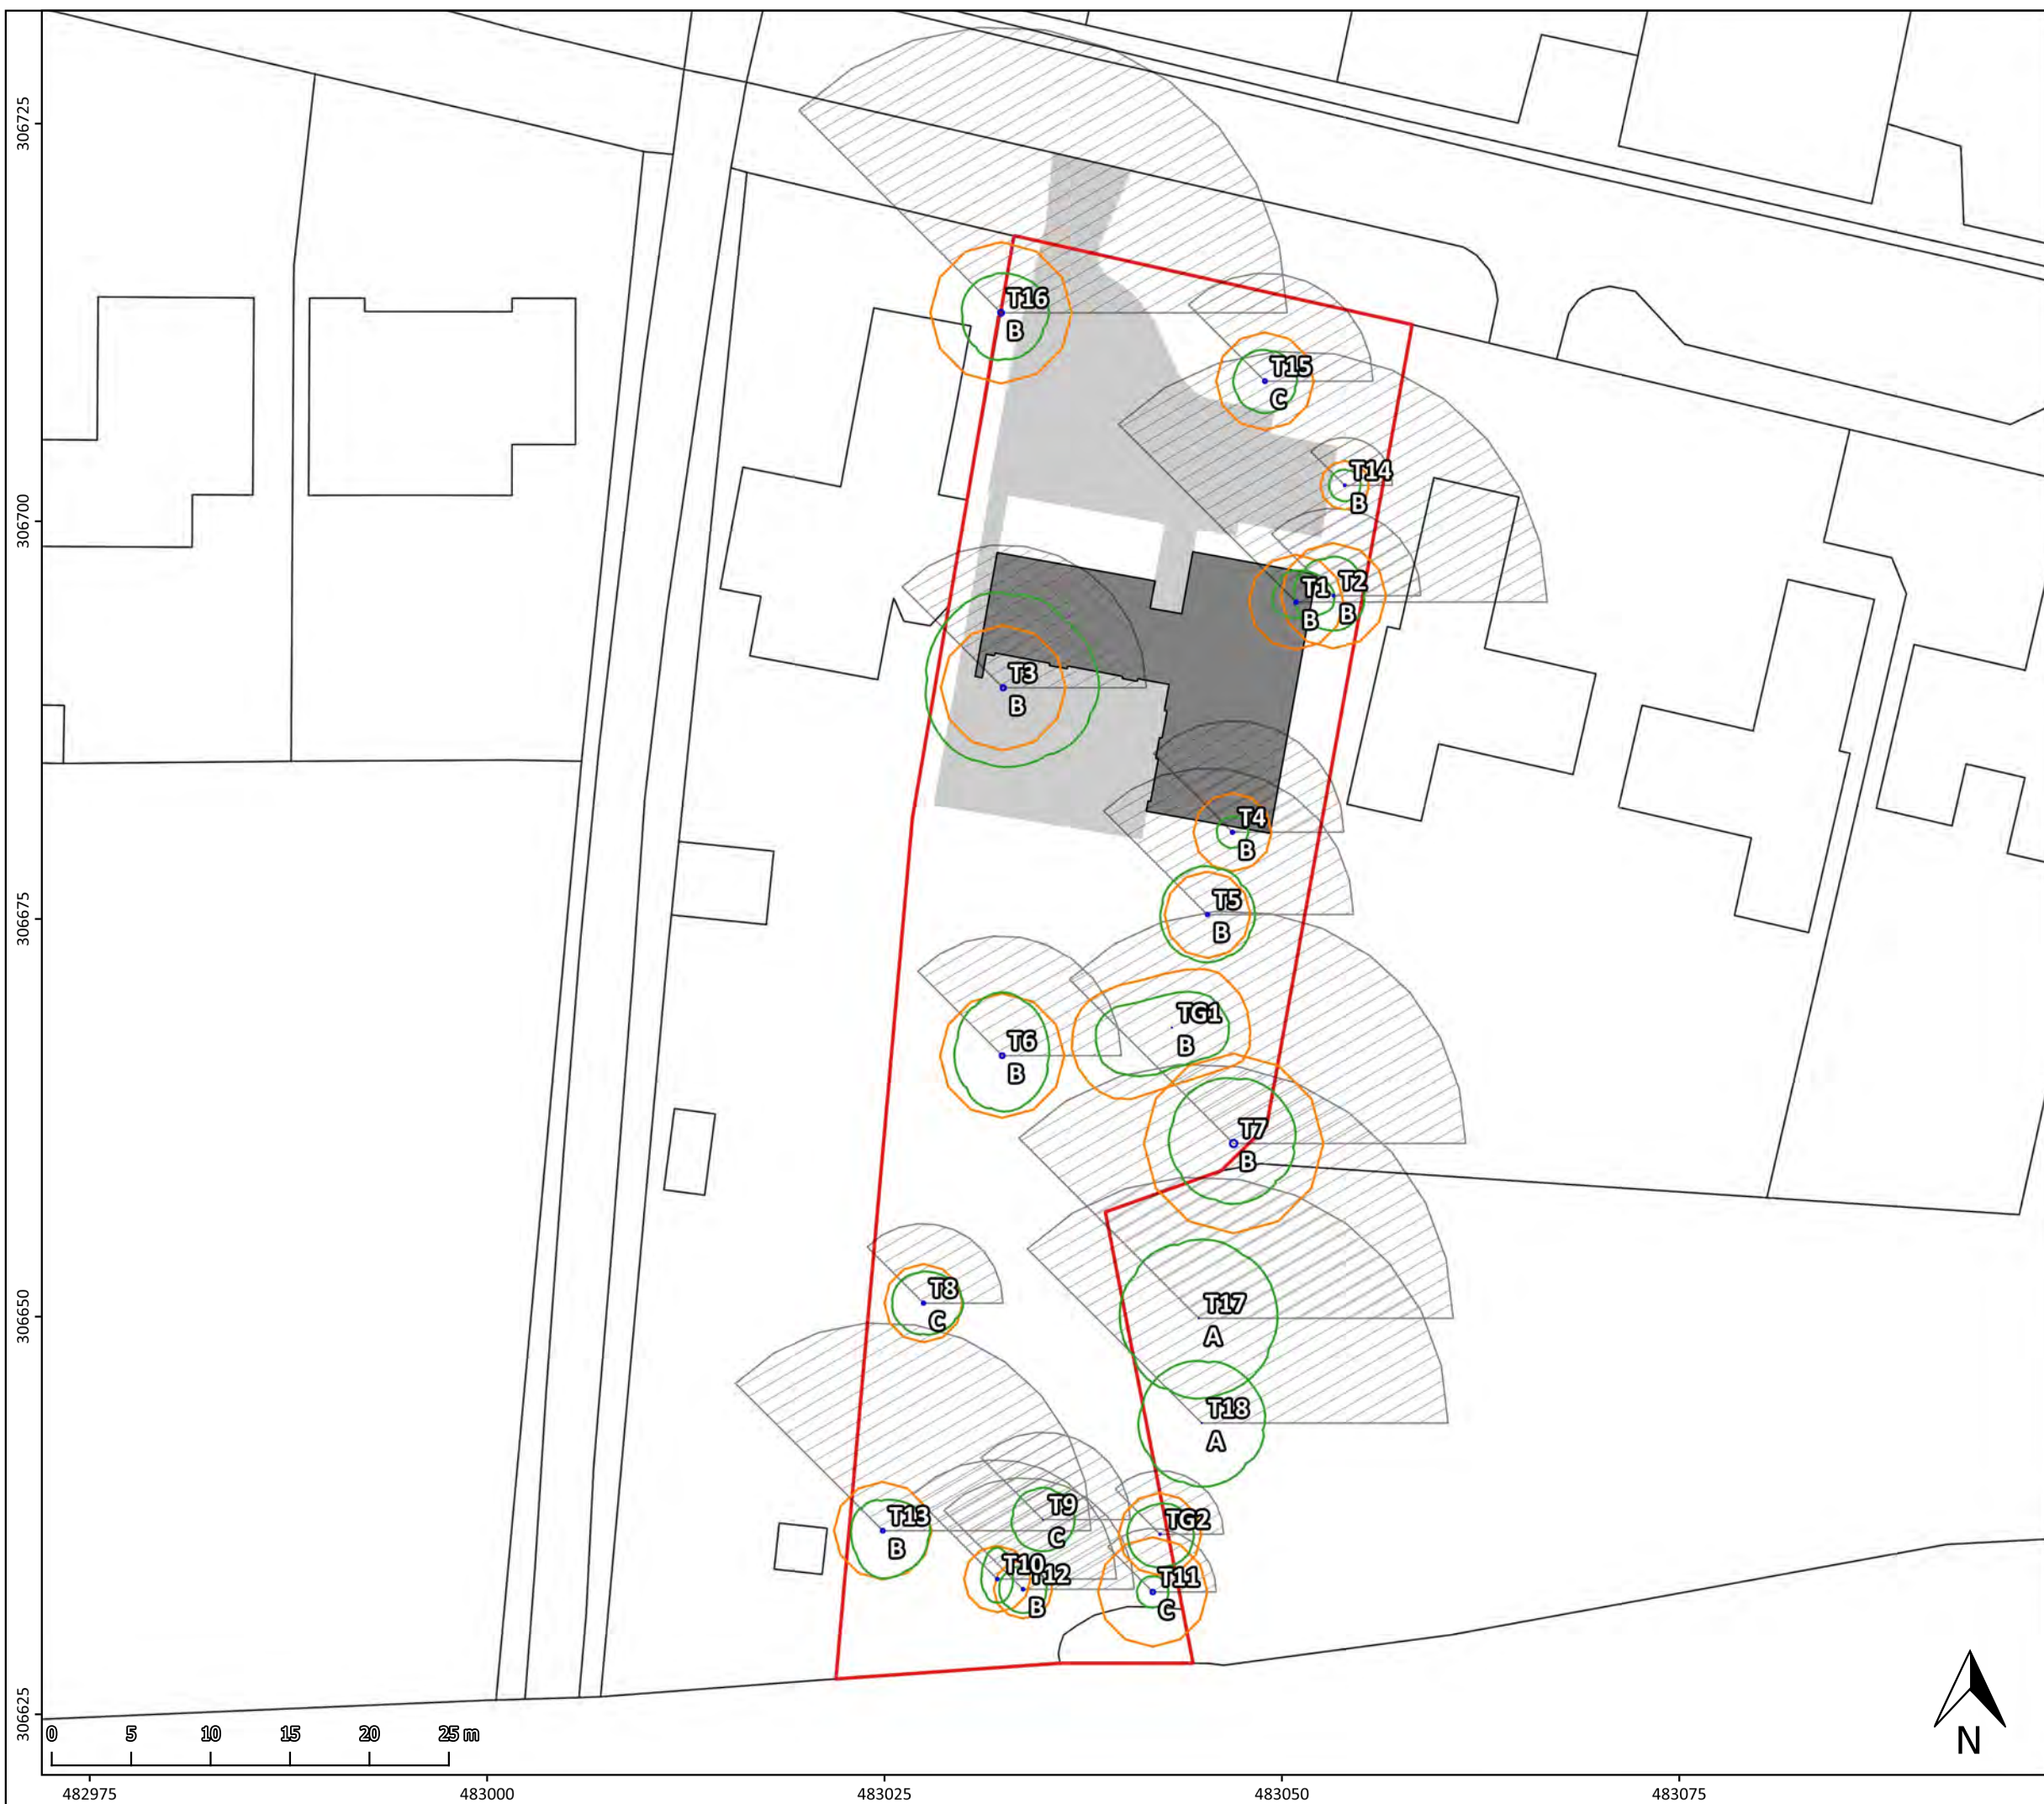
Figure 1 - Tree Constraints Plan

- the construction of the new dwelling will require the removal of trees T1, T2, T3 and T4 either because of overlap with the new dwelling's footprint (T1 and T3) or because the extent of encroachment on the Root Protection Area (RPA) is such that the structural and biological integrity of the tree would be irreversibly compromised.
- the root system of tree T16 is exposed to damage through resurfacing of the driveway (assumed to be part of the property's redevelopment).
- albeit only marginally exposed to construction activities, the removal and replacement of Tree T15 is proposed in light of its poor arboricultural value.

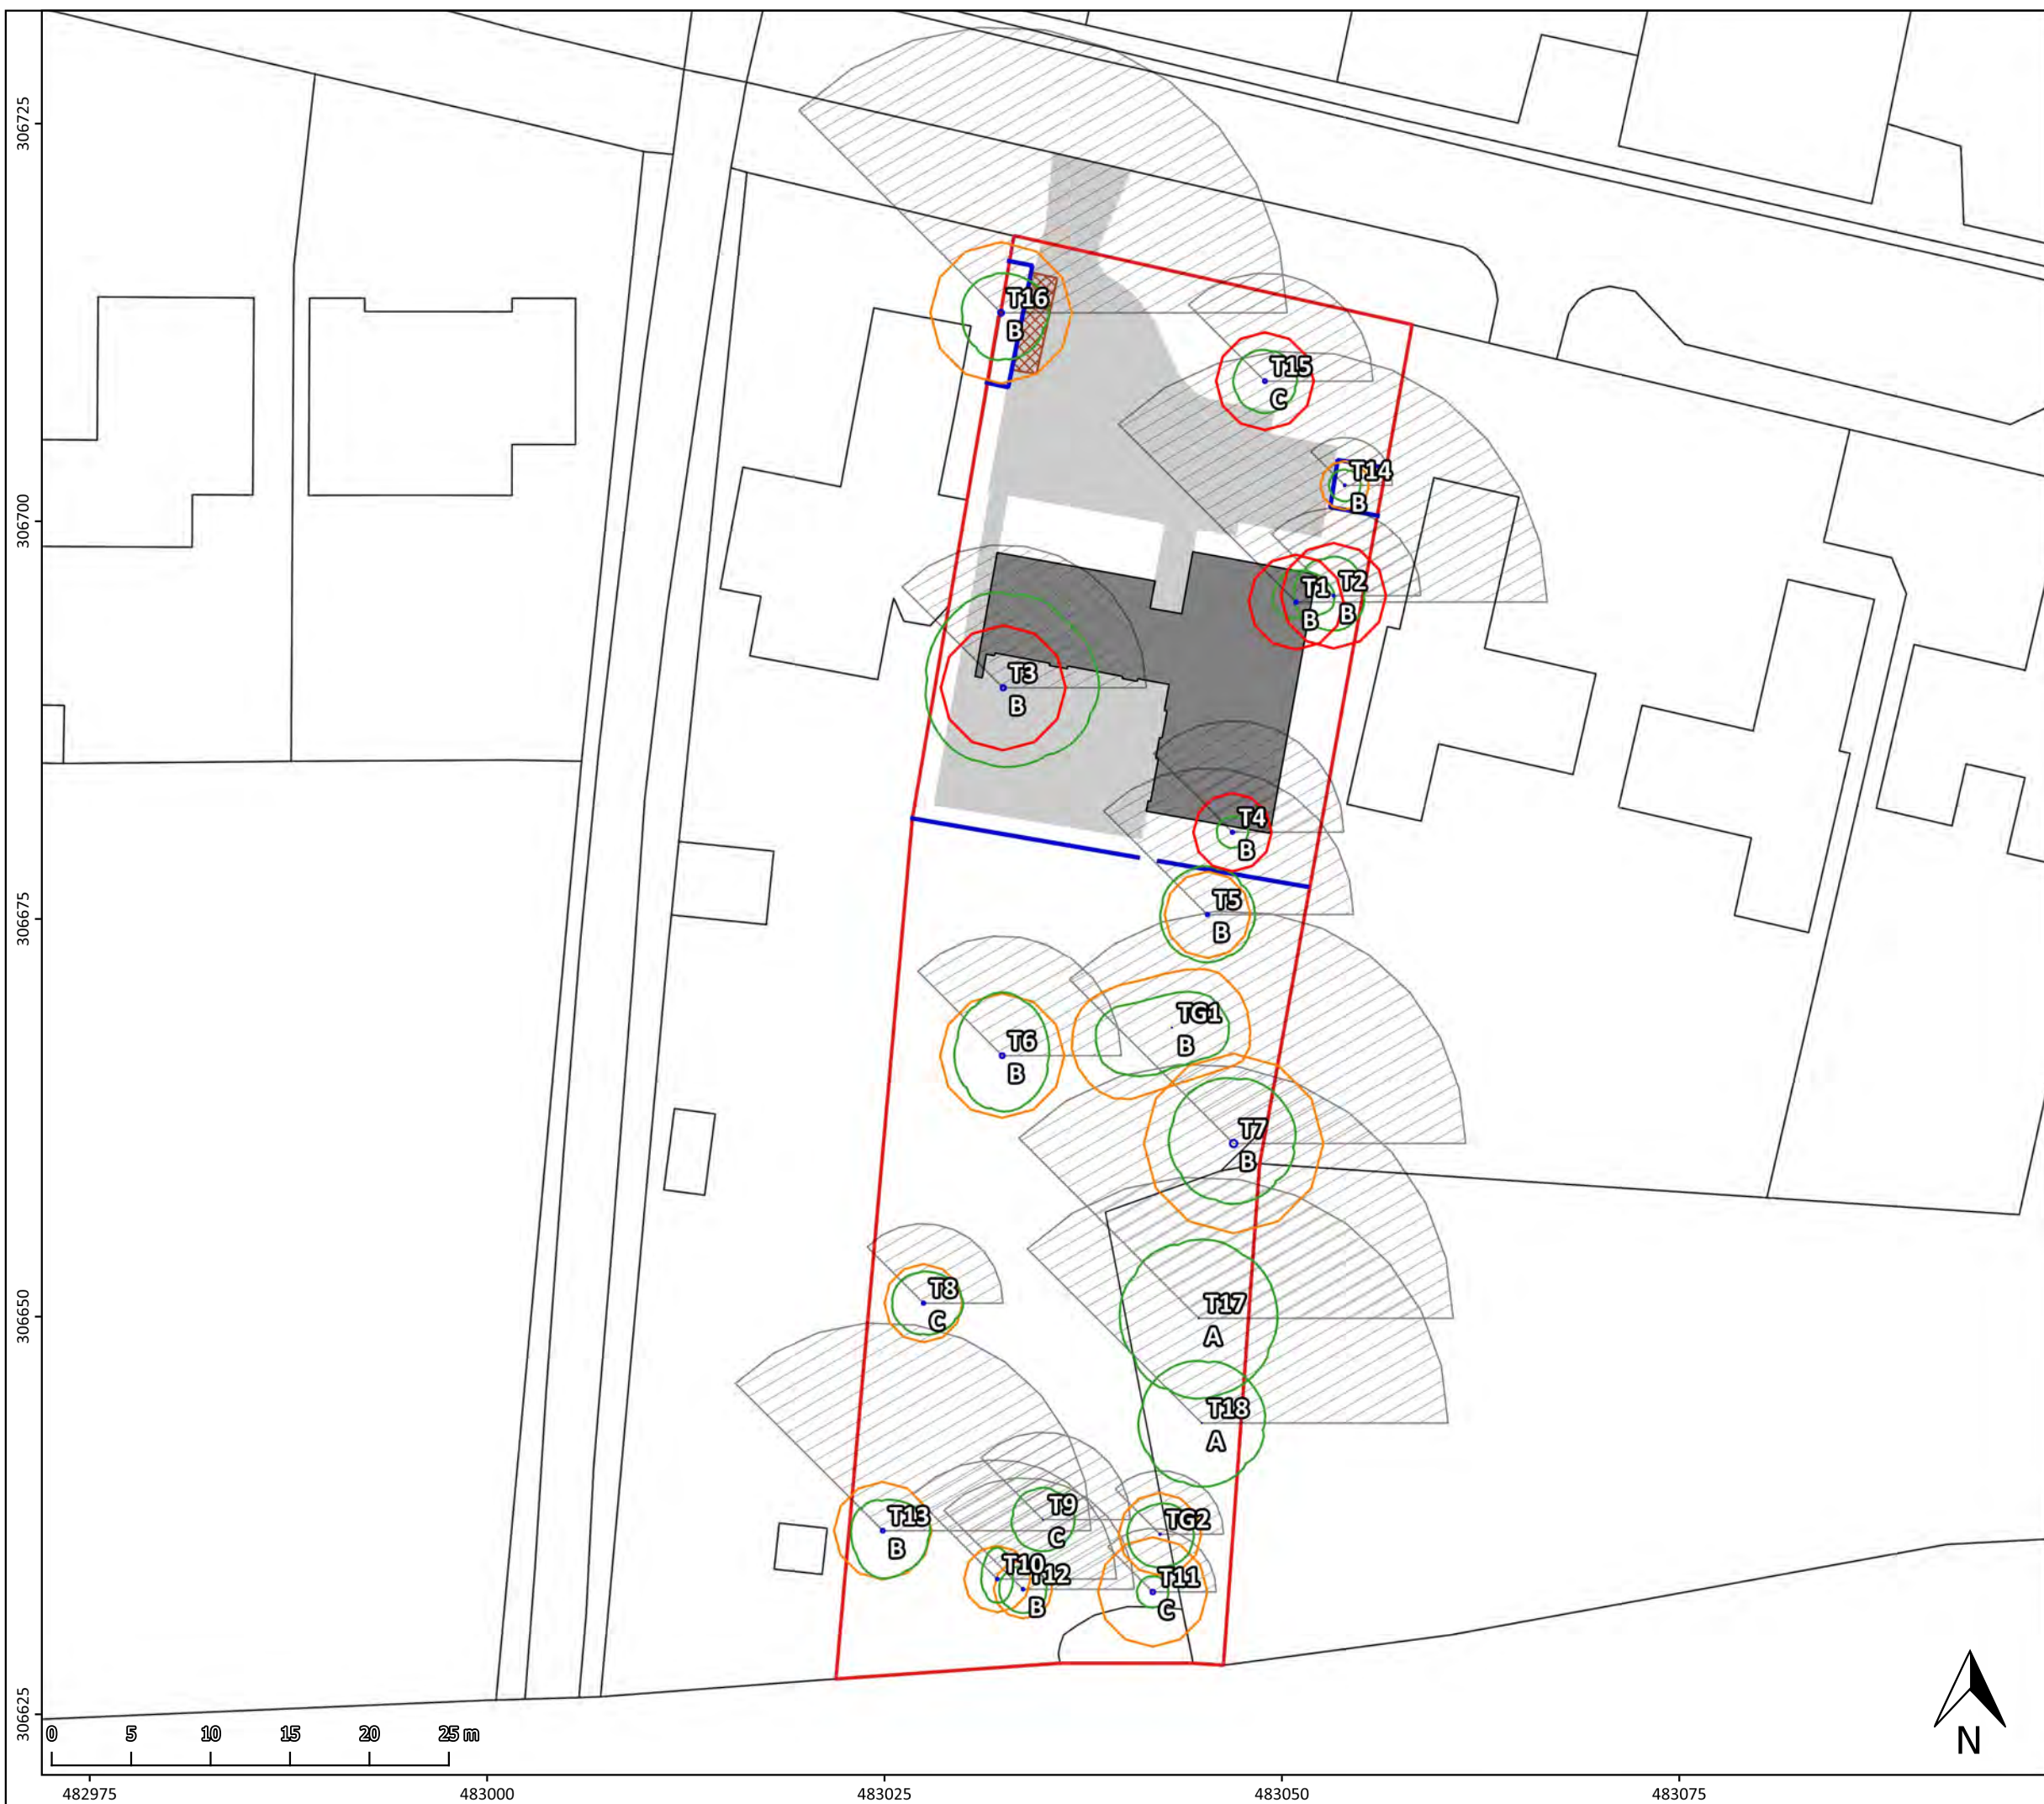
Figure 2 - Tree Protection Plan

- 5.3 The demolition of the residential dwelling could result in damage to trees T14 and T5. To prevent this, protective fencing *shall* be installed in line with the specifications set out in Para. 5.8 – 5.11 and as shown in Figure 2.
- 5.4 The resurfacing of the hardstanding at the fore of the existing dwelling could lead to the damage of aerial and below-ground parts of tree T16. To minimise and suitably control this risk, protective fencing and protective matting *shall* be installed, the latter to be placed across the area of RPA protruding beyond the fence (as shown in Figure 2).

- 5.5 During the construction phase, the only trees deemed at risk of damage both above and below ground are T16 and T14, due to exposure to vehicular traffic and because their RPAs extend within the footprint of the driveway, which is likely to be resurfaced. To mitigate against damage, the protective fencing and matting (where applicable) installed during the demolition phase shall remain in place throughout the duration of the project.
- 5.6 Elsewhere, exclusion can be effectively afforded through the installation of protective fencing along the southern edge of the construction impact zone, as shown in Figure 2.
- 5.7 The installation of protection measures and of any additional measures aimed to prevent/minimise arboricultural impact *shall* be delivered in accordance with the methodology set out in the paragraphs to follow.
