The Old Forge
Mendlesham Road
Brockford
Stowmarket
IP14 5NU

Design Access and Heritage Statement

Soleplate Repairs and Replacement

Removal of concrete render from, and repairs to, brickwork in plinth

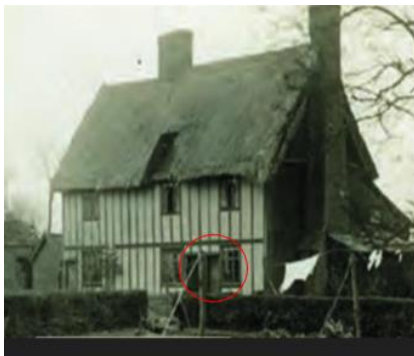
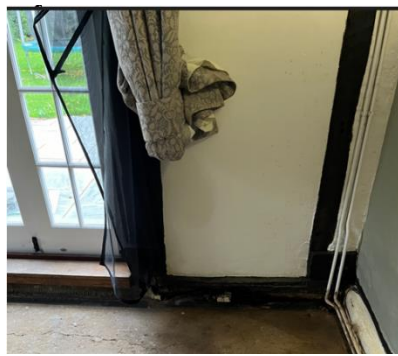
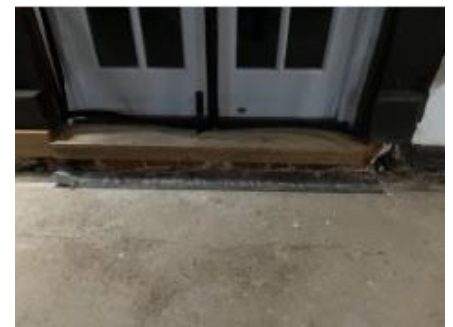
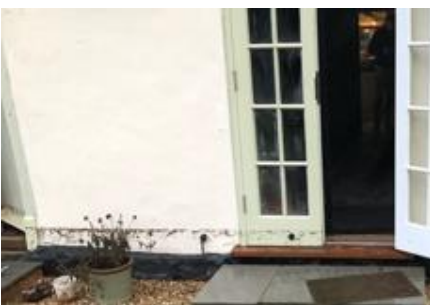
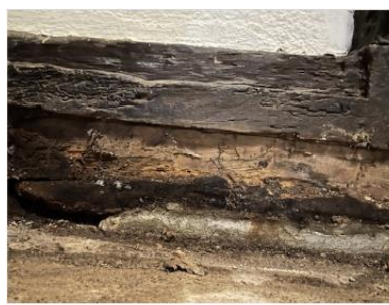
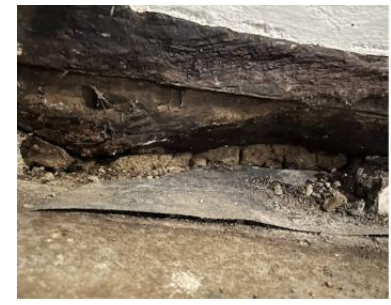
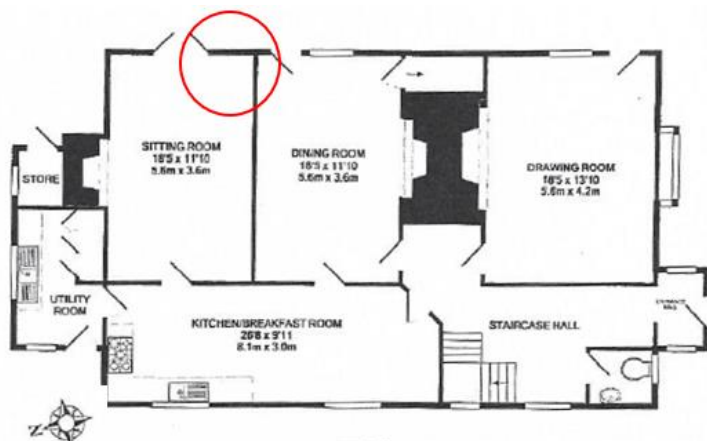
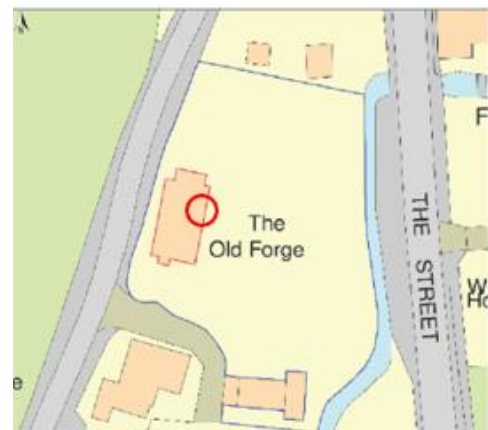
When the wooden suspended oak flooring was removed following flooding caused by storm Babet on October 20th, 2023, there was a need to remove the damaged flooring and to allow the substrate to dry. This revealed a small section of the soleplate beneath the east wall which showed signs of significant rotting and degradation.

Pictures of the House from 1910 show that this used to be a doorway, so the original soleplate will have been cut away to create the threshold for the door. It is this section that is showing signs of needing urgent repair. The French doors are now where the window was and thus there are large parts of the soleplate that have been cut away over the course of the property's history. It is therefore important that repairs are undertaken to ensure that the structure of this part of the property remains structurally sound. It has been recommended that we aim to retain as much as possible from the former entranceway (including the uneven worn top layer, which shows years of feet stepping over the threshold over the Centuries) and therefore the intent to replace only part of the soleplate is considered appropriate and is sufficient to mitigate or avoid harm to the significance of the building.

The modern hardwood threshold to the French doors will need repair as it has lifted because of flooding.

There are no visible signs that the studs are putting pressure on the soleplate or causing the walls to roll outwards. However, whilst the floors have been lifted to allow the substrate to fully dry, this area needs urgent repair before the flooring can be re-laid.

Once the repairs are made and the external walls and render made good, the external look of the building and therefore the heritage of the property will be maintained and the existing access to the property will remain unaltered.

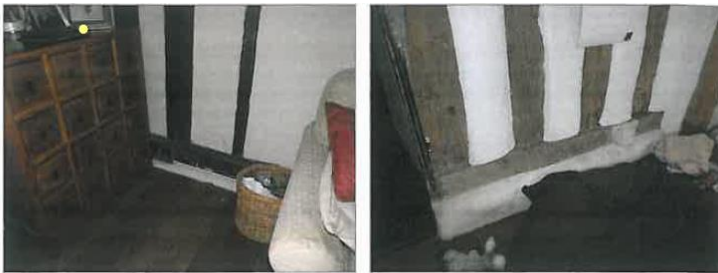
When the wooden flooring in the reception rooms was installed, concrete render plinths were applied to the brickwork beneath the soleplate down onto the flooring. Where the damp readings indicated the presence of damp the concrete render plinths were removed immediately to aid the drying process (*see amber / red lines on floor plan below*). The concern was that this was preventing any dampness to evaporate and allowing the damp to penetrate the soleplate above (this was pointed out in the RICS survey of 2014). Permission by the Heritage officer was given to remove the concrete from the internal elevations of the plinth (email Kathleen.Fisher@babberghmidsuffolk.gov.uk 01 December 2023 11:52). It appears however that the plinth has been damaged by the concrete render, and many of the bricks are delaminated due to water damage - (*see red lines on floor plan below*). Many of these will likely need to be carefully removed and replaced. The plinth is a mix of modern brickwork in places with some historic brickwork, although now severely damaged and it seems likely that much of the brick plinth will need to be repaired.

In a building of this type and age the wall plate does tend to act as a damp proof course (DPC), not that this was how it was originally intended. Provided the timbers are left exposed and allowed to breathe, the oak frame is pretty resilient. It is when the frame is covered that this causes a problem. For this reason it is possible for the front of the wall to be perfectly sound and the back of the wall plate which is concealed in the wall to suffer. You then tend to get a rolling effect with the wall plate twisting outwards, forcing the timber studs above the walls to move outwards.

It is proposed that that the render is not reapplied but left so that the bricks beneath the soleplate are left exposed. Where the brickwork is aesthetically unpleasing the render plinth will be replaced by lime-render plinths.

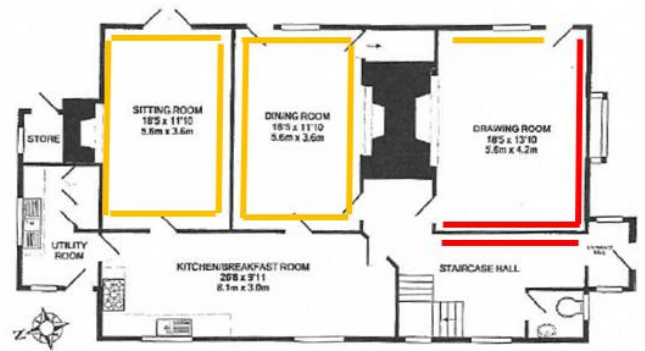
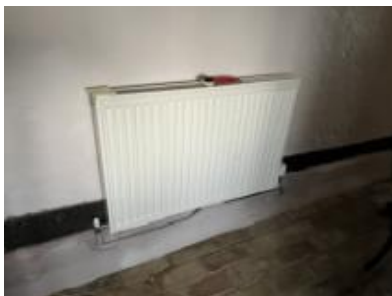
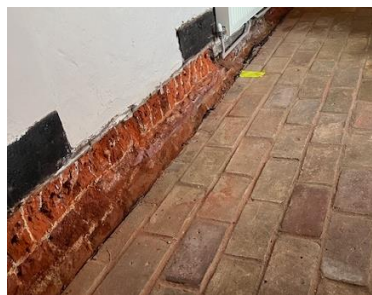
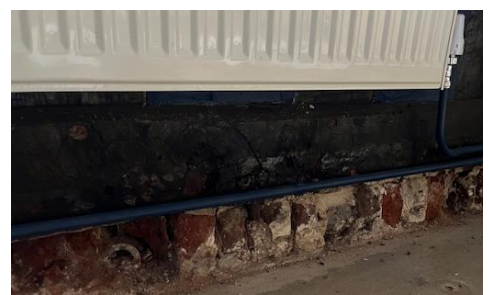
Removal of render exposed the delaminated bricks as marked by the red line below.

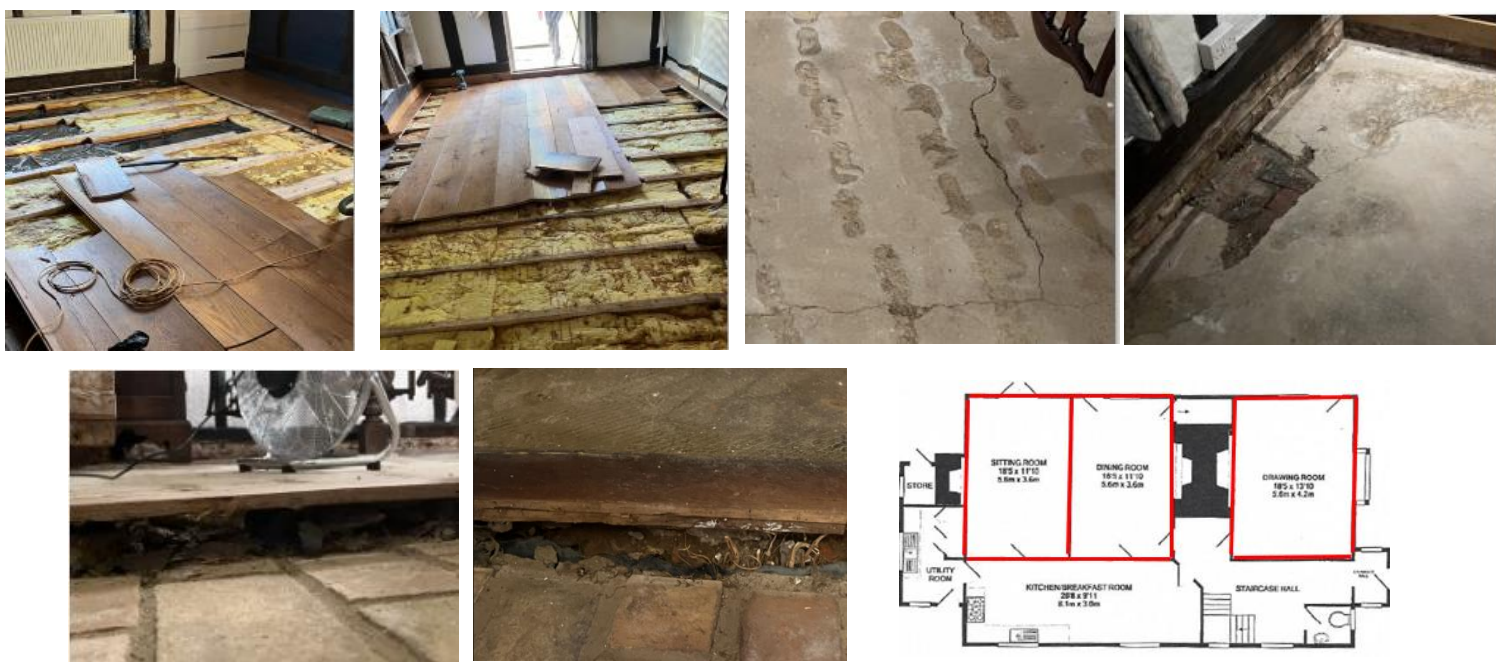
The three (east side) reception rooms (outlined in red below) had forms of wooden oak flooring which 'cupped' and disintegrated and was damaged beyond repair following the flood. The substrate consists of a concrete screed (which is believed to be approximately 35 mm thick) which, to some degree, has suffered some damage and is now cracked due to water damage and needs to be removed. Some of the screed has flaked away and shows a likely historic brick floor below the surface. This flooring should be retained where possible throughout the works. Two of these raised floors sat on battens on a plastic damp proof membrane with fibre glass insulation, the other was glued directly onto the concrete screed. Where it was unimpeded, the flood water disipated through the floors and the plinths at the base of the walls within hours of the flood water receding, but this left the concrete substrates and base of walls with varying degress of damp.

It has been recommended that the concrete screed is not replaced 'like-for-like' and instead a new flooring system which is flood resilient and sympathetic to a building of this age is installed. As a timber-framed building, much of its historic fabric is breathable. This means that it deals with moisture passively, allowing it to freely move and escape the building. The concrete screed has significantly reduced this ability, meaning that flood water has become trapped in the fabric of the building, and may do again should any future flooding occur. To create a more stable substrate, it is recommended that a geotextile membrane is laid and a floor substrate such as limecrete is utilised.

It is proposed that limecrete is used as it is designed to allow water to soak down through the substrate to prevent the water penetrating through the base of the walls and to allow the building to breathe, especially as the external walls have a concrete screed. The aim is to minimise the impacts of future flooding to allow the building to be habitable within a few days of a flood and to allow the building to dry with minimal impact on its residents.
