The Old Forge
Mendlesham Road
Brockford
Stowmarket
IP14 5NU

Schedule of works

Soleplate Repairs and Replacement

REPAIRS TO: SOLE PLATE
OLD FORGE, BROCKFORD STREET, SUFFOLK

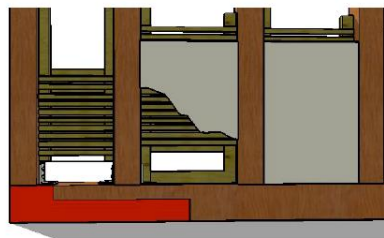
EXTERNAL FACE EXISTING Lime render on lath over beams

INTERNAL FACE EXISTING Lime render on lath between beams

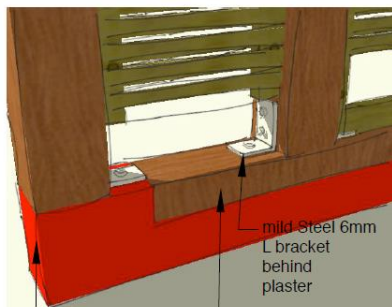
PROPOSED REPAIR DETAIL

Necessary repairs are immediately required, prior to the post flood replacement of flooring, to the threshold of what was previously an entrance into the room at the Northeast end of the property. In 1910, when the property was separated into three separate collages, that this was a doorway. It has since been blocked up and French-doors now occupy the space where a window used to be.

- acroprop up the walls above soleplate.
- remove approximately 3 courses of bricks below sole plate until it is accessible.
- cut away the bottom half of the rotten sole plate using dark oak, leaving the top part of the original threshold in place.
- recut joints; jack up into place.
- Use steel L bracket hidden behind the plaster bolted to the stud & soleplate.
- re-brick using same bricks.
- slate packers will be used to tighten under beam where necessary (and to serve as a dpc).
- using white cement render and lime putty, replace any rendering outside where disturbed to match existing.

NEW TIMBER
Dark oak
Spliced under to
match

mild Steel 6mm
L bracket
behind
plaster

HISTORIC TIMBER
Preserve shape
Of historic door
threshold

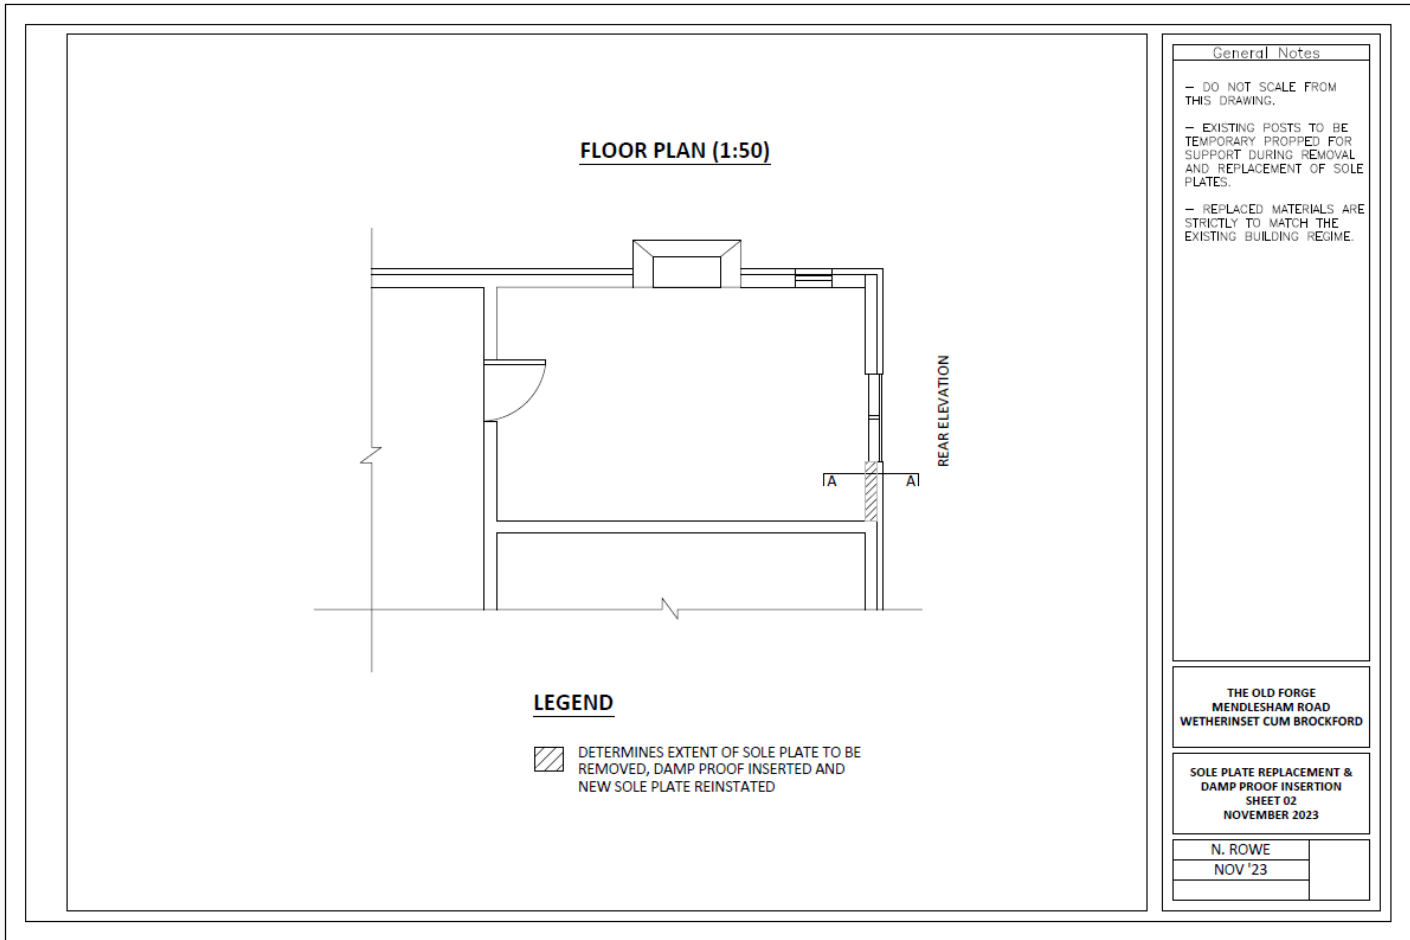
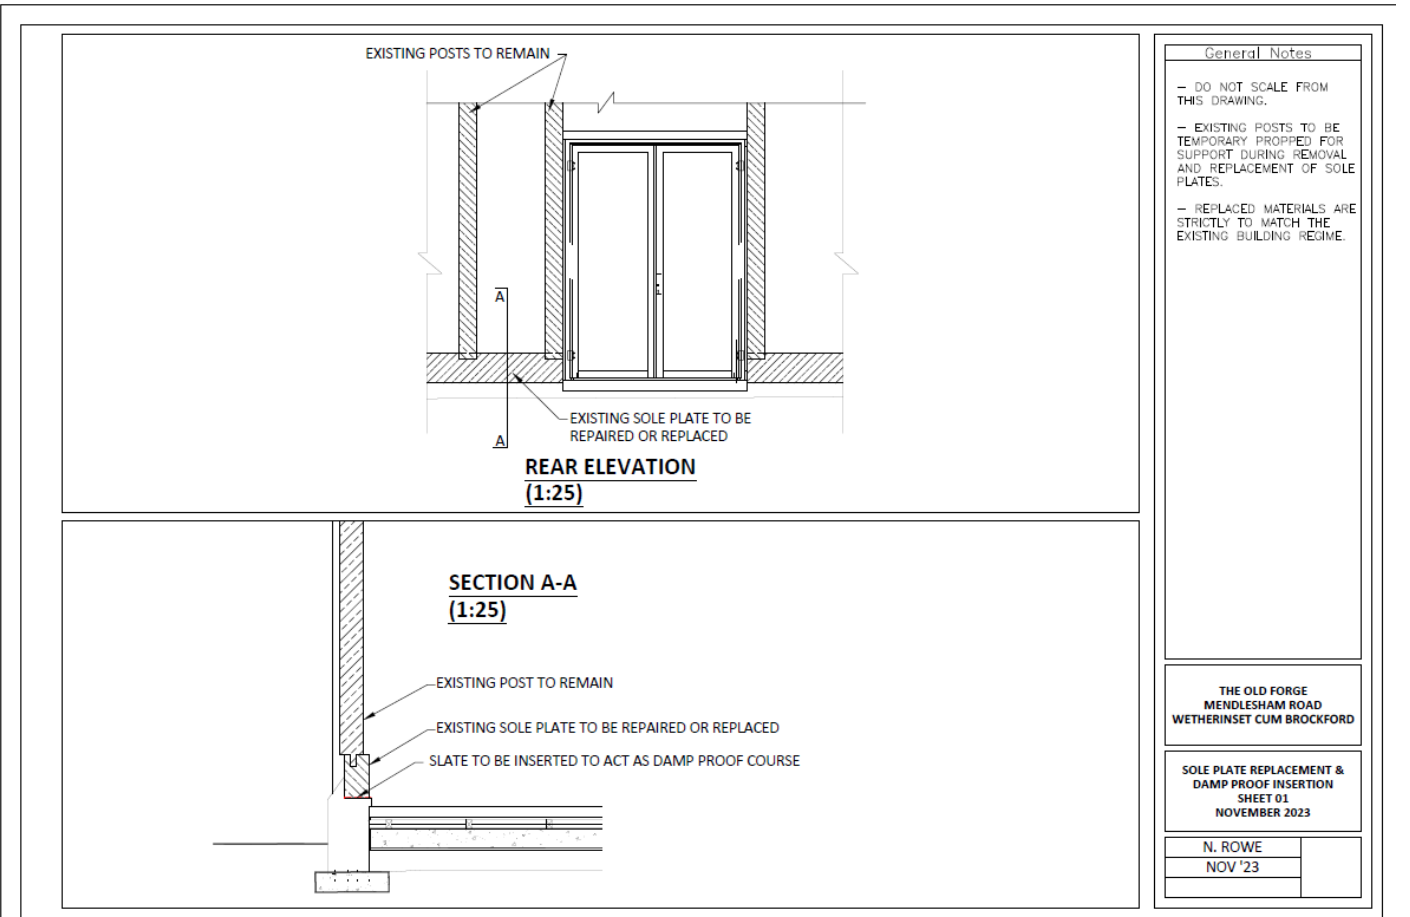
The bricks to a greater or lesser extent are showing signs of their age and in the most extreme cases, the face of the bricks in the plinths that have significantly delaminated due to water damage as the render was removed. Where significant delamination has occurred, this will necessitate careful removal and replacement, involving up to 3 courses of brick; this is especially so for the bricks in plinth in the hallway entrance. It is proposed that the bricks will be removed in small sections so as not to destabilise the structure above, preventing the need to acro prop the walls above and prevent unnecessary damage to the fabric. There is no intention to insert any damp proof membrane unless a geotextile membrane is recommended and approved, or it is suggested that a more modern damp proof course will future proof the building without inhibiting the dissipation of water should the area flood again.

Where the existing bricks do not need to be replaced, they will be retained and repointed with lime mortar to allow them to be more aesthetically pleasing.

The intention is then to leave the bricks within the plinths exposed (as has been successfully achieved in the kitchen) to add character to the building of this age and to allow the building to breathe. This will also allow aid the drying process should the area flood in the future. An approved 100% breathable stabilising sealant will be applied.
