Goodmans Fold Barn
Chorley Rd
Adlington
BL6 5LG

Re: Structural inspection of Agricultural style Barns at Goodmans Fold Barn, Chorley Rd, Adlington, BL6 5LG.

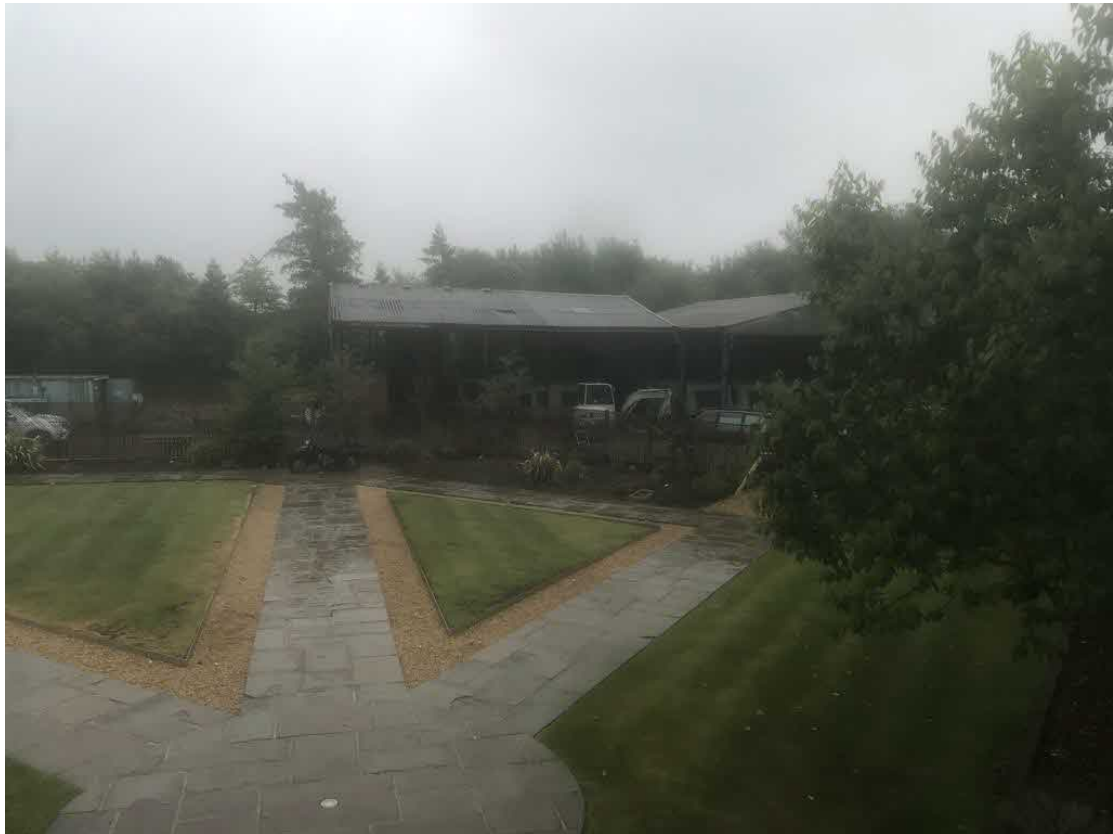
General view of barns

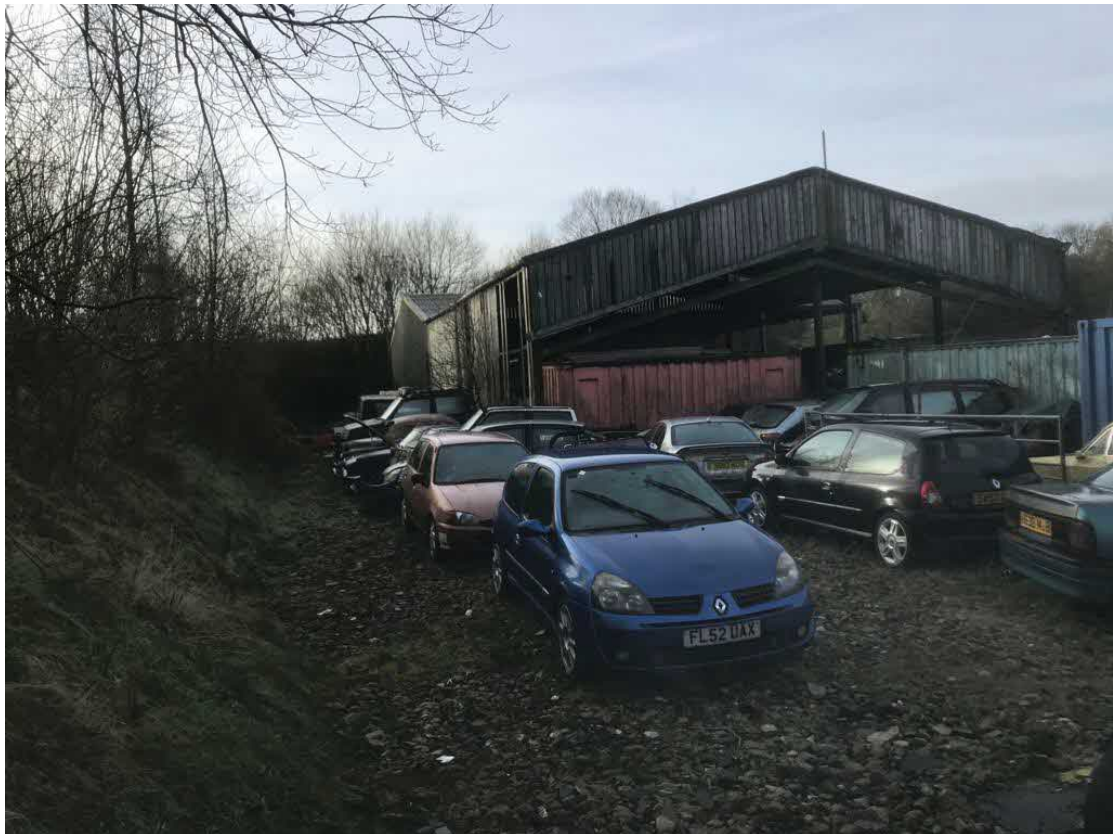
General view of barns.

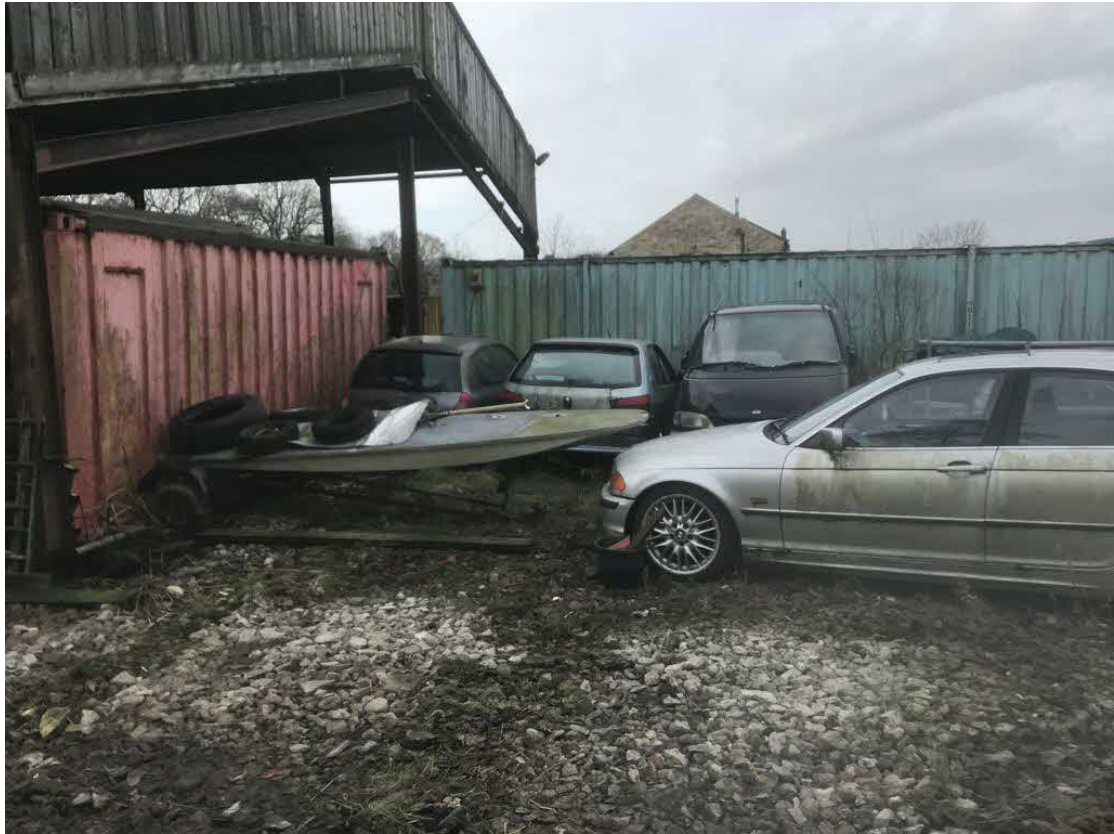
The water ingress over the years has caused some of the steel sections to corrode locally, particularly at the base of the columns and the eaves connections where the corrosion is causing distortion of the steel plates and section loss due to delamination.

Note exposed slender beams and columns with extensive corrosion.

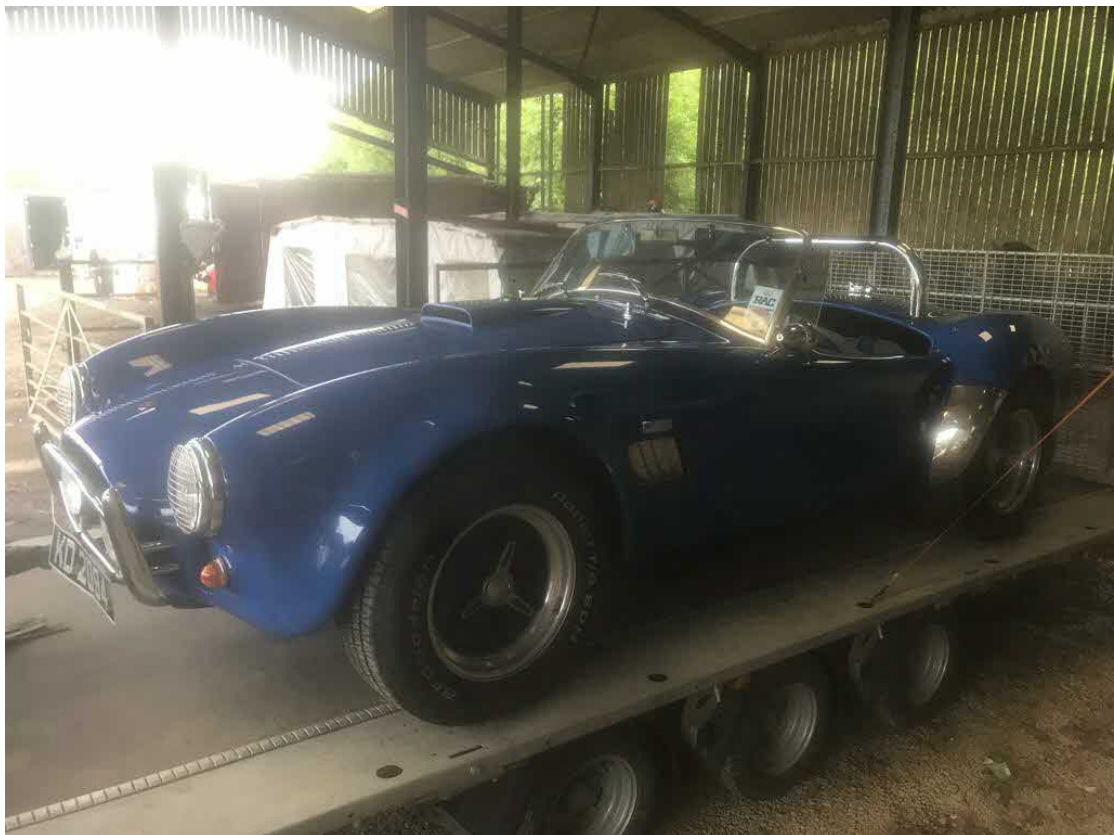
The steel portal frame sections used for the rafters and columns are very small considering the size and span of the frames and although the building appears to be supporting the loads currently it is our opinion that providing calculations to justify this would be very difficult. There is little or no lateral stability provided within the steel frame currently as such the cladding must be providing some notional stability.

Note small haunches and lack of lateral vertical bracing.

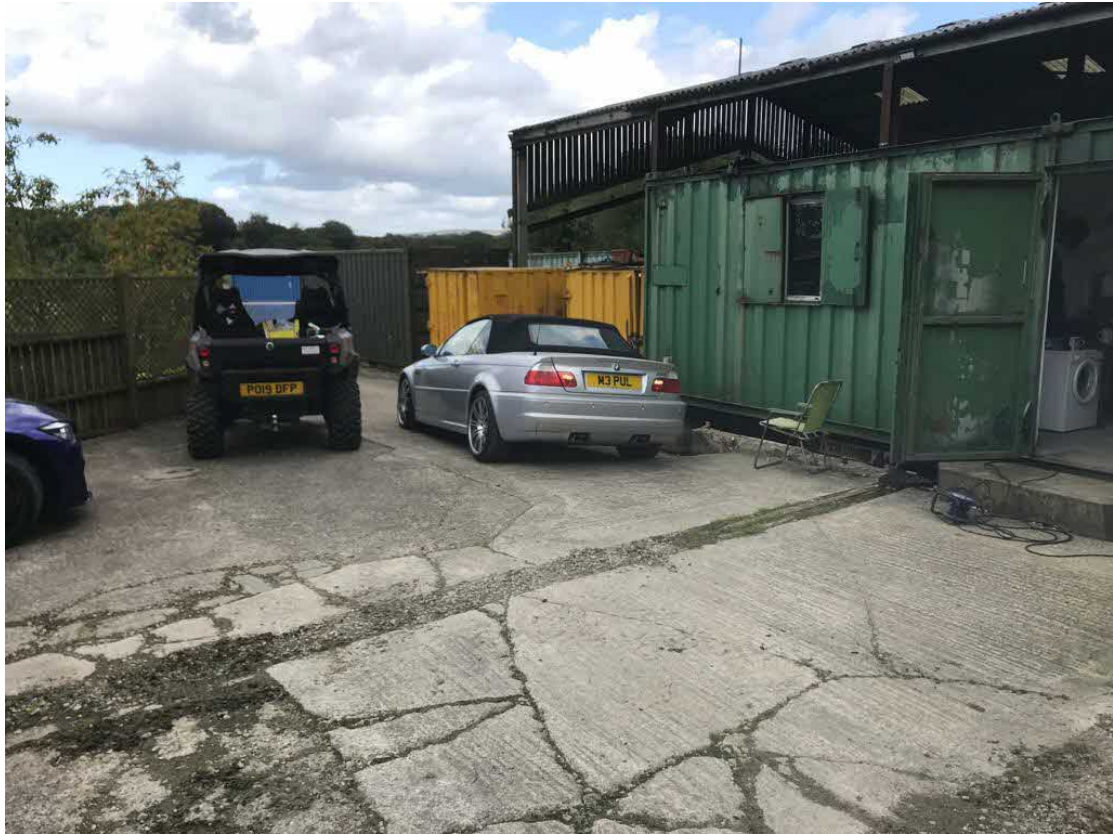
The buildings are generally in poor condition with little or no repairs and maintenance carried out over the years, the gutters and downpipes are in poor condition or missing, there are significant areas of roof leaks and side cladding is missing in several locations.

Note lack of gutters and downpipes and general poor condition of steel frame and cladding.

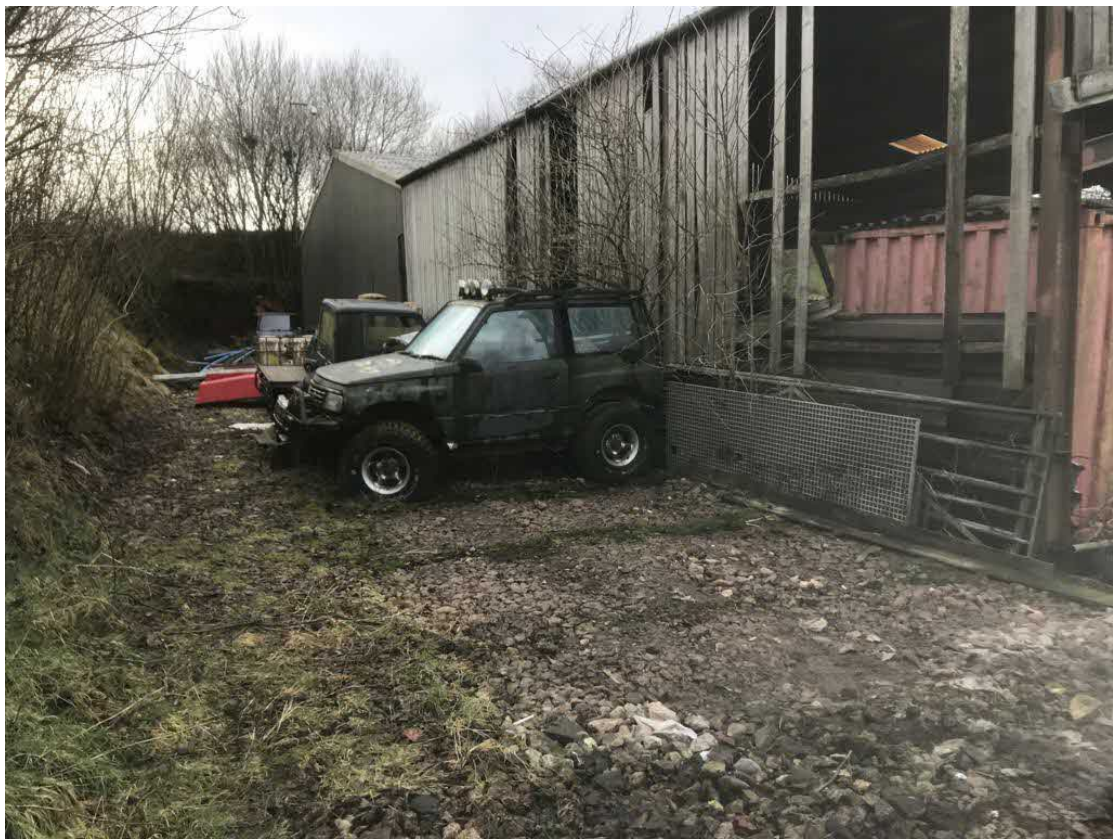
Note poor condition of cladding and steel frame.

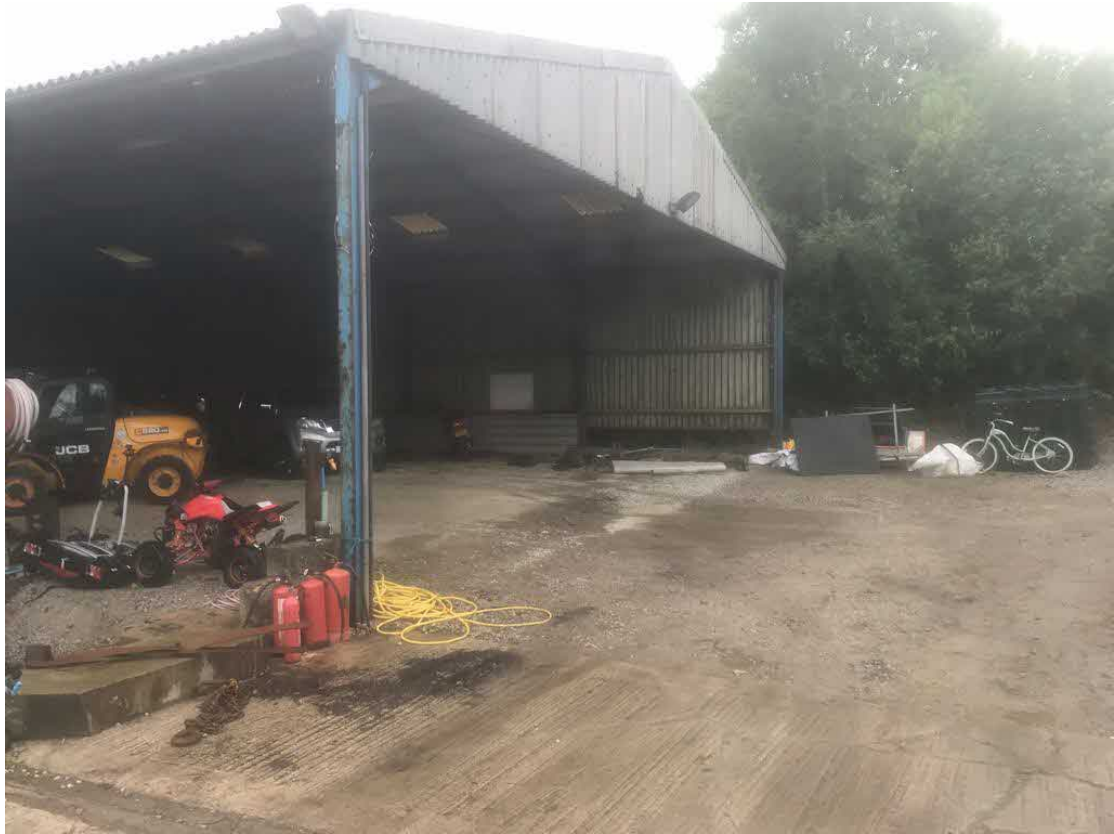
Note slender columns, lack of bracing and haunches and corrosion of steel frame.
