# STRUCTURAL SURVEY REPORT

1 Devonshire Terrace

SC-3231-SS-01

Swantest was contracted by Kefo Construction to undertake a structural survey of the u/s of 1<sup>st</sup> floor balcony to understand the make up of the slab and cause of the cracking of the soffit and to the decorative scroll bracket as shown below.

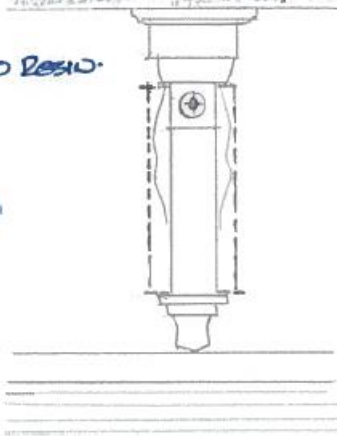
**VIEW A**

POCKET TO BE APPROX 20 WIDER THAN REPLACEMENT SECTION OF BRACKET.

- STAGE 1 CAREFULLY REMOVE SCROLL SECTION OF BRACKET & RUSTED STEEL & DISC CUT 100 DEEP POCKET INTO WALL FACE & APPROX 20 WIDER THAN REPLACEMENT BRACKET.
- STAGE 2 DRILL 25Ø HOLE & INSERT 20 STAINLESS THREADED BAR SET IN RESIN INTO BRICKWORK.
- STAGE 3 BUTTER END OF BRACKET & INSIDE FACE OF POCKET WITH RESIN/SIKADUR 31(SLOW) FILL 25Ø PREFORMED HOLE IN BRACKET WITH RESIN. HILTI HIT C150 RESIN.
- STAGE 4 ASSEMBLE BRACKET OVER STAINLESS STEEL BAR TIGHTEN BOLT AND FOR TO PULL THE BRACKET INTO PLACE

- STAGE 5 TEMP PROP BRACKET INTO PLACE
- STAGE 6 MAKE GOOD AROUND BRACKET & COVER BOLT+NUT WITH DECORATIVE BOSS.
