Seq No: 6 - T6.

**Position:** Churchyard of St Mary's Church  
By gate and public footpath

**Species:** Taxus baccata ( Common Yew)

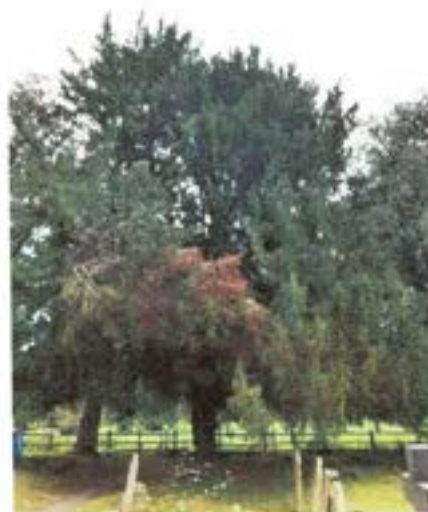
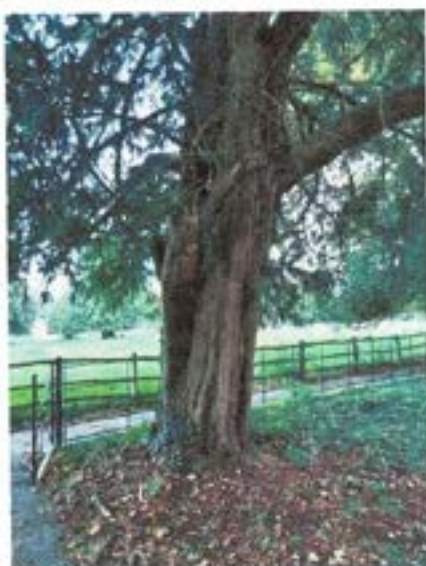
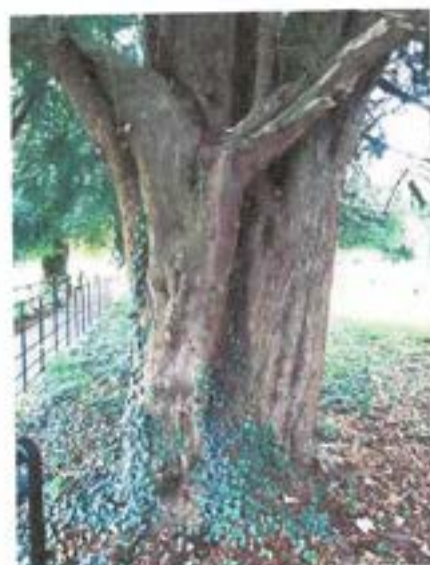
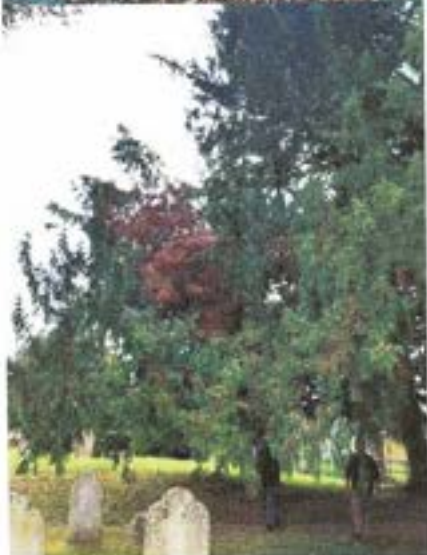
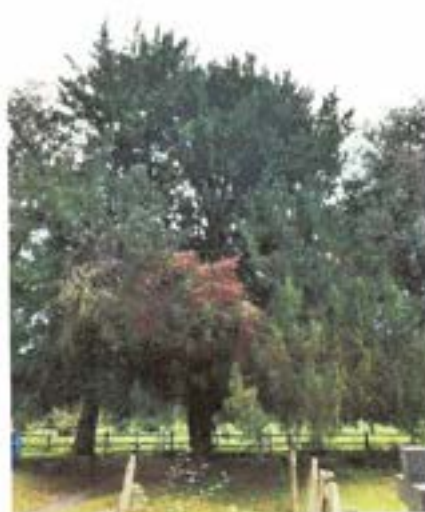
**Notes:** This is a Veteran Yew tree around 260 - 340 years of age. Yews are one of the longest-lived native trees and are ecologically valuable as well as historically, culturally and environmentally. They are associated with immortality and the ability of the species to renew itself and they are evergreen. Yew is symbolic of everlasting life and rebirth as well as death and resurrection.

**Failure:** Potentially

Branch stubs present  
Crown shape distorted due to group pressure  
Epicormic growth  
Hanging broken branches - failed hazard beam  
Ivy or climbing plants  
Low hanging branches  
Major dead wood >50mm  
Minor dead wood <50mm

**Risk:** Insignificant (48)

**Remove dead wood (>50mm )** - within 1 month for reasons of health and safety

**Remove hanging/broken limb** -over footpath within the churchyard, snapped out hazard beam, browning foliage within 1 month for reasons of health and safety

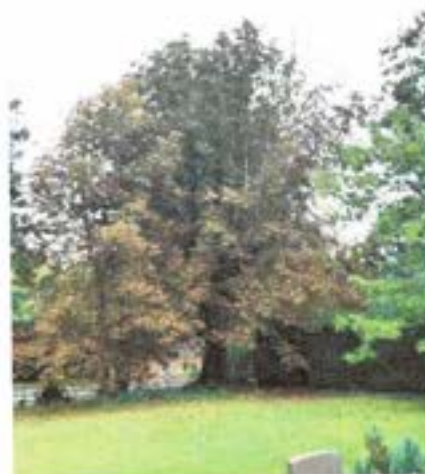
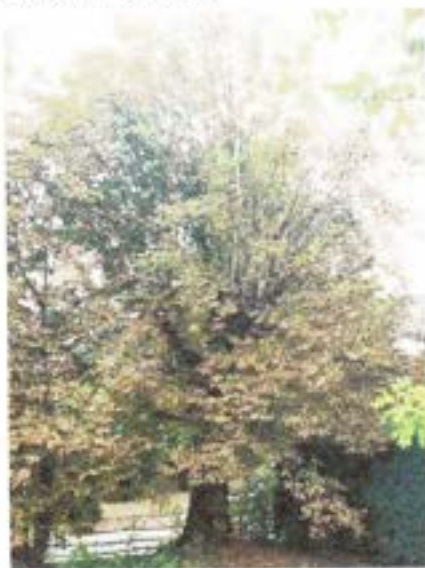
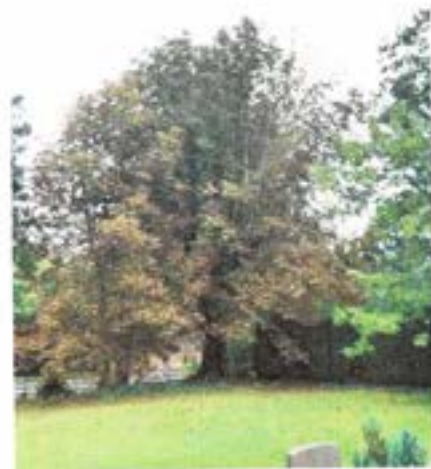
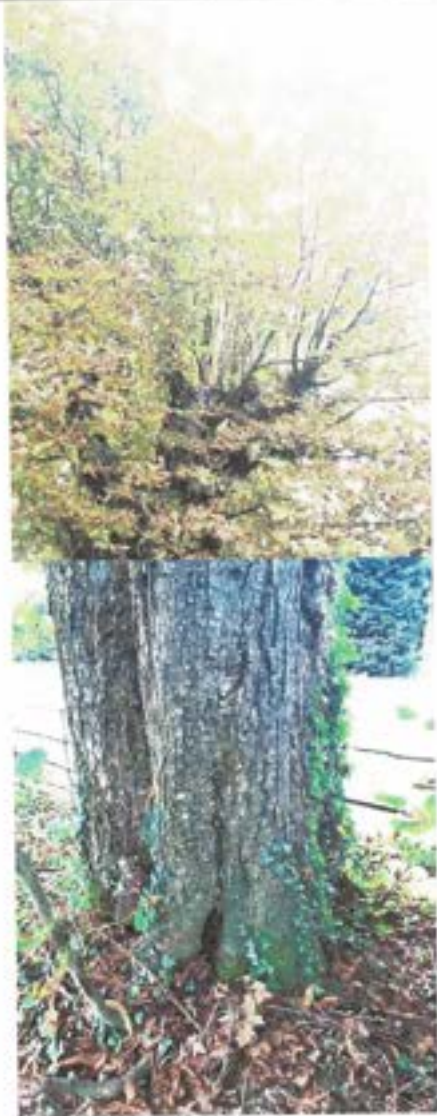
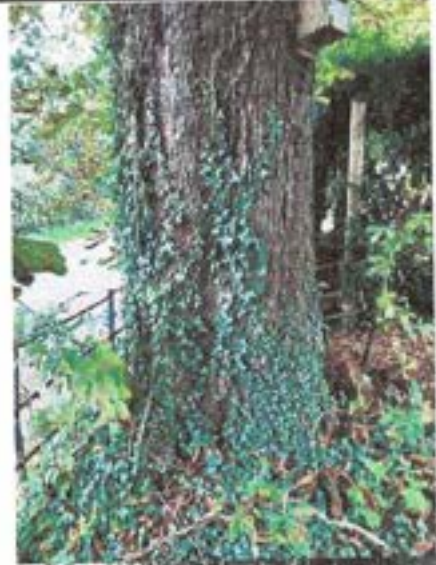
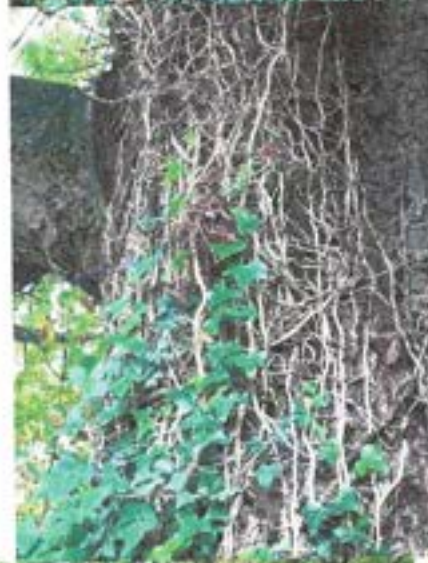
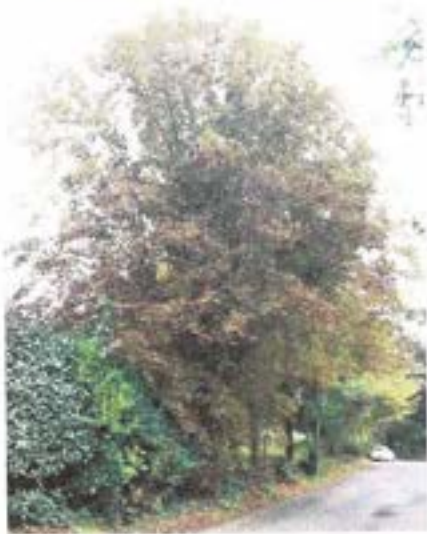
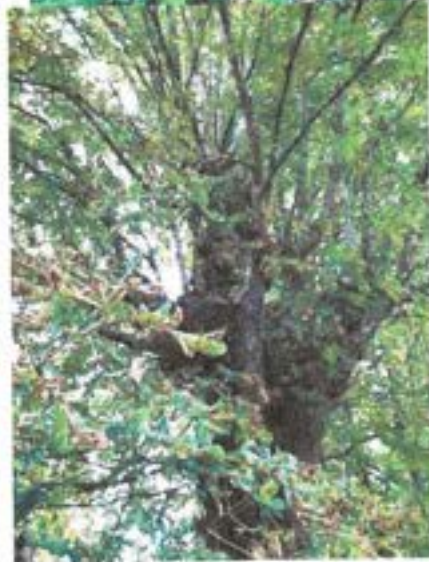
**Seq No:** 7 - 77

**Notes:** Notable old pollard circa 115-120 years of age. Potential veteran, with Veteran tree characteristics including deadwood habitat, old large breakout wounds and cavities, decaying heartwood, water pools, bark loss, and the potential for fungi but none currently observed.

**Failure:** Likely

Basal decay - decayed heartwood visible at bark wounds on lower trunk  
Bird box - plus natural bird nest on trunk in ivy  
Bleeding canker  
Bat potential  
Basal suckers  
Branch stubs present  
Cankers on branches  
Cankers on trunk  
Cavities present - decay present in the old pollard heads  
Crossing branches  
Crown issues or observations - Leaf blotch and leaf miner  
Epicormic growth  
Fluted buttresses  
Ivy or climbing plants - around buttresses  
Minor dead wood <50mm  
Multiple old pruning wounds Occluded pruning wounds Occluding pruning wounds  
Pollarded  
Stem issues or observations -flaking and delamination bark  
Veteran tree potential  
Wildlife habitat

**Risk:** Slight (240)

**Reduce crown by 4m** - Reduce crown down by 4m but not to the original pollard points.

- Retain a smaller crown above the pollard points.
- Thin out each pollard head to retain the smaller stems and remove the two largest diameter stems on each pollard head back to the pollard head at around 6m to reduce the weight on the pollard heads.
- Works to be carried out within 3 months during the dormant season and bat check prior to work.
- Works to prevent pollard head collapse under the weight of the new regrowth that has lapsed and to retain a smaller managed crown due to the proximity to the roadside.

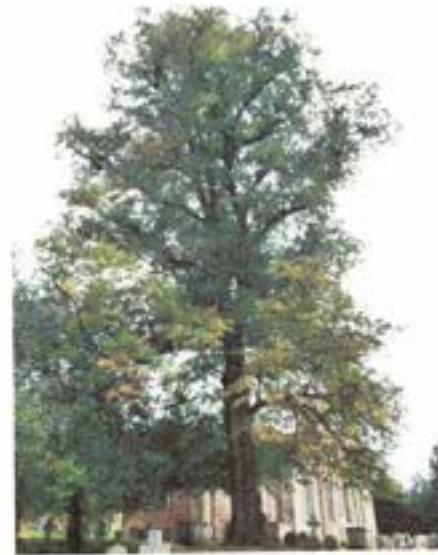
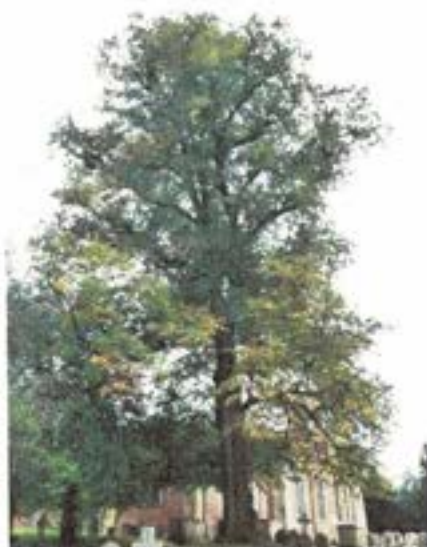
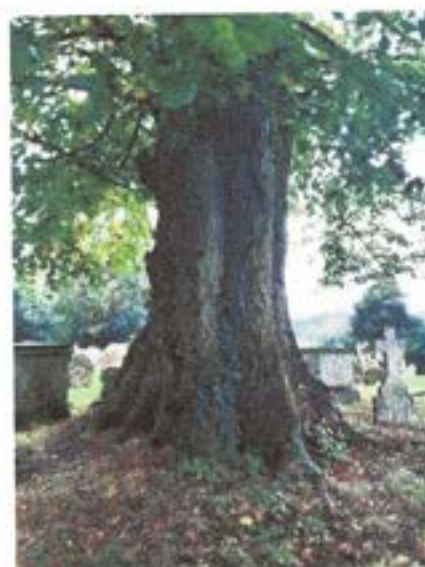
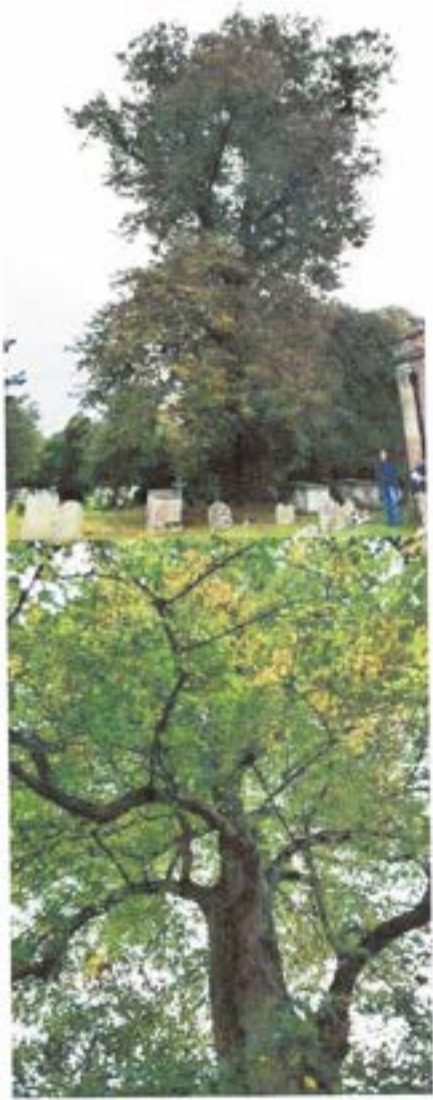
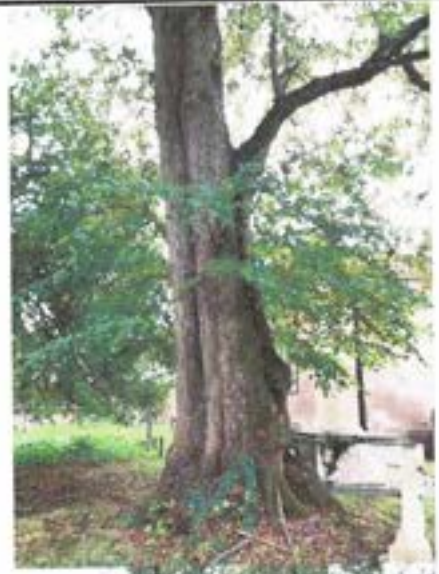
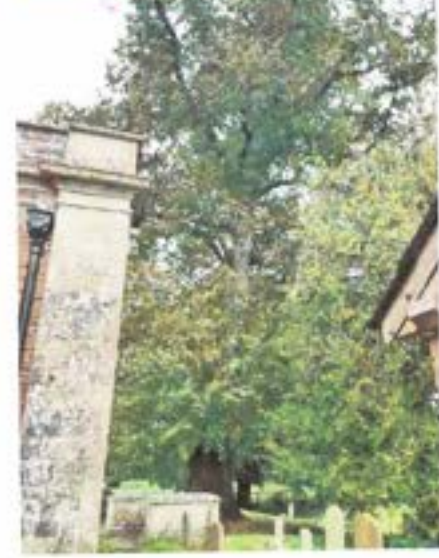
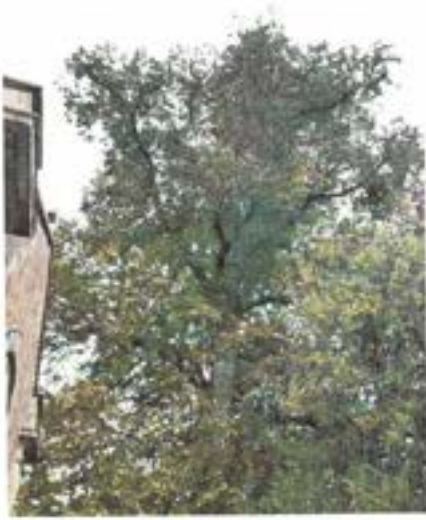
Seq No: 8 - T8.

**Notes:** Veteran tree characteristics include a large girth minimum of 25% of species age equating to around 140-170 years of age circa 1850's. With potential for internal heartwood decay, large quantities of deadwood, habitat holes and epiphytic plants including lichens. This is an important tree locally as well as historically, culturally, ecologically and environmentally.

Bat potential  
Basal suckers  
Cavities present  
Epicormic growth  
Fluted buttresses  
Ivy or climbing plants - starting up the trunk and around the buttresses  
Live epicormic growth rafting  
Major dead wood >50mm  
Minor dead wood <50mm  
Multiple old pruning wounds  
Occluded pruning wounds  
Occluding pruning wounds  
Surface roots - lifting tarmac path and visible in the grass bank,  
bark damage to some exposed roots and decay present

**Risk:** Minimal (64)

**Remove dead wood (>50mm )** - within 3 months for reasons of health and safety

**Lift canopy to 3m** - over the footpath within 3 months for reasons of health and safety

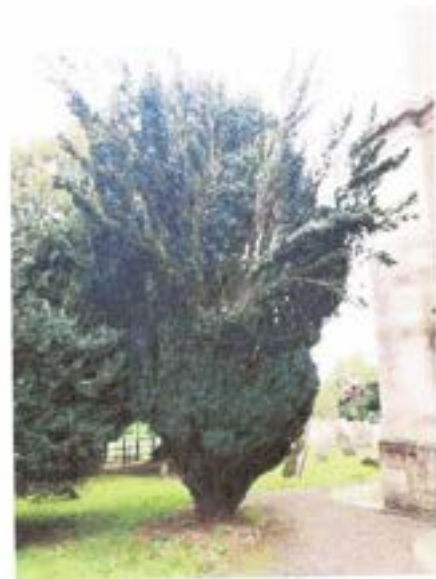
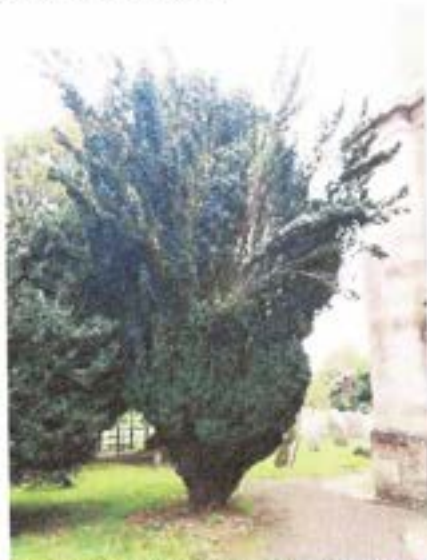
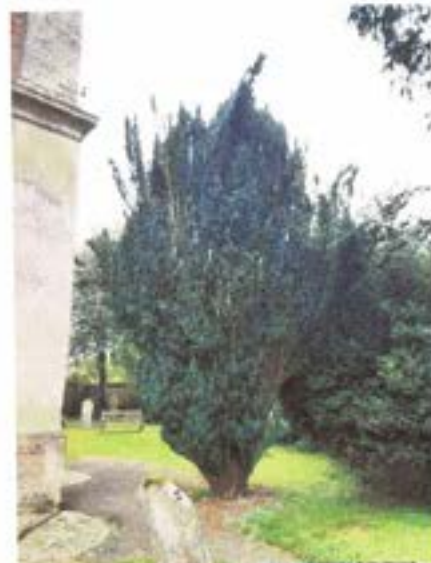
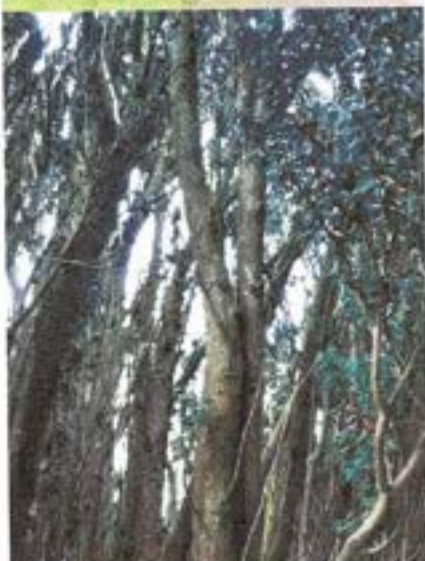
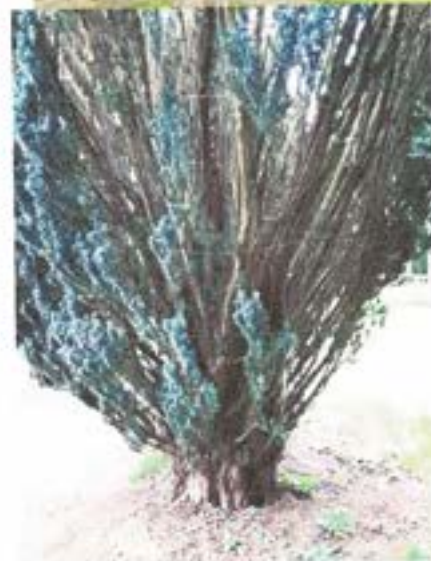
Seq No: 9 - T9

Bark damage - from wire cutting into branches

Crown issues or observations - Branches collapsed out of the crown and are hanging down. Fastigate form opening up. Previously supported by wire which in places is now imbedded wire cables which are now causing bark and branch damage.

**Crown support** - Re-apply structural support around the crown. Use a dark greenhouse hose pipe threaded with a steel cable tensioned to create support around the canopy at three or four separate levels up the crown set at around 1-1.5m intervals to bring the crown in to create a tighter form. Once the new supports are in place cut the old wire supports off.

Carry out the works within 6 months to aid with managing the crown and to retain a more compact form.

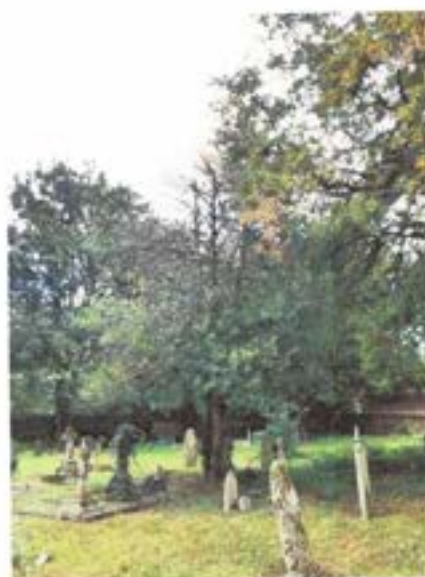
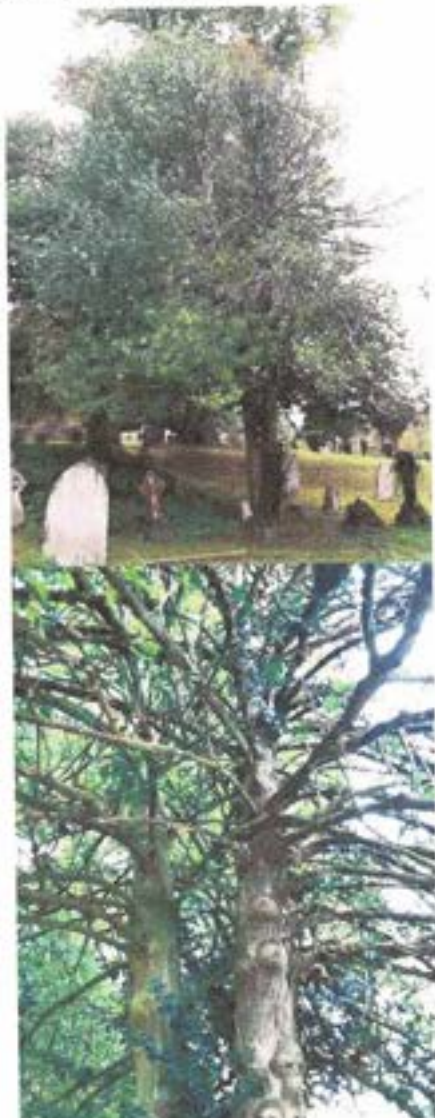
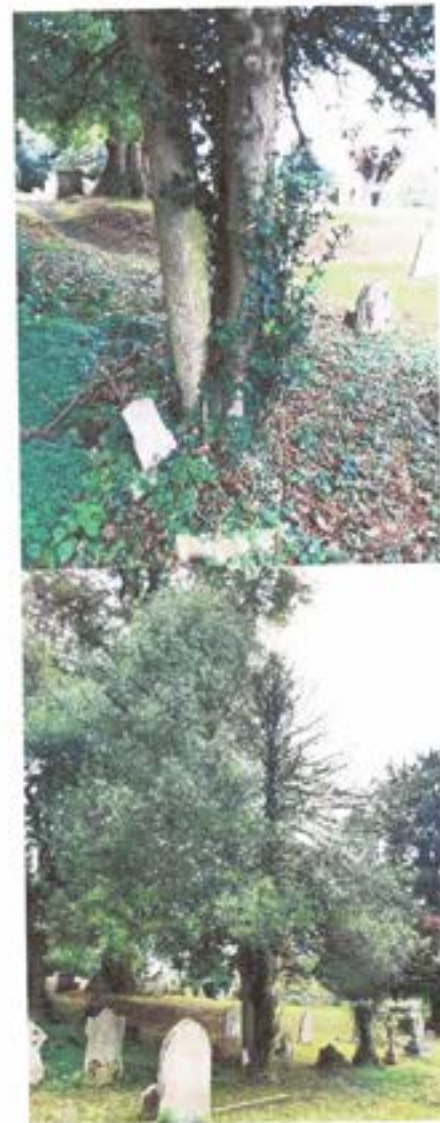
**Seq No:** 10 - T10

**Comments:** measured at below trifurcation just above ground level

Basal suckers  
Crown shape distorted due to group pressure  
Die back  
Epicormic growth  
Ivy or climbing plants  
Major dead wood >50mm  
Minor dead wood <50mm  
Trifurcated - just above ground level, one stem healthy, remaining two stems in decline

**Reduce crown by 3m** - reduce the two dying stems to the North and East down by 3 metres to reduce the risk of failure but allow the lower stems to regenerate. Within 3 months for reasons of health and safety.
