Structural Survey

Mount Pleasant Farm, Hopton, Nesscliffe, SY4 1DJ

APPENDIX 1 – CONDITION - Mount Pleasant Farm, SY4 1DJ

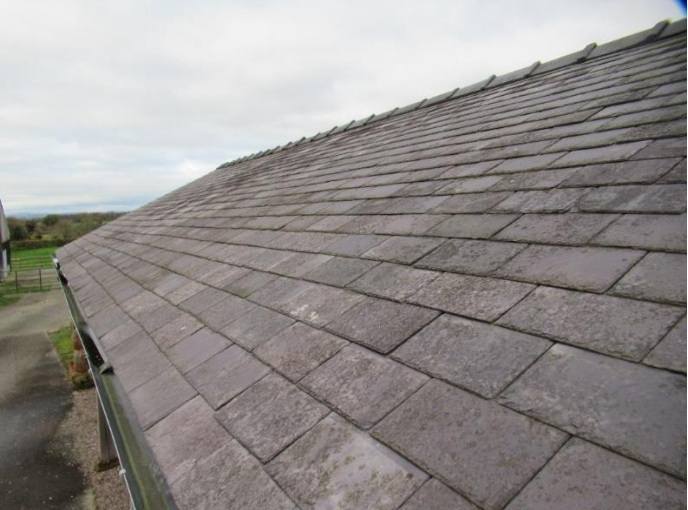
Element	Description	Condition	Recommendation
<u>EXTERNAL</u>			
1. Roof Coverings	<p>Pitched timber structure clad with natural slates. Slates are set over a breathable membrane.</p> <p>The ridge comprises angular tiles and verges are closed off with cement.</p>	<p>Good condition.</p> <p>The roof has been re-slatted in recent years and displayed no significant damage.</p> <p>Roofing felt has broken down at the roof edges and no longer adequately laps into the rainwater gutters.</p>	<p>Install eaves tray to front and rear roof slopes.</p>

Modern slate coverings		
1.2

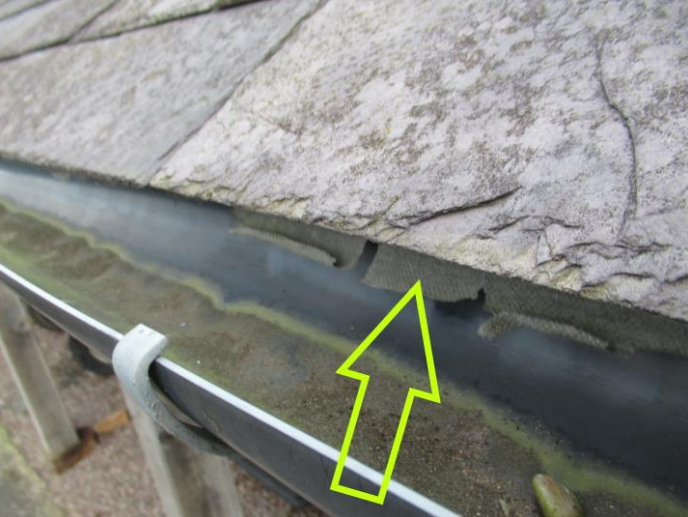
Breakdown of roofing felt at roof edge		
2	ROOF STRUCTURE	
2.1

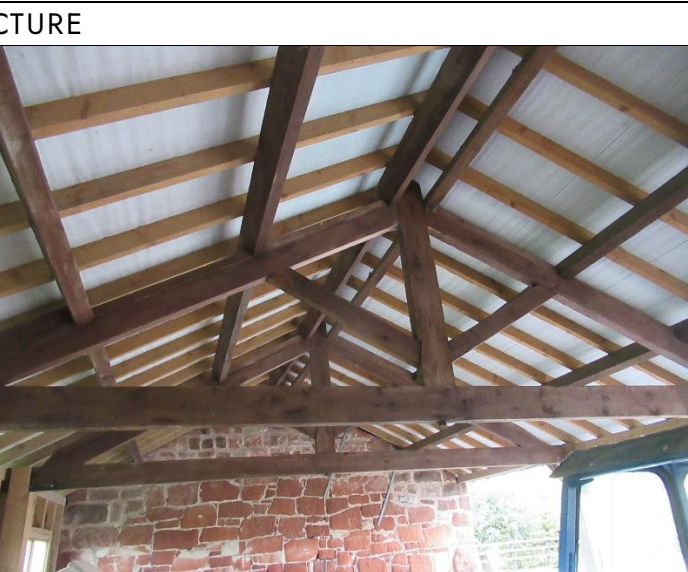
2. Roof Structure	<p>Timber framework incorporating;</p> <p>purlins (70 x 200mm) common rafters (100x50mm) wall plates (100x50mm)</p> <p>Three king post trusses and vertical beams support structural framework.</p>	<p>By and large, roof structures adequately support the coverings and display no obvious timber decay or beetle infestations.</p>	<p>No repairs needed.</p>

Roof frame

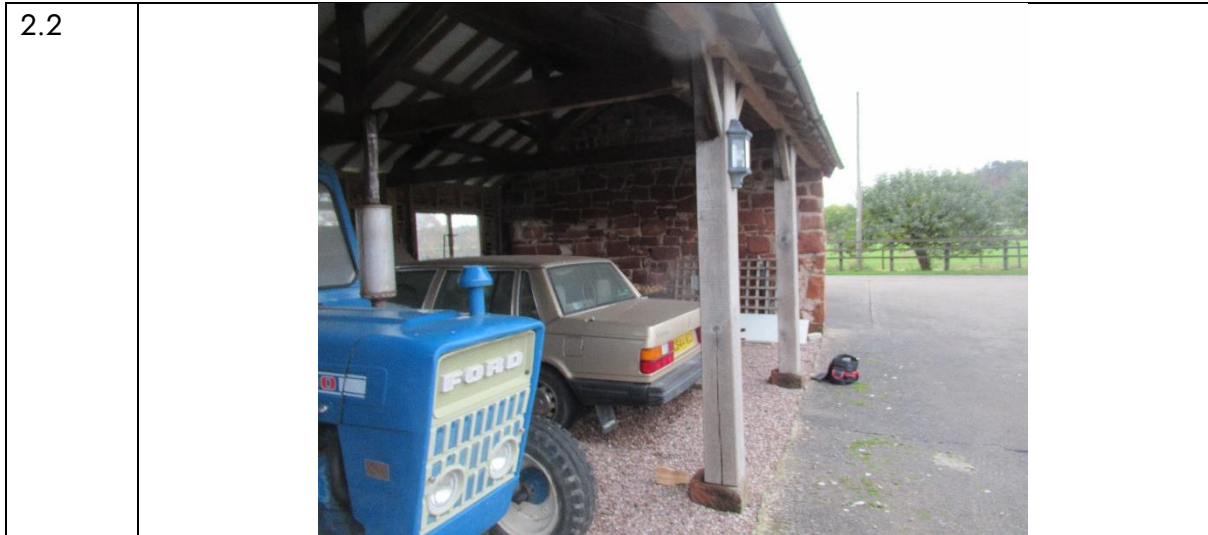
Vertical supporting beams sit upon stone feet. Rear supports are concealed within plywood linings.		
3. Rainwater Fittings	The rainwater fittings are formed in plastic.	Neglected condition. The rear gutter has disconnected centrally. The left sided drainpipe show has disconnected, and rainwater is discharging against the base of the wall.	Overhaul rainwater fittings and reseal joints. Rainwater fittings to be connected to soakaway drains via storm gullies.

Supporting beams for frame

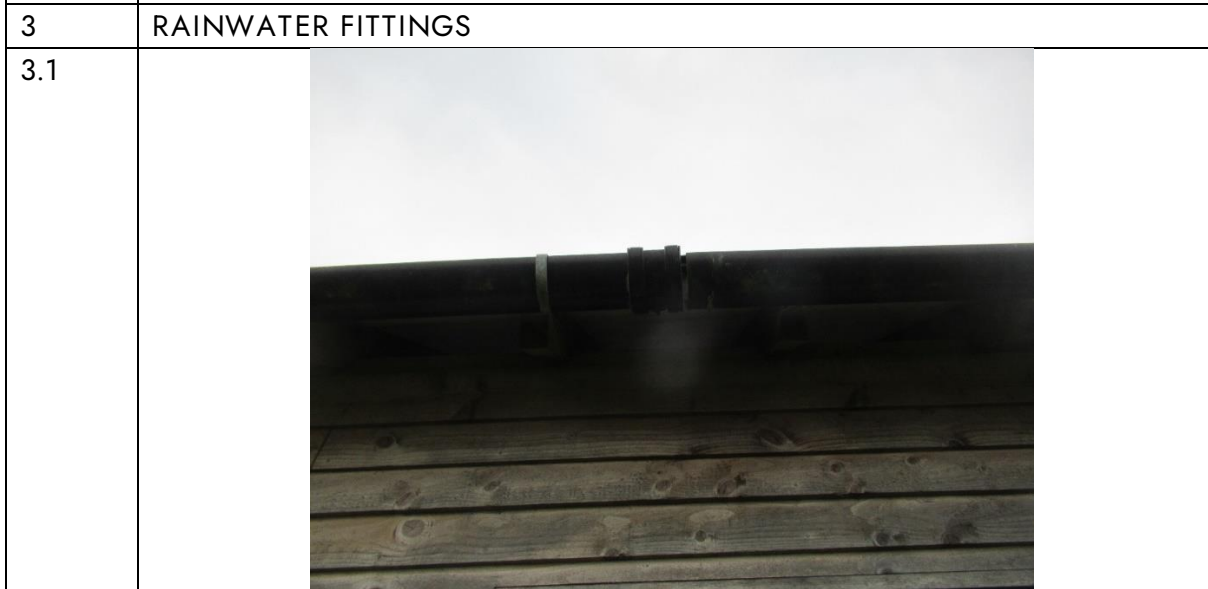
Disconnected gutter joint

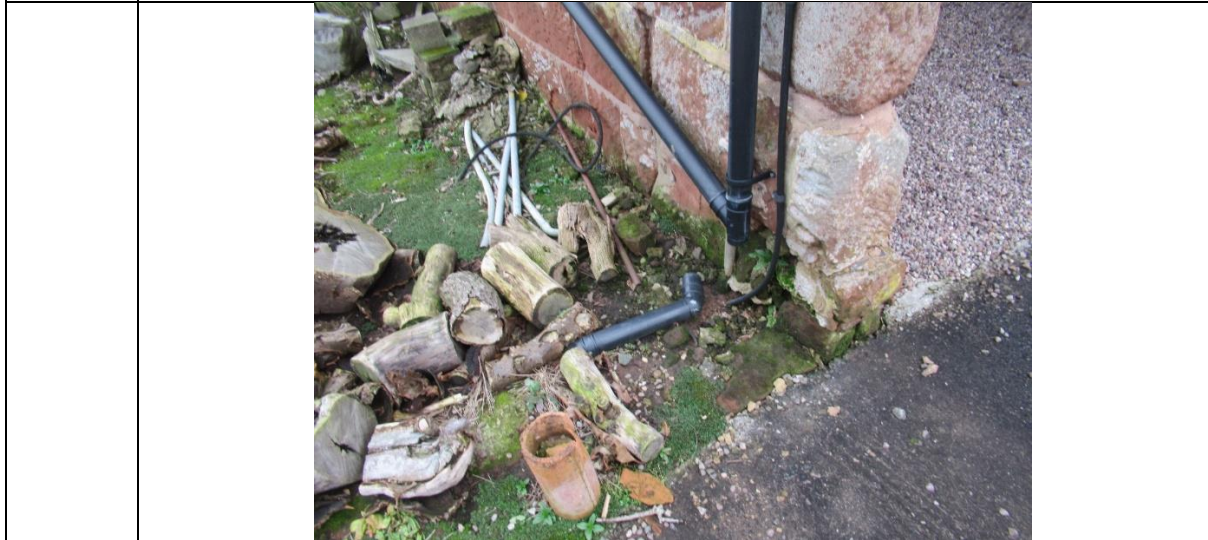
Disconnected shoe to drainpipe

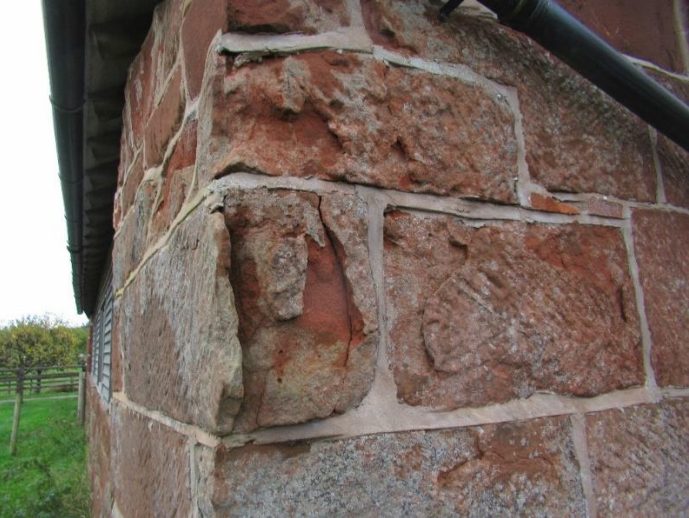
4. Main Walls:	The main walls are formed in solid sandstone ranging from 220-440mm thickness. Footings not seen. There is no damp-proof course (DPC) to the main walls.	Repairs needed. Significant frost damage evident to the right-hand side flank wall owing to previous 'ribbon' style repointing with hard cement mortar. Biological growth evident at the base of the left gable side wall and rear elevation wall where rainwater fittings have failed.	Cement mortar to be raked out and walls re-pointed in more appropriate mix e.g. Ty-Mawr lime. Rainwater fittings to be repaired and connected into storm gully's. External walls to be repaired with traditional materials to promote moisture evaporation or 'breathability'.

Frost damage to stone faces
4.2

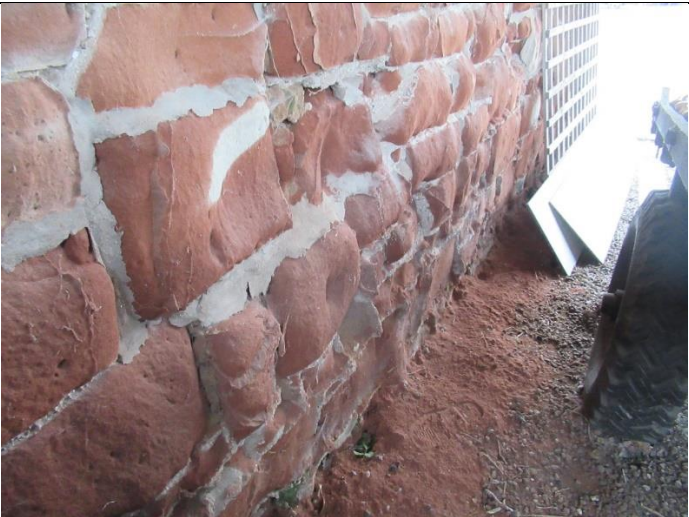
<u>INTERNAL</u>			
6. Walls and Ceilings	<p>There are no internal coverings or linings; walls and ceilings remain exposed.</p> <p>There is no internal joinery.</p>	<p>Significant frost damage to stone owing to use of cement mortar pointing to interior walls within the barn.</p>	<p>Internal linings to be informed by project design.</p>
7. Ground-floor structure	<p>The main floors appear to be a continuation of the driveway hardstanding and covered over with pebbles.</p>	<p>Functional, but designed for agricultural use.</p> <p>Full inspection not available owing to storage.</p>	<p>Complete replacement using suitable materials. Consider limecrete</p>

Significant erosion to internal stone faces
4.3

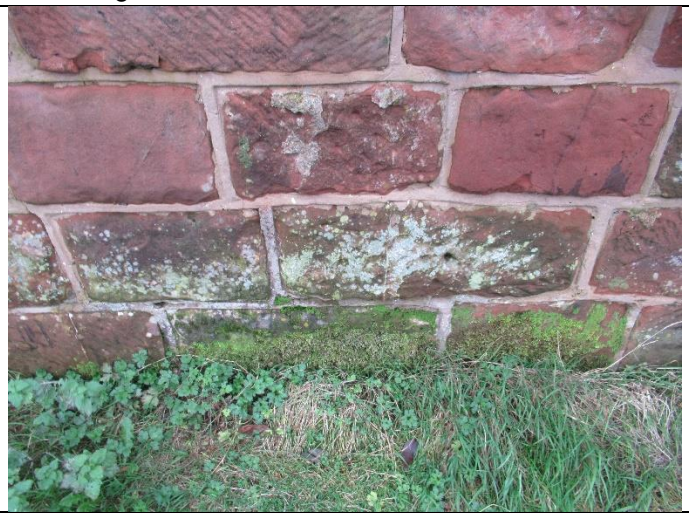
Staining to stone faces below leaking gutter

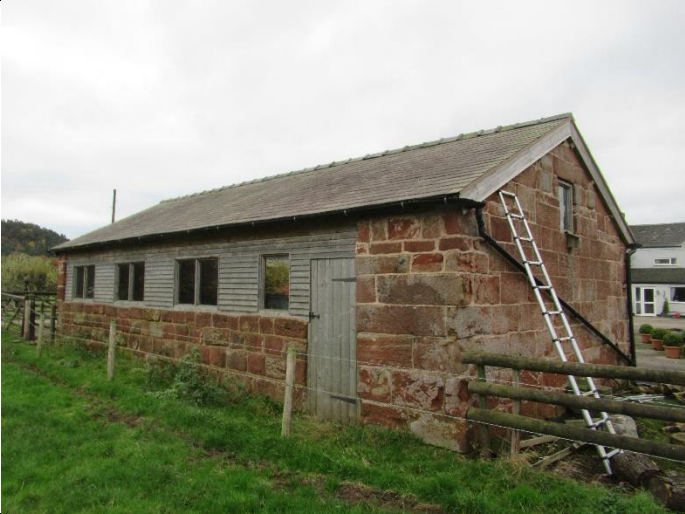
Shiplap boarding over rear joinery
5.2

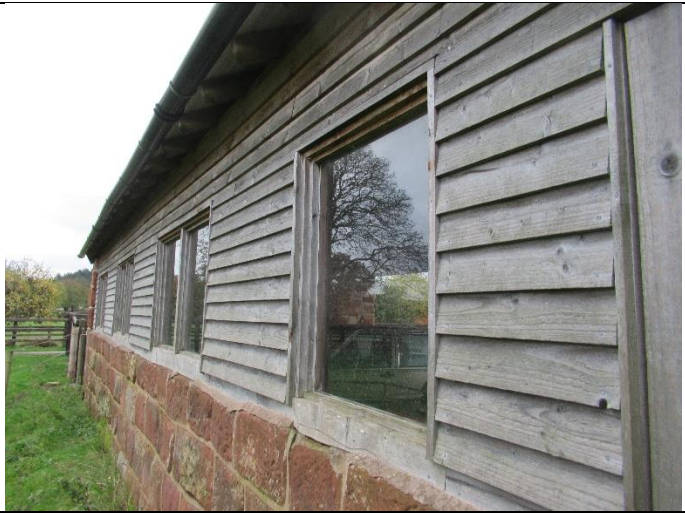
There is no requirement for invasive damp proofing interventions (as per BS7913:2013 – Conservation of Historic Buildings).	
5. External Joinery	<p>The rear elevation wall comprises a 100x100mm modern timber frame with three window openings and a door.</p> <p>Windows include single glazed panels, and the door is formed with basic timber panels.</p> <p>Rear face of framing is clad with shiplap timber panels.</p>	<p>Good condition.</p> <p>All joinery retains its basic shape and form. Three parts can easily be altered to incorporate more appropriate forms for residential usage.</p> <p>Shiplap provides basic weather protection. Staining to the internal face of the boards and frame indicate some damp penetration occurring.</p> <p>The connection between the frame and supporting stone wall is closed off with cement. The mortar has mostly loosened and detached. Replacement with lead would be preferable.</p>	Complete replacement/redesign of door and windows – to be informed by project design.

Basic single glazed window
5.3

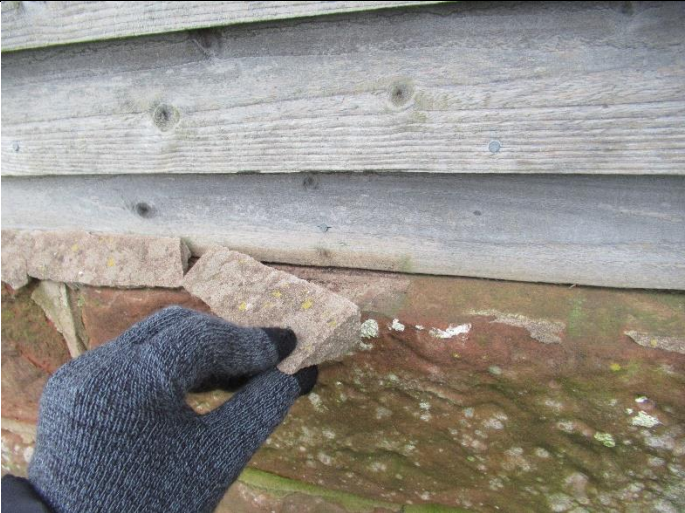
Detaching cement mortar at framing/wall junction

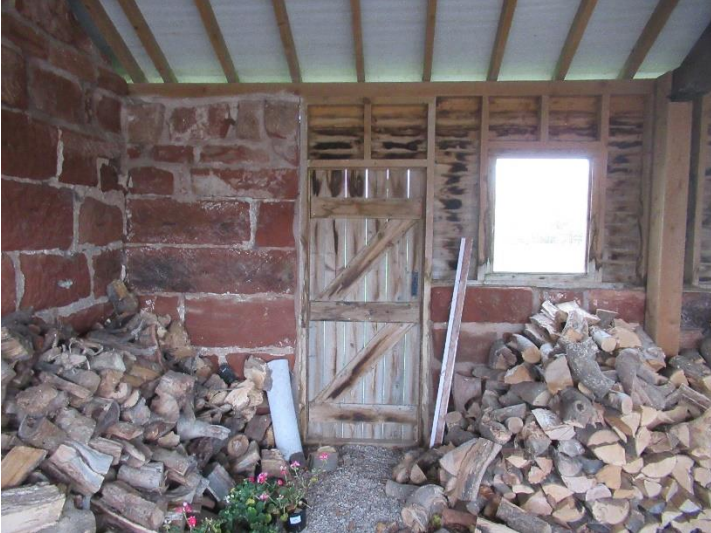
5.4

Deterioration/moisture staining to inner side of door and shiplap
6	WALLS AND CEILINGS
6.1

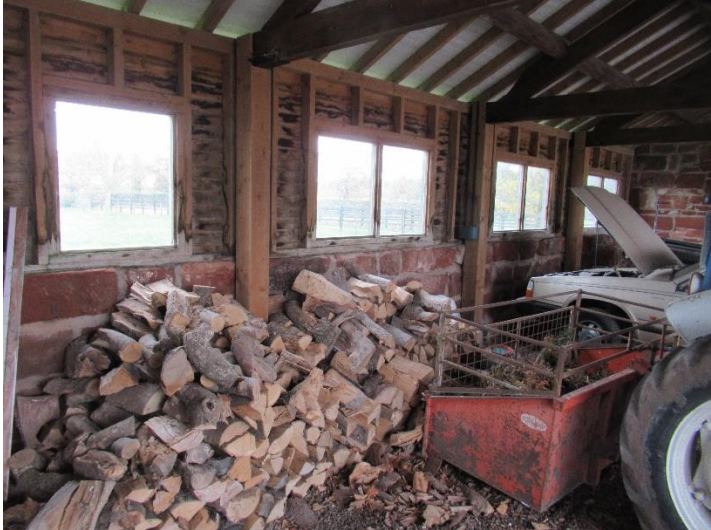
Inspection restricted by storage

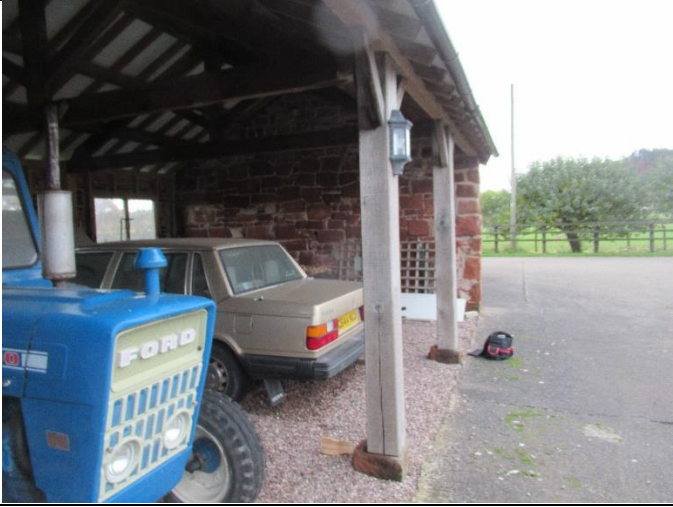
A photograph showing the ground floor structure of a building. A blue Ford tractor is parked in the foreground, and a silver car is parked behind it. The building has a stone wall and a wooden post-and-beam roof structure. The floor is covered in pebbles. A black bag is on the ground near the car.
	Pebble covered floor
