**OVERVIEW SURVEY**

**ABERTILLERY & DISTRICT HOSPITAL  
ABERBEEG  
BLEANAU GWENT  
WALES  
NP13 2DA**

Elysium Healthcare Ltd  
2 Imperial Place  
Maxwell Rd  
Borehamwood  
WD6 1JN

April 2023

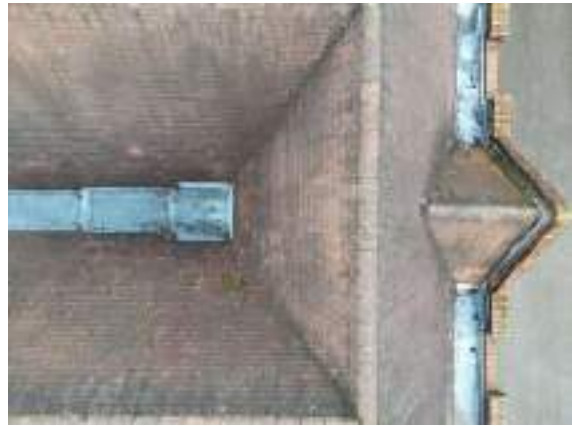
Photo 101.

Item	Photo	Element	Location	Description	Condition/Defect	Works Required	Quantity	Cost £
<b>A</b>		<b>Externals</b>						
1.00		<u>Roofs</u>	-	-	-	-	-	
1.01	101	Roof Coverings	Main pitched roof	Clay tile pitched roof.	Pitched tiles generally in poor condition with slipped and missing tiles, previous repairs and battens rotted tile fixing nails corroded. Some areas of underfelt missing. Current and previously repaired roof leaks.	Reroof complete with tiles on new battens and felt. Allow 70% tile reuse. New ridges and hips where necessary.	550m <sup>2</sup>	247,000

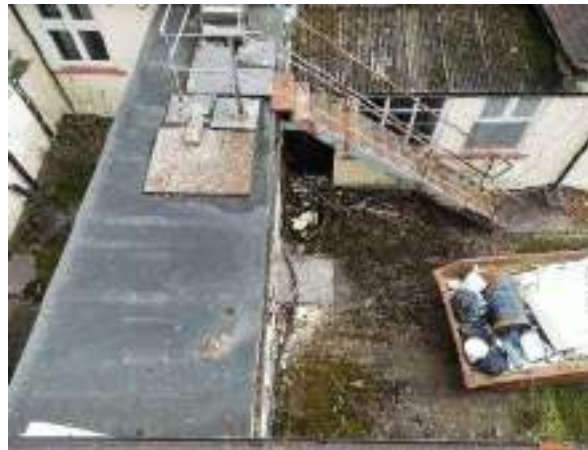
Photo 103.

1.03	103		-	Lead flashings to first floor external staircase.	Area of lead flashing missing under window adjacent to the first floor external door.	Replace lead flashing	1m <sup>2</sup>	250

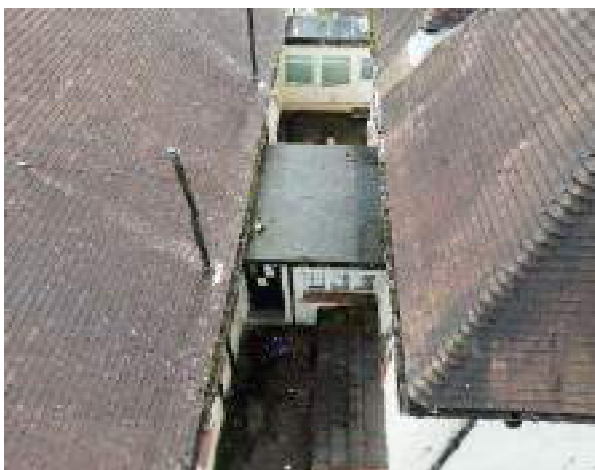
Photo 104.

1.04	104		Link corridor roof	Felt flat roof.	Generally in very poor condition with evidence of water ingress internally. There is also some deflection of the roof deck where it abuts the external staircase.	<u>LINK DEMOLITION INCLUDED IN SUMMARY</u>	Item

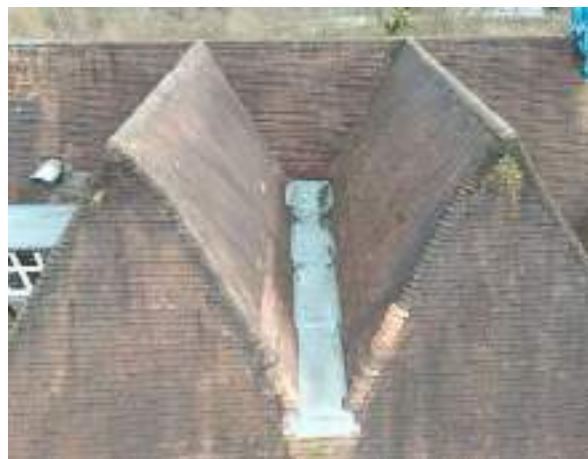
Photo 105.

1.05	105		Flat roof to main corridor central link	Felt flat roof.	In weathered and deteriorated condition, no leaks at present but recommend reroof to same standard as other roofing works.	Strip existing and lay new felt warm deck flat roof system.		15,000

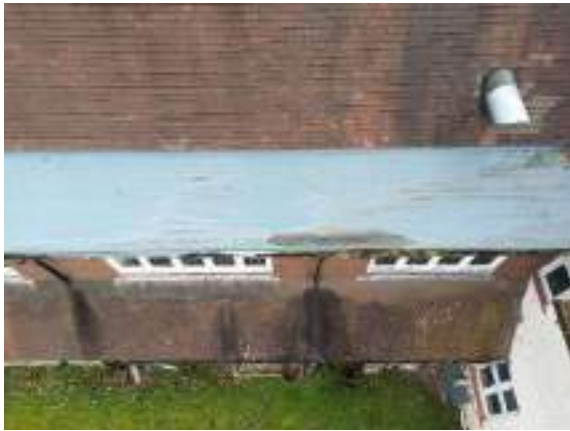
Photo 106.

1.06	106		Flat roof to central roof valley	Lead flat roof in center of rear roof valley.	In poor condition with leaks evident and deterioration to the lead sheet. Dressing up underneath tiles is lifting.	Strip up existing lead cap sheet and install new lead roof complete to match existing arrangement	16m <sup>2</sup>	25,000

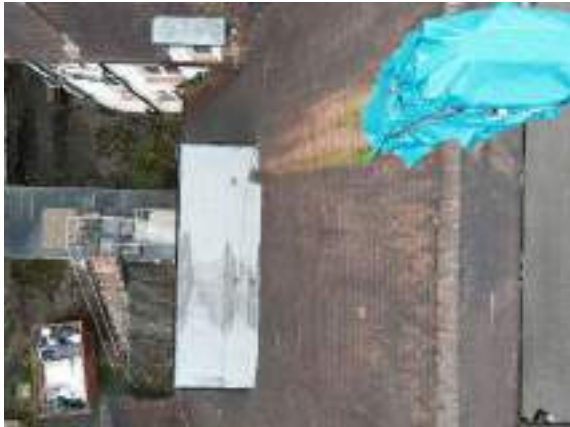
Photo 108.

1.08	108		Monopitched roof above Rooms 15 and 17	Monopitched asbestos sheet roof.	Asbestos sheet roof in very poor condition and allowing water to ingress into the areas below.	Undertake licensed removal of asbestos roof covering. INCLUDED WITH ASBESTOS REMOVAL - SEE SUMMARY	6m <sup>2</sup>

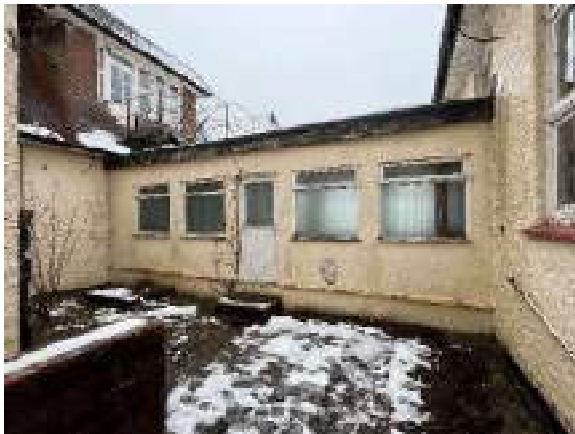
Photo 114.

2.03	114		Outside of Kitchen Manager's office	Pebbledash render.	Some cracking to render where saturated.	Hack off approx. 1m <sup>2</sup> of defective render and refinish with matching render.	1m <sup>2</sup>	500

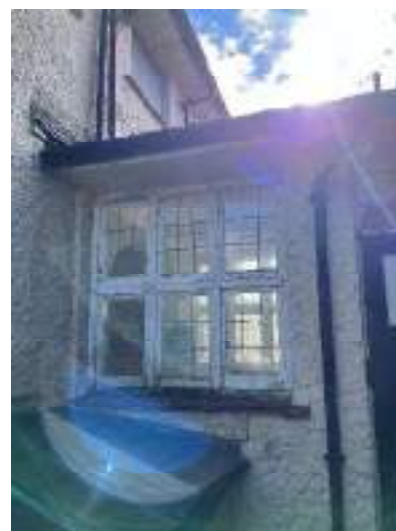
Photo 117.

2.06	117	Windows	Windows generally	Timber single glazed windows (5no).	Windows in reasonable condition but worn. Glazing putty has deteriorated and needs to be replaced, full redecorations required.	Renew putty to 5no windows.	30cm	500

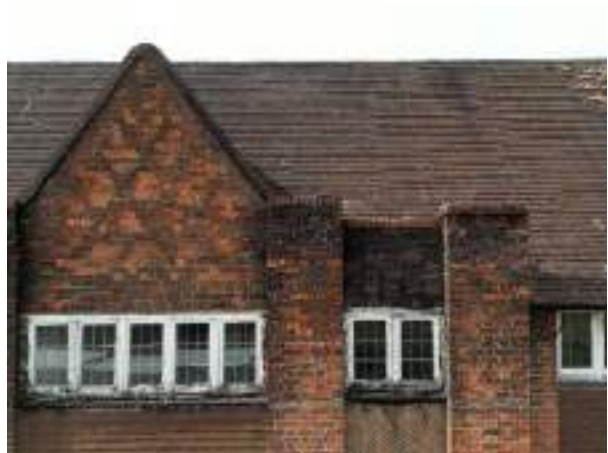
Photo 119.

2.15	119		Brickwork and lower entrance door (Room 10)	Cement mortar to red brickwork.	Area of pointing either side of doorway poor at low level, repointing required.	Rake out loose pointing around door and repoint.	2m <sup>2</sup>	250

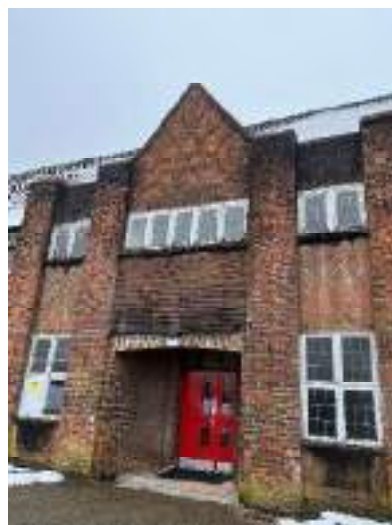
Photo 123.

2.20	123		-	Solid brickwork underneath adjacent window.	Area of brickwork saturated at low level, caused by leaking gutters	Dry out brickwork. Minor repairs only.	4m <sup>2</sup>	250
