Repairs and Refurbishment Works to:

Aberbeeg Hospital,
Aberbeeg,
Abertillery
NP13 2DA

Project: Aberbeeg Miners Hospital – Roof replacement works

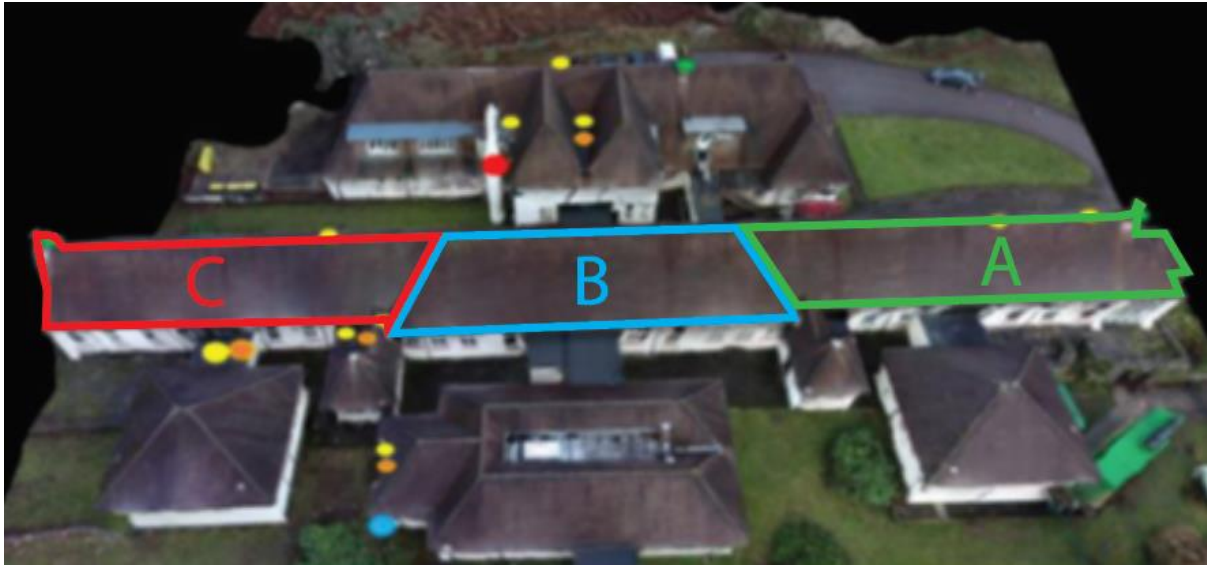
Aerial view showing the proposed area of works to the main building, Aberbeeg Hospital..

- Erect scaffolding to main building commencing with Zone A, followed by zones B & C over the contract period of 24 weeks.
- Remove asbestos soffits.
- Take down and rebuild chimneys.
- Strip existing roof areas in zone order and replace on a like for like basis.
- Fit new timber soffit and fascia boards
- Replace Rainwater goods.
