REPORT ON THE TREES LOCATED AT 16 HOPE TERRACE, EDINBURGH

18 December 2023

Prepared at the request of Elpis Property Ltd

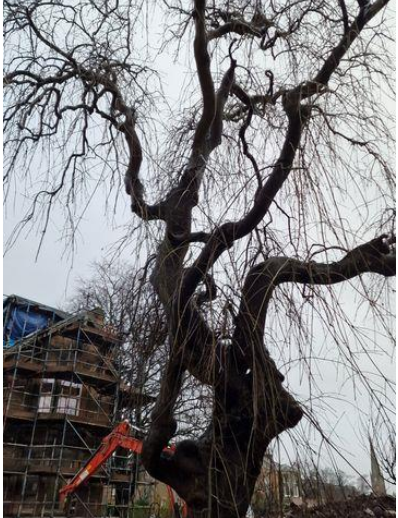
- 3.3 It is seen from the inspection of Ash Tree T0952 that the fungal body *I. hispidus* is growing from the trunk of the tree. It should be noted David Lonsdale's "Principles of Tree Hazard Assessment and Management" Forestry Commission: Research for amenity N0.7 says, "Since *I. hispidus* weakens the wood of *F. excelsior* at an early stage of decay, its presence on this species, often indicates that breakage of the affected branch or trunk could be imminent." Whilst this specimen is Weeping Ash, (*Fraxinus excelsior* "pendula") this would still be relevant and more so as its general weeping form has an inherent structural weakness. It is often seen in collapse of ash stems and branches caused by *I. hispidus* undermining the structural integrity of the tree's heartwood. The reason it does this is that this is a heart rot fungi that feeds on both the lignin and cellulose in the heartwood, weakening the trees structural integrity by undermining the trees flexibility and rigidity at the same time. David Lonsdale also points out in the same publication that Ash has a low resistance to decay this is because "*The relatively low moisture content of Fraxinus wood makes it rather susceptible to decay. Also the heartwood does not appear to be rich in preformed defensive substances*" What this means is the trees level of toxins that are used by trees to fight decay and fungal – bacterial infection are low in this species and as such fungi like *I. hispidus* can cause high levels of damage here whereas in a plane tree it may be lower. It is for this reason the fungi is commonly found on Ash trees.

- 3.4 Further, tree T0952 has significant dieback throughout the canopy with large amounts of dead wood present. This tree has symptoms consistent with Ash Dieback and removal is recommended within the next 6 months

Ref.	Species	Measurements	Recommendation	Work Timescale	Photo
T0952	Weeping Ash (<i>Fraxinus excelsior</i> 'Pendula')	Height (m): 16 Crown Radius (m): 5 DBH (cm): 69 Life Stage: Mature Life Exp.: <10 years	Fell tree.	13-Dec-2024 (1 Year)

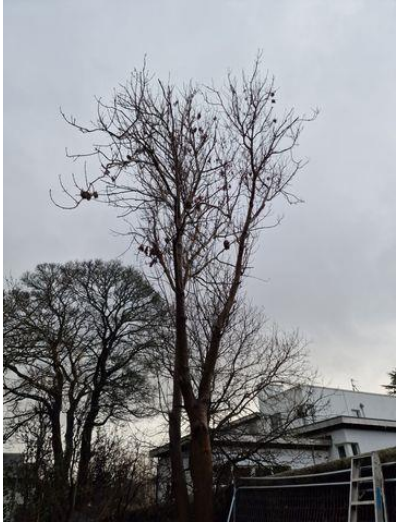
- 3.5 Ash Tree T0954 is located next to the boundary wall of 14 Hope Terrace. A self-seeded tree growing immediately adjacent to stone wall. Forks into two codominant stems at the base, this provides a very acute union with included bark. This creates a significant structural defect. This specimen also has significant dieback throughout the canopy with large amounts of dead wood present, there is epicormic growth growing on the structural branches which is a good indicator of stress. This tree has symptoms consistent with Ash Dieback and removal is recommended within the next 6 months. Removal of all timber and arisings will need to comply with government guidance, see attached notes.

T0954	Ash (<i>Fraxinus sp.</i>)	Height (m): 9 Crown Radius (m): 2 DBH (cm): 34 Life Stage: Early Mature Life Exp.: <10 years	Fell tree.	13-Dec-2024 (1 Year)
