PROJECT: BEE PARK BARN, HAMETETHY, CORNWALL

REPORT TITLE: SITE INVESTIGATION REPORT –

WATER SUPPLY PIPEWORK

REPORT REF: YES 2070

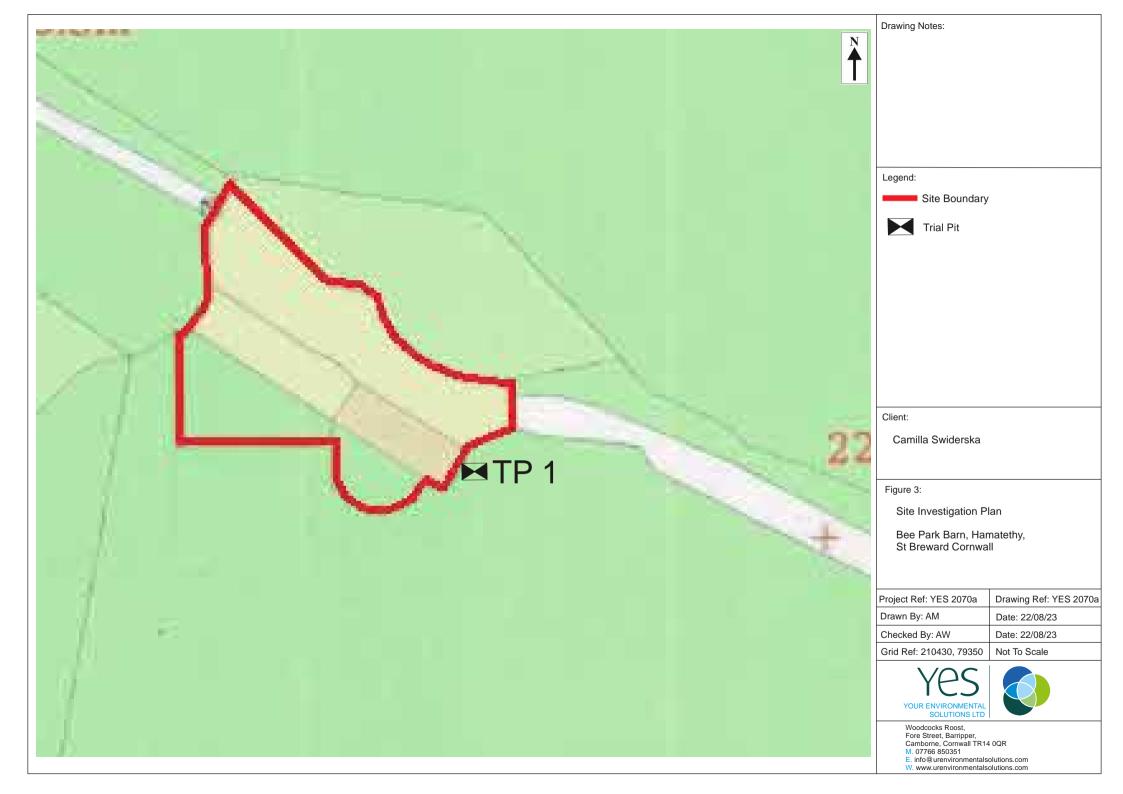
A site investigation was undertaken on 17th August 2023. The site investigation comprised the excavation of a single trial pit (TP) undertaken along the route and depth of the proposed water supply.

The site investigation layout is shown on Figure 3.

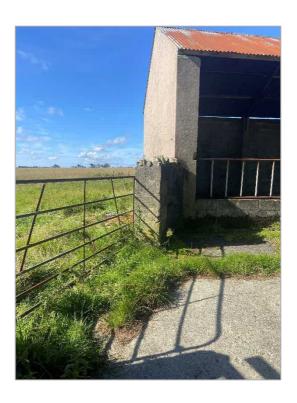
PHOTOGRAPH 1: View of the trial pit's location immediately adjacent to the south-eastern gable end of the building

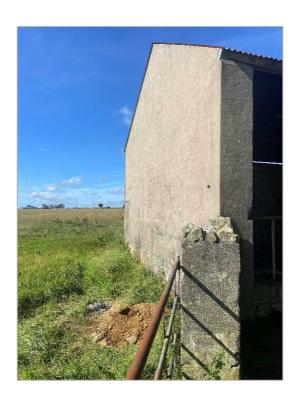
PHOTOGRAPH 2: View of the trial pit's location immediately adjacent to the southern-eastern gable end of the building

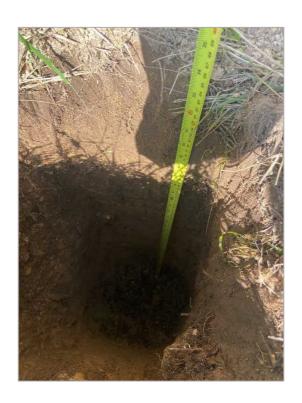
PHOTOGRAPH 3: View of the trial pit

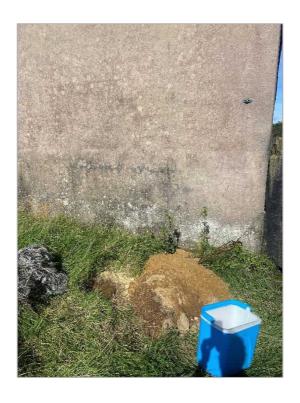
PHOTOGRAPH 4: View of the trial pit's location

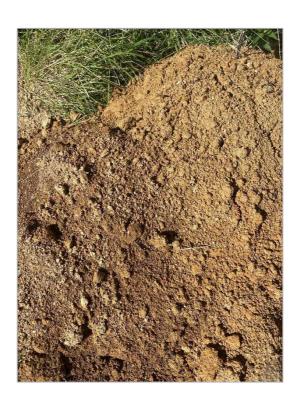
PHOTOGRAPH 5: View of the excavated arisings

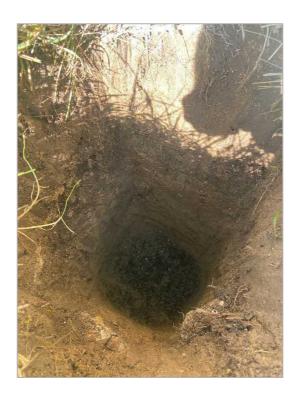
PHOTOGRAPH 6: View of the trial pit
